# Evaluation of the performance of coated and uncoated carbide tools in drilling thick CFRP/aluminium alloy stacks

**Abstract** This paper aims to establish the wear mechanisms of coated and uncoated tungsten carbide drills when drilling carbon fibre reinforced plastics (CFRP)/aluminium alloy (Al) stacks. During the drilling experiments, thrust forces were measured. A scanning electron microscope (SEM) and a numerical microscope, provided with a scanning device, were periodically used to analyse tool wear mechanisms and to measure wear progression of the tool cutting edges. For both coated and uncoated drills, abrasion was the dominant tool wear mechanism, affecting the entire cutting edges. Higher wear was observed on uncoated tools which caused a significant increase in thrust force during drilling both Al and CFRP materials. The influence of these phenomena on the quality of the holes and on the generated roughness was also discussed.

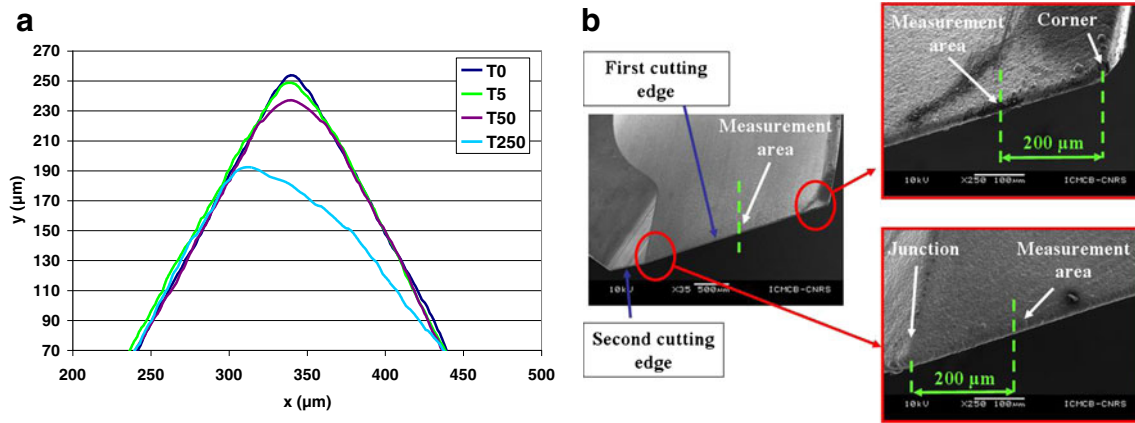
**Fig. 1** a Cutting edge profile for tool A at 200  $\mu\text{m}$  from the drill corner after 5, 50 and 250 holes compared with the unworn profile (T0). b Measurement location on the cutting edge to obtain 2D edge profile

measures were performed on three locations on the tool cutting edges: at 200  $\mu\text{m}$  from the drill corner, at the centre and at 200  $\mu\text{m}$  from the junction between the first and the second cutting edges, as seen in Fig. 1b. In addition, tool wear mechanisms were identified using a scanning electron microscope (SEM).

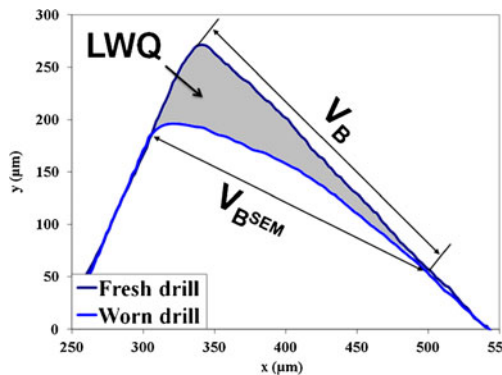
**Fig. 2** Measurements of flank wear ( $V_B$ ) and local wear quantity (LWQ) on a cutting edge profile

edge and the last point worn on the flank face ( $V_{\text{BSEM}}$  in Fig. 2).

From the 2D cutting edge profiles, the actual flank wear value ( $V_{\text{B}}$  in Fig. 2) can be obtained. It is also possible to estimate, from the tool edge profiles superposition, the amount of the material locally lost by the tool (grey surface in Fig. 2)

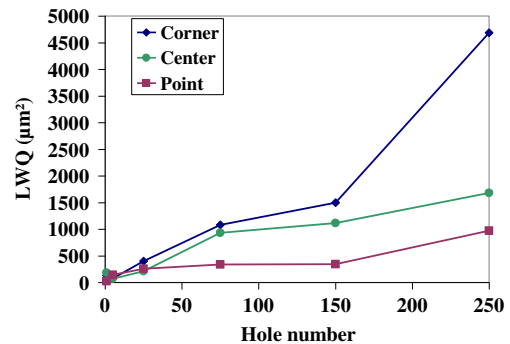
**Fig. 3** LWQ measured on three locations on the cutting edge

The measurement of the LWQ, on three locations on the cutting edge, has shown the non-proportionality of the LWQ with the radial position of the measurement location (Fig. 3). The higher LWQ is found at the drill corner and it decreases up to the drill point.

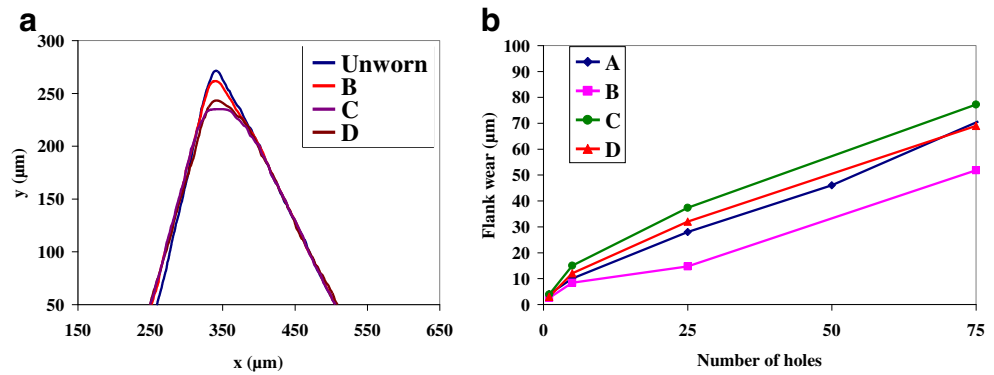
**Fig. 4** **a** Cutting edge profiles near the drill corner after 75 holes for drills B–D. **b** Flank wear evolution with the number of holes (located at 200  $\mu\text{m}$  from the drill corner) for drills A–D

unworn profile of the drill A is shown. TiAlCrN (tool C) and AlTiSiN-G (tool D) coatings were not efficient. Their flank wear was very close to the one measured on the uncoated tool A (Fig. 4b). As shown in Fig. 4a, the cutting edge profiles of these tools are also similar.

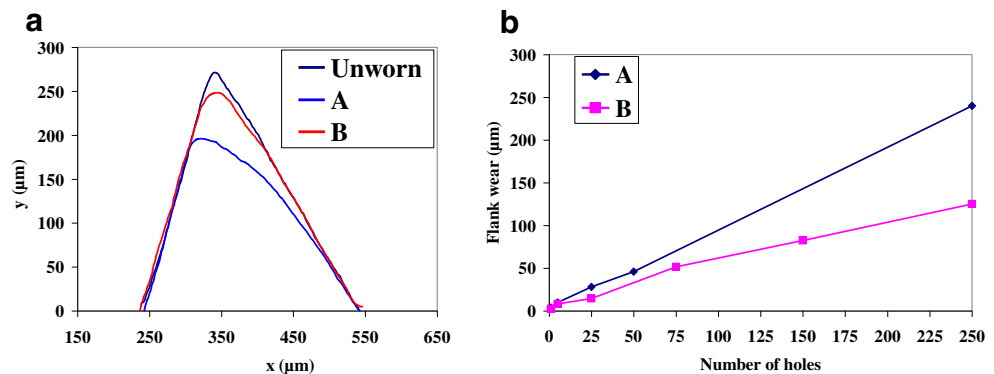
**Fig. 5** **a** Cutting edge profiles of unworn and worn A and B drills (after 250 holes). **b** Flank wear (near the drill corner) evolution with the number of holes

Diamond coated tool B is the only really effective one. For this tool, the coating breakage occurred after drilling 150 holes. The flank wear measured on this coated drill is 50 % lower than that measured on the uncoated drill (tool A), as shown in Fig. 5b. As for the LWQ, the use of a diamond coating allows a drill wear decrease of about 80 %.

Low hole surface roughness with a good stability in time (Fig. 14) is obtained by diamond coated tool B, due to its slight evolution of the cutting edge profile (Fig. 5a).

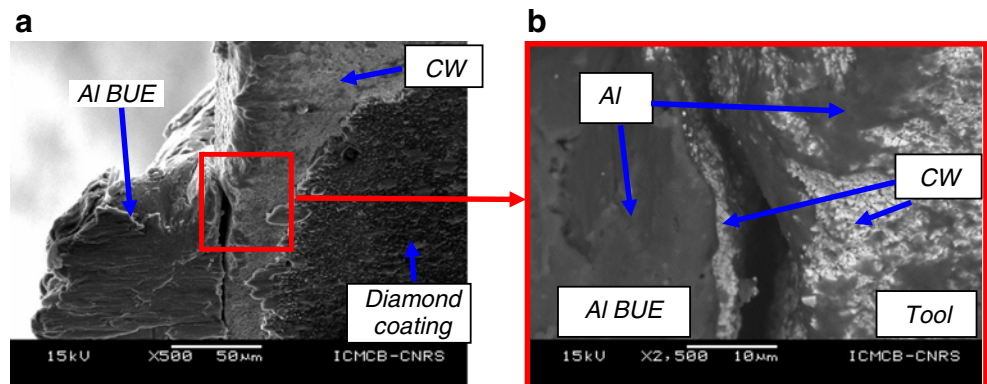
**Fig. 7 a** Attrition phenomenon on the cutting edges for tool B. **b** Zoom of the zone of interest, in chemical contrast (magnitude, 2,500)

For uncoated tools, abrasion was observed on the chisel edge, on the corner, on the primary and on the second cutting edges. Before the coating failure, coated drill B underwent the same type of wear as the uncoated drill. It was subjected to abrasion, followed by coating failure on the cutting edge. After the coating failure, an aluminium layer replaced it on the cutting edge and created a build-up edge (BUE). This adhesive wear is then the site of WC attrition. The BUE, stuck on the cutting edge, tears WC particles when it is removed, as observed on Fig. 7a, b.

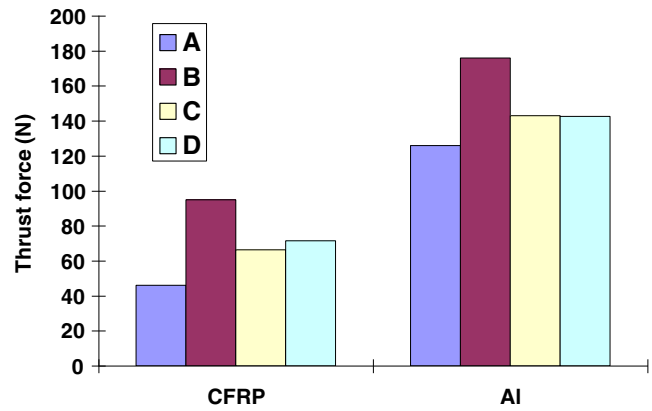
Fig. 9 Average thrust force on the first hole

For the first hole, when the drills are unworn, the average thrust force of the uncoated drill A is from 30 to 50 % lower than the thrust forces of the coated drills B–D (Fig. 9), mainly due to the cutting edge sharpness. Cutting edge radius was 9  $\mu\text{m}$  for tool A, 11  $\mu\text{m}$  for tools C and D, and 15  $\mu\text{m}$  for tool B. This difference concerning the cutting edge sharpness is the consequence of the coating thickness.

CFRP and Al have dissimilar mechanical properties. Therefore the thrust force generated by drilling has different magnitudes. As shown in Fig. 9, the force generated by CFRP drilling was lower than that produced in the aluminium, on the first hole. Zitoune et al. [12] obtained a similar trend, using comparable drill diameters. Brinksmeyer et al.

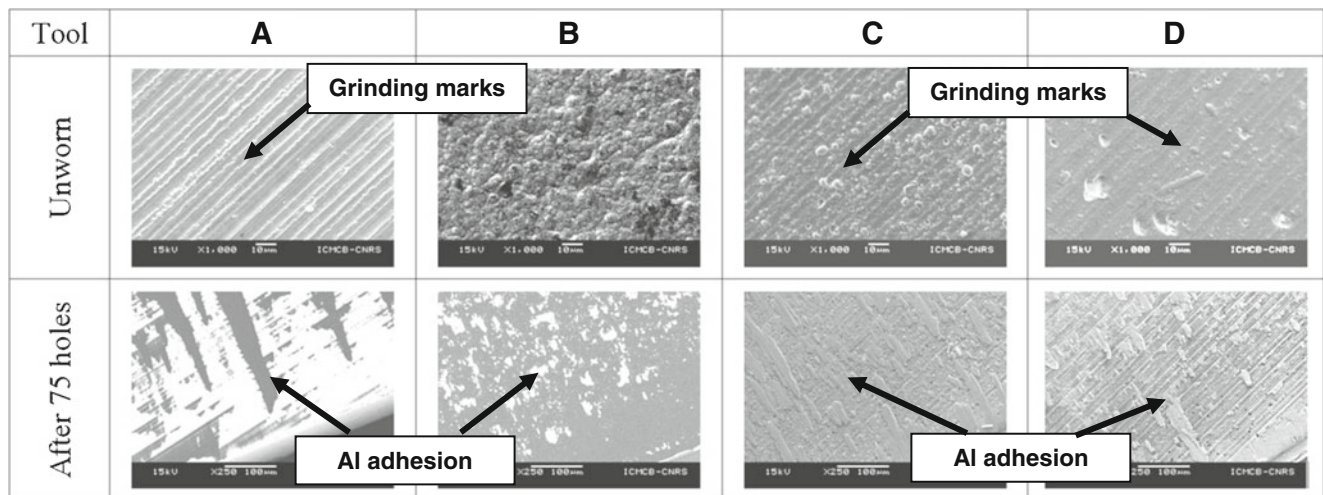
Fig. 8 SEM images of rake faces of unworn and worn drills (after 75 holes)

Adhesion was also observed on the tool rake face. Grinding processes, carried out to prepare drill flutes, generate a relatively rough surface. Therefore, Al adheres on the rake face. The amount of Al deposited on the tool depends on the surface roughness. With a thin layer coating, like for tools C and D, the coating thickness was unable to totally erase the grinding marks (Fig. 8). It can be observed that the coating takes the surface profile and the same amount of material adheres on the tool, as for the uncoated drill. The diamond coating thickness was able to “erase” the previous grinding marks (see tool B on Fig. 8). Therefore, for this coating, less Al alloy has stuck on the rake face, as seen in Fig. 8.

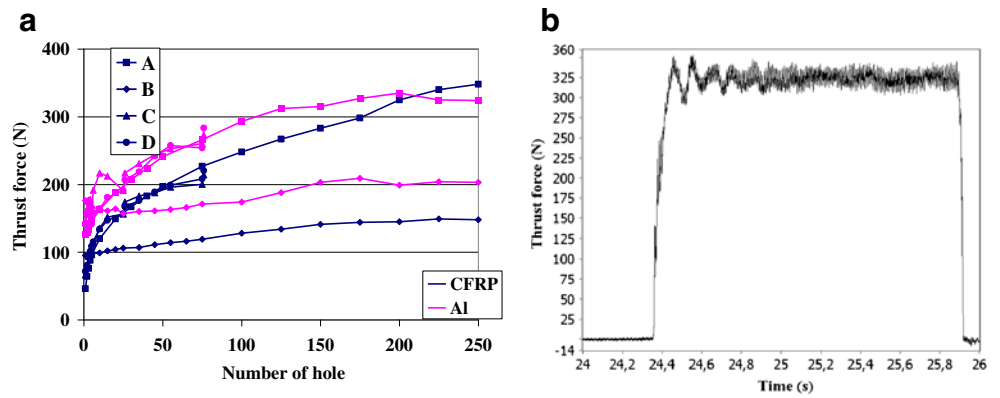
**Fig. 10** **a** Evolution of average thrust force with the number of holes. **b** Thrust force signal on hole No. 200 (for one of the five cutting passages in Al plate)

The average thrust forces increase with the number of drilled holes (Fig. 10a). The thrust forces generated by the uncoated drill, gradually rise in both CFRP and Al alloy. This trend was also observed for the coated drill B, but it was lower. This increase is mainly due to the tool wear. The thrust force grow is dissimilar between the two materials. For the aluminium, the increase of thrust force is asymptotic near the 250th hole while for the CFRP, the thrust force continues to increase. This implies that the thrust force measured in the CFRP can become higher than that observed in the aluminium, as for tool A on the 250th hole.

The benefit of the diamond coating on thrust force is shown in Fig. 10. For the same cutting conditions, the use of a diamond coating can decrease the force (by limiting wear) by 65 % when drilling CFRP and by 35 % in Al.

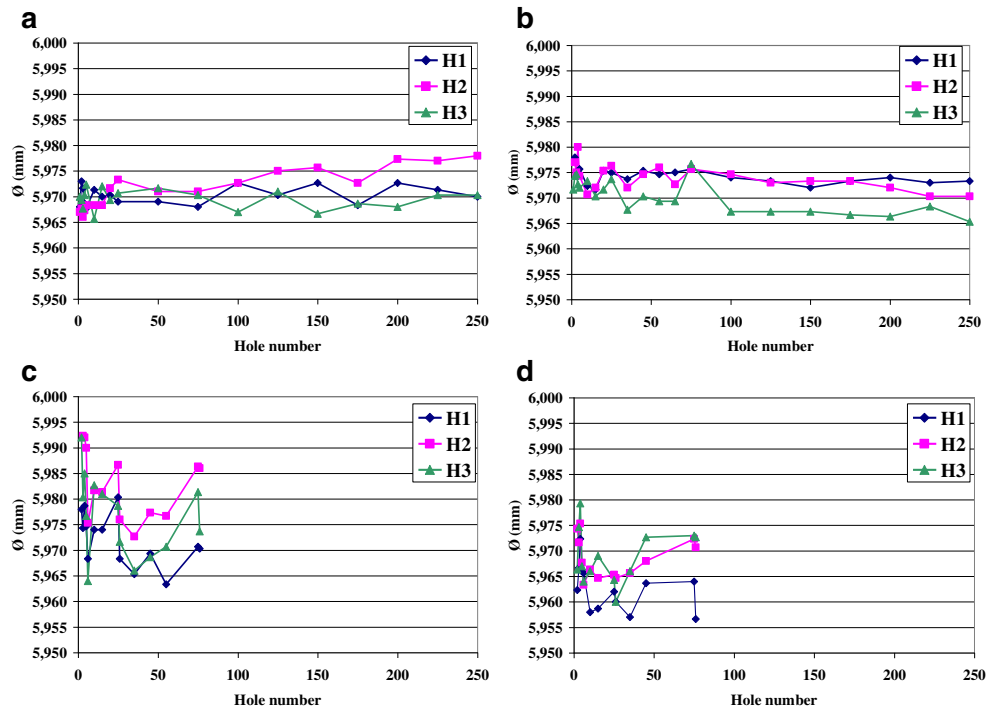
**Fig. 11** Hole diameter evolution for tool **a** A, **b** B, **c** C and **d** D

Figure 11a–d shows that the evolution of the diameter of the holes with the number of drilled holes is relatively stable, especially for tools A and B. This stability was also observed by Benezech et al. [17]. It can also be seen that the diameter of the holes drilled in CFRP (H1 and H2 in Fig. 11) is bigger than the one measured in the Al alloy. Some additional experiments have shown that opposite trends can be obtained following the used cutting condition and particularly, the lubrication condition. Without lubrication and for the same tool geometry, the diameter of the holes drilled in CFRP remains the same but bigger diameters are produced in the aluminium. Therefore, diameters of the holes drilled in Al are becoming bigger than those produced in the CFRP. This difference can be due to thermal phenomena that occur during the drilling process. A diameter difference in CFRP and in the metal part was also noted by Shyha et al. [18].

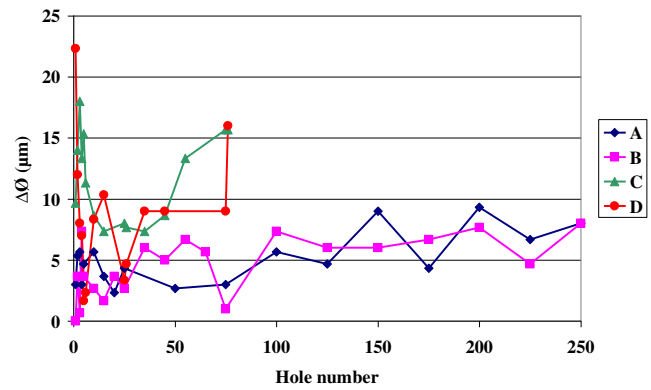
Fig. 12  $\Delta\phi$  evolution with the number of drilled holes

The difference between the average diameter in both altitudes in CFRP, and the diameter in metal, noted  $\Delta\phi$ , is shown in Fig. 12. Best results are observed for drills A and B with a  $\Delta\phi$  of 8 to 9  $\mu\text{m}$  against 16 to 18  $\mu\text{m}$  for drills C and D. As it can be seen in Figs. 11 and 12, the presence of a coating has little or no influence on the diameter difference ( $\Delta\phi$ ). No diameter deviation was observed with the number of holes, as it can be seen in Fig. 11. With a similar drill diameter, different results were obtained by Benezech et al. [17] where the diameter difference was nearly 30  $\mu\text{m}$ .

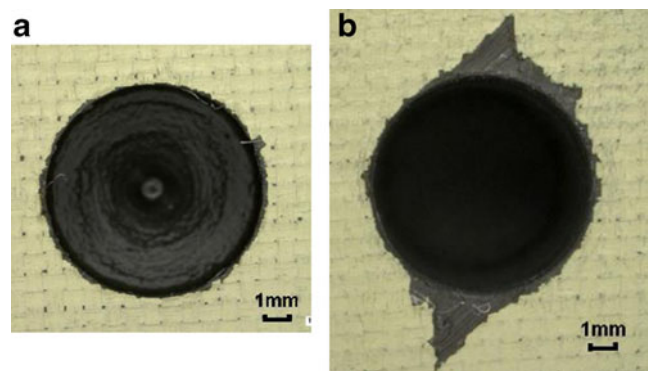
Fig. 13 CFRP damages at the hole entry a before and b after aluminium chip evacuation

The CFRP damage at the hole entrance, shown in Fig. 13b, was observed whatever the drill used, starting with the first hole. Therefore, it can be concluded that this phenomenon is not due to the tool wear. It can be caused by the tool geometry, as described by Hocheng et al. [19], where the drill flute pulls out the first layers of the composite material. Or, in the case of a multi-material, this damage can be due to the metallic chip evacuation through the hole, as observed by Brinksmeier et al. [8]. The last hypothesis has been proved in our case by observations made before aluminium part drilling and chip evacuation. Due to the chip removing cycle, the drilling process can be stopped at any time. For ten holes, the drilling process was stopped before creating aluminium chips. A workpiece photo was taken at this moment and no CFRP damage was observed, as it can be seen in Fig. 13a. After completed drilling process, the CFRP damage reaches more than 2 mm (Fig. 13b). The drill flute does not guide the chip

enough all along its length and, as seen by a CCD high speed camera, the metal chip is in contact with the hole entrance. As shown in Fig. 13b, this damage is not localised all around the hole entrance. It is situated in places where the direction of the chip movement (due to drill rotation) and the fibre orientation creates a  $-45^\circ$  angle. In this configuration, similar damages have been observed by Iliescu [20] during CFRP cutting.

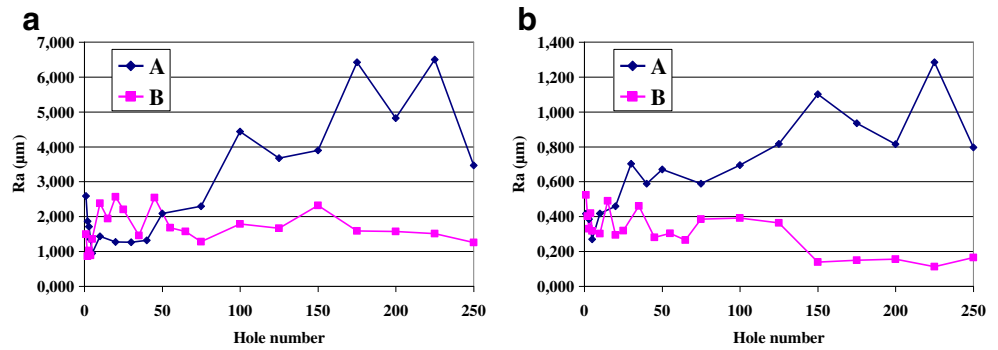
**Fig. 14** Roughness Ra for the **a** CFRP part and **b** Al part

As it can be seen in Fig. 14, the hole wall roughness on the first 50 drillings was similar for uncoated (A) and coated (B) tools. The same roughness level was found by Zitoune et al. [12] in their study on the influence of machining parameters on drilling performance of CFRP/aluminium stacks.

The roughness of the holes performed by the uncoated tool (A) increases with the number of drilled holes, in both materials (Fig. 14a, b). This phenomenon is greatly problematic, because the roughness can become higher than the one required in the aeronautics industry. Currently, the maximum acceptable roughness in aeronautics is  $1.6 \mu\text{m}$  in Al and  $3.2 \mu\text{m}$  in CFRP. In the Al, the roughness increase is slight and remains at an acceptable level. In the CFRP part, the uncoated tool produces hole wall roughnesses higher than  $3.2 \mu\text{m}$ , after 75 drilled holes.

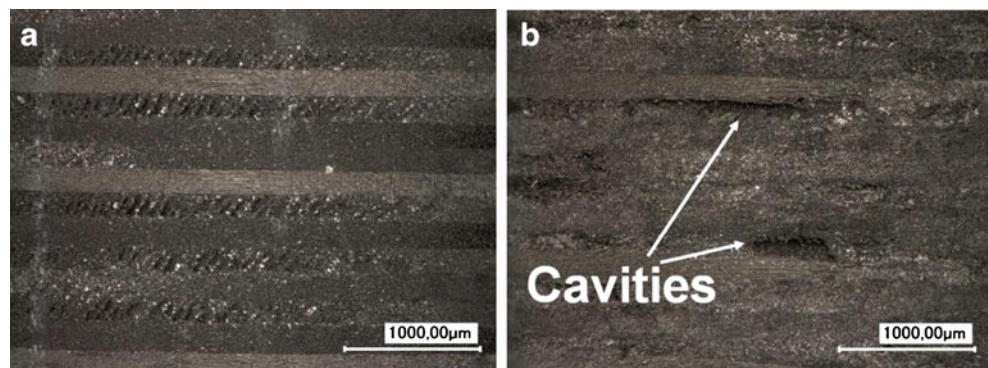
**Fig. 15** CFRP hole wall on the **a** 1st and **b** 250th hole drilled by the uncoated tool A

The increasing of the roughness is due to the wear undergone by tool A and its rapid growth. Sharp cutting edges generate no defect on the holes wall (Fig. 15a) and low roughness is measured. When the tool cutting edge sharpness becomes too low, the drill is unable to cut the carbon fibres. These fibres are rather pulled out than cut, especially when the cutting direction and the fibres create a  $-45^\circ$  angle. As a consequence, little cavities are generated on the holes wall (Fig. 15b) and therefore, the roughness increases. The same phenomenon was observed by Iliescu [20] when drilling CFRP plates.
