Impact of disturbed drilling conditions on the surface integrity of a Nickel-base superalloy

V.Dutilh^{1,2}, A.Popa², G.Dessein², J.Alexis², G.Perrin¹

Abstract

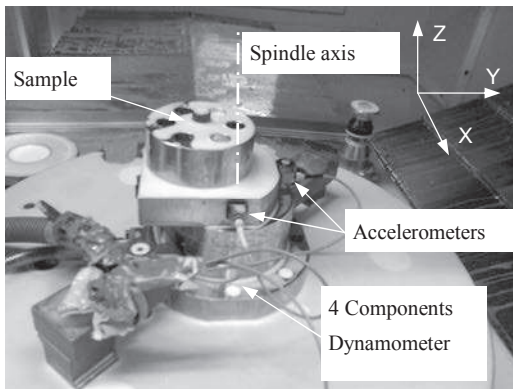
Figure 1. Experimental set up

The machine-tool was instrumented by a 4 components Kistler dynamometer (Fx, Fy, Fz and Mz), and three accelerometers placed following the directions X, Y and Z. The spindle power, the position of Z axis, the intensity of the spindle and the motors intensity of the three axes are also recorded through the Siemens Profibus.

Finally, we designed an assembly to manage the drilling of 6 holes per bar and to make those holes systematically at the center of the dynamometer. In this type of dynamometer, the torque is measured by a sensor and not calculated as in a 3 components dynamometer (figure 1).

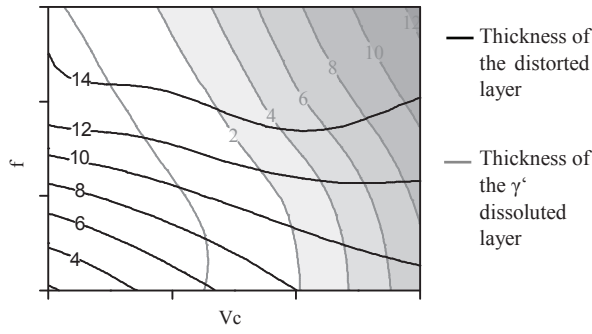
Figure 2. Thickness (μm) evolution of the distorted and γ' dissolved layer vs. cutting speeds.

The accurate observation of the thermo-mechanically affected layer with the SEM shows that it corresponds to two layers. A layer characterized by a heavy distortion of grains and primary γ' (black curves on figure 2) and a second layer characterized by a dissolution of the primary and secondary γ' phases (grey curves on figure2). This dissolution indicates a local overheating and mechanical stresses. Figure 2 present the evolution of the thickness (μm) of the both layers compared to the cutting speeds. The thermo-mechanically affected layer is always associated with the work-hardening in sub surface, measured with the micro-hardness profile. Furthermore, the larger the thickness of the thermo-mechanically affected layer is, the deeper the influence of the work-hardening in sub-surface is. Further analysis with residual stress measurements will complete those observations.

Observations carried out on each anomaly as made on figure 2, have permitted to establish a cutting domain without surface integrity damages (figure 3) with more precision than the previous one defined in paper [10].

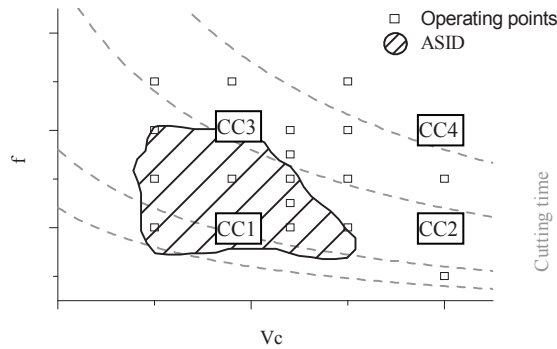
Figure 3. Cutting conditions and Acceptable Surface Integrity Domain

On figure 3 the Acceptable Surface Integrity Domain (ASID) is also delimited for the low speeds but this range of speeds were not explored. The upper limit for the feed axis was mainly delimited by the roughness value and the distorted layer. The upper limit for the V_c axis was mainly delimited by the apparition of the γ' dissolved layer. In paper [10] the ASID was different but it was not the same machine and the rigidity of the first machine was lower.

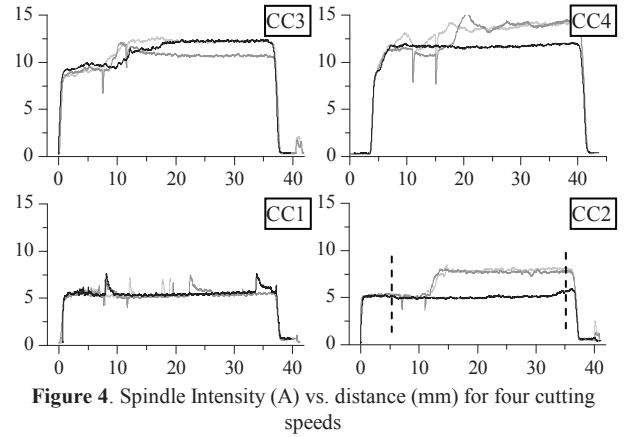
Figure 4. Spindle Intensity (A) vs. distance (mm) for four cutting speeds

Figure 4 presents the Intensity of the spindle during the drilling for each cutting conditions tested. Spindle Intensity is used because the signal is already filtered and presents the same topography as the power. The X axis represents the distance (mm) from the entrance of the hole and the Y axis is the intensity (A) value of the spindle. The black curve represents a normal operation without lubricant interruption. The grey curves represent two different drillings (new tools for each one) with the same lubricant interruption. The

lubricant interruption can be identified with the two consecutive decrease and increase in intensity. This is a consequence of the Z axis feed stop during data processing the lubricant interruption by the numerical controller, but the tool never leaves the material.

On the figure 4, for the cutting conditions 2 and 4 (CC2 and CC4), we observe that the experiments with lubricant interruption show a rapid increase in intensity compared to the normal drilling. The cutting conditions 1 (optimal operating point) do not present any change between signals. The cutting conditions 3 do not present a significant change between the curves with the lubricant interruption compared to the normal drilling. But this particular cutting condition is at the limit of Acceptable SI Domain (ASID) and in the case of normal drilling has a very important dispersion due to hazardous tool wear. Nevertheless the trials with lubricant interruption have an excellent reproducibility whatever the cutting conditions tested for the same experimental campaign. These trials show that the combination of the cutting conditions with the lubricant interruption leads to an increase in signals amplitude (for all the measurement systems) except in optimal cutting conditions. However, the same phenomena (increased power, etc) were observed for the CC1 during another experimental campaign.

Surface Integrity examinations were carried out at 5 mm and at 35 mm from the entrance (dash lines on figure 4, CC2) on each hole which presented two different types and values of signals. Concerning micro-hardness measures, the load chosen is 0.1 kg which leads to have a print with 20 μm diagonal length. Figure 5 present two micro-hardness profiles (at 5 and 35 mm) for the CC4. This figure shows the influence in sub-surface of the drilling operation, and availability of the micro-hardness measurement as a criterion to define the surface integrity.

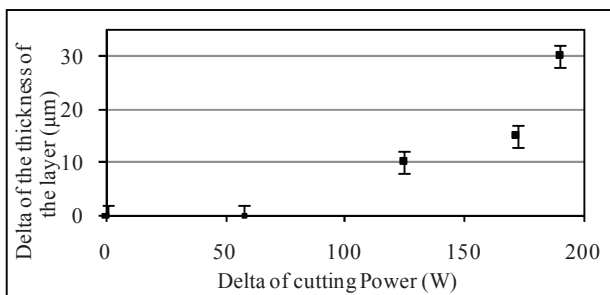
Figure 6. Delta of the thickness of the thermo-mechanically affected layer vs delta of the cutting power (between measures performed at 5 and at 35 mm from the entrance of the hole)

Figure 6 presents the delta between the entrance and the exit of the hole of the thermo-mechanically affected layer thickness (sum of the distorted layer and the γ' dissolution layer) compared to the delta of the corresponding cutting power. Paper [2] presents this type of analysis for normal drilling. Concerning this correlation, the power criterion is the most reliable because it takes into account the torque Mz and the axial force Fz of the drilling. Both SI criteria were added in order to be easier to measure but maybe they should be considered separately. In fact when the layer with the γ' dissolution appears, the thickness of the distorted layer seems lower than just before. Although the influence of γ' dissolved layer on fatigue life is proved, that of the distorted layer on fatigue life is not confirmed. Furthermore, some papers deal with the benefits of work-hardening on the fatigue life.

This type of correlation is a first step in order to establish a model able to estimate in real time the thickness affected by the drilling operation.
