## Lessons learned from structures damaged by delayed ettringite formation and the French prevention strategy

Bruno Godart, Loïc Divet. Lessons learned from structures damaged by delayed ettringite formation and the French prevention strategy. Fifth international conference on Forensic Engineering, Institution of Civil Engineers, Apr 2013, France. 12p. hal-00945667

# Lessons learned from structures damaged by delayed ettringite formation and the French prevention strategy

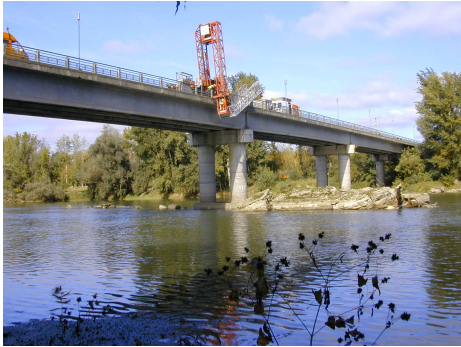
This bridge, located near Toulouse, was completed and opened to traffic in 1955. It consists of four pre-tensioned beams which are joined together by a top slab and crossbeams (Fig.2). It has a total length of 202 m and consists of five independent spans. The average height of the piers is 6.8 m. They are constructed on mass concrete which is set in the molassic substratum and they consist of two circular columns, 2 m in diameter, which are connected at the top by a

cap beam (see Fig.2). These latter are either hollow, at piers P1 and P3 supporting the moving bridge bearings, or solid, at piers P2 and P4 to which the fixed bridge bearings are fitted.

**Figure 2:** Overall view of the Ondes bridge

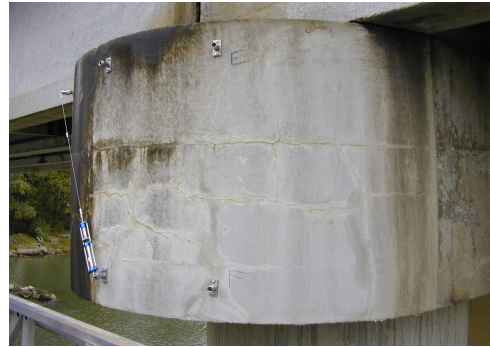
The damage only affects the solid cap beam of pier P2 (Fig. 3), the concrete of which was cast in August 1954. This is a solid parallelepiped reinforced concrete cap beam, measuring 1.5 m high, 8.2m long and 2.7 m wide. The first visible defects were observed during a detailed inspection conducted in 1982. The inspection report mentions the presence of cracking and the growth of vegetation at the ends of the pier cap beam. The previous inspection reports did not mention these defects. We can consequently assume that the damage first occurred in the early 1980s.

**Figure 3:** View of the end of the cap beam in 2005, after the treatment applied in 1995

The damage appeared as a network of widely-spaced multidirectional cracks. Cracking sometimes has a preferential orientation that depends on how the reinforcement is distributed. The crack widths vary from a few tenths of millimetres to a few millimetres according to the zones. The cracks are frequently emphasized by moisture and, occasionally, a whitish or greyish substance has been observed to exude from the cracks. The horizontal cracks appear to be more severe and are occasionally as much as 7 mm wide. Lastly, the damage is mainly present at the cap beam ends, on the facings that are directly exposed to bad weather and water dripping from the footpaths. No damage was found on the central part of the cap beam.

As part of the remedial programme on the Ondes bridge, the waterproofing membrane was repaired and the expansion joints of the roadway and sidewalk were reformed in June 1995. On pier P2, the extremities of the cap beam were treated by an injection of the cracks and then protected by a surface coating. In July 1996, a discontinuous horizontal crack of width 0.2 mm was observed. Water inflows are also observed on the extremities, despite the repair made in 1995. The evolution of the phenomenon is confirmed in 1998 with the occurrence of new cracks and by the results of the monitoring of the global deformations that has been installed. This attests of the difficulty to implement durable repair solutions for this type of pathology, and justifies the interest in enforcing preventive measures during construction to avoid DEF.

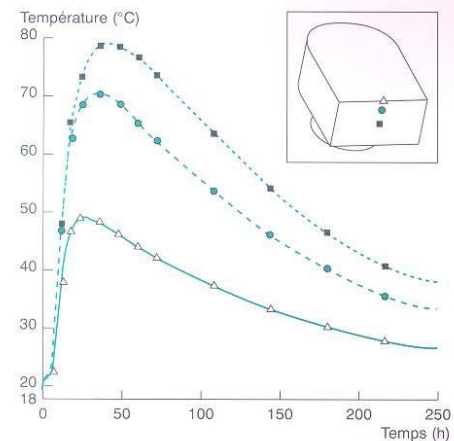
The heating cycle of the concrete during its setting was then estimated by a numerical simulation using the TEXO module. For this, information was required on: meteorological data during the setting period of the concrete, geometry of the structural element, type and duration of use of the formwork, construction phases, exothermic properties of the concrete. A three-dimensional thermal modelling was performed using this data (fig. 4). Figure 5 shows a plot of temperature versus time. The temperature increase was important for the cap beam of pier P2: the maximum temperature reached in the centre of the material was close to  $80 \text{ }^\circ\text{C}$ , while for the cap beam of pier P4, the temperature did not exceed  $70 \text{ }^\circ\text{C}$ . Moreover, the temperature in the concrete of pier P2 remained over  $70^\circ\text{C}$  during about 70 hours.

Figure 5: Computed temperatures in the cap beam of pier P2

In consequence the deterioration due to the DEF is limited to that in the cap beam of pier P2. This is the consequence of the initial heating of the concrete from the combination of several causes: use of an exothermic OPC for a massive concrete part, pouring of the concrete during summer time without any particular precautions and an overdose of the cement relative to the initial specified concrete composition.

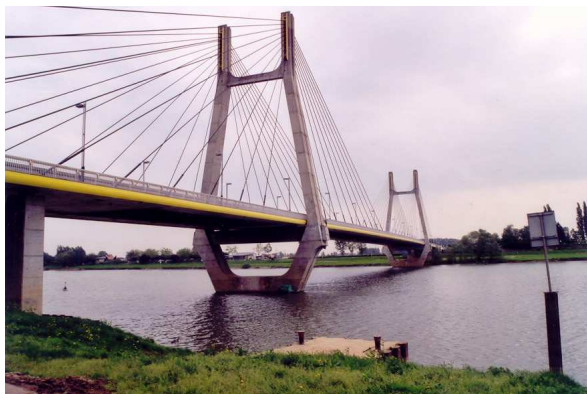
The Bourgogne bridge is a cable-stayed bridge built during the years 1989-1992 over the Saône River in Chalon/Saône (Fig. 6). It has a total length of 351 m and comprises 8 spans. The main span is 151.80 m long, and the pylons are 46 m high. The deck is made of a prestressed concrete slab. The lower part of each pylon is composed of a footing, a base and two legs. The dimensions (in metres) with respect to length, width and height are respectively for the footing: 15.20 x 6 x 2, for the base: 11.90 x 3 x 6.5, and for the legs: 2.20 x 3 x 6.

**Figure 6:** Overall view of the Bourgogne bridge

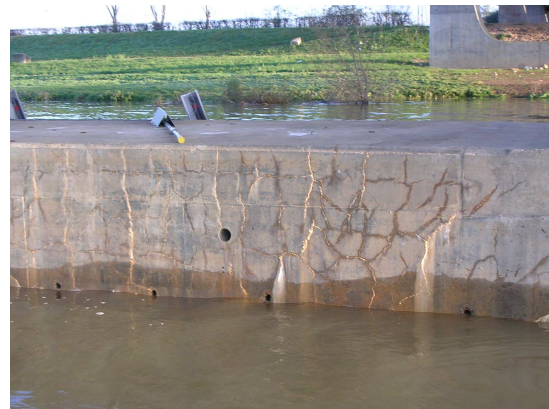
The footing is always immersed, the base is partially immersed in water but may be sometimes fully immersed during floods, and the legs are always above the water level of the river. The immersed parts of the base of the pylons P3 and P4 are affected by a multidirectional cracking like in the aerial parts (fig. 7). The width of the cracks reaches several millimetres on P3, and is lower than one millimetre on P4. A high cracking density is observed on the faces of the base, with a maximum density in the middle of the faces. The most important crack is observed on the top face of the base with a width of 1 cm. Some cracks also show an offset of the crack lips which is typical of a differential expansion inside the concrete; the most important offset is 2 to 3 mm on the top face of the P3 base. The lateral faces of the legs of pylons P3 and P4 present some cracks that are oriented horizontal, with widths varying between 0.2 and 0.4 mm.

**Figure 7:** Cracking of the aerial part of the pylon base

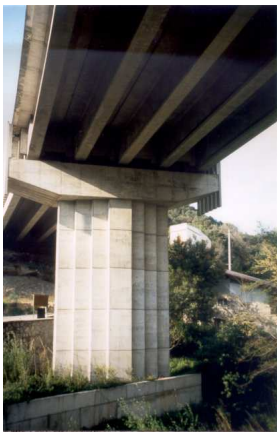
This bridge was constructed during the years 1980-1981. It is a statically determinate prestressed beam structure with a three span deck which is 120 m long and 13 m wide. The deck is supported by two abutments and two piers constructed on footings. The damage is confined to the cap beams of the two piers. Each pier (Fig. 8) consists of a pillar whose cross-section fits within a rectangle measuring 3.1 x 7.5 m, with a height of 14.5 m in the case of the northern pier and 9.3 m in the case of the southern pier. Each pillar is topped by a cap beam which has a length of 14 m, a width of 3.5 m, and whose height varies between 1.1 m and 2.0 m. The extremities of the cap beams are covered with architectural facings consisting of six prefabricated reinforced concrete units. The two cap beams were built in August and September 1980.

Figure 8: Overall view of a Lodève Bridge pier

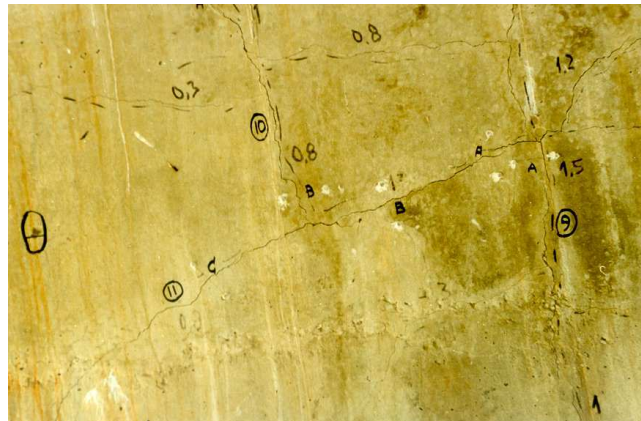
The cap beam on the North pier has closely-spaced vertical cracks on both sides with a maximum crack width varying between 0.2 mm and 1.2 mm (fig. 9). The extremities of the cap beam are covered by the architectural facings which prevent their observation. Some cracks contain streaks of calcite, which indicates a circulation of water inside the concrete. Several horizontal cracks are also present and appear to be located at construction joints. The results of the 1997 crack survey for the cap beam of the north pier shows a considerable increase in cracking as compared with the 1989 inspection.

Figure 9: Network of cracks on the cap beam of the North pier

The damage rating of a concrete structure may be determined with the help of a cracking index which corresponds to the summation of cracks intercepted on axes of variable lengths and normalized to a length of one metre (LCPC 1997). One of the cap beam of the Lodève bridge has been monitored with the help of cracking indexes and measurements of overall movement (LCPC 2009) since 2000. The cracking index measured in the central part of the cap beam is 0.55 mm/m and is stabilised. According to the classification (LCPC 1997), this value corresponds to a low cracking. For the extremity of the cap beam, the cracking index

reached 1.64 in 2002 and 2.0 in 2007; it indicated an evolution of the phenomenon and the cracking is rated moderate to high. This was confirmed by the overall movement monitoring which gives a global deformation rate for the cap beam extremity of 0.2 mm/m/year.

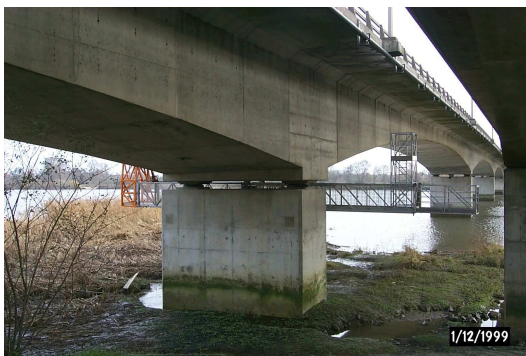
This bridge was constructed in Nantes in 1988–1989 and opened in 1990 (Fig. 10). It is a continuous box girder bridge with 6 spans and a total length of 385 m, and has 7 supports (2 abutments and 5 piers). The 5 reinforced concrete piers are massive and are 6.3 m long by 3.0m wide. The damage is mostly confined to pier P6 on which multidirectional cracking typical of that caused by an internal swelling reaction is apparent (Fig. 11). In addition the map cracking is mainly localised within the tidal zone, where the average tidal range is between 3 and 4 metres. The four sides of the pier are affected and cracking seems to be progressing in the dry zone. The concrete of this pier was cast in August and September 1989. Pier P4 also exhibits map cracking, but this is less severe. Lastly, piers P3 and P5 have vertical cracks with widths reaching 0.8 mm. However, this cracking was observed immediately after construction and was attributed to thermal shrinkage of the concrete.

**Figure 10:** Overall view of The Bellevue Bridge

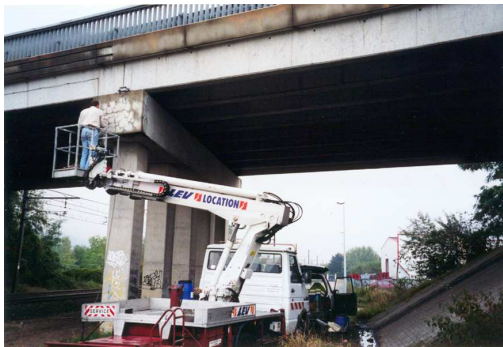
This bridge, built in 1992, has a deck made of reinforced concrete beams and is composed of three independent spans made continuous on piers by the slab over the beams. The spans are skewed and have different length (14.92 m – 17.44 m – 9.47 m). The deck is resting on two abutments and two intermediary piers (fig. 12). Each abutment is composed of 4 rectangular columns topped by a cap beam. Each pier is composed of 5 columns of 5.4 m height and also topped by a cap beam.

Figure 12: Partial view of the Saint Maurice de Beynost bridge

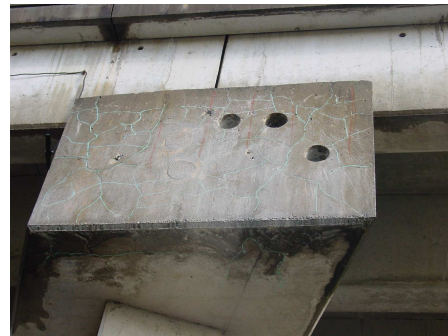
The damage has occurred only on the extremity of the cap beam of the pier P2 which is exposed to the elements (fig. 13). A map cracking was observed during the first detailed inspection of the bridge in 1992. This cracking is evolving since the width of the cracks was below 0.3 mm in 1992 and reached up to 2 mm in the detailed inspection of 1997.

Figure 13: Map cracking at the end of the cap beam exposed to rain

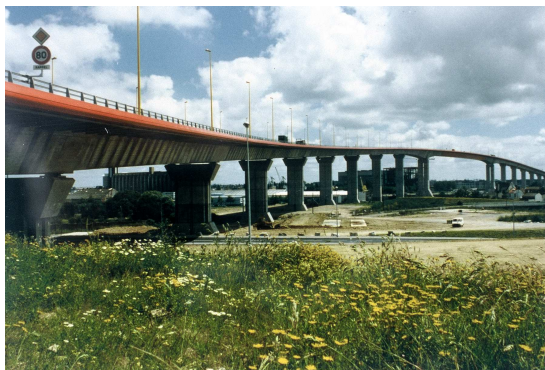
The Cheviré bridge was opened to traffic in May 1991 and is classified as an exceptional bridge (Fig. 14). It comprises two access viaducts composed of continuous box girders made

Figure 14: General view of the Cheviré Bridge. (Courtesy G. Forquet)

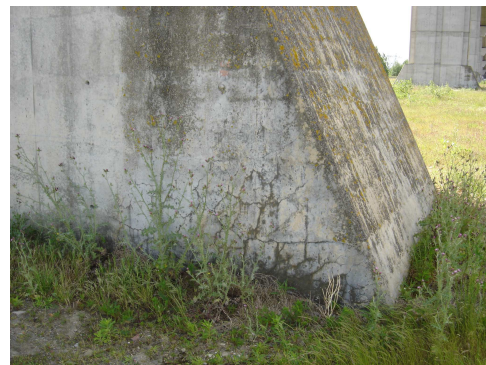
In 1998, map cracking was observed on the facings of some bases of the South access viaduct (Fig. 15). DEF was identified by laboratory investigations. The rate of deterioration of the bases is variable: some bases presented only some vertical cracks with a width lower than 0.3mm while others exhibited more or less developed map cracking (up to a width of 0.6 mm). The phenomenon is globally slow and the rate of opening of the cracks was 0.1 mm/m/year, from 2003 to 2006.

Figure 15: Cracking is more important in the bottom of the base because of the capillary suction (Cheviré bridge)
