Lessons learned from structures damaged by delayed ettringite formation and the French prevention strategy

Bruno Godart, Loïc Divet

Bruno Godart, Université Paris-Est, IFSTTAR, Paris, France

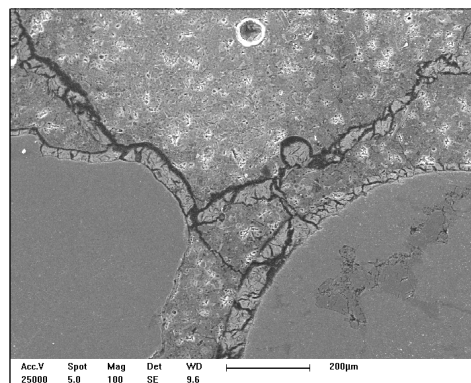
The internal sulphate reaction results in the presence of ettringite. This latter was present throughout the material and on all the examined surfaces. The ettringite that is generally observed in the concrete has a wide range of textures, but it is mainly poorly crystallized and massive. Furthermore this form is principally present at the cement paste/aggregate interfaces. Figure 1 is a back-scattered electron (BSE) image showing ettringite-filled gap around aggregate particles.

Figure 1: BSE image of a polished sample showing ettringite-filled gap around aggregate particles.

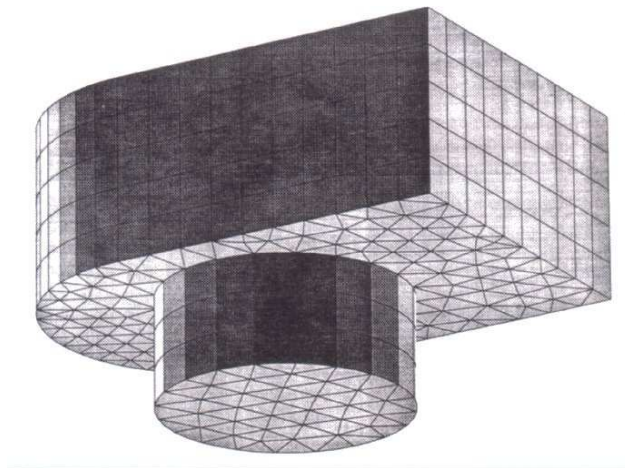
The heating cycle of the concrete during its setting was then estimated by a numerical simulation using the TEXO module. For this, information was required on: meteorological data during the setting period of the concrete, geometry of the structural element, type and duration of use of the formwork, construction phases, exothermic properties of the concrete. A three-dimensional thermal modelling was performed using this data (fig. 4). Figure 5 shows a plot of temperature versus time. The temperature increase was important for the cap beam of pier P2: the maximum temperature reached in the centre of the material was close to $80 \text{ }^\circ\text{C}$, while for the cap beam of pier P4, the temperature did not exceed $70 \text{ }^\circ\text{C}$. Moreover, the temperature in the concrete of pier P2 remained over 70°C during about 70 hours.

Figure 4: 3D modeling of the cap beam of pier P2 with CESAR-LCPC.

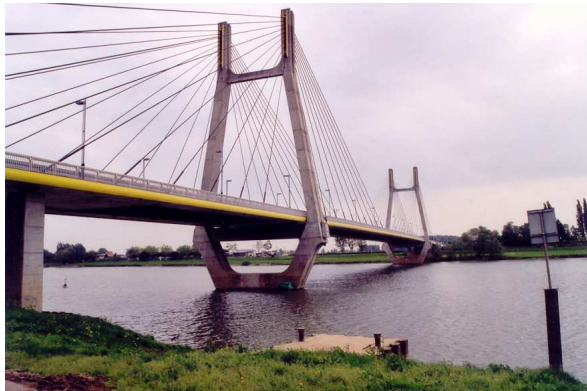
The Bourgogne bridge is a cable-stayed bridge built during the years 1989-1992 over the Saône River in Chalon/Saône (Fig. 6). It has a total length of 351 m and comprises 8 spans. The main span is 151.80 m long, and the pylons are 46 m high. The deck is made of a prestressed concrete slab. The lower part of each pylon is composed of a footing, a base and two legs. The dimensions (in metres) with respect to length, width and height are respectively for the footing: 15.20 x 6 x 2, for the base: 11.90 x 3 x 6.5, and for the legs: 2.20 x 3 x 6.

Figure 6: Overall view of the Bourgogne bridge

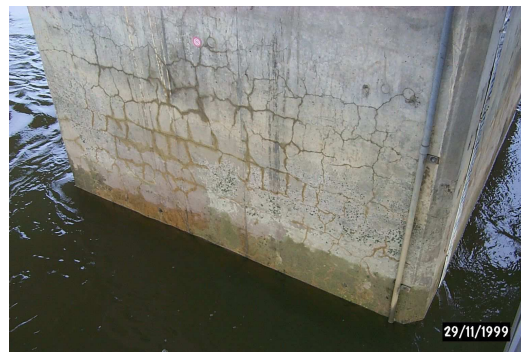
Figure 11: Pier 6 of the Bellevue Bridge with map cracking in the tidal zone.
