Application of non destructive testing to the detection of aeronautical defects in composite structure

APPLICATION OF NON DESTRUCTIVE TESTING TO THE DETECTION OF AERONAUTICAL DEFECTS IN COMPOSITE STRUCTURES

ABSTRACT: A study of two Non-destructive Testing methods (NDT) was carried out in specimens with different kinds of simulated defects. Ultrasonics test (US) and Infrared Thermography (IRT) were applied with the aim to evaluate the detectability and the accuracy of each method. These techniques have acquired great importance in the aeronautics industry because they allow to control the aerostructures without intervening in their physical and mechanical integrity. In the second part of the study, a comparison of both techniques was achieved in order to analyse their limits and advantages. It appeared that detectability of defects was much better in a sample with flat-bottomed holes defects in the case of Ultrasonic Test. However it was found that Infrared Thermography is much more limited to the thickness of the specimen than the ultrasonic waves. On the other hand, defects were all revealed with IRT in a sandwich composite including Teflon inserts, which was not the case for US

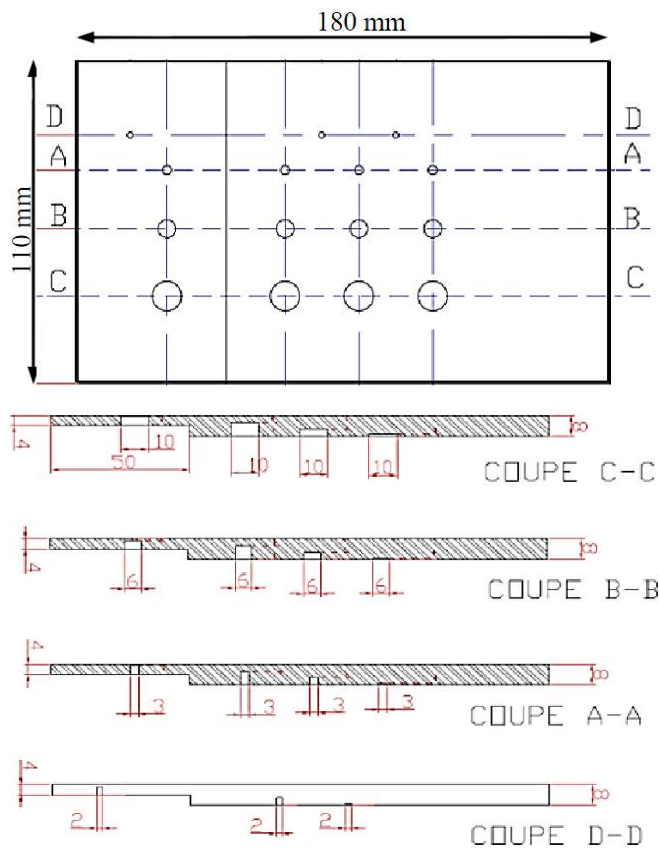
Figure 1. Manufacturing drawing of the specimen A

The specimen used to compare the detectability and accuracy between the IRT and the US is a carbon/epoxy laminated composite with flat bottomed holes defects and variable thickness. It is called specimen A (figure 1). This sample is divided in 2 sections. The first one is 4 mm wide in 50 mm long. The second section is 130 mm long with 8 mm wide. This sample contains 15 holes with diameters ranging from 2 mm to 10 mm. These holes have different depths (from 0.52 mm to 7.5 mm). The aim of these holes is to simulate discontinuity on the specimen that is considered as a continuous medium.

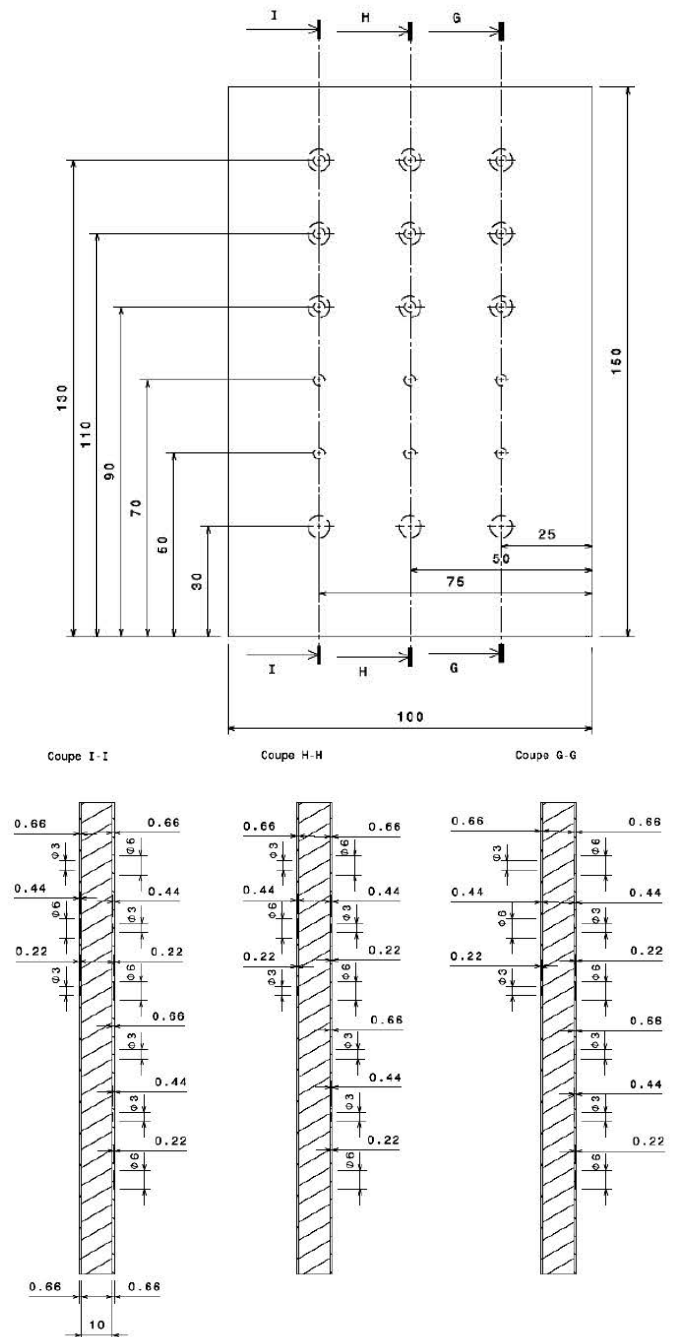
Figure 2. Manufacturing drawing of the specimen B

The second sample, called specimen B, was only tested with infrared thermography because of its material properties. This specimen is a carbon-glass-epoxy with foam-core sandwich composite

including Teflon inserts. Its skin is 0.66 mm thick. It has been demonstrated that the foam-core is a sound insulation; thereby the ultrasonic waves cannot penetrate this specimen and be detected by the receiving transducer [5]. This specimen contains 18 defects. These simulated flaws are Teflon inserts ranging from 3 mm to 6 mm. They are located at the skin section. These inserts were placed during the stacking of the tissues so that they simulate as well as possible a delamination within the sample. The manufacturing drawing of this specimen is shown in figure 2.

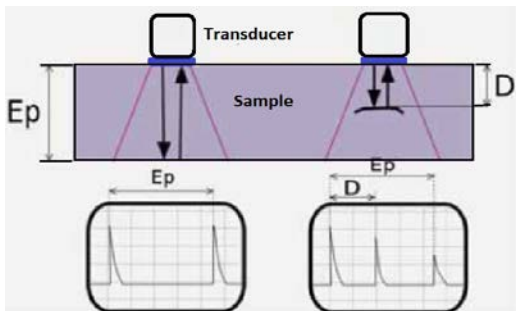
Figure 3. US configuration

waves. When there is a discontinuity (such as inclusion, delamination or disbonding) in the wave path, part of the energy will be reflected back from the flaw surface. The reflected wave signal is turned into an electrical signal by the transducer and is displayed on a screen. The configuration used on this US testing is called reflection mode (figure 3). One transducer is used to send and receive the wave at the same time.

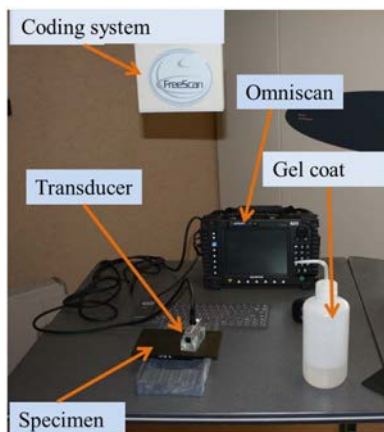
Figure 4. Ultrasonic measurement

In this study, an Omniscan 32: 128 PR is used with a 5L64-NW1 multi-elements transducer connected to it. The transducer is both ultrasonic source and receiver at the same time. The frequency of it is 5 MHz, which is the common frequency in aeronautics NDT [5]. For specimen A, the wave velocity is 2983 m s^{-1} with a standard deviation of 5.7 m s^{-1} . This experiment was carried out by contact; therefore it is necessary to use a coating gel between the sample and the transducer. Ultrasonic testing enables two-dimensional mapping, accordingly a coding system is used to detect the position of the transducer. Specimen A was placed in a support to hold it while the experiment was being carried out. Figure 4 shows the ultrasonics device.

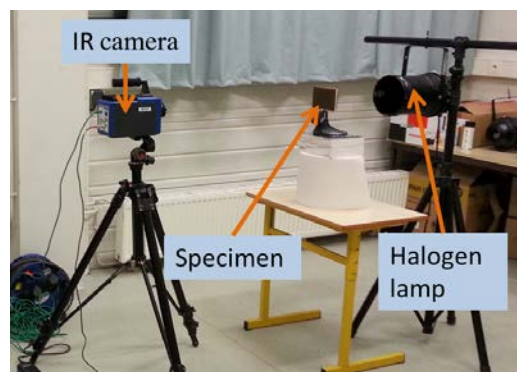
a) Transmission mode

The heat source is a 1000 W halogen lamp. It is used in two configurations: transmission and reflection mode (figure 5). Specimen A and B were tested in both modes (figure 5a and 5b). The infrared sensor was an IR camera with thermal resolution of 20 mK. A 30 s and 50 Hz movie was recorded in which 15 s corresponds to the heating of the sample and the 15 last seconds to its cooling. These times are long enough to heat the sample and make defects to appear in the thermal mapping. Defects are thermally visible while the heating and cooling of the sample. The treatment of the movie was done with the ALTAIR software. The analysis of the movie is done in relative mode with the purpose to remove the ambient temperature and all environmental noise.

Figure 5. Infrared measurement

On the other hand, it is clearly noticed that IRT is very limited to large thicknesses. Defects are not visible beyond 2.8 mm in a carbon-epoxy laminated composite because heat diffusion inside the material does not reach the inspected surface in transmission mode (figure 5a). However, by the use of lock-in

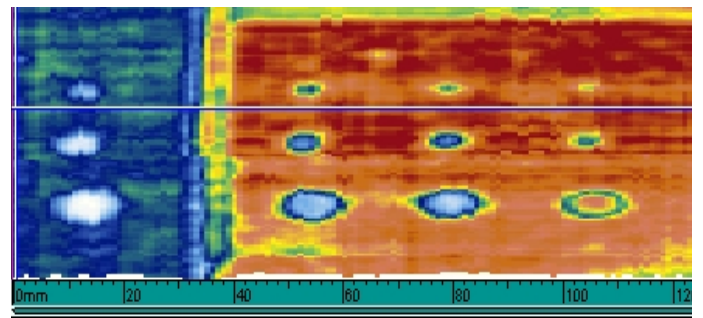
Figure 7. C-Scan mapping on specimen A

Figure 7 shows the C-Scan mapping for this specimen in which measurements were done.

The size of defects was measured with a visual rule. In this case it is said that there is a defect where the colour of the health part changes and becomes a circular spot with another colour.

Results analyses are made through two parameters: detectability and accuracy. 14 of the 15 holes (93%) were detected by US. The only defect that was not detected is located at 1 mm deep and 2 mm diameter. It is noticed that defects located near the contact surface (less than 1 mm) are hardly distinguished from the signal input peak. Nevertheless defects at 0.52 mm deep were visible in the C-Scan mapping (figure 7). On the other hand, the detected defects were measured on average 1 mm larger or smaller than they really are. Defects located at 7.5 mm deep (3 and 6 mm diameter) were measured 1 mm smaller than their real size, and those located at 5.2 mm deep (2, 3 and 6 mm diameter) were measured at the correct dimension. 10 mm diameter defects were all measured 1 mm larger than their real size. Table 1 shows the measured dimension for each range of defects.

The C-Scan mapping in US shows that detectability is more affected by the diameter of defects rather than thickness. This detection becomes more difficult when the defect is close to the detecting

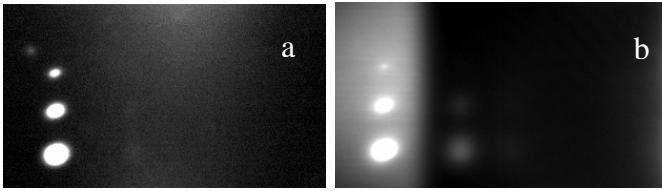
Figure 8. IRT mapping of specimen A

As in US test, two parameters were taken into account to analyse the results: detectability and accuracy. A single picture must be selected from the recorded film. That selection depends on the quality of the image for each defect. In this study, for specimen A, 2 different images in transmission mode (figure 8) were selected to measure 2 ranges of defects located in two different sections of the specimen. These ranges of defects are located at 0.52 mm and 2.8 mm deep respectively and they are in the 4 mm width section and 8 mm width section of the sample. Figure 8 shows that only 6 from the 15 defects, were detected using classical IRT in transmission mode.

Defects at 0.52 mm deep were measured using image 8a and those at 2.8 mm deep using image 8b. In figure 8b it is noticed that heat saturation is generated after a short period of time. The 4 mm width section is rapidly saturated and in the 8 mm width section, no other defect is revealed with the increasing temperature.

IRT, the thickness reached comes to 5.2 mm in reflexion mode (figure 5b). At any rate, diameter of defects also affects the detectability in IRT. Figure 8b and 9 show that flaws located in the same range of deepness with different diameter are not all detected. The heat diffusivity inside the material does not lead to enough temperature difference in the surface of the sample.

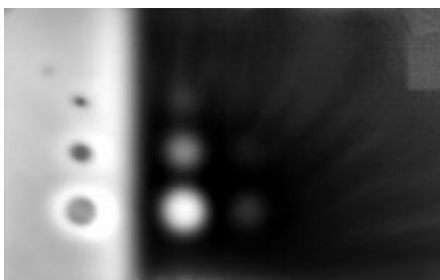
Figure 9. Lock-in IRT in specimen A

In lock-in IRT, the number of detected defects in specimen A increased. Best results were obtained in reflection mode and with 0.1 Hz frequency. However, no measurement of their size was done because of the poor temperature contrast. In addition to classical IRT (with transmission mode), 3 mm diameter defect at 2.8 mm deep and 5.2 mm deep defects (6 and 10 mm diameter) were visible as shown in figure 9.

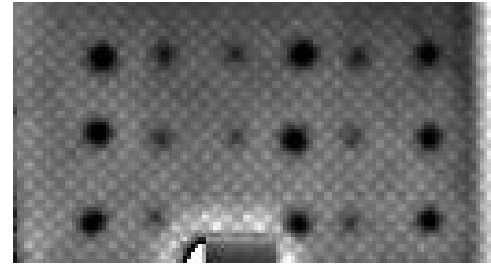
Figure 10. Lock-in IRT in specimen B

In the case of specimen B, lock-in IRT leads to similar results as classical IRT. All defects were detected and they could be measured in diameter (figure 10).

Better results were obtained at 0.1 Hz for both specimens tested in lock-in IRT. It was found that the textured surface of specimen B was confounded with the defects in IRT mapping. Measurements were therefore less accurate than classical IRT in specimen A.

Defects located at the camera side were easily distinguished whereas, defects located on the opposite side of the camera, were difficultly detected. That is way both skins of the sandwich were tested. In addition, the dimension of the measurements was 2 or 3 mm larger than the real size of the defect. Table 3 shows the measured size for each range of defects.
