The detection of aeronautical defects in situ on composite structures using Non Destructive Testing

Christian Garnier ^{a,*}, Marie-Laetitia Pastor ^b, Florent Eyma ^b, Bernard Lorrain ^a

A B S T R A C T

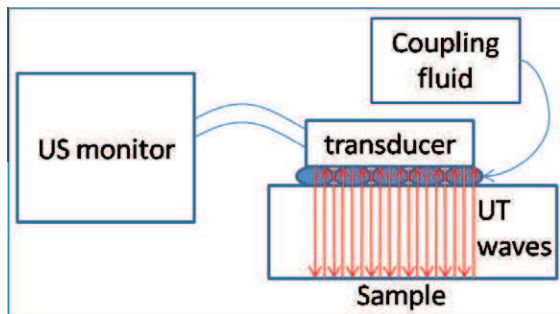
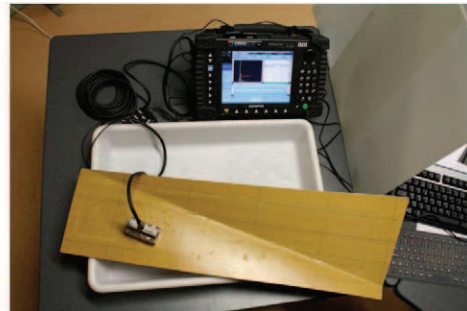
Fig. 3.1. Ultrasonic device.

In this study, a 5L64-NW1 multi-element transducer connected to an Omniscan 32: 128 PR (US monitor) is used as the ultrasonic source and the receiver. The wave velocity depends on the materials. And so, for the three tested specimens, the waves have a velocity ranging from 2600 to 5300 m s⁻¹ and a frequency of 5 MHz. In order to carry out the experiments, a gel coating was applied (cf. Fig. 3.1) and so the wave ratio transmitted to the sample is much better.

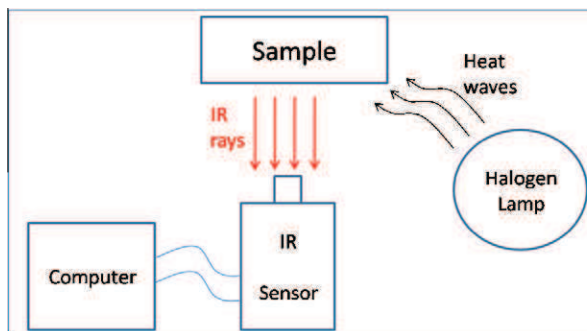
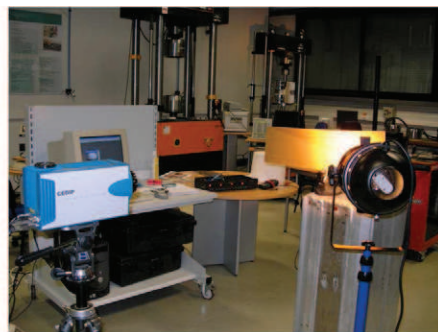
Fig. 3.2. IR Thermography device.

Halogen lamps are used to provide thermal solicitation to the sample. They are positioned 300 mm from the front surface of the specimen. The front surface has been chosen as being similar to an in site inspection. The specimen is heated for 10 s, and a 30 s movie is recorded at 50 Hz. The installation of the experimental device is very fast (around 5 min). The camera is a Flir Titanium and its thermal resolution is 20 mK (cf. Fig. 3.2). In order to detect the defect present in the recording, a relative movie has been created. The relative movie consists of withdrawing the first 10 images from the recorded film in order to eliminate the temperature due to the ambient environment. The presence of the defect appears during heating and cooling time. The defect is most visible in the image corresponding to the inflection point of the temperature curve. For the study, infrared images were taken at this point (example for the carbon plate Fig. 3.3).

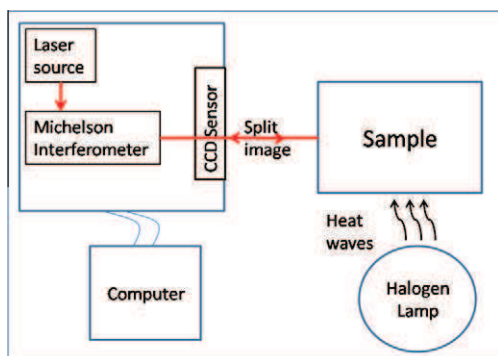
Fig. 3.4. Shearography device.

In this study, the specimen was heated by a paint burner positioned 50 mm away. The heating temperature was 300 °C and was applied for 30 s. The shearographic image was recorded by a CCD camera (cf. Fig. 3.4). As is the case for InfraRed Thermography, setting up the experimental protocol can be done very quickly (around 3 min).

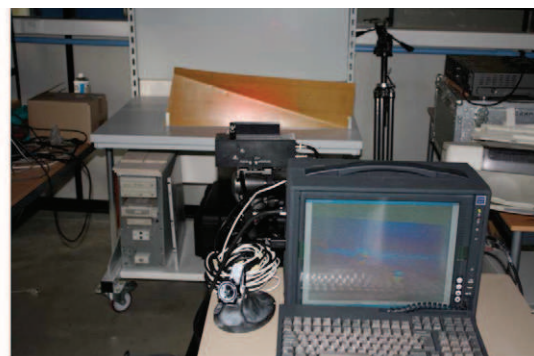
Fig. 4.1. Specimen A: carbone/epoxy rod.

Damage analysis on each of the three specimens is extremely difficult because of their distinctive geometry: Specimen A is a hollow cylindrical rod, 100 mm diameter, 10 mm thick and 1 m long. Its specific shape prevents access to the inside of the rod. In addition, it is coated with blue gloss paint to comply with aeronautical service specifications but in order to improve the quality of optical results, the damaged area has to be matt.

Each specimen has surface damage. The defect on Specimen A is delamination caused by an in-service impact. During a GVI, the size of the defect can be obtained quite simply using a steel ruler. The GVI defect is 98 mm and 18 mm.

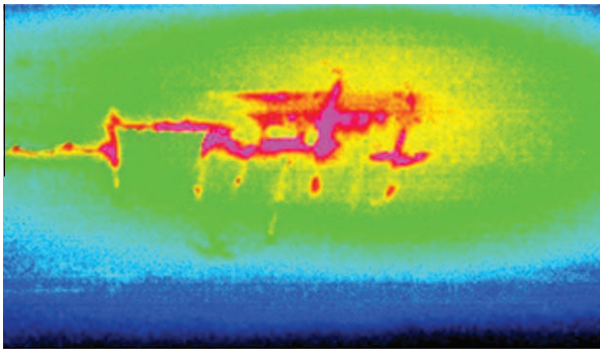
Fig. 4.2. InfraRed Thermography map of Specimen A.

The InfraRed Thermography tests made it possible to identify the presence of defects on Specimen A in a very short time, around 30 s (cf. Fig. 4.2). The size of the pixel is calculated from the images. Therefore, the dimensions of the defects can be determined accurately. Indeed, the defect is 97 mm × 20 mm. It is obvious that the results obtained with InfraRed Thermography are similar to GVI measurements (maximum deviation around 10%).

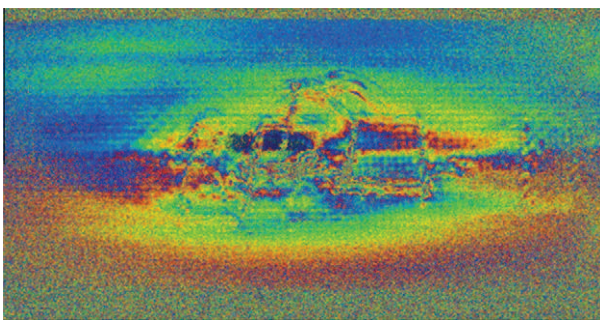
Fig. 4.3. Shearography map of Specimen A.

The defects on Specimen A were identified quickly by Shearography tests, around 1 min (cf. Fig. 4.3). It is important to note that the images obtained by Shearography are not easily analysed. There were many defects on this specimen and Shearography detected them all. This means that a considerable amount of the information was shown on the image, making it illegible. Nevertheless, it was possible to determine the size of the defects. The range of the defect area is 107 mm × 22.5 mm. The difference between the GVI and the Shearography results represents 9% as regards length and 25% as regards width. This measurement variation is due to the difficult in analysis of the shearographic image.

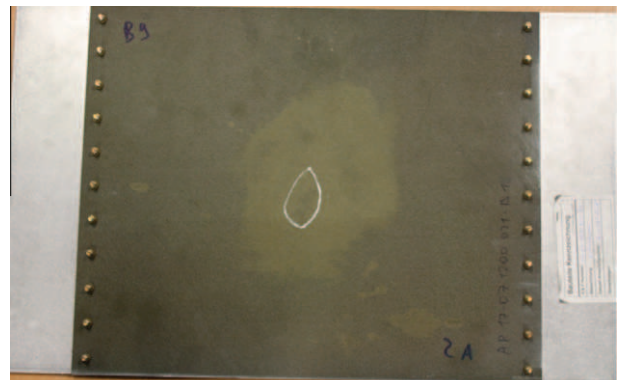
Fig. 4.4. Specimen B: carbone/epoxy plate.

Specimen B is a flat plate, 500 mm × 400 mm × 2 mm.

Specimen B damage is the result of a lightning impact which occurred in service. The defect measures 41 mm and 75 mm.

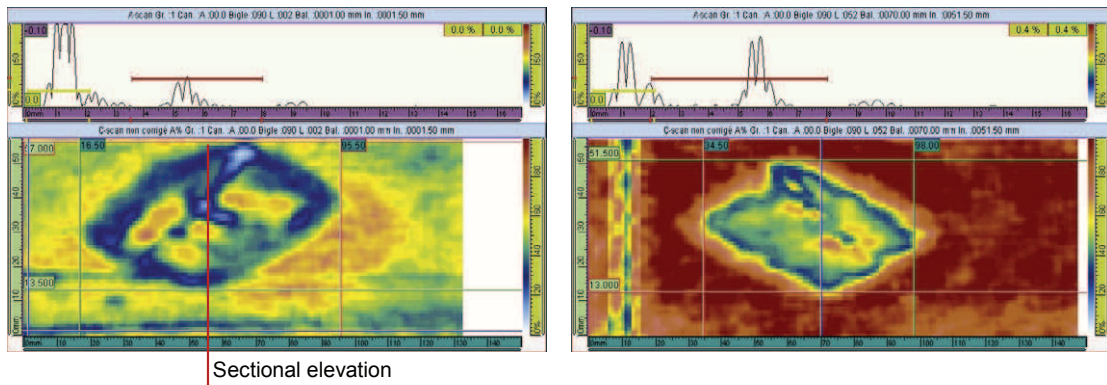
Fig. 4.5. Ultrasonic Testing map of the both faces of Specimen B.

Two C-Scan inspections were carried out : one on the front of the specimen and the other one on the back. For the front surface inspection (i.e. the surface on which the lightning impact is located), the defect measured 43.5 mm × 79 mm (cf. Fig. 4.5). On the back, the defect measurements were 38.5 mm × 63.5 mm (cf. Fig. 4.5).

Three reasons may explain the relatively smaller size of the defect on the back:

- firstly, signal loss through the thickness of the specimen,
- secondly, surface coating on the back,
- thirdly, position of the probe focus because the defect is on the surface.

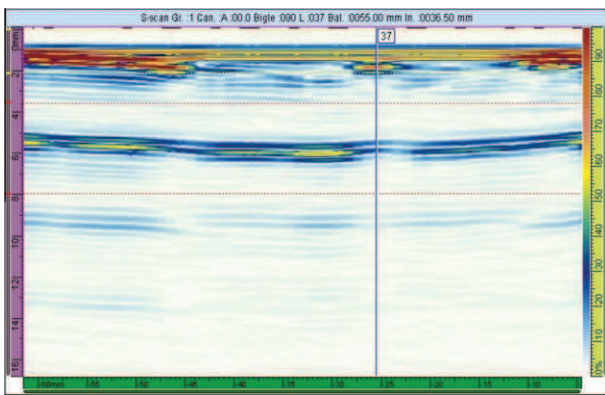
Fig. 4.6. Sectional elevation of the 2D map (S-scan).

The in-depth position is the same from both front and back. The shape of the defect is similar to that of the GVI defect. The actual size of the defect on the specimen and its UT size are virtually the same (around 5%). From the 2D map, a sectional elevation can be traced showing that the defect is on the surface of the specimen (Fig. 4.6).

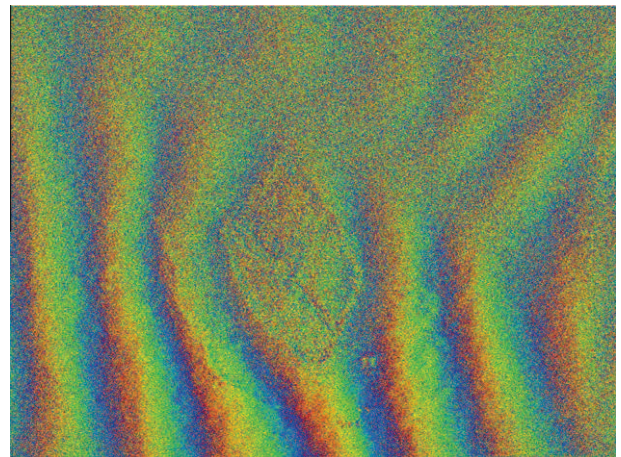
Fig. 4.8. Shearography map of Specimen B.

The defects on Specimen B can be identified by Shearography tests in a relatively short time: approximately 1 min (cf. Fig. 4.8). The size of the defect is 37.5 mm × 59.5 mm. The differences between the GVI and the Shearography measurements are 8% as regards length and 21% as regards width. This difference is due to the fact that the shearographic image is a little fuzzy preventing the size of the defect to be measured properly.

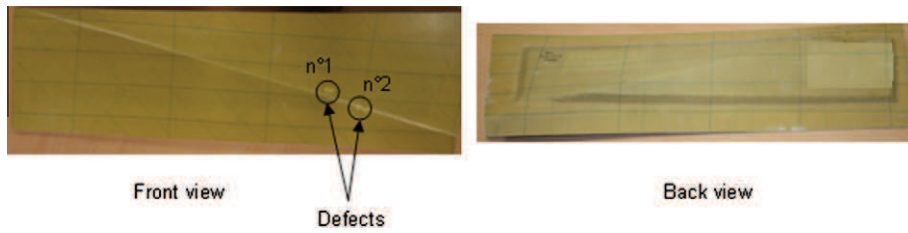
Fig. 4.9. Defects of Specimen C.

The Specimen C defects are two cases of delamination due to the impact of a falling tool or of hailstones. These were created in the laboratory using a drop weight tester. The defect located above geometrical discontinuity is called no. 1 and the defect located on the geometrical discontinuity is called no. 2 (as defined in Fig. 4.9). Defect no. 1 is 13 mm and 9 mm. Defect no. 2 is 18 mm and 8 mm.

For Specimen C, two GVI defects had to be detected. Defect no. 1 was located above geometrical discontinuity and defect no. 2 was located on the angle of this geometrical discontinuity (cf. Fig. 4.9).

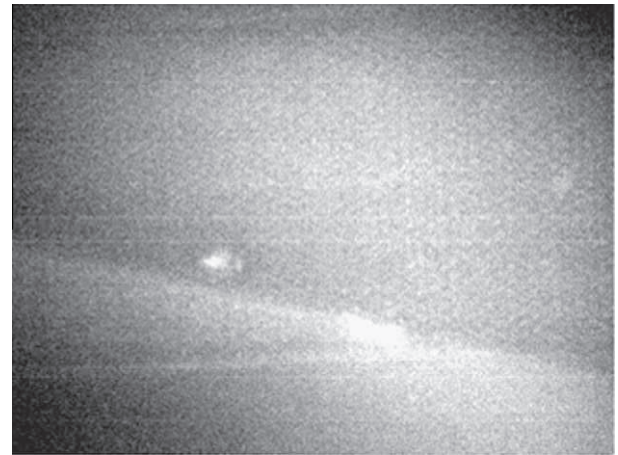
Fig. 4.11. InfraRed Thermography map of Specimen C.

Both defects were determined by InfraRed Thermography within a few seconds (cf. Fig. 4.11). Defect no. 1 is 15 mm × 10 mm. The difference between the GVI and the IR thermography measurements is 15% in length and 11% in width.

The dimensions of the defect no. 2 are 22 mm length and 8.5 mm width. The differences between the GVI measurements and the IR thermography measurements are equal to 22% as regards length and 6% as regards width. The considerable deviation in length can almost certainly be attributed to the focusing problem due to the geometrical discontinuity.

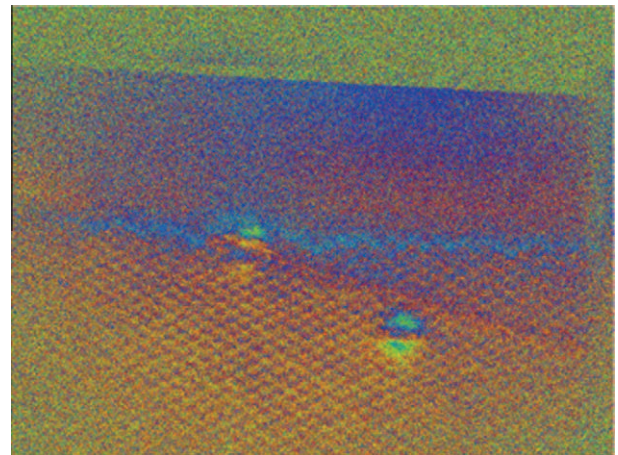
Fig. 4.12. Shearography map of Specimen C.

The defects on Specimen C were identified by Shearography tests within a relatively short time of around 1 min (cf. Fig. 4.12). The image is very clear and the defects are perfectly visible. Shearography therefore seems well suited to the detection of defects in this type of specimen.

Defect no. 1 is 15 mm × 15 mm. The variation between the GVI and the Shearography measurements is 17% in length and 87.5% in width. However, on the shearographic image, the defect appears circular which is not surprising for an impact defect; and so in this case, the GVI measurement may be incorrect.

Defect no. 2 is 15 mm × 8 mm. The variation between the GVI and the Shearography measurements is 16% in length and 11% in width.

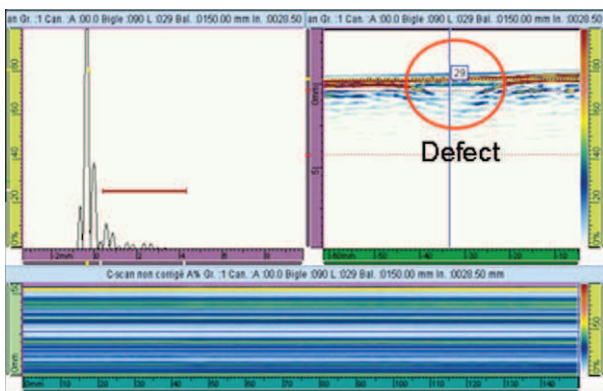
Fig. 4.10. Ultrasonic map on Specimen C.

Defect no. 1 was detected by ultrasonic tests (cf. Fig. 4.10). The geometry of the specimen (defect slightly on the angle) made UT measurement difficult. Thus, only the defect length could be determined: 22 mm. The difference between the GVI and the UT measurements of length is 22%. As shown on Fig. 4.10, the defect was located not only on the surface of the specimen but also in depth.
