# An Image Analysis Based Damage Classification Methodology

Vikram Pakrashi, Alan O'Connor, Franck Schoefs

Vikram Pakrashi, Alan O'Connor, Franck Schoefs. An Image Analysis Based Damage Classification Methodology. 10th International Conference on Applications of Statistics and Probability in Civil Engineering, 2007, Tokyo, Japan. hal-01007861

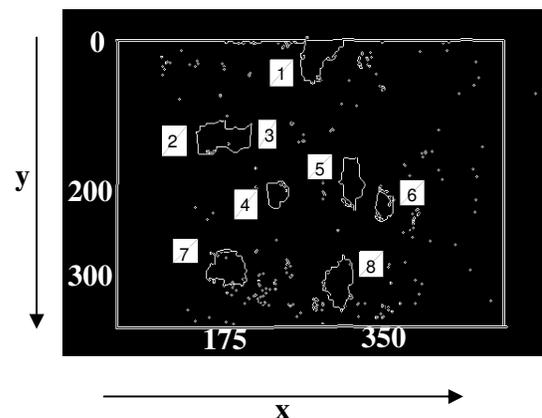
Figure 3. Detected Damage Regions in a Specimen.

An example of a successful image processing based damage region detection as proposed in the paper is given in Figure 3, where Figure 2 has been successfully analyzed to isolate eight major closed damaged areas of irregular geometry with precision. Some spurious features are also identified due to the environmental noise but are insignificant with respect to the damaged regions. Sometimes, a visual idea about the spurious features can be helpful to preprocess the picture to make the computational effort of the pattern recognition scheme easier and the scanning region comparatively smaller.

It is also important to note that the objects labeled 2 and 3 in Figure 3 are considered to be a single object while processing and hence the combined geometric property of the system has been rendered instead of their individual statistics. This is due to the fact that in the real specimen the damages are in fact physically connected. However, by a proper control on preprocessing, lighting and camera resolution these two geometric regions can be separate incorporating some additional effort.

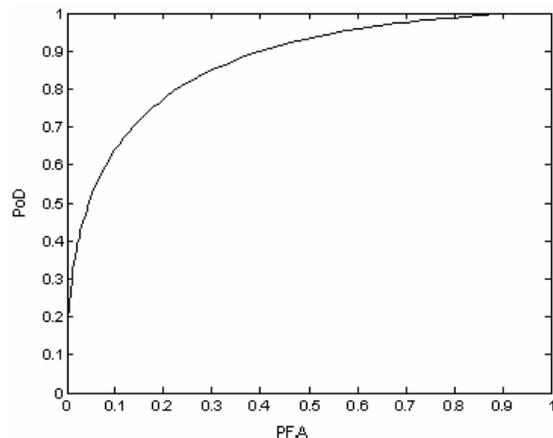
where  $A$  is the measured area.  $A_d$  is a deterministic parameter or a random variable. This definition implies that PoD is a monotonic increasing function. To complete this concept, the probability of false alarm has been introduced. It is the probability to defect a non-existing defect. For a given range of defects  $A_i$ , the curve that joints the points of coordinates (PFA,  $PoD(A_i)$ ) is called Receiver Operating Characteristic (ROC) curves (Arques (1982), Fücsök et al. (2000)). Such a curve is plotted on figure 4.

Figure 4. Receiver Operating Characteristic curve.

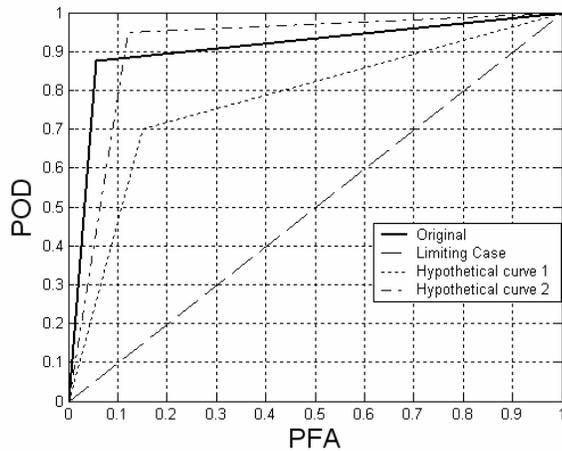
An application of such a case is provided in the current problem and the results are provided in Figure 5. The ROC of the current detection condition is constructed. With the increase of resolution, the PoD detection increases, but so does the PFA. On the other hand with poor resolution characteristics within the image, both PoD and PFA are considerably low. It is only at some intermediate level of resolution is the optimized value obtained where a high PoD corresponds to a minimum of PFA. The effects of high and low resolutions are earmarked within the figure. Two alternative hypothetical curves in dotted lines are employed to emphasize the effects of the presence of other factors within the same methodology like lighting, nature of damage, etc.

The hypothetical ROC curves illustrate the uncertainties associated with the measuring conditions (which are variable) like luminosity, contrast, noise etc. and emphasize the shift of the efficiency achieved using the proposed NDT tool due to such uncertainties. It can be observed from Figure 5 that there may be possible cases where the ROC can be unsatisfactory due to the quality of the measured data itself and such situations can be identified by considering an envelope of ROC due to various conditions through existing data or simulations close to the chief governing conditions due to the change of the major affecting parameters. The efficiency and the robustness of the methodology are thus illustrated within the structural health monitoring framework in this regard.

Figure 5 ROC Curves for the Current Problem.
