## **Combining NDT tools for analysing the efficiency of repair techniques of wharves: the MAREO project**

# COMBINING NDT TOOLS FOR ANALYSING THE EFFICIENCY OF REPAIR TECHNIQUES OF WHARVES: THE MAREO PROJECT

KEYWORDS: Destructive Testing, Non-Destructive Testing, Ultrasonics, Chloride, Repair.

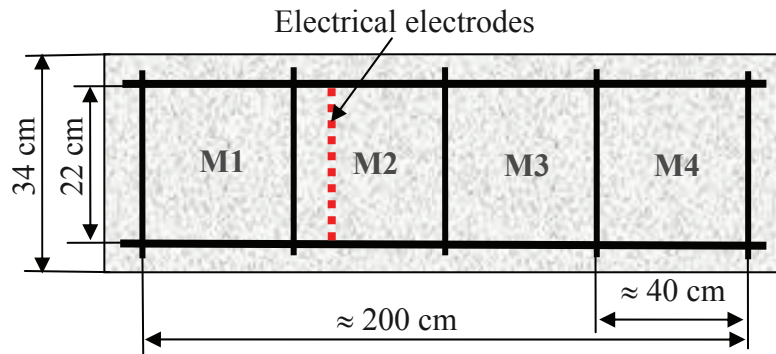
In this work four beams of  $200 \times 34 \text{ cm}^2$  and 75 cm of height are considered. These beams arise from the demolition in 2006 of a wharf made of reinforced concrete at the Lorient port in the west of France. Then, the contaminated area by chlorides has been removed by hydro-demolition and beams were repaired in September 2008. Three different industrial ready-to-mix concretes were used to repair the beams with four different techniques. The reparation techniques are: (I) wet shotcrete, (II) dry shotcrete, (III) manual repair and (IV) formed concrete. The reparation mixings (I) and (III) contain the same industrial cement. After reparations, all surfaces were form worked for minimising the roughness. Frames were identified in the beams by using radar method. Based on these frames, four meshes were chosen on the horizontal surface of each beam (e.g see Figure 1).

Figure 1 Upper view from the central part of the beams

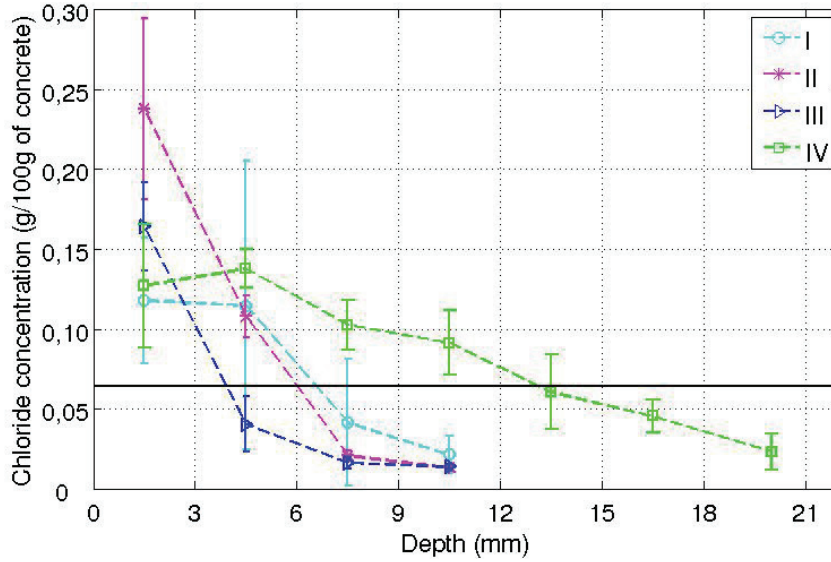
Figure 2 depicts profiles of totals' chloride and error bars measured on three cored samples from each slab (5) and each concrete of reparation. The line (0,064%) on this figure designates the threshold of corrosion. It can be shown that the chloride concentration of the formed concrete (IV) reaches the corrosion threshold between 1.2 and 1.5 cm of depth. However, concretes I, II and III reach the aforementioned threshold between 0.3 and 0.9 cm of depth. Although the wet shotcrete (I) is more porous than the dry shotcrete (II), the chloride concentrations have the same order of magnitude except between 0 and 0.3 cm of depth. Notice that the threshold indicated by the European standard [NF EN 206-1, 2004] was 0.4 % with respect to the mass of cement. In this work, the used threshold was recomputed with respect to the mass of the concrete by supposing cement content of 350 kg/m<sup>3</sup>.

Figure 2: Chloride concentrations measured on slabs of wet shotcrete (I), dry shotcrete (II), manual repair (III) and formed concrete (IV) at  $t_1$  after 43 days of accelerated tests.
