NDT for need based maintenance of civil infrastructure – FilameNDT a Franco-German project for monitoring and inspection of bridge cables, ropes and pre-stressed elements

NDT for Need Based Maintenance of Civil Infrastructure – FilameNDT a Franco-German Project for Monitoring and Inspection of Bridge Cables, Ropes and Pre-Stressed Elements

Jochen H. KURZ*, Laurent LAGUERRE**, Frank NIESE*, Laurent GAILLET**, Klaus SZIELASKO*, Fabien TREYSEDE**

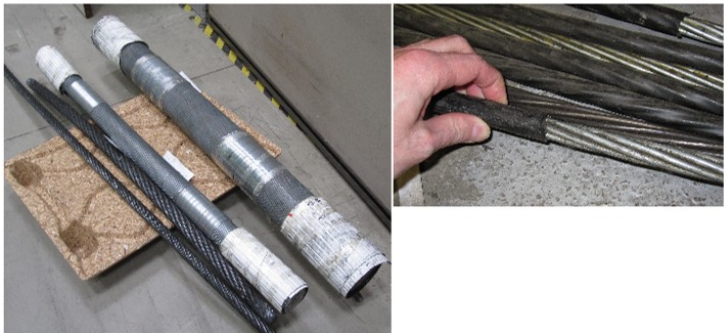
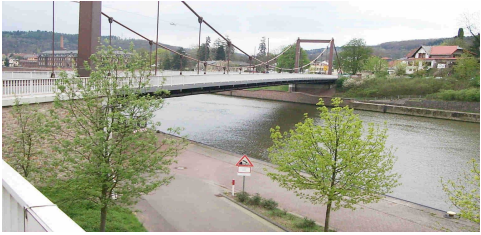
Table 1. Investigated configurations

Configuration	NDT Method
<p>1. Bare cables of different diameters</p>

<p>Ultrasound guided waves (EMAT (SH – torsional mode, L – lamb wave)) 3MA (7 wired strand)</p>
<p>2. Fully locked rope and 7 wire strand (pure rope only)</p> <div style="display: flex; align-items: center; justify-content: center;"> <div style="text-align: center;"> <p>fully locked rope</p>

<p>3. Anchorage Zone</p>  	<p>Ultrasound guided waves (EMAT (SH – torsional mode, L – lamb wave)) 3MA (monitoring) AE (monitoring)</p>
<p>4. Cable stayed bridge provided for inspection and monitoring (Saar river, Mettlach, Germany)</p>

<p>Ultrasound guided waves (EMAT (SH – torsional mode, L – lamb wave)) AE (monitoring) 3MA (monitoring)</p>

Within the frame of the Franco-German project FilameNDT, several relevant elements of typical constructions requiring special attention in form of inspections or monitoring were identified. The most relevant ones are summarized in Table 1. Results from inspections and monitoring tests will be described within the frame of this paper of the configurations 1 to 4, whereas the bridge shown in configuration 4 represents a realistic test scenario.

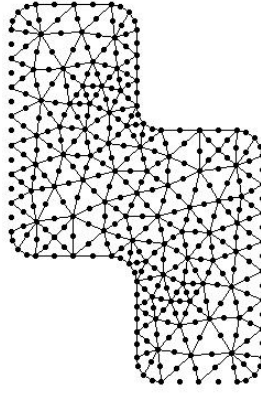
The goal of this subsection is to improve the theoretical understanding of guided wave propagation at the periphery of fully closed spiral ropes. As a first step, a single simplified z-shaped wire has been modelled (Figure 1).

Figure 1. Finite-element mesh for a simplified single z-shaped wire geometry

No coupling with adjacent wires has been considered. Due to the geometrical complexity, a numerical method must be used. Here the method is based on the so-called semi-analytical finite element technique, which consists in reducing the problem to the cross-section only, thanks to a spatial Fourier transform performed along the axis. With a Semi-Analytical Finite Element (SAFE) method, the only assumption required is that the structure must be translationally invariant, which is the case for a single z-shaped wire. The problem to be solved, initially three-dimensional, hence becomes two-dimensional. The curvature of the helical axis has been accounted to be based on the use of a specific curvilinear coordinate system, corresponding to a twisting system, recently developed at IFSTTAR. Results have shown that the curvature of the axis can be neglected for the structure and the frequency range considered. Some theoretical dispersion curves are presented in Figure 2, which plots, respectively, the dimensionless phase velocity and group velocity with respect to the dimensionless frequency for each propagating mode. The dimensional frequency range considered corresponds to the range $[0 - 1 \text{ MHz}]$. It can be observed that many modes are propagating in this range. Typical for prismatic waveguides, compressional, torsional, and flexural modes occur. At this stage, additional information is needed for a proper identification of branch modes that are mainly excited with the experimental device (frequency, wavenumber and direction of excitation, ...). Interestingly, future works would consist in taking into account the excitation in the numerical model and plotting the corresponding dispersion diagrams.

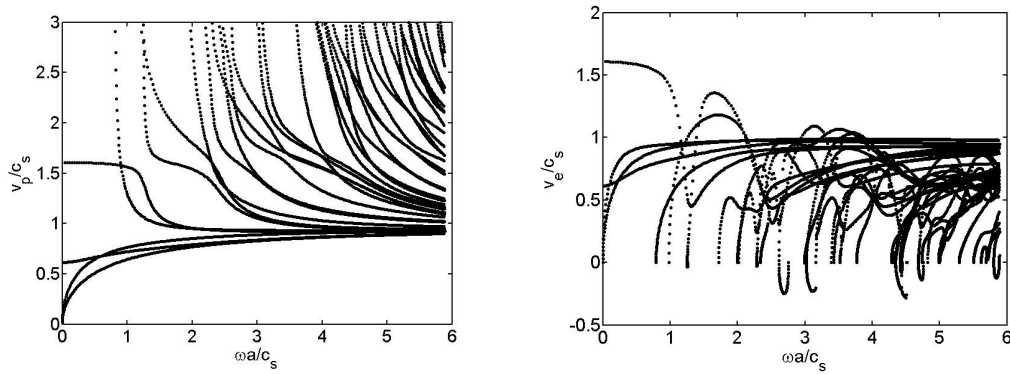
Figure 2. Calculated dispersion curves of guided wave modes in single z-shaped fiber (left: phase velocity; right: group velocity; $a = 3 \text{ mm}$, $c_s = 3.2 \text{ mm}/\mu\text{s}$)

For a single fibre of a z-shaped fully closed rope, the dispersion diagram was calculated (see section 2.2). Due to the results of the dispersion curves EMAT probes were designed and built for shear and longitudinal guided wave modes running in a single z-shaped fibre of a fully closed rope. Several EMATs with different trace wave lengths and corresponding frequencies were applied. The ultrasonic inspection parameters are shown in Table 3.

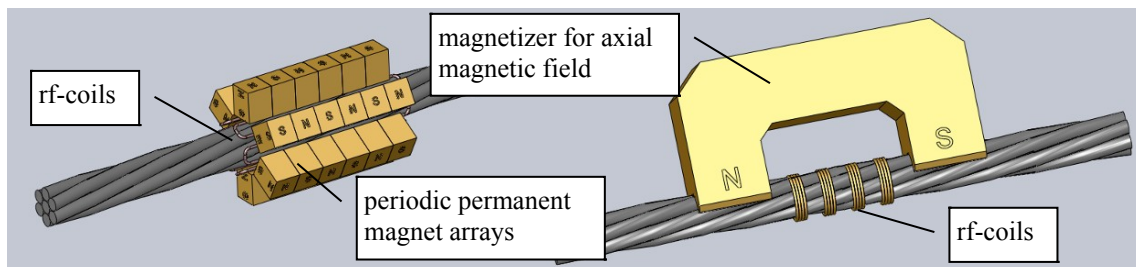
For the experiments on 7-wire strands EMAT probes were built up for the excitation and pick up of longitudinal and torsional guided wave modes. The principle design of the probes and the relevant ultrasonic inspection parameters are shown in Figure 3, respectively Table 2. The EMAT probes were applied to pre stressed and differently prepared 7-wire strands. The set of specimens contains coated strands with grease, concrete and free ones. In addition, a few wires were modified with artificial pitting or cracks like defects.

Figure 3. The principle design of EMAT probes for rod waves (left: torsional wave modes, right longitudinal wave modes)

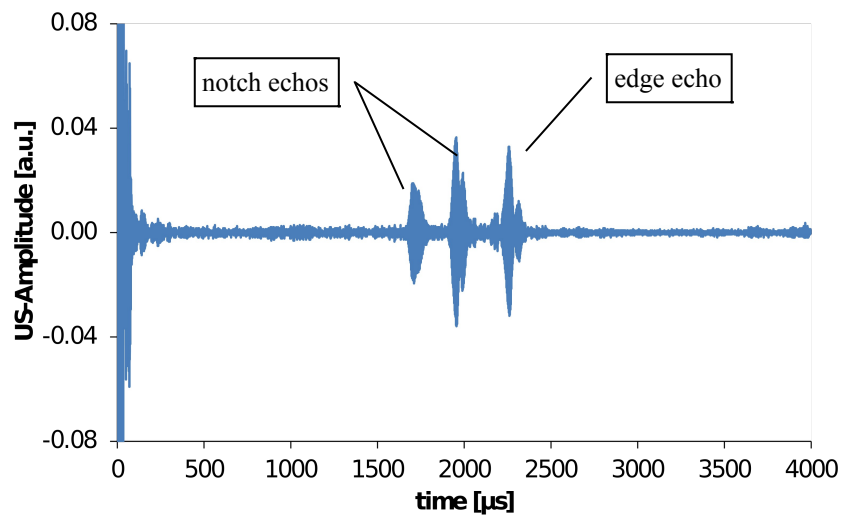
During the experiments we found out that the transduction efficiency of longitudinal wave modes in 7-wire strands is much higher compared to torsional wave modes. Therefore the following examinations are concentrated using longitudinal modes. The artificial defects can be detected via an ultrasonic echo signal over a several meters distance in all uncoated strands (see Figure 4). The ultrasonic signals are extremely damped by a coating layer of grease or grout. Under these conditions the ultrasonic signal extinguishes during a sound path of about one meter.

Figure 4. Ultrasonic A scan of a 7-wire strand with artificial defects, partially coated with concrete, the total length is about 5 m

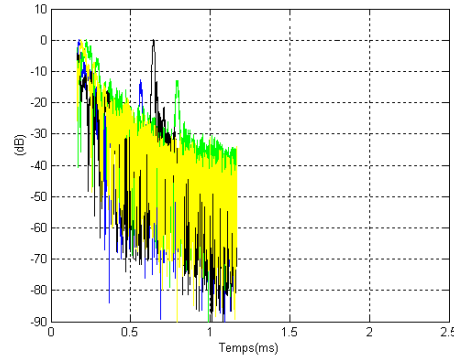
The Figure 6 corresponds to the 3 time envelopes of the echo signal amplitudes relative to each damaged wire of the strand (case 1 to 3). We observe that the straight broken peripheral wire is still detectable at 2 m. We can conclude 3 m inspection range distance

could be reasonably reached. Concerning, the case 3 damaged wire (with a broken wire whose ends are with an angle of 45°), we observe that its amplitude is lower than the two farthest straight broken peripheral wire defects due to the lower reflectivity of a such defect.

Figure 6. Time envelopes of echo signal for the damaged strand with 3 broken wires at 1.6 m case 1 (black curve), 2 m case 2 (green curve) and 1.4 m case 3 (blue curve). The yellow curve is for the central wire (undamaged wire).

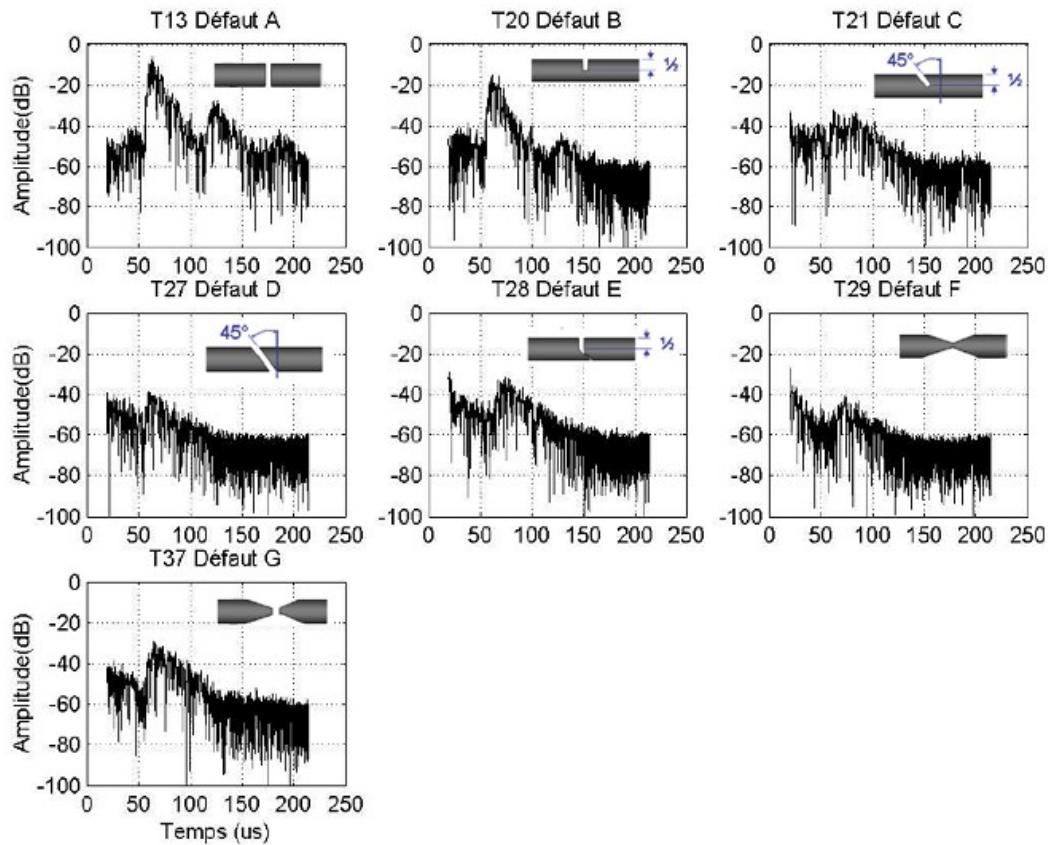
Figure 7. The time envelopes of the damaged wire of each strand

Figure 7 represents the time envelopes of the damaged wire of each strand. We observe that all type of defects produce one (or more) distinguishable echo signal (s). For instance, it is

possible to detect the complete straight broken wire defect echo (and associated multiples), as well as the mid depth straight notch echo signal (and its multiple) respectively. As expected, the more difficult echo signals to detect are those whose reflectivity is assumed low. This concerns the 45° inclined notch at mid depth case (T21 Defect C) and the tapered wire with no break (T29 Defect F).

Another series of experiments were conducted on a separate bench from the one considered before. This is a 2.5 m-bench with individually HDPE coated greased strands prestressed at around 30% of the ultimate strength. Artificial defects were machined in a short distance range (lower than 50 cm). Contrary to measurement performed in the above part, high-frequency wideband excitation signals were used for the short-distance defect detection. Various types of defects were machined to observe the influence of defect shape on the echo signal amplitude. The same methodology as above was used.

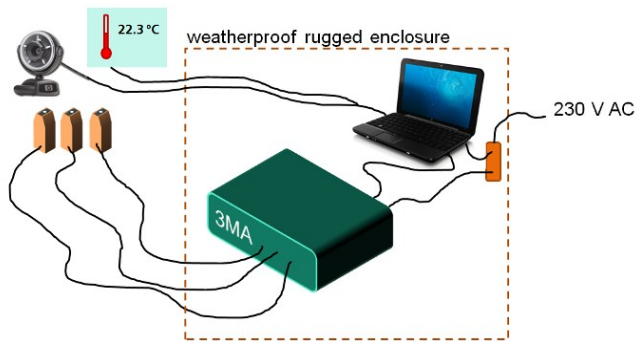
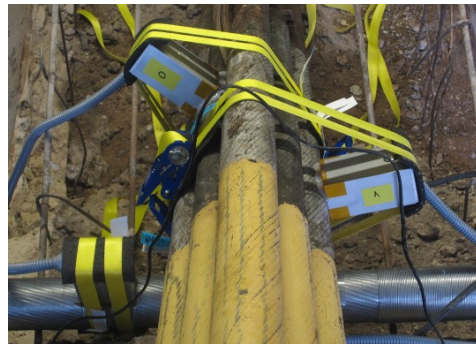
An on-site test of the micromagnetic monitoring approach was performed at the bridge over the Saar river in Mettlach, Germany. The applied measurement setup is shown in Figure 8. In order to test the remote flaw detection approach a set of three rugged micromagnetic devices was built, and an appropriate software for the long-term control of several devices with a single PC was created. A netbook PC, a USB hub for controlling the devices, and the power supplies were placed in a weather-proof box. The unit was connected to the 230 V mains line, available at the construction site. Two devices were strapped on loaded bridge

ropes, and one device was strapped on an unloaded fully locked wire rope of similar design. In order to monitor the environmental conditions (temperature, humidity) and the traffic load, a time lapse camera and a weather logger were installed as well.

Figure 8. Schematic representation of the monitoring equipment tested in Mettlach and photo of three installed devices (two on the loaded ropes and one device on an unloaded similar rope located below the loaded ropes)

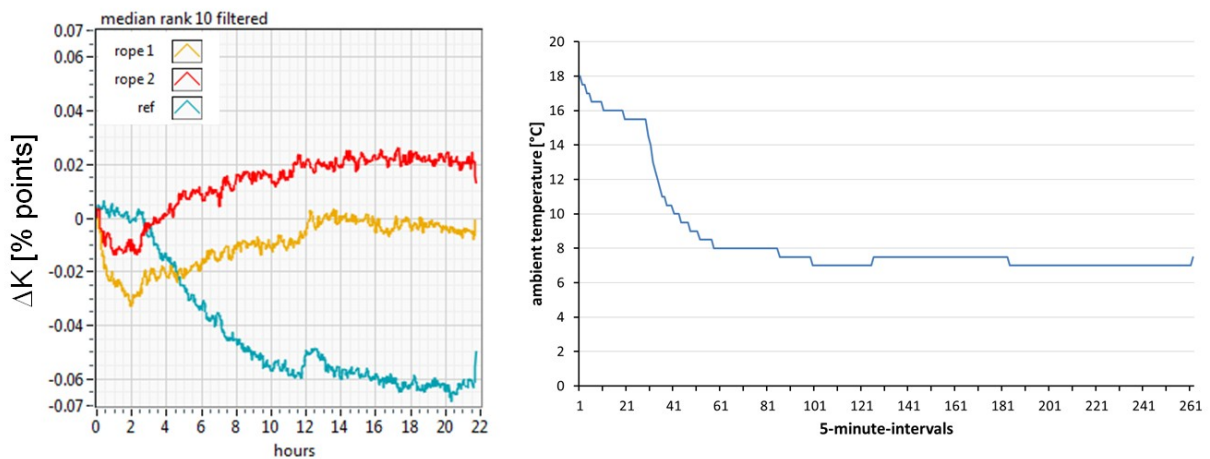
- A small, but significant correlation between the measured values and the ambient temperature was found (Figure 9). Further lab tests were performed which have shown that the effect is related to the temperature of the material, rather than the temperature of the device. A remarkable observation is that the temperature coefficient of the values measured on the loaded ropes had opposite sign and a smaller magnitude than the one in case of the reference rope. This suggests that the effect might be at least partially related to the thermal expansion of the wire and the related variations in tensile stress.

Figure 9. Change of harmonic distortion factor K (to the left, filtered by Median rank 10) and temperature (to the right) throughout the first experiment at the bridge

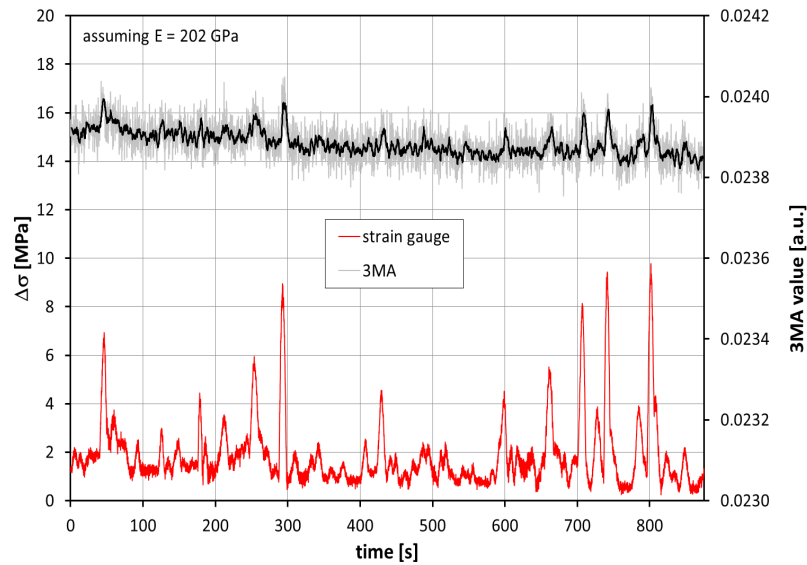
In a second on-site measurement, the actual effect of traffic was quantified using strain gauges, and the stress-sensitivity of the micromagnetic method was increased by tuning the device settings and analysis methods. Figure 10 shows the result. Assuming a Young's

modulus of $E = 202 \text{ GPa}$, the stress change $\Delta\sigma$ was computed from the measured strain ϵ (red curve). The micromagnetic materials characterization was performed using a 3MA device (3MA = Micromagnetic Multiparameter Microstructure and Stress Analysis), and the most stress sensitive parameter, derived from the incremental permeability measurement, was plotted over the same time axis as the strain gauge values (gray curve). In order to improve the signal/noise ratio, the 3MA signal was smoothed using a moving average filter, resulting in the black curve. The results show that a strong correlation between strain gauge signal and micromagnetic signal exists. Each peak in the strain gauge results from heavy loaded vehicles like trucks. This was confirmed by camera observations of the traffic. The strain gauge was calibrated with tension tests in the laboratory. Theoretical calculations of the static load on the ropes, due to a truck passing the bridge, let to a value of 15 MPa. The measured values are in good accordance with this calculation. The result of the micromagnetic measurement, which was performed parallel to the strain gauge tests, show that all peaks in the strain gauge signal can also be resolved in the micromagnetic signal. This experiment indicates that the resolution limit of the micromagnetic measurement should be approximately in the same order of magnitude as the traffic load. Therefore, we can assume that it will be sufficient to detect probable wire breaks within the frame of these planned long term monitoring activities, since wire breaks would generate much greater stress changes than the observed traffic loads. In the next on-site experiment in Mettlach, the relation of this traffic-load induced effect to the other load-affecting influences such as temperature and wind will be examined.

Figure 10. Strain gauge and micromagnetic signal of traffic load
