NDT for need based maintenance of civil infrastructure – FilameNDT a Franco-German project for monitoring and inspection of bridge cables, ropes and pre-stressed elements

NDT for Need Based Maintenance of Civil Infrastructure – FilameNDT a Franco-German Project for Monitoring and Inspection of Bridge Cables, Ropes and Pre-Stressed Elements

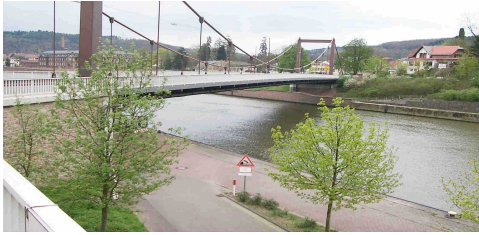
<p>Ultrasound guided waves (EMAT (SH – torsional mode, L – lamb wave)) 3MA (monitoring) AE (monitoring)</p>
<p>4. Cable stayed bridge provided for inspection and monitoring (Saar river, Mettlach, Germany)</p>

<p>Ultrasound guided waves (EMAT (SH – torsional mode, L – lamb wave)) AE (monitoring) 3MA (monitoring)</p>

The bridge shown in Table 1 will be renovated in the near future. Inspection activities within the frame of this process started in autumn 2011. This period was used for the first monitoring tests. The main renovation phase begins in autumn 2012 and during this process the concrete deck will be replaced by a much lighter one. Within the frame of these activities additional load tests are envisaged for this construction. Therefore, a micromagnetic monitoring at two anchorage zones and an acoustic emission monitoring at all 4 anchorage zones is planned. The bridge has eight wire ropes on each side as elements carrying main load. Stress changes should be equally distributed over all wires. Therefore, not all ropes have to be instrumented. Acoustic emission monitoring for the detection of wire breaks is a well referenced approach. This method will be used validating the micromagnetic results and to have redundant measurements for the assessment of the results. Micromagnetic measurements rely on the fact that the magnetic properties of ferromagnetic materials are strongly correlated to the mechanical properties. Using this approach, monitoring stress changes is possible. The transfer of the micromagnetic technique from the application field of material characterization and quality assurance to structural health monitoring is a new approach. However, this application needs to be tested which was performed in a first field test at the described bridge. The load signal due to the traffic was known and therefore continuous measurements were performed for a short period of a few days.

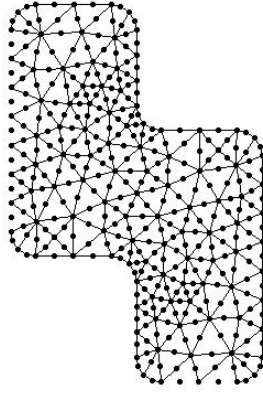
Figure 1. Finite-element mesh for a simplified single z-shaped wire geometry

The goal of this subsection is to improve the theoretical understanding of guided wave propagation at the periphery of fully closed spiral ropes. As a first step, a single simplified z-shaped wire has been modelled (Figure 1).

No coupling with adjacent wires has been considered. Due to the geometrical complexity, a numerical method must be used. Here the method is based on the so-called semi-analytical finite element technique, which consists in reducing the problem to the cross-section only, thanks to a spatial Fourier transform performed along the axis. With a Semi-Analytical Finite Element (SAFE) method, the only assumption required is that the structure must be translationally invariant, which is the case for a single z-shaped wire. The problem to be solved, initially three-dimensional, hence becomes two-dimensional. The curvature of the helical axis has been accounted to be based on the use of a specific curvilinear coordinate system, corresponding to a twisting system, recently developed at IFSTTAR. Results have shown that the curvature of the axis can be neglected for the structure and the frequency range considered. Some theoretical dispersion curves are presented in Figure 2, which plots, respectively, the dimensionless phase velocity and group velocity with respect to the dimensionless frequency for each propagating mode. The dimensional frequency range considered corresponds to the range [0 - 1 MHz]. It can be observed that many modes are propagating in this range. Typical for prismatic waveguides, compressional, torsional, and flexural modes occur. At this stage, additional information is needed for a proper identification of branch modes that are mainly excited with the experimental device (frequency, wavenumber and direction of excitation, ...). Interestingly, future works would consist in taking into account the excitation in the numerical model and plotting the corresponding dispersion diagrams.

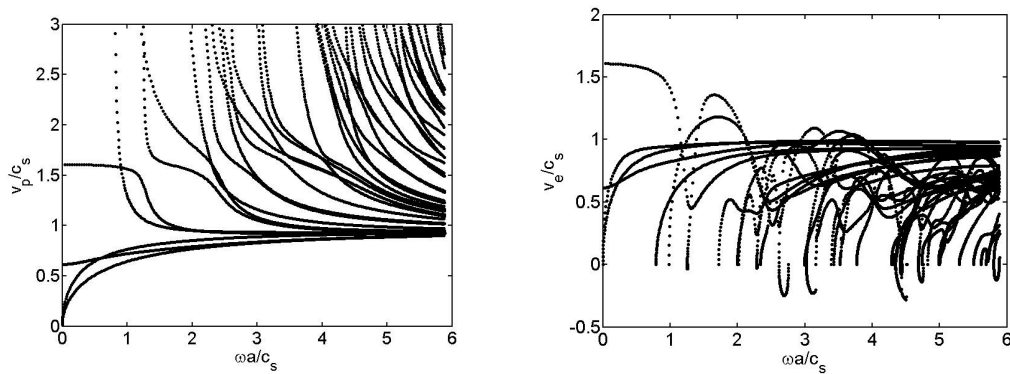
Figure 2. Calculated dispersion curve of guided wave modes in single z-shaped fiber (left: phase velocity; right: group velocity; $a = 3 \text{ mm}$, $c_s = 3.2 \text{ mm}/\mu\text{s}$)

For a single fibre of a z-shaped fully closed rope, the dispersion diagram was calculated (see section 2.2). Due to the results of the dispersion curves EMAT probes were designed and built for shear and longitudinal guided wave modes running in a single z-shaped fibre of a fully closed rope. Several EMATs with different trace wave lengths and corresponding frequencies were applied. The ultrasonic inspection parameters are shown in Table 3.

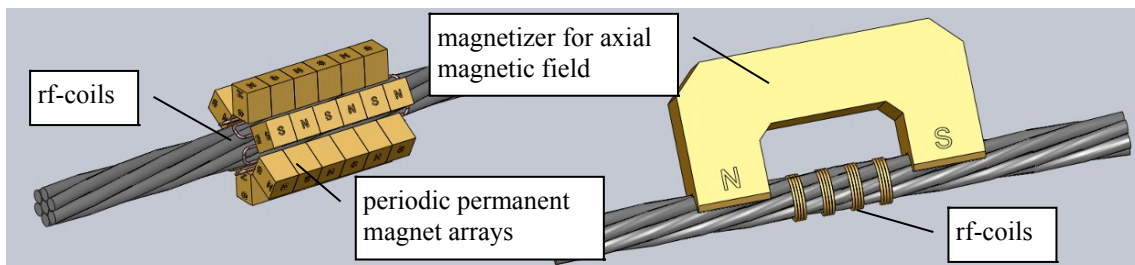
Figure 3. The principle design of EMAT probes for rod waves (left: torsional wave modes, right longitudinal wave modes)

For the experiments on 7-wire strands EMAT probes were built up for the excitation and pick up of longitudinal and torsional guided wave modes. The principle design of the probes and the relevant ultrasonic inspection parameters are shown in Figure 3, respectively Table 2. The EMAT probes were applied to pre stressed and differently prepared 7-wire strands. The set of specimens contains coated strands with grease, concrete and free ones. In addition, a few wires were modified with artificial pitting or cracks like defects.

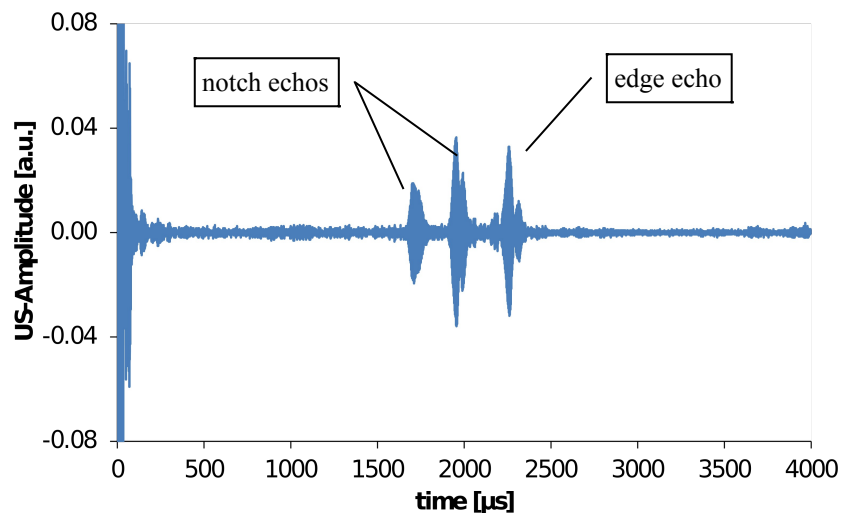
Figure 4. Ultrasonic A scan of a 7-wire strand with artificial defects, partially coated with concrete, the total length is about 5 m

During the experiments we found out that the transduction efficiency of longitudinal wave modes in 7-wire strands is much higher compared to torsional wave modes. Therefore the following examinations are concentrated using longitudinal modes. The artificial defects can be detected via an ultrasonic echo signal over a several meters distance in all uncoated strands (see Figure 4). The ultrasonic signals are extremely damped by a coating layer of grease or grout. Under these conditions the ultrasonic signal extinguishes during a sound path of about one meter.

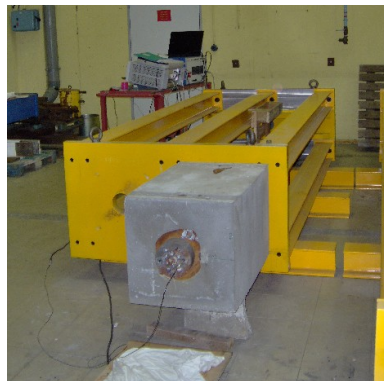
Figure 5. 5 m bench for cement grouted 7-wire strand prestressed at 80% of the ultimate strength

A bench of 5 m length including 3 prestressing 7-wire strands were used for the experiments (Erreur : source de la référence non trouvée5). All the 3 strands are 5m long are grouted over 2.5 m length with cement grout in a polyethylene high density (HDPE) duct. The strands are prestressed at 80% of the ultimate strength.

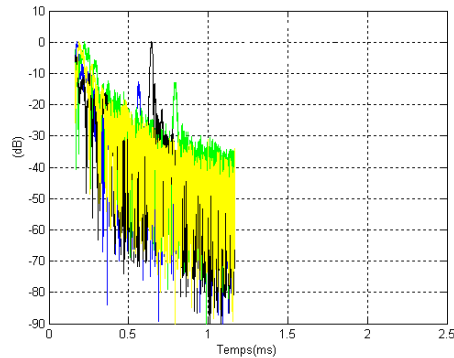
Figure 6. Time envelopes of echo signal for the damaged strand with 3 broken wires at 1.6 m case 1 (black curve), 2 m case 2 (green curve) and 1.4 m case 3 (blue curve). The yellow curve is for the central wire (undamaged wire).

The Figure 6 corresponds to the 3 time envelopes of the echo signal amplitudes relative to each damaged wire of the strand (case 1 to 3). We observe that the straight broken peripheral wire is still detectable at 2 m. We can conclude 3 m inspection range distance

could be reasonably reached. Concerning, the case 3 damaged wire (with a broken wire whose ends are with an angle of 45°), we observe that its amplitude is lower than the two farthest straight broken peripheral wire defects due to the lower reflectivity of a such defect.

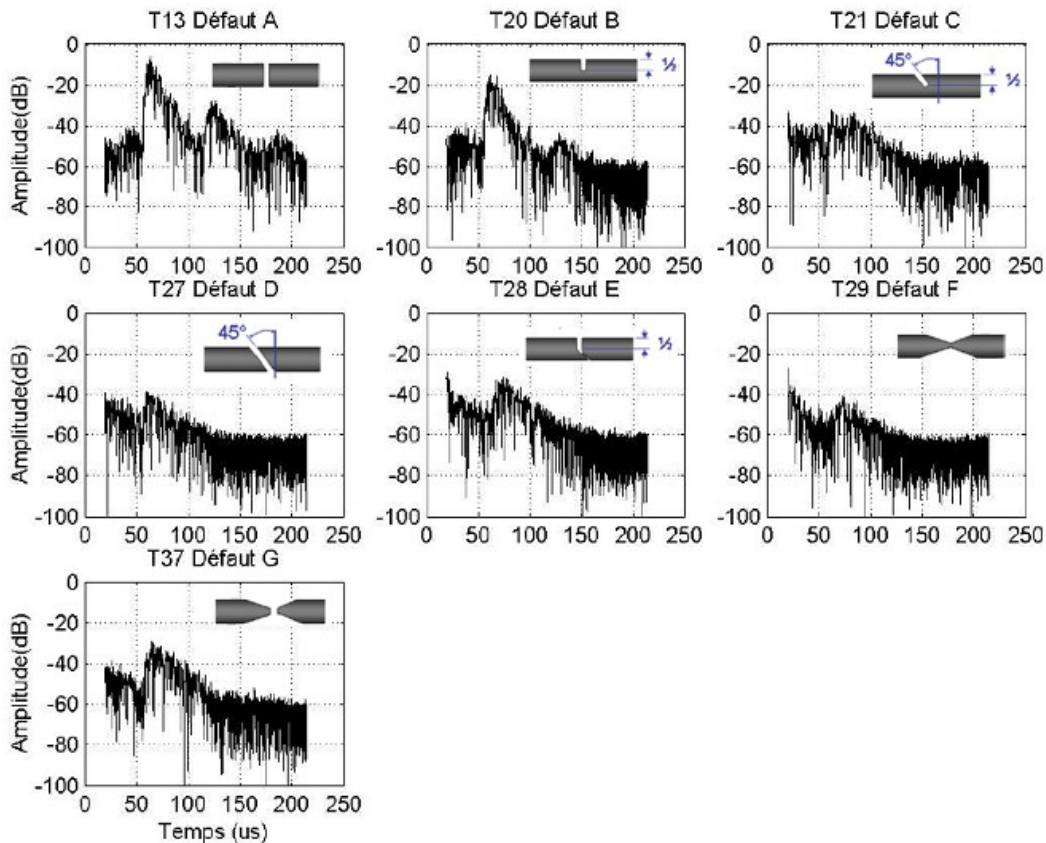
Figure 7. The time envelopes of the damaged wire of each strand

Figure 7 represents the time envelopes of the damaged wire of each strand. We observe that all type of defects produce one (or more) distinguishable echo signal (s). For instance, it is

possible to detect the complete straight broken wire defect echo (and associated multiples), as well as the mid depth straight notch echo signal (and its multiple) respectively. As expected, the more difficult echo signals to detect are those whose reflectivity is assumed low. This concerns the 45° inclined notch at mid depth case (T21 Defect C) and the tapered wire with no break (T29 Defect F).

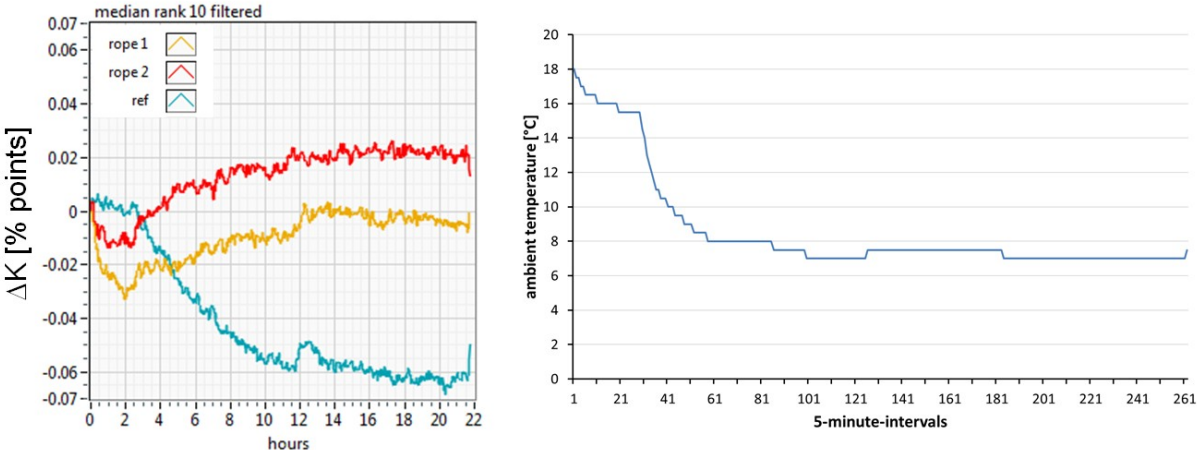
Figure 9. Change of harmonic distortion factor K (to the left, filtered by Median rank 10) and temperature (to the right) throughout the first experiment at the bridge

- A small, but significant correlation between the measured values and the ambient temperature was found (Figure 9). Further lab tests were performed which have shown that the effect is related to the temperature of the material, rather than the temperature of the device. A remarkable observation is that the temperature coefficient of the values measured on the loaded ropes had opposite sign and a smaller magnitude than the one in case of the reference rope. This suggests that the effect might be at least partially related to the thermal expansion of the wire and the related variations in tensile stress.
