NDT for need based maintenance of civil infrastructure – FilameNDT a Franco-German project for monitoring and inspection of bridge cables, ropes and pre-stressed elements

NDT for Need Based Maintenance of Civil Infrastructure – FilameNDT a Franco-German Project for Monitoring and Inspection of Bridge Cables, Ropes and Pre-Stressed Elements

Jochen H. KURZ*, Laurent LAGUERRE**, Frank NIESE* Laurent GAILLET**, Klaus SZIELASKO*, Fabien TREYSEDE**

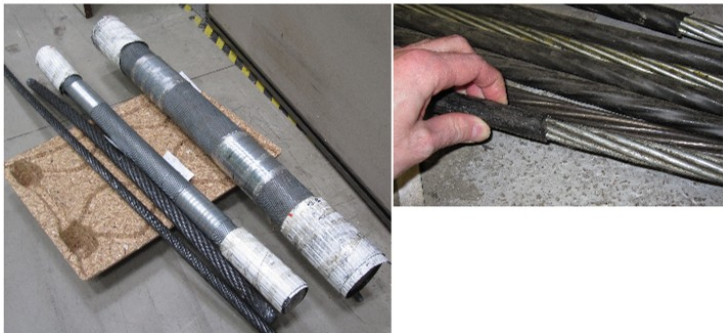
| Configuration | NDT Method |
|--|---|
| <p>1. Bare cables of different diameters</p> | <p>Ultrasound guided waves (EMAT (SH – torsional mode, L – lamb wave)) 3MA (7 wired strand)</p> |

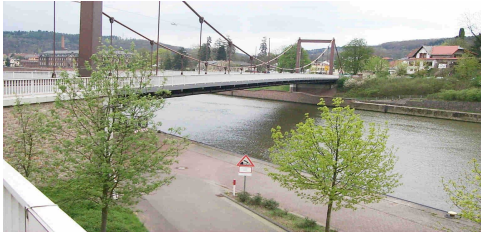
| <p>4. Cable stayed bridge provided for inspection and monitoring (Saar river, Mettlach, Germany)</p> | <p>Ultrasound guided waves (EMAT (SH – torsional mode, L – lamb wave)) AE (monitoring) 3MA (monitoring)</p> |

The bridge shown in Table 1 will be renovated in the near future. Inspection activities within the frame of this process started in autumn 2011. This period was used for the first monitoring tests. The main renovation phase begins in autumn 2012 and during this process the concrete deck will be replaced by a much lighter one. Within the frame of these activities additional load tests are envisaged for this construction. Therefore, a micromagnetic monitoring at two anchorage zones and an acoustic emission monitoring at all 4 anchorage zones is planned. The bridge has eight wire ropes on each side as elements carrying main load. Stress changes should be equally distributed over all wires. Therefore, not all ropes have to be instrumented. Acoustic emission monitoring for the detection of wire breaks is a well referenced approach. This method will be used validating the micromagnetic results and to have redundant measurements for the assessment of the results. Micromagnetic measurements rely on the fact that the magnetic properties of ferromagnetic materials are strongly correlated to the mechanical properties. Using this approach, monitoring stress changes is possible. The transfer of the micromagnetic technique from the application field of material characterization and quality assurance to structural health monitoring is a new approach. However, this application needs to be tested which was performed in a first field test at the described bridge. The load signal due to the traffic was known and therefore continuous measurements were performed for a short period of a few days.

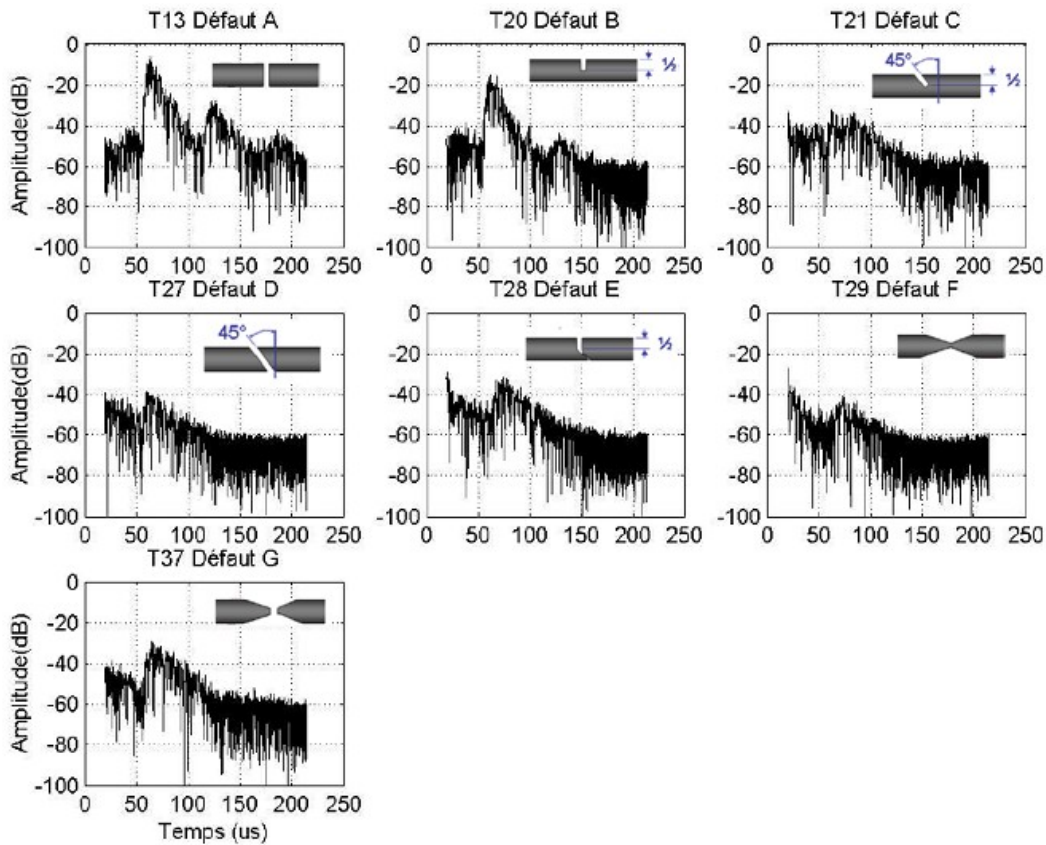
Figure 7. The time envelopes of the damaged wire of each strand

Figure 7 represents the time envelopes of the damaged wire of each strand. We observe that all type of defects produce one (or more) distinguishable echo signal (s). For instance, it is

possible to detect the complete straight broken wire defect echo (and associated multiples), as well as the mid depth straight notch echo signal (and its multiple) respectively. As expected, the more difficult echo signals to detect are those whose reflectivity is assumed low. This concerns the 45° inclined notch at mid depth case (T21 Defect C) and the tapered wire with no break (T29 Defect F).

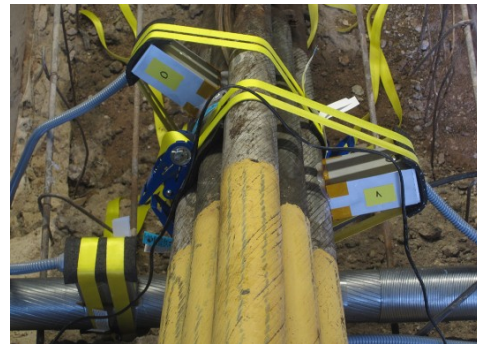
Figure 8. Schematic representation of the monitoring equipment tested in Mettlach and photo of three installed devices (two on the loaded ropes and one device on an unloaded similar rope located below the loaded ropes)

An on-site test of the micromagnetic monitoring approach was performed at the bridge over the Saar river in Mettlach, Germany. The applied measurement setup is shown in Figure 8. In order to test the remote flaw detection approach a set of three rugged micromagnetic devices was built, and an appropriate software for the long-term control of several devices with a single PC was created. A netbook PC, a USB hub for controlling the devices, and the power supplies were placed in a weather-proof box. The unit was connected to the 230 V mains line, available at the construction site. Two devices were strapped on loaded bridge

ropes, and one device was strapped on an unloaded fully locked wire rope of similar design. In order to monitor the environmental conditions (temperature, humidity) and the traffic load, a time lapse camera and a weather logger were installed as well.
