NDT for need based maintenance of civil infrastructure – FilameNDT a Franco-German project for monitoring and inspection of bridge cables, ropes and pre-stressed elements

NDT for Need Based Maintenance of Civil Infrastructure – FilameNDT a Franco-German Project for Monitoring and Inspection of Bridge Cables, Ropes and Pre-Stressed Elements

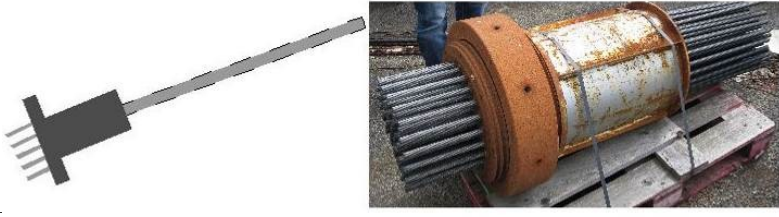
<p>3. Anchorage Zone</p>

<p>Ultrasound guided waves (EMAT (SH – torsional mode, L – lamb wave)) 3MA (monitoring) AE (monitoring)</p>
<p>4. Cable stayed bridge provided for inspection and monitoring (Saar river, Mettlach, Germany)</p>

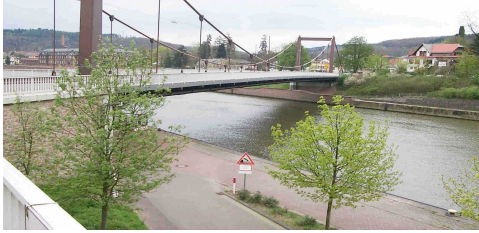
<p>Ultrasound guided waves (EMAT (SH – torsional mode, L – lamb wave)) AE (monitoring) 3MA (monitoring)</p>

The bridge shown in Table 1 will be renovated in the near future. Inspection activities within the frame of this process started in autumn 2011. This period was used for the first monitoring tests. The main renovation phase begins in autumn 2012 and during this process the concrete deck will be replaced by a much lighter one. Within the frame of these activities additional load tests are envisaged for this construction. Therefore, a micromagnetic monitoring at two anchorage zones and an acoustic emission monitoring at all 4 anchorage zones is planned. The bridge has eight wire ropes on each side as elements carrying main load. Stress changes should be equally distributed over all wires. Therefore, not all ropes have to be instrumented. Acoustic emission monitoring for the detection of wire breaks is a well referenced approach. This method will be used validating the micromagnetic results and to have redundant measurements for the assessment of the results. Micromagnetic measurements rely on the fact that the magnetic properties of ferromagnetic materials are strongly correlated to the mechanical properties. Using this approach, monitoring stress changes is possible. The transfer of the micromagnetic technique from the application field of material characterization and quality assurance to structural health monitoring is a new approach. However, this application needs to be tested which was performed in a first field test at the described bridge. The load signal due to the traffic was known and therefore continuous measurements were performed for a short period of a few days.
