Degradation modes and tool wear mechanisms in finish and rough machining of Ti17 Titanium alloy under high-pressure water jet assistance

Yessine Ayed, Guénaél Germain, Amine Ammar, Benoit Furet

Yessine Ayed, Guénaél Germain, Amine Ammar, Benoit Furet. Degradation modes and tool wear mechanisms in finish and rough machining of Ti17 Titanium alloy under high-pressure water jet assistance. *Wear*, 2013, 305 (1-2), pp.228-237. 10.1016/j.wear.2013.06.018 . hal-01068090

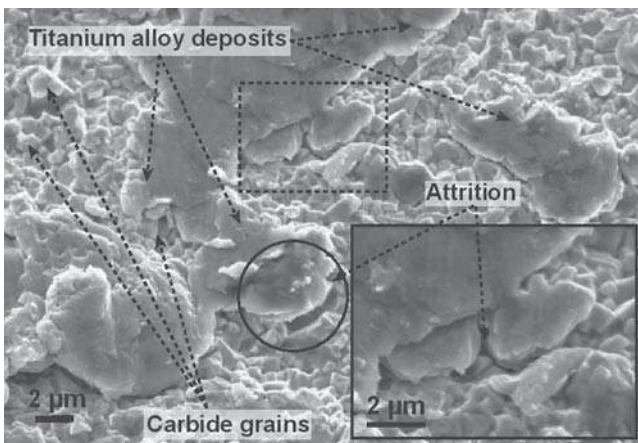
Fig. 10. Adherent layers on the tool rake face after 5 min of roughing machining at a pressure of 100 bars.

Fig. 10 shows material deposits sticking to tungsten carbide grains. Furthermore, it shows the attrition or loss of carbide grains. Fig. 11 shows that the areas with material deposits are protected and are not subjected to damage.
