Degradation of solar cells due to in orbit electrostatic discharge?

(Dated: September 2013; Revised May 14, 2014)

A follow-up from EMAGS3
#123

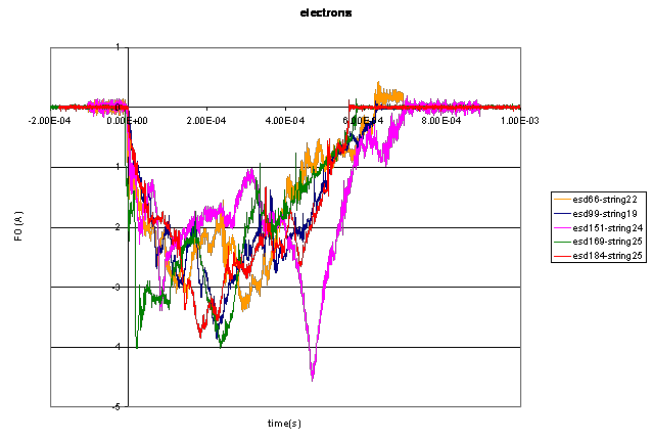
FIG. 1. Summary of flash-over transients detected during EMAGS3 study[13]

The study primarily focused on a better understanding of the flash-over phenomenon and its characteristic parameters, the typical duration and amplitude of the flash-over current, which could be translated into a velocity of the discharge front along the surface and the area that could be discharged by a single flash-over.

Already from first sight of the transients one could guess the way and speed the discharge took over the panel. The speed

that could be read directly from the peak current on each string and its respective position [14] was about 4.5 km/s and thus much lower than 10 to more than 30 km/s reported by other authors[15, 16].

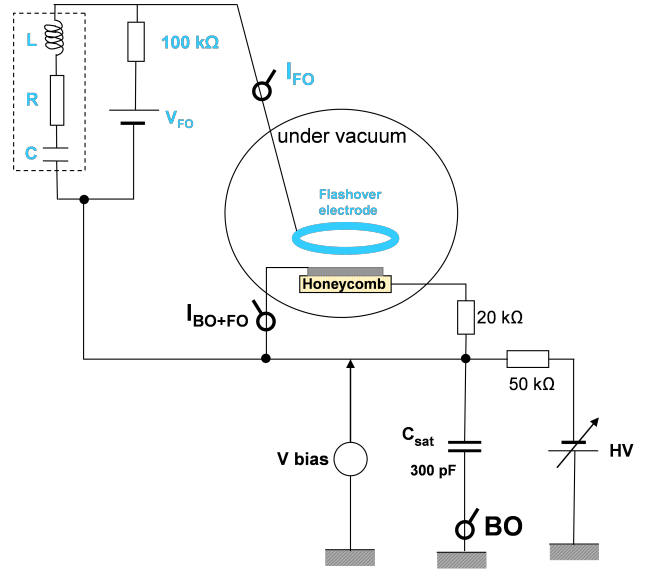
FIG. 2. Circuit for flash-over experiments[18]

Thereafter the aim was to propose a simulation circuit that, based on the experimental results, could provide a most representative flash-over pulse shape to experiments on samples which are much smaller, typically coupons, and thus not capable to produce a full scale flash-over. While the individual shape of the pulses varied significantly as shown in fig. 1, duration and peak current kept to the same order of magnitude. So the proposed simulator consisted just of a simple R-L-C circuit, as shown in fig. 2.

It should be noted, that the elements of the circuit represent nothing other but the charged surface of the cover glasses and the part of the circuit of the discharge that is closed over the vacuum by the flash-over itself.

The experiments have been performed by ONERA at their facilities in Toulouse[18] using a circuit as described in fig. 2 designed to simulate the discharge of a whole panel. The coupons were placed in a vacuum chamber and the surface was charged by Argon plasma while being set at negative potential of up to -5kV to generate inverse potential gradient conditions. Above the coupon the flash over antenna was placed to gather any electrons emitted by the anticipated cathodic spot. To concentrate discharges on the area below the antenna, it was agreed to cover all other cell edges by insulating Kapton. Compared to the panel testing, were the cathodic spot nearly never occurred twice on the same cell, all the discharges were forced to happen on the 4 cm short edge of the cell. Thus one must consider these repeated discharges when comparing data to the real case.

The electrical parameters of the components might appear a bit out-of-world compared to typical values for inductance and capacity of a panel. It must be recalled that the elements of the flash-over simulator represent no circuit element of the panel but the charged surface of the cover glasses and the part

of the circuit of the flash-over that is closed over the vacuum by the discharge itself. Especially the inductance has to be considerably high to spread the discharge of the capacitor to the desired duration.

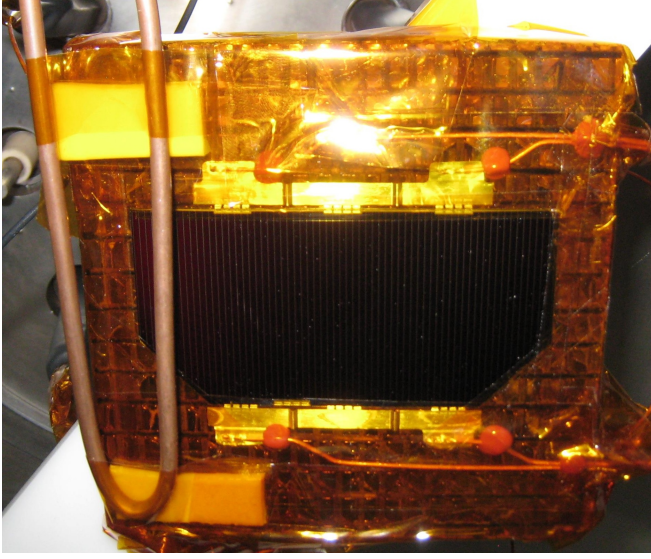
FIG. 3. Test coupon with AZUR Space Solar Power GmbH 3G28 GaAs triple cell in test chamber. The flash-over antenna is visible as a loop of copper strand

To support these encouraging finding a couple of samples on a panel structure like fig. 3 were prepared using solar cell assemblies (SCA) from both: Single silicon cells of same type as on the panel and 3G28 GaAs triple junction cells from AZUR Space, to be subjected to the flash-over generated by the proposed flash-over simulator to see if it has any effect on the cell performance and if it hence could be considered representative.

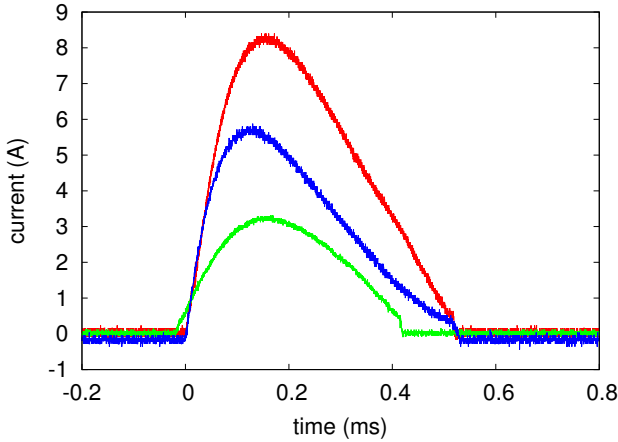
Fig. 4 shows, respectively, a minimal, typical and maximal flashover current transient generated by the flash-over simulator during this tests.

FIG. 4. Typical flash-over current transients

The characteristic parameters of the transients generated were an average peak current value of (5.3 ± 1.7) A on the GaAs cell and (5.1 ± 1.2) A on the silicon cell and an average duration of $(500 \pm 100) \mu s$ on both.

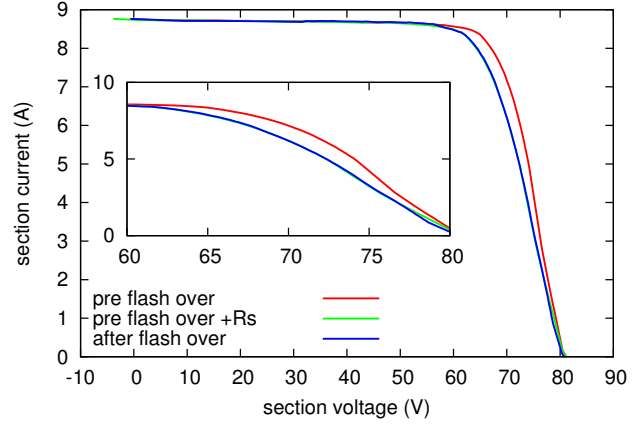
FIG. 5. IV Measurement on full section under one sun illumination. The inset gives a closer look to the right portion of the curve showing the effect of serial resistance of 0.35Ω associated with the additional cabling.

box, barely restoring the electric circuitry, we performed the same measurements as in 2006 and to our enthusiastic surprise the IV-curves in fig. 5 fitted onto each other within 1 % at the characteristic points.

The current voltage (IV) curves measured (long!) before the experiments almost lie on top of the newly measured – at least for the horizontal part of the curve. And we have to consider the different cabling and a lot of additional interconnectors in the circuit. As shown in fig. 5 the effect of 5 m additional cable having a resistance of 0.35Ω added to the measured data before test was sufficient to improve the correspondence to a perfect reproduction of the performance data before the test.

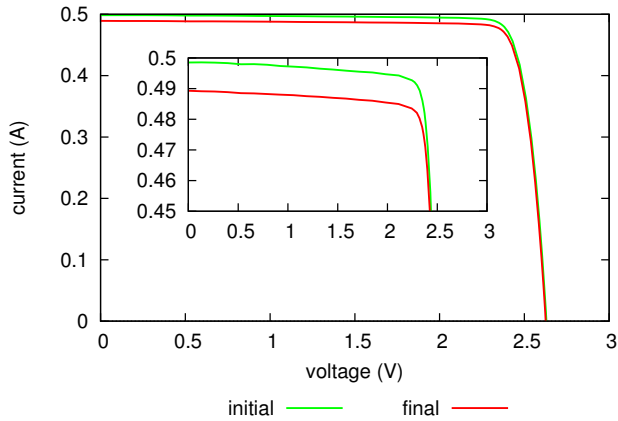
FIG. 6. IV curve of GaAs triple cell under one sun illumination. The inset shows a close up of the current branch.

On the first glance the results appeared inconclusive: On both cells, there was no degradation in filling factor as it would be suspected if shunts were created, but current was reduced by about 1.4 % as in fig. 6. The dark IV curve of the GaAs cell fig. 7 shows no shunt at all, whereas on the silicon cell in fig. 9 a weak shunt of about 139Ω was created and could also be derived from the slope in fig. 8 but could not account for the loss in short circuit current. From dark IV-measurements in fig. 10 taken during the experiments after every 20 ESD inception we knew, that the shunt must have been generated after 40 and before 60 flash-over inceptions. Since the shunt resistance was stable before 40 and after 60 ESD, we deduce, that it has been generated most likely by one single event. Fig. 11 shows a chip out in the cover glass and a small disturbed area

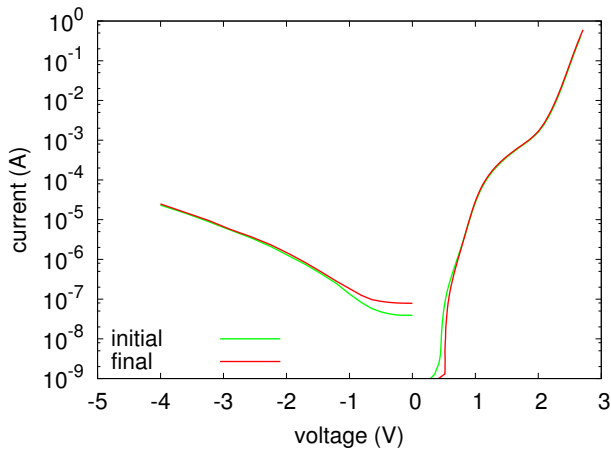
FIG. 7. Dark IV curve of GaAs triple cell

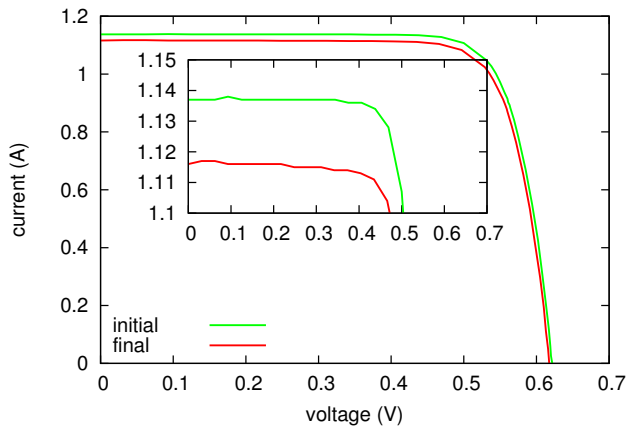
FIG. 8. IV curve of Si cell SCA under one sun illumination. The inset shows a close up of the current branch.

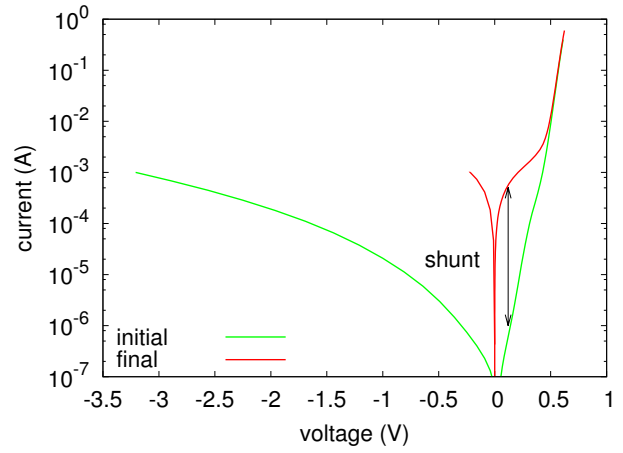
FIG. 9. Dark IV curve of Si cell SCA

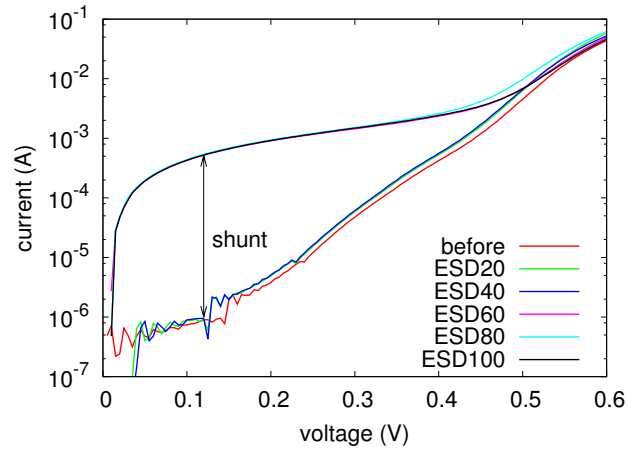
FIG. 10. Dark IV curve of Si cell SCA during ESD experiments

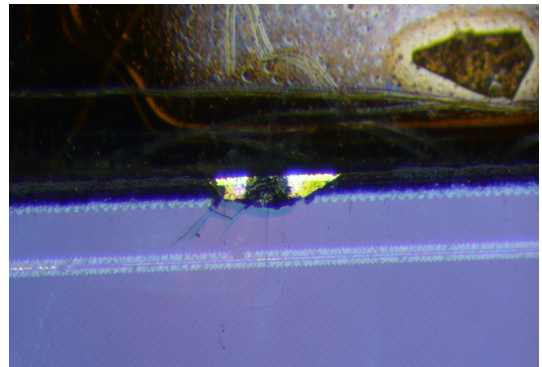
FIG. 11. Cathodic spot on Si cell

that might present the corresponding cathodic spot. But since this shunt cannot affect the short circuit current there has to be another cause for the observed reduction of current. A closer look to the surface of the tested silicon cell reveals degraded coating on about two thirds of cover glass. Considering du-

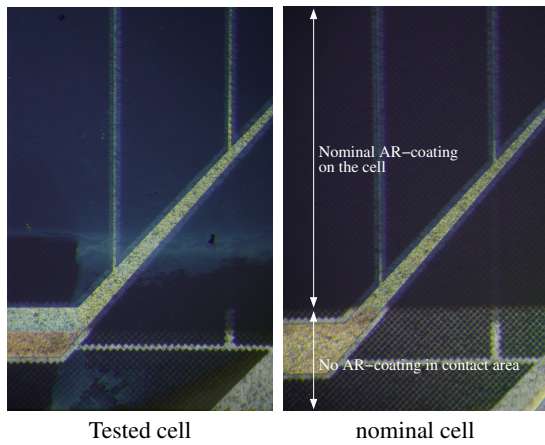
FIG. 12. Surface of Si SCA

In fig. 12 the tested cell shows a blurry fog on some parts compared to the dark sight of an unaffected one. By measuring absorption of the cells before and after the test, on both cells a slight decrease of absorption can be observed in the short wavelength part.

One explanation could be the blurry appearance of the cover glass surface shown in fig. 12 that might reduce transparency to the lower cell without reducing absorption.

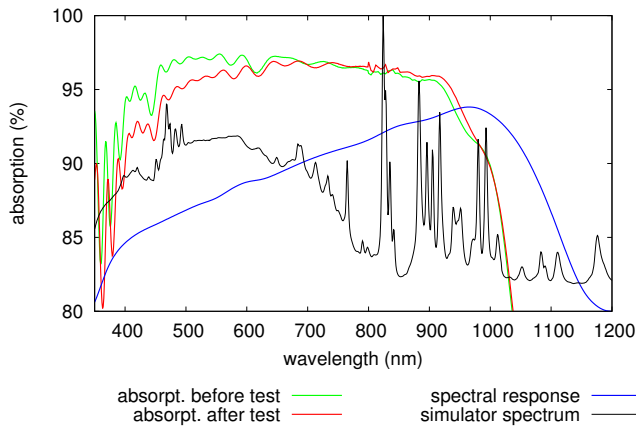
FIG. 13. Optical properties of Si cell SCA

If we integrate the absorption with the spectral properties of the light source (a solar simulator) and the spectral responsivity of the cell, shown in fig. 14 and 13, the loss in absorption of 0.93 % for the GaAs cell could account for the loss in short circuit current that was measured. The silicon cell however shows loss of absorption of 0.41 % only, that appears too low to fully understand its loss in short circuit current.

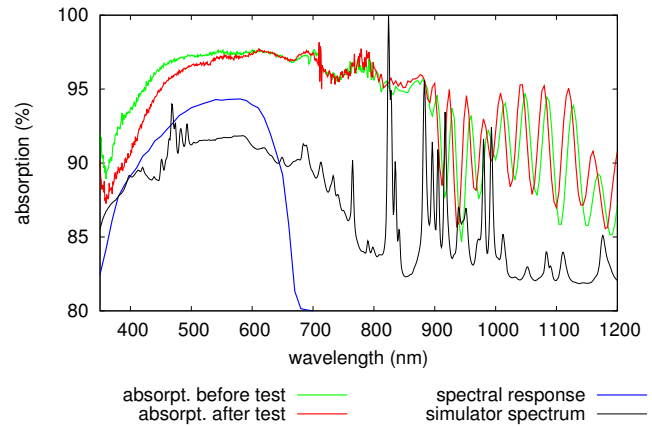
FIG. 14. Optical properties of GaAs triple cell SCA. Only the top cell as the current limiting cell has to be considered

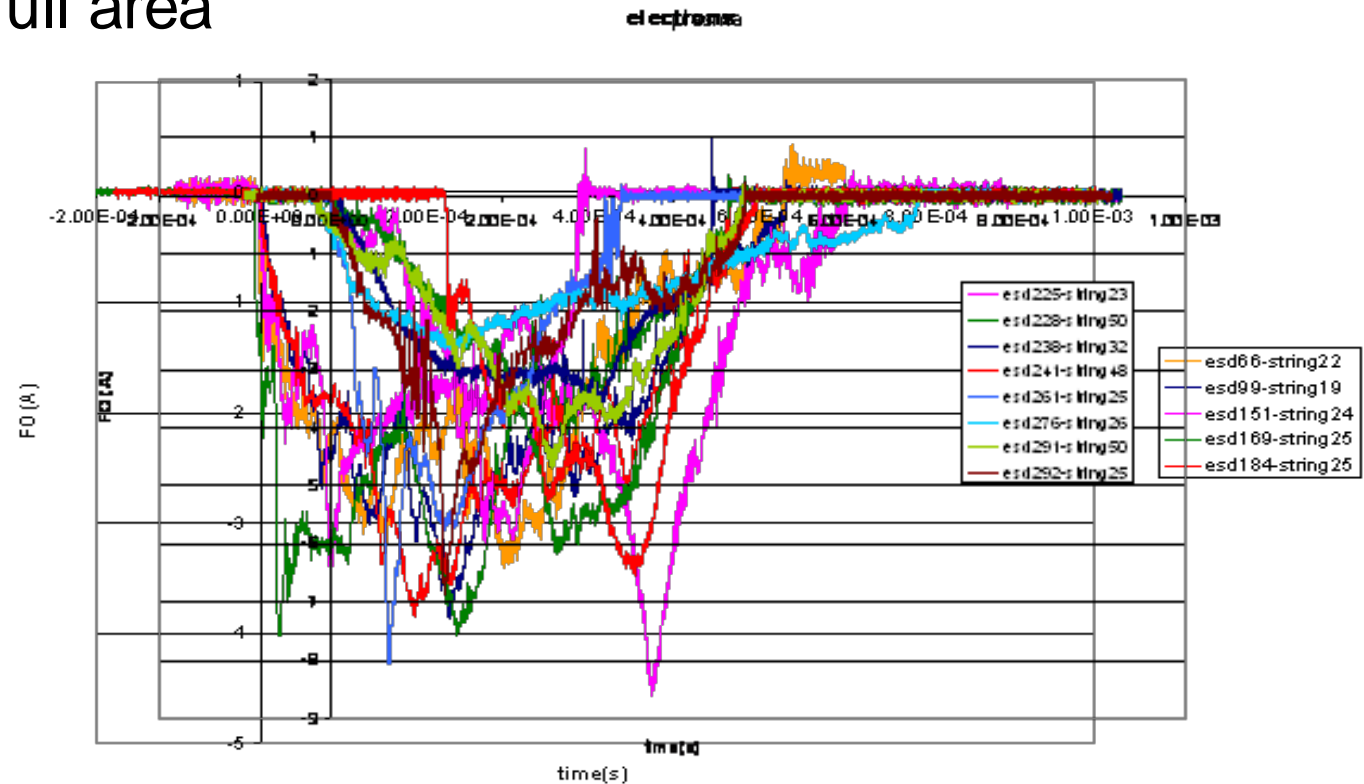
EMAGS3: Characteristic of ESD

- About 1400 flash over registered
- Some 10% discharged full area
- Max current: 8A
mean: about 5A
- Max duration: 800 μ s
typical: 500 μ s

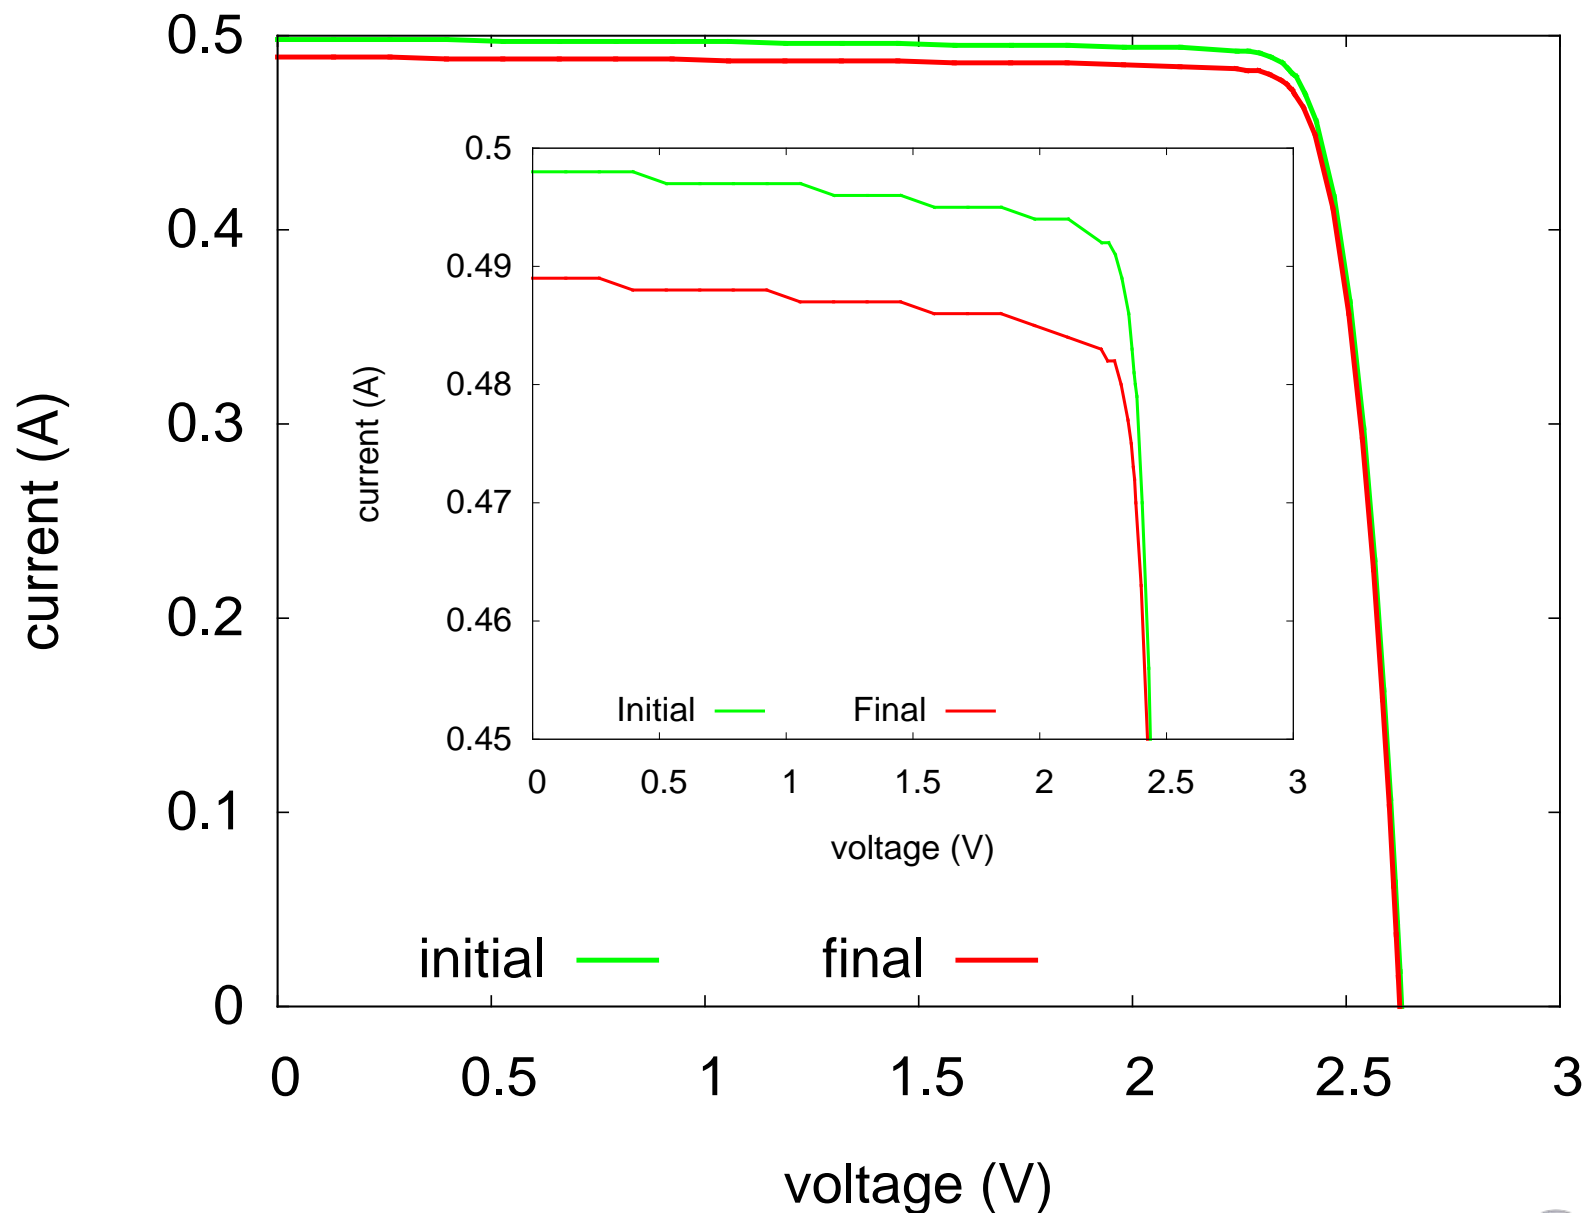
3G28: Degradation in efficiency - not in filling factor!

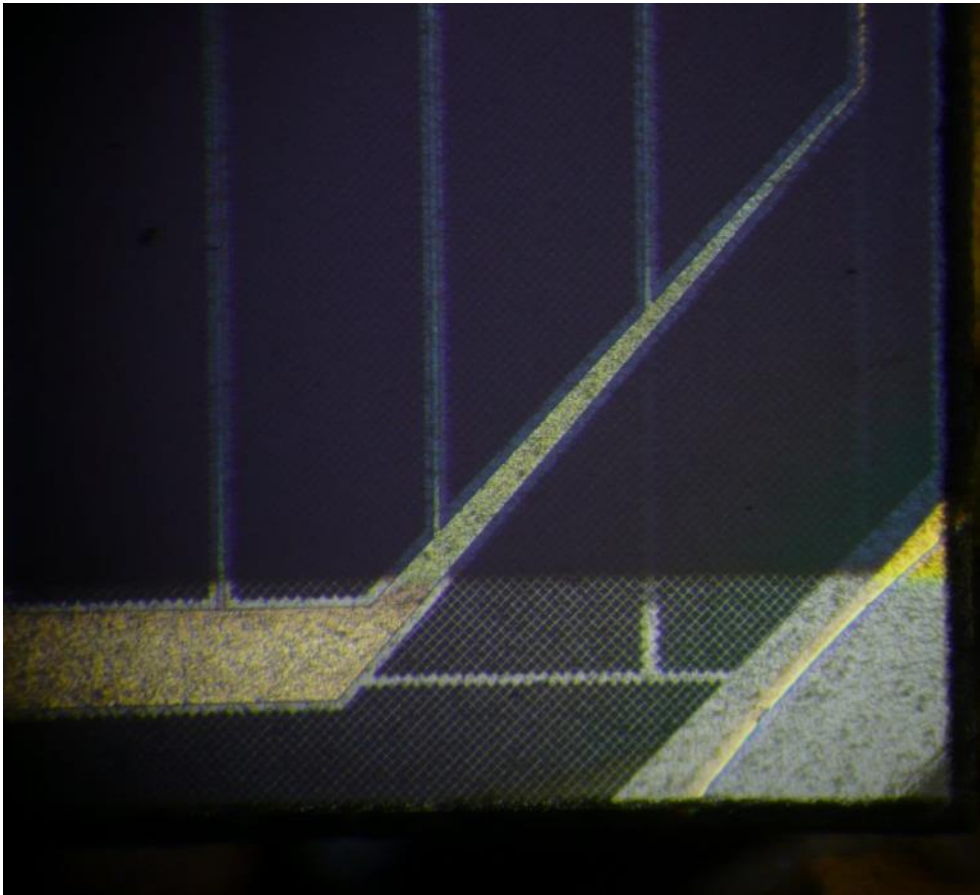
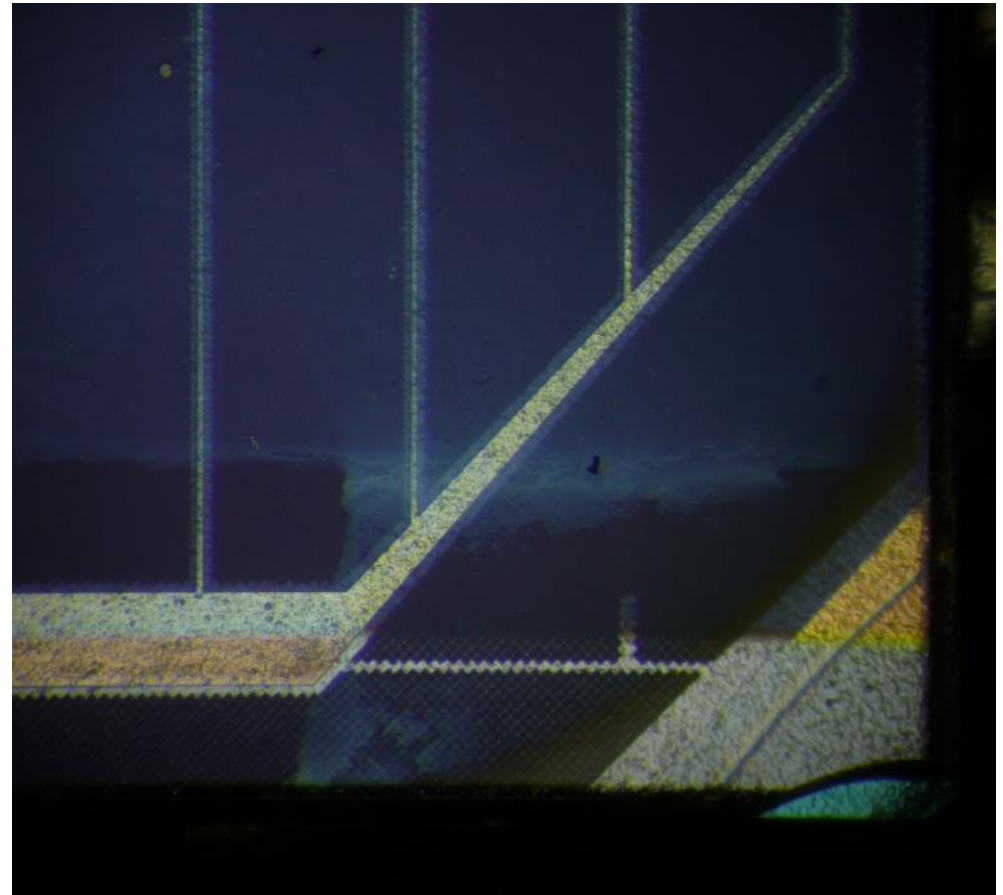
3G28: Degradation of AR coating

New cell

After experiment

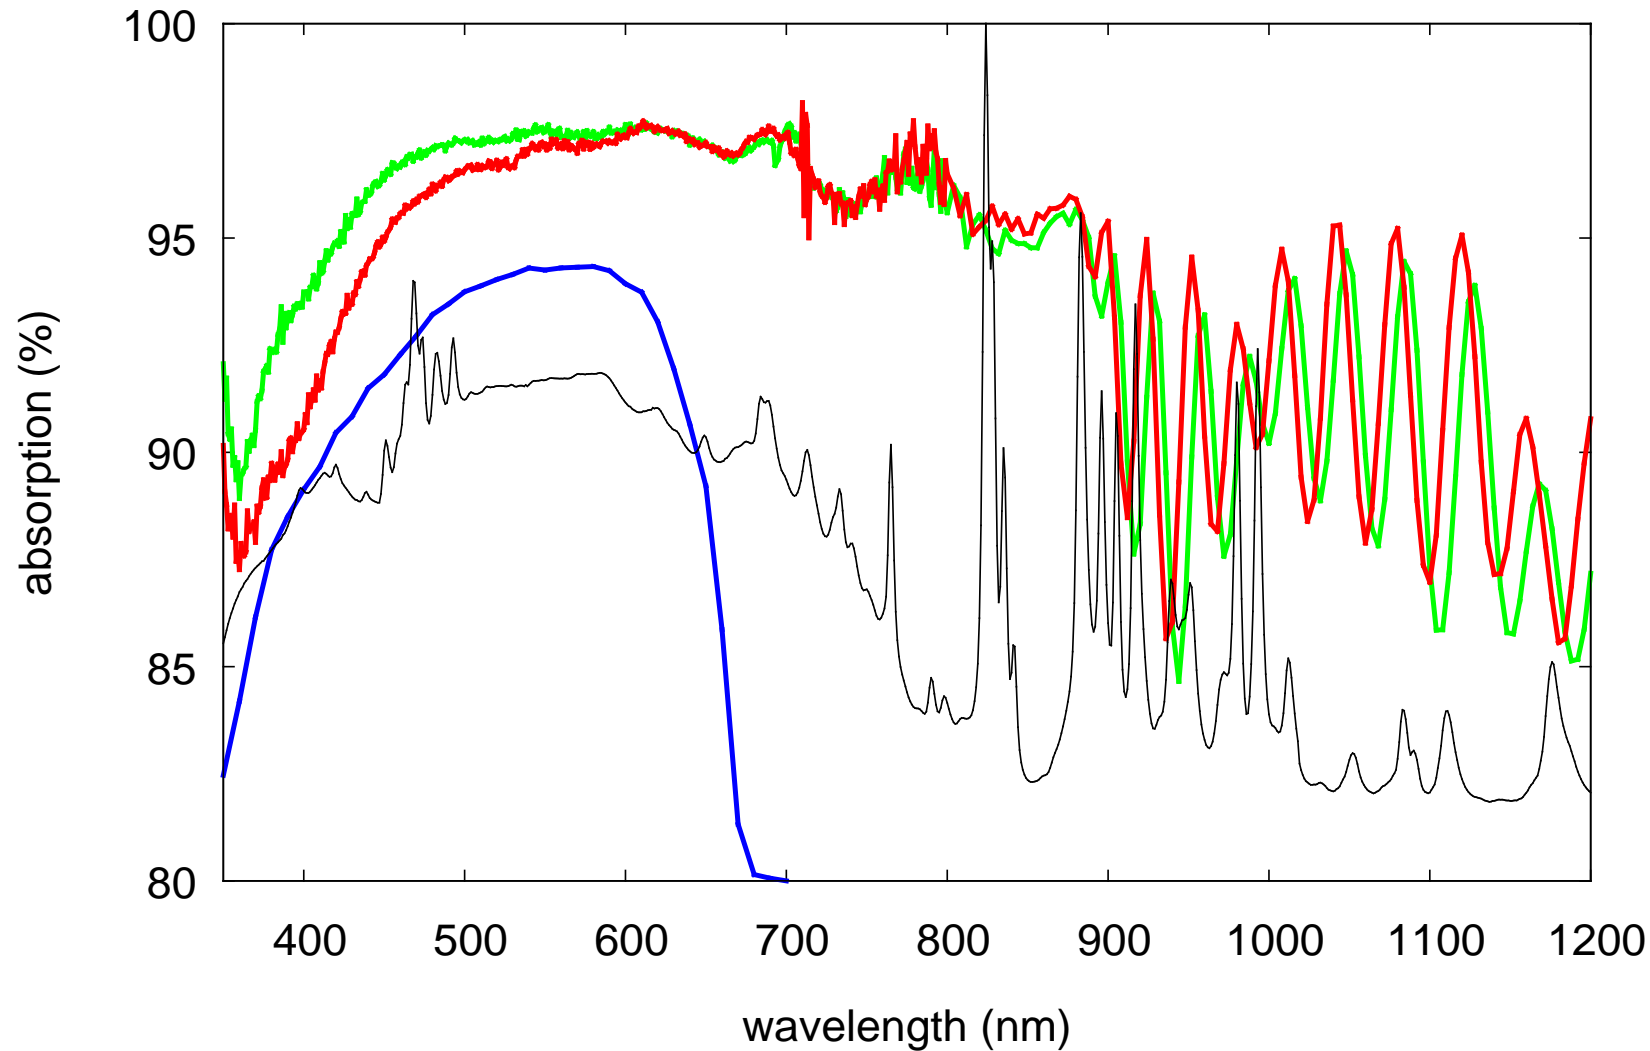
3G28: Degradation of AR coating

absorpt. before test —
absorpt. after test —

spectral response —
simulator spectrum —

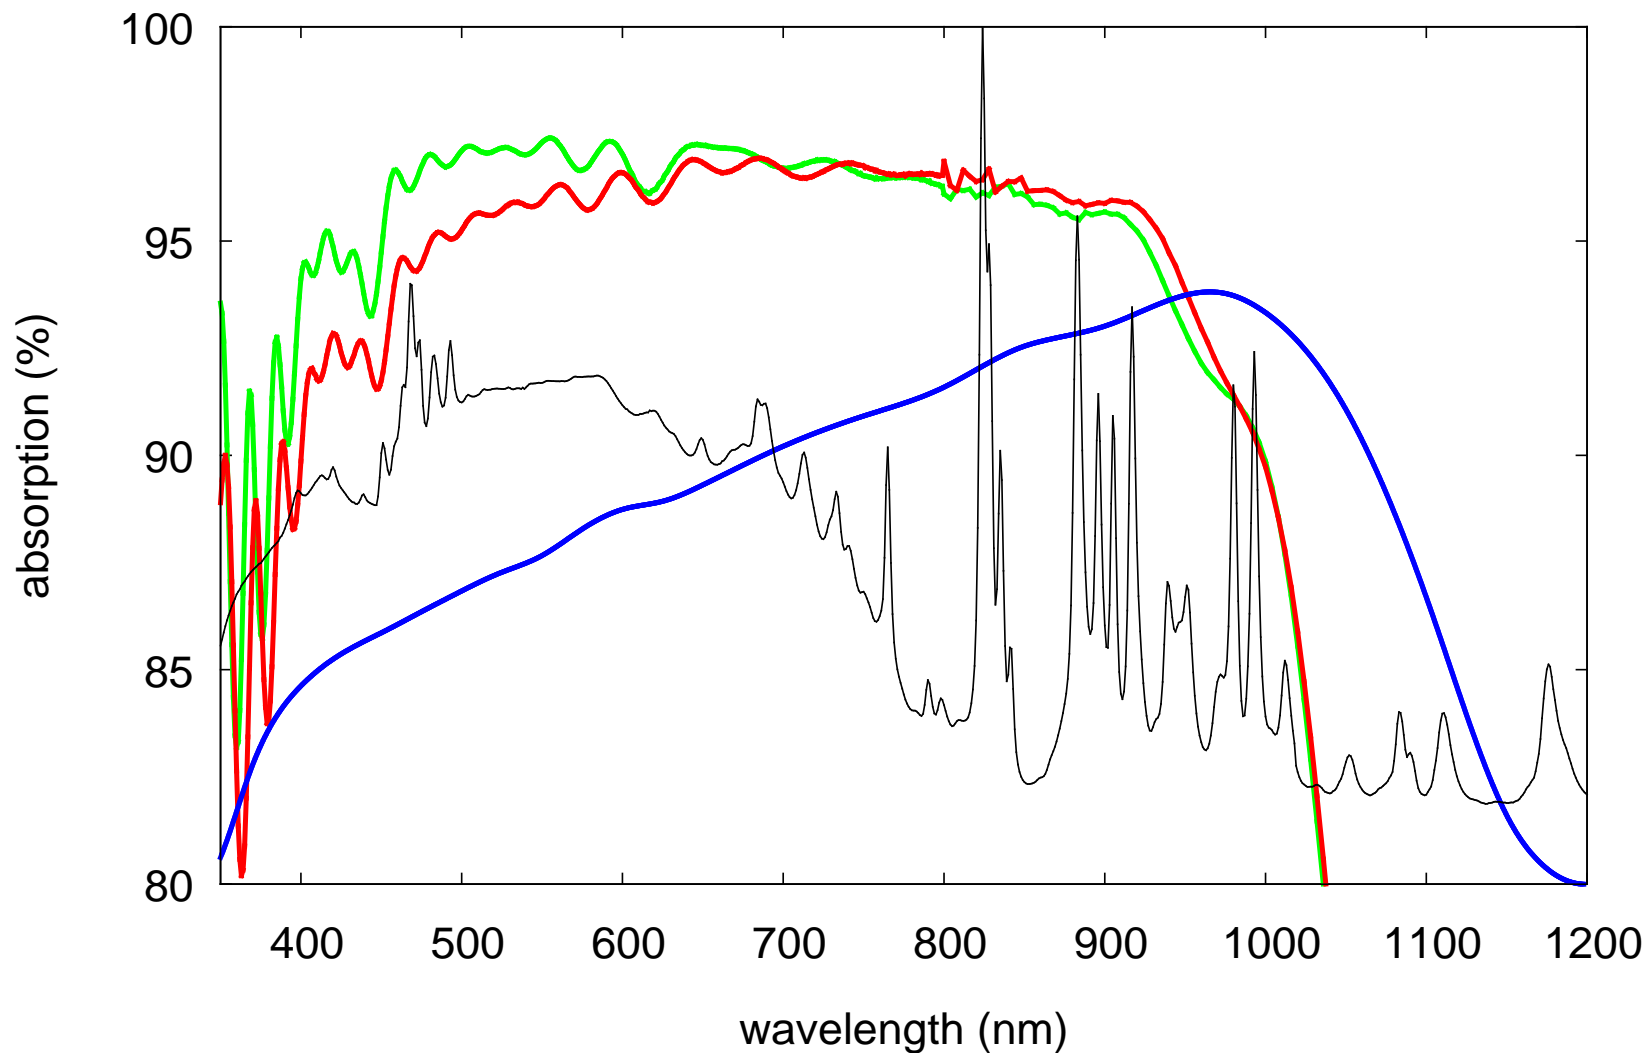
2wiTHI-ETA3: Degradation of AR coating

absorpt. before test —
absorpt. after test —

spectral response —
simulator spectrum —
