In situ monitoring of corrosion processes by coupled micro-XRF/micro-XRD mapping to understand the degradation mechanisms of reinforcing bars in hydraulic binders from historic monuments

Sophie Grousset, Florian Kergourlay, Delphine D. Neff, E. Foy, J. L. Gallias, et al.. In situ monitoring of corrosion processes by coupled micro-XRF/micro-XRD mapping to understand the degradation mechanisms of reinforcing bars in hydraulic binders from historic monuments. *Journal of Analytical Atomic Spectrometry*, 2015, 30 (3), pp.721-729. 10.1039/C4JA00370E . hal-01187814

Cite this: *J. Anal. At. Spectrom.*, 2015, 30, 721

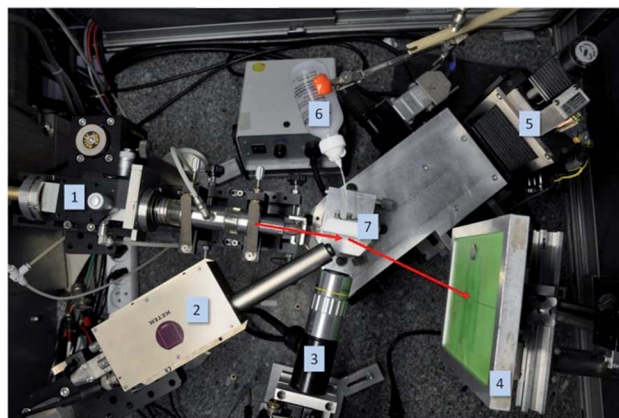
Fig. 2 The *in situ* monitoring set-up on a rotating anode X-ray generator: 1. X-ray (Mo, $\lambda_{\text{K}\alpha} = 0.709 \text{ \AA}$), 2. XRF detector, 3. OM, 4. image plate, 5. translation table, 6. chlorinated solution, 7. cell.

Set-up on a rotating anode X-ray generator. For the micro-XRD measurements, a Mo anticathode of a rotating anode X-ray generator delivered a monochromatic beam at 17.48 keV focused to a 50 $\mu\text{m} \times 30 \mu\text{m}$ surface (flux of about 10^6 ph s^{-1}) using a Xenocs® FOX2D Mo 25_25P diffraction optic (Fig. 2). This optic is a curved mirror with graded multilayer coatings that monochromatizes the incident beam from a single reflection. The cells were placed at an angle of 3° from the incident beam in order to work in reflection mode, and the spot size at the sample surface was about 1000 μm (horizontal finger print due to incident angle) $\times 30 \mu\text{m}$. Diffraction patterns were collected during about 1 h 30 min using a two-dimensional detector (image plate). Data processing was carried out with the EVA software and the ICDD-JCPDS database. XRF analysis was acquired using a silicon drift detector.
