Comparison of damage behaviour of different plant fibre composites under laser impact loading

Key words: Laser shocks / eco-composites / non-destructive technique / damage analysis

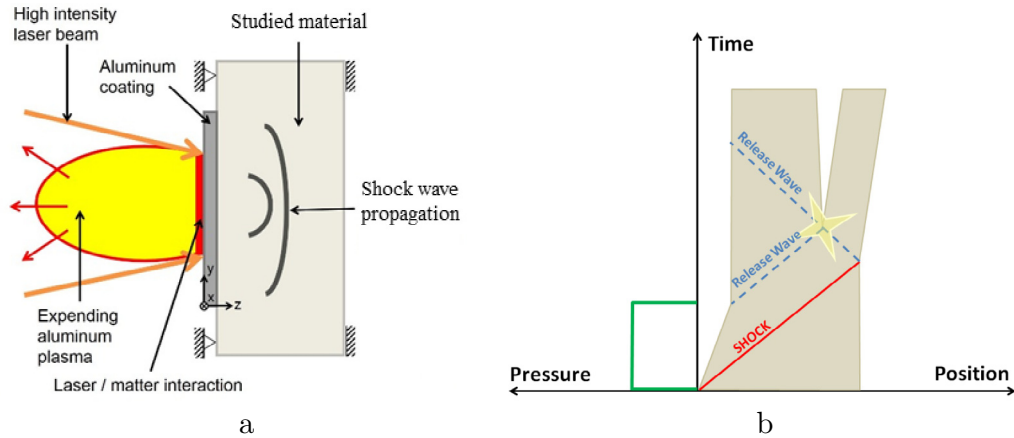
Fig. 1. (a) Sketch of the laser/matter interaction used to study the laser induced shock wave propagation into the studied material, (b) Time-position diagram representing the one-dimensional propagation of a shock and release waves into the studied material.

The principle of shock generation by using of laser source is described in Figure 1. The laser is focused on the specimen surface. An aluminium coating forces the laser/matter interaction to be produced on the sample surface, the created high pressure plasma expands rapidly. A shock wave is generated by reaction inside the material (see in Fig. 1a). The propagation of shock waves inside material can be simply described by a schematic 1D space/time diagram (see in Fig. 1b). Shock propagates through the material according to properties depending on its characteristics and geometry. When reaching the sample back face, this incident shock wave is reflected into a release wave propagating backward due to impedance mismatch. This release wave is crossing the incident release wave coming initiated by the end of the loading (back to the initial state). This crossing of two release waves can lead to local high tensile stresses which could damage the material if the local damage threshold is exceeded.

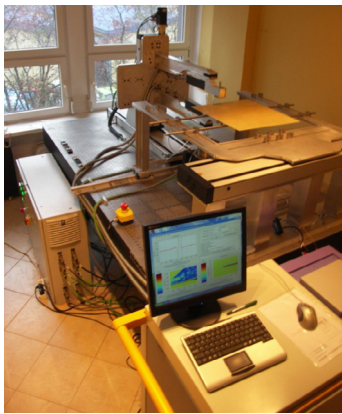
Fig. 2. Terahertz TDS spectrometer with scanning unit.

THz-TDS-system TPS Spectra 3000+ by TeraView Limited generates radiation in the form of repeated, very narrow pico-second pulses, which are focused and sent toward the investigated structure. Wide frequency content, small power and non-ionizing radiation are the main characteristics of the pulse. This approach is very interesting when the material allows for penetration at THz-frequencies, such as polymer composites. The experimental setup using THz TDS system is shown in Figure 2. The investigated samples are supported by steel bars mounted to system. They are responsible for the movement in the horizontal plane.

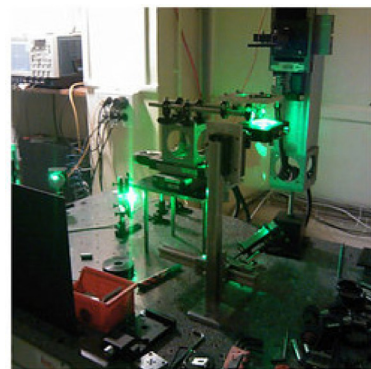
Fig. 3. HEPHAISTOS laser facility.

In this study, laser shock tests have been performed using HEPHAISTOS laser facility (Fig. 3). Laser shocks with several intensity levels have been realised on the different studied materials. The focused laser beam had a diameter of 6 mm, and the pulse duration was 10.2 ns.

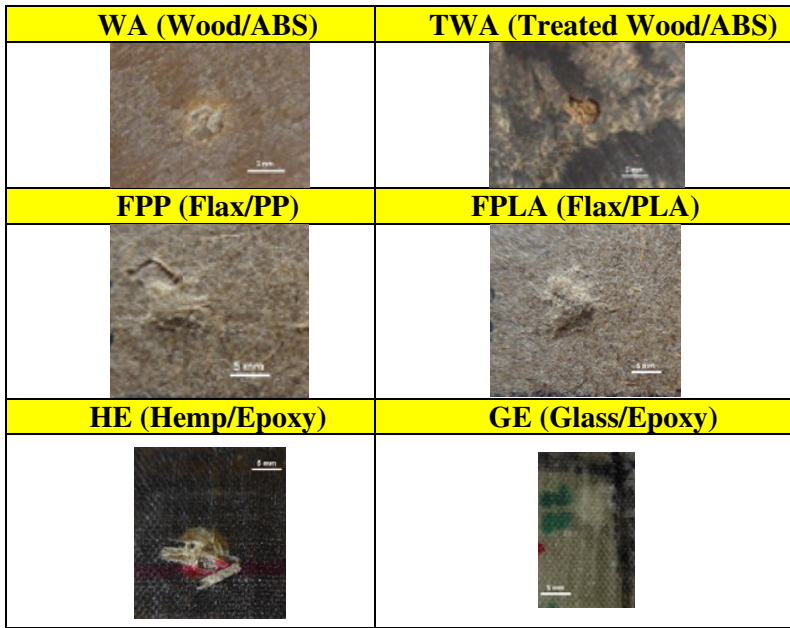
Fig. 4. Residual damage visible on back face surfaces of each composite for a laser impact with intensity of around 4.5 GW/cm^2 (bar scales of 5 mm long).

In Figure 4, is shown the residual damage that are visible on back face surface of each composite after a laser impact with intensity value of around 4.5 GW/cm² are shown. In short fibre composites, WA and TWA, there is a separation and ejection of fragments from the surface, which is named the spallation phenomenon. This phenomenon does not cover the same area for the two

composites: the diameter of the spallation zone is about 4.7 mm in WA, whereas it is about 6.8 mm in TWA. This result seems to demonstrate that the thermal treatment of spruce fibres leads to a higher brittleness of the composite, when it is submitted to high strain rate loading. For composites with flax mat reinforcement, no spallation is observed (Fig. 4). The inside damage induced by the laser shock creates a residual relief, leading to small blisters on the back face surfaces of these two composites. Measurements of the diameter values of these blisters show that there is also a difference between these two composite behaviours. For the FPP sample, the blister diameter value is about 8.5 mm, and it reaches 10 mm for the FPLA sample. It shows that laser shock induces larger damage in the composite with PLA matrix than in the one with PP matrix. In Figure 4 are also presented the results obtained for the two woven composites. On the hemp/epoxy composite, a blister with partial spallation is visible, with a diameter of about 9.4 mm, whereas on the glass/epoxy material only a whitened zone can be seen, with a diameter of about 7.7 mm.

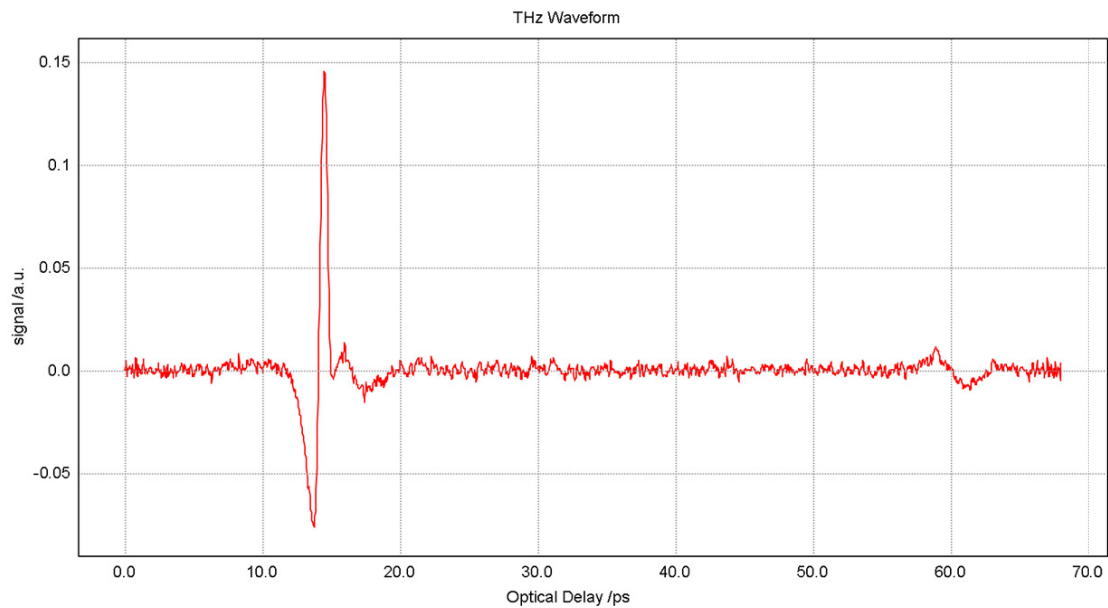
Fig. 5. Time domain signal from the terahertz spectroscopy.

First results of terahertz NDT technique were obtained for WA sample. The exemplary time domain signal registered is presented in Figure 5. The initial peak (about 15 ps) represents the strong reflection for the upper sample surface. The reflection from the bottom of the sample is visible at about 60 ps. In order to perform a NDT assessment the sample was scanned with a fine grid of measurement points spaced by 0.25 mm. The scanning result is presented in Figure 6 in a form of a C-scan. The colours represent the peak-to-peak values of time signals

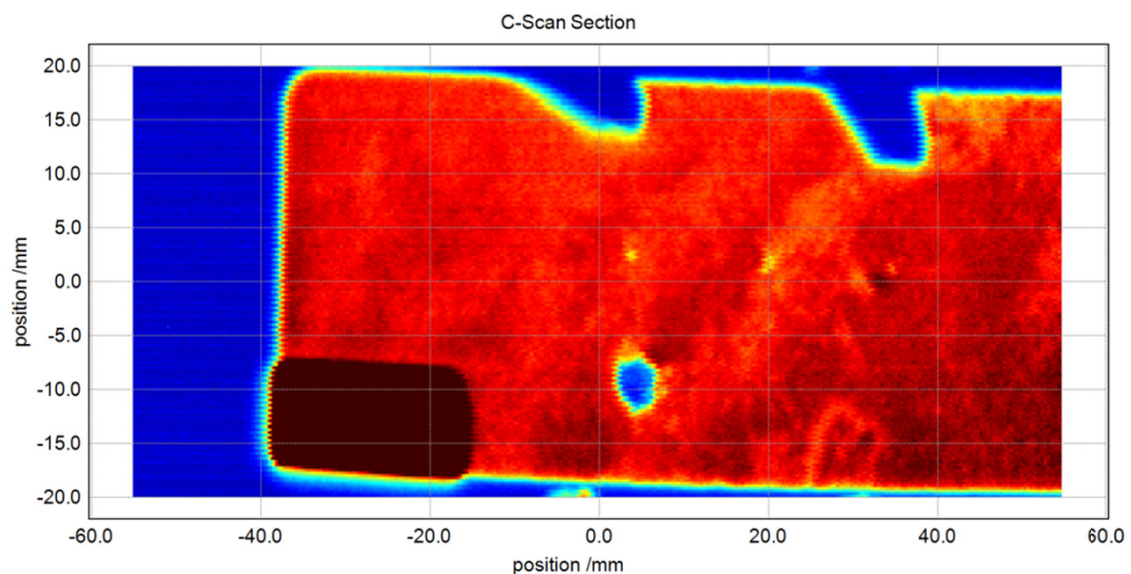
Fig. 6. Peak-to-peak C-scan of the WA sample obtained using terahertz technique.

(Fig. 5). The strongest reflection is observed in lower left corner at which a metallic tape was placed for referential purposes. The clear presence of surface damage is visible due to sudden drop of the signal value at position (5.0 mm, -10.0 mm). The lower intensity shocks caused less pronounced damage visible at $y = 0.0 \text{ mm}$ in the range from $x = 0.0 \text{ mm}$ to 40.0 mm.
