1st International Conference on Structural Integrity

Mechanical behavior and durability of fibre reinforced mortar in an aggressive environment

O. Fedaoui-Akmoussi^{a*}, L. Molez^b, S. Kaci^a, R. Jauberthie^b

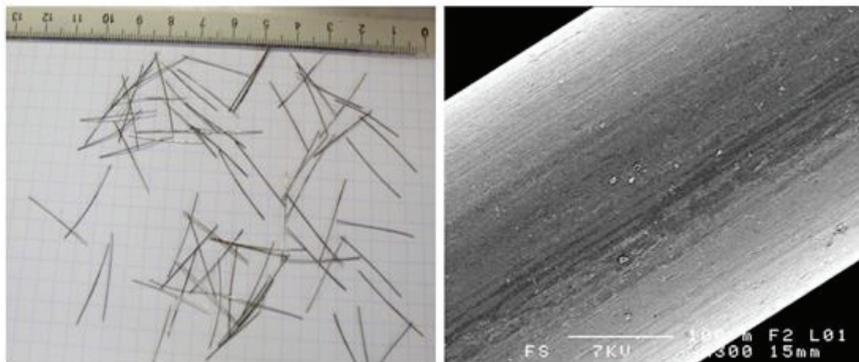
Fig. 1. The steel fibres used (left), SEM observation of fibre (right).

The cement used is a Portland cement CEM I 52.5, the Blaine specific surface area is $3600 \text{ cm}^2 \cdot \text{g}^{-1}$. The sand used is standard sand conforms to EN 196-1. The granulometric range is between 0.08 and 2mm. The steel fibres used are 25mm long and 0.25mm diameter (Fig. 1), their physical and mechanical properties are set out in Table 1. The fibre content used is 0.5% by volume of the mortar; this frequently used proportion enables good workability [13-14] and 10% (in substitution of cement) for the silica fume with 97.64% SiO_2 .

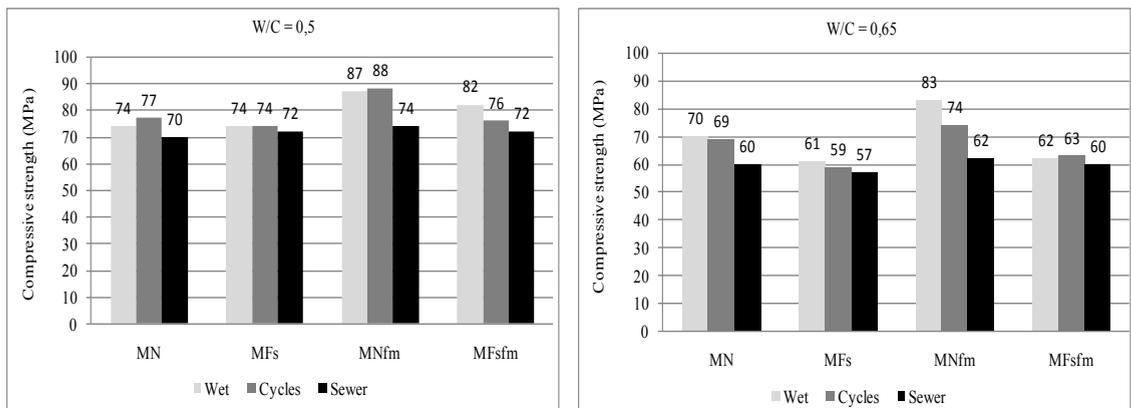
Fig. 2. Compressive strength of the mortars.

The stress at failure was determined in compression for the various water cement ratios (Fig.2). So we plotted curves efforts-displacement 3 point bending for different water cement ratios which were presented in Fig. 3 and Fig. 4. The results relate mortars conserved for a year in the different environments.

With regard to the compressive strengths: the mortar with fibres (MNfm, MFsfm) showed slightly higher strengths, when compared with the same mortars without fibres (MN, MFs), for all water cement ratios and environments. It is observed that the mortar with silica fume have slightly lower strength compared to mortar without silica fume.

The results of this study, after one year of conservation in the sewer environment, show us that the addition of the silica fume for the various studied mortars does not improve their mechanical behaviors. The compressive strengths of the mortars preserved in different environments are appreciably the same ones.

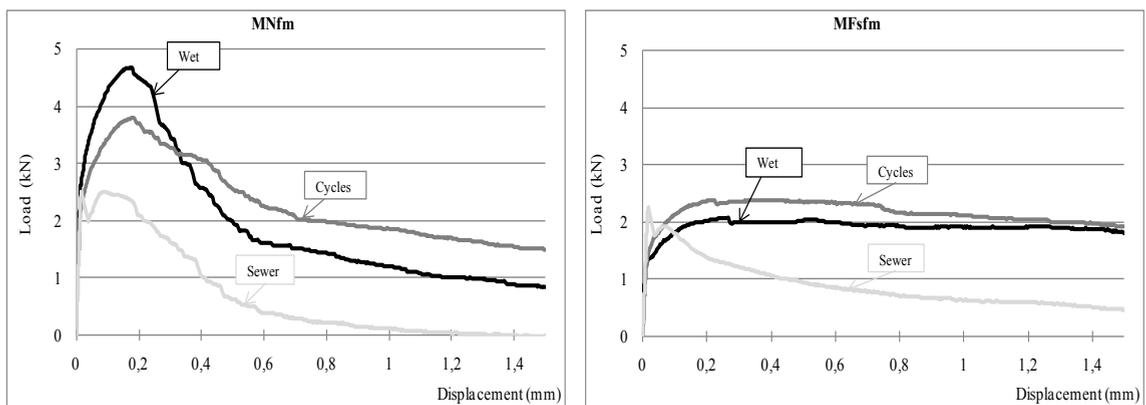
Fig. 3. Force-displacement curves for W/C = 0,5.

The flexural strength of the MNfm and MFsfm mortars was lower than the MN and MFs mortars. These samples have been exposed to aggressive agents in the sewer; the steel fibres have corroded and suffer a loss in section and consequently a reduction of physicochemical characteristics; this has also resulted in an increase in porosity and surface cracking with a consequential reduction in flexural strength. On the basis of these observations it is noted that the use of steel fibres in a wastewater environment may have a detrimental effect on performance except if the fibres are well coated. The ductility of the mortars with silica fume is better compared to the mortars without silica fume in the sewer environment.

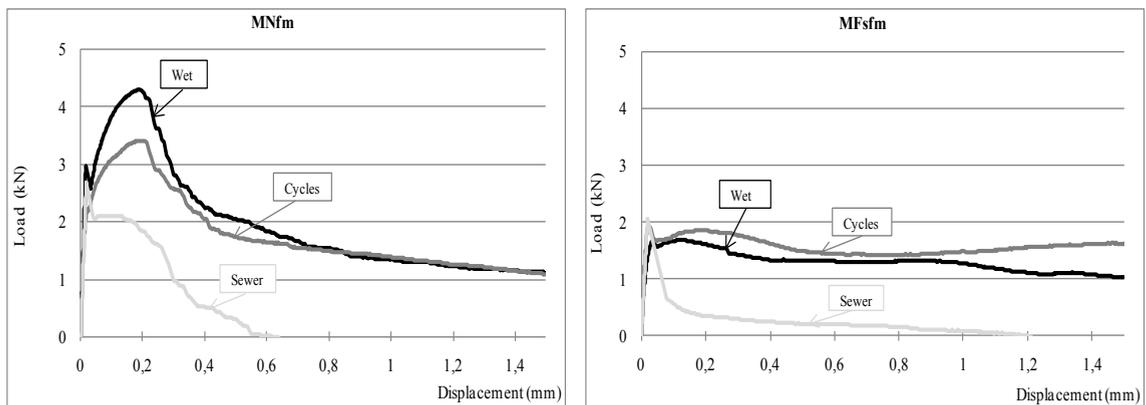
Fig. 4. Force-displacement curves for W/C = 0,65.

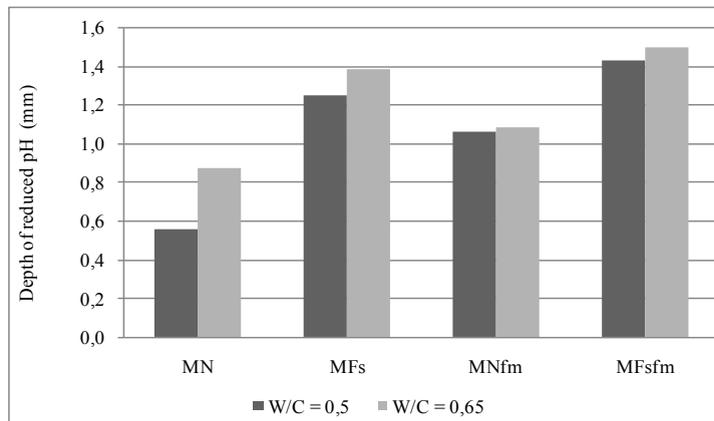
Fig. 5. Depth of pH change of the samples stored in sewers.

The depth of pH modification of the mortar was determined by the phenolphthalein test (color indicator); a sprayed solution turns pink if the pH is greater than 9 which allow the visualization of the modification to the mortar. Five measurements were taken from each face of the sample, ignoring the measurements at the corners; this allowed a mean value of 20 reading for each sample. Fig. 5 sets out the average depth of pH reduction and Fig. 6 shows examples of the fractured surfaces treated with phenolphthalein.

All the samples preserved in the wet and cycles environments do not have a depth of pH reduced. As against those stored in sewers have a depth of pH reduced which varies according to the W/C ratio for the Four types of mortar (mortar without silica fume (MN, MNfm) and mortar with silica fume (MFs, MFsfm)).

The depths of pH alteration in the samples exposed in the sump are significant. It is normal that the humidity in a closed space such as a sump would be high, a condition not favouring carbonation. Given the reduced portlandite content in the mortars and the high humidity it is suggested that carbonation is not the reason for the reduction in pH. It is probable that bio-chemical effects are responsible for the alterations to the external mortar surface under sewer conditions; SEM images show organic inclusions and bacteria within the surface layers of these mortars, thus supporting the hypothesis that bio-chemical modifications have taken place in the surface layer of the mortar.

The depth of pH alteration obtained on the mortars with silica fume are more important than those obtained on the mortars without silica fume, thus the presence of silica fume did not slow the progress of the front reduced basicity. One notes that there' is a slight increase in the depth at pH reduced for the mortars fibers compared to those without fibers, this can be explained by the fact that on the external surface of the specimens some fibers remained visible, they have favored access to the aggressive solution.

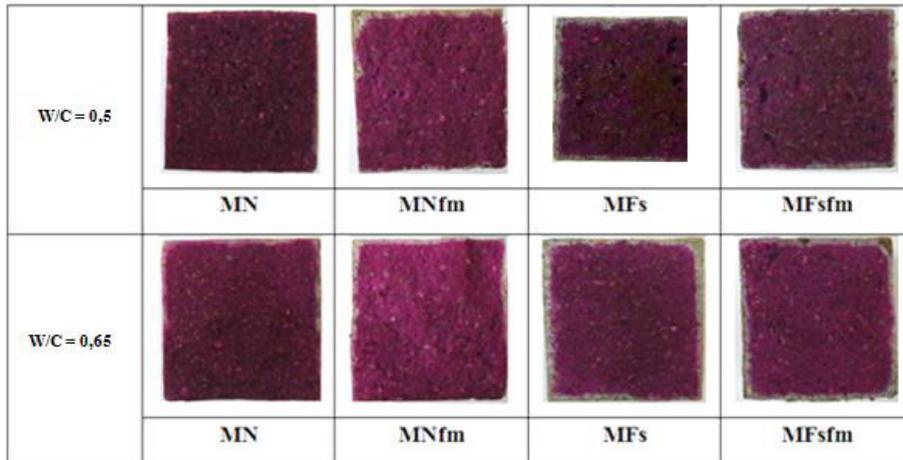
Fig. 6. pH modification detected by spraying with phenolphthalein.

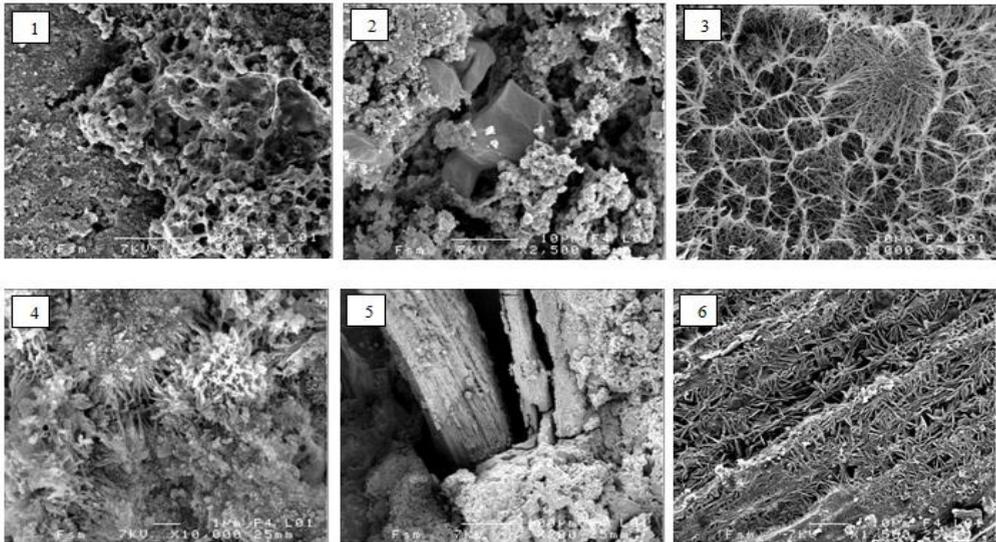
Fig. 7. SEM observations.

Observations by scanning electron microscope (SEM) are shown in Fig. 7; these observations were restricted to the mortars with silica fume preserved in the sewer in order to better analyze the various modifications of the microstructure.

Fig. 7 presents the aspect of the various formations microstructural of the matrix. On the photograph (1) and (2), one sees the organic matter deposits located inside a pore and the aspect of degraded mortar. The photograph (3) and (4) illustrate respectively the formation of the secondary ettringite and the aspect of C-S-H degraded. The aspect of fibre in contact with the sewer environment is shown in photographs (5) and (6). Judging by the SEM images the corroding front appears to be quite complex, pockets of ettringite and bacteria have both been observed. Ettringite is stable at a pH above about 10.7, consequently as the corrosion front progresses the pH will reduce and the ettringite will decompose to gypsum and Al hydroxide. The evidence of bacteria existing in the matrix would suggest that locally the pH has fallen to allow the existence of neutrophilic thiooxidans.

The SEM observations revealed: superficial degradation mortar which progress inwards leading to secondary ettringite formation and the presence of degraded C-S-H.
