Wear performance of duplex treated low alloyed steel against wood (beech) as static partner

WEAR PERFORMANCE OF DUPLEX TREATED LOW ALLOYED STEEL AGAINST WOOD (BEECH) AS STATIC PARTNER

The sliding tribological behaviour of Cr-(WC-Co) coating against wood (beech) as counterpart was investigated using a duplex treatment of low carbon steel (DIN 18CrMo4). The duplex treatment consists of LPC (low pressure carburising) + R.F magnetron co-sputtering of Cr and WC-Co. Pin on disk configurations in dry condition wear tests were performed. The wear scars of the coatings were evaluated using optical profilometry, scanning electron microscopy (SEM/EDS) and the wear mechanisms were consequently discussed. The aim of this work is to study wear mechanisms on the wood pin/disc couple. It was concluded that best behaviour was observed in the case of higher Cr content coating.

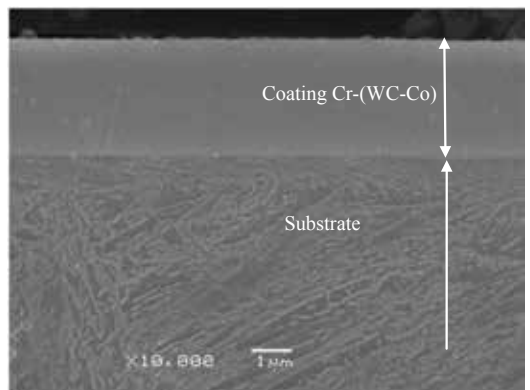
Fig. 1. SEM micrograph: cross-section view of duplex treated samples. The Cr-(WC-Co) layers developed a dense structure

Sample elaboration. The substrate used in this work was a commercial low alloy steel DIN 18CrMo4. Before thermo-chemical treatment, the samples were polished with P800 paper, ultrasonically cleaned, and finally introduced into a vacuum furnace 'BMI Furnace'. The carburising gas was ethylene (C_2H_4) and the temperature was 900°C . The total durations of the boost/diffusion stages were 120 min (carburising C1) and 105 min (carburising C2). After the carburising process, samples are in-situ quenched in a high pressure N_2 environment (500 kPa), subsequently annealed at 200°C for 120 min, and finally cooled in a 100 kPa N_2 atmosphere. The Vickers hardness values of C1-treated surface layer is $H_{v.100} = 768 \pm 5$ and the C2-treated samples yield $H_{v.100} = 654 \pm 5$. Additionally, carbon analysis of the surface layer yields 0.667 wt.% and 0.615 wt.% for C1 and C2 treatments, respectively. Both of treated C1 and C2 samples present the same hardness's value at the core of the substrate ($H_{v.100} \sim 300$) and approximately the same depth of carburised layers (550–600 μm). A standard and typical microstructure was developed after carburising process. At the top layers, the microstructure consists of martensite phase and cementite (Fe_3C) with evidently a few quantities of γ retained austenite. After that, Cr(WC-Co) coatings onto carburised surface samples were elaborated as can be seen in Fig. 1.

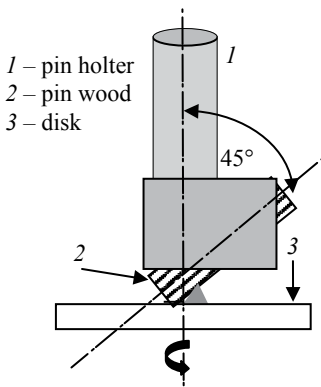
**Fig. 2.** Pin-on-disk tests**Table 2.** Parameters of experimental wear tests

Parameters	
Humidity	40%
Sliding speed	2 cm/s
Normal load	5 N
Track radius	4 mm
Sliding distance	200 m
Temperature	20°C

Samples characterisations. Wear properties of the coatings were evaluated under dry sliding condition at room temperature using a pin-on-disk tribometer (CSM HT1000) and Tribotest 4.1.1 software. The two main standards referring to the pin-on-disk tribometer are DIN 50324 and ASTM G 99 – 95a (Ref. 7). The pin-on-disk tests were performed with the test configuration schematically illustrated in Fig. 2. The pin wood with a diameter of 6 mm is positioned at 45° on the holder and loaded against a rotating disc. Only cemented (C1 and C2) and cemented +coated (F101 and F102) samples were studied.

In order to approach real contact conditions, e.g. the wood process as peeling of beech, test parameters were chosen appropriately as listed in Table 2. A particular preparation is needed when tests are conducted with wood counterpart: the pin was cut perpendicular to fibres (length 20 mm; Ø of 6 mm) from a specific specimen of beech tree provided by a regional sawmill. It was then polished to remove any chips and immersed into hot water (70–75°C) for 24 h.

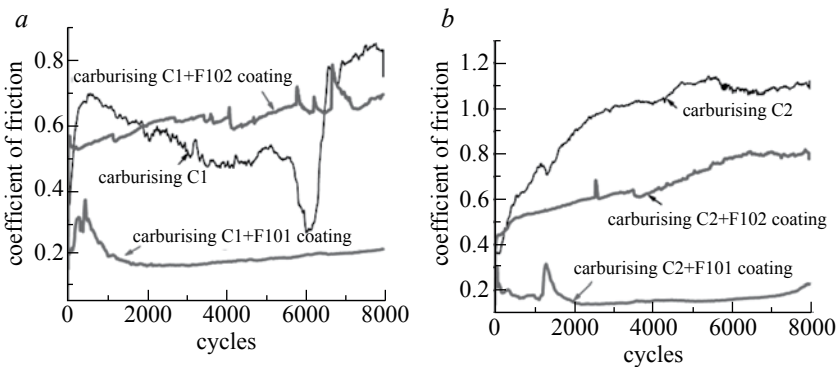
Coefficient of friction evolution. As can be seen in Fig. 3a, when sliding against the wood pin, the coefficient of friction (COF) of the C1 specimen at the start increases rapidly after that it decreases slightly. Then it reached a maximum value of 0.65 (500 cycles), followed by a sudden decrease to 0.25 (6000 cycles). This phenomenon is also observed when the applied load equals to 1 N. At the end of test, the friction coefficient increases to its maximum value of ~ 0.8 – 0.85 . However, the coefficient of friction of the C2 sample rises slowly and gets stabilised at the end of test about 1–1.2 (Fig. 3b). Both curves show a run-in period followed by a friction coefficient increase. The C1 sample presents a lower COF (0.85) than the C2 sample (1.15) after 8000 cycles of sliding against wood pin.

When duplex treated samples were tested, the coefficient of friction showed a run-in period, and afterwards an increase in slope of curves, as can be seen in Fig. 3. The F102 coating had a high run-in friction and showed a short period of

Fig. 3. Friction behaviour of the duplex treated samples ($C_{1,2}+F101$ and $C_{1,2}+F102$) compared with uncoated samples (C1; C2) in interaction with pin wood as counterpart

stabilised COF of around 0.6–0.65 for (C1+F102) and (C2+F102). On the contrary, the F101 coating shows a nearly constant evolution of COF. For both (C1+F101) and (C2+F101) samples, after a run-in period, a value about 0.2 was reached.

It can also be seen that the F101 coating has a lower wear rate than the F102 one probably due to its low COF (0.2). This confirms SEM analysis and the COF evolution curves.

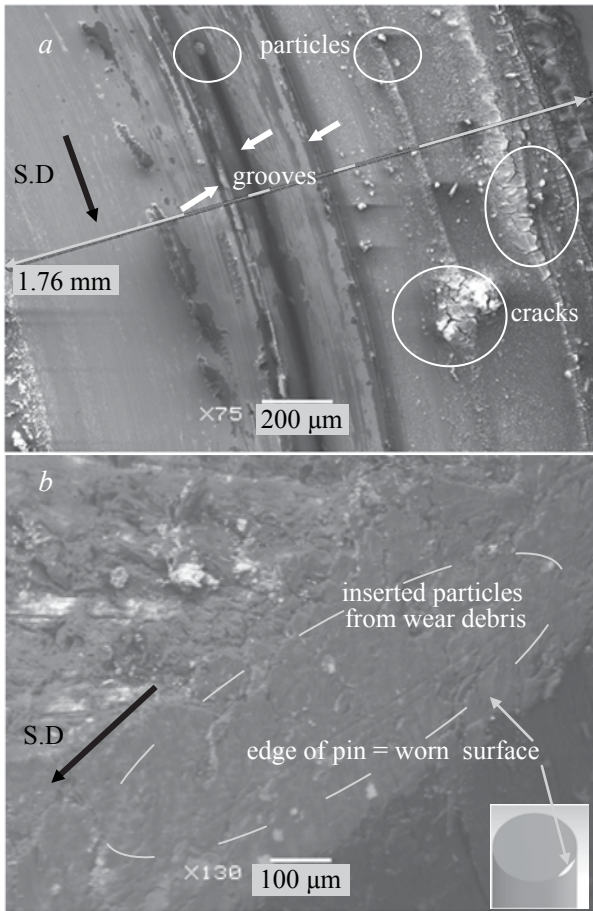
Wear analysis. After a tribotest, SEM analysis of the uncoated samples surface revealed a large wear track (1.5–1.8 mm), and substantial amount of wear particles on its edges. These remarks are valuable for all samples treated C1 and C2. An example of wear track of disk seen on C1 samples is shown in Fig. 4a: inside the circular wear track, wear debris were formed. SEM micrographs show also finest and parallel grooves as result of ploughing by oxide particles (third body wear).

Fig. 4. Example of SEM micrographs of: wear track on disk carburized C1 (a) and the corresponding counterpart worn surface of pin wood after pin-on-disk test (b). The insert image was obtained by CATIAV5 software

Moreover, the wear scar of the counter face, i.e. the edge of the pin wood became smooth as reported in Fig. 4b. Some particles (oxides) are incrustated inside the fiber of wood and a few ‘chips’ are formed at its circumference. Thus initially, at the asperity contact tips, formation of oxides film and, after reaching a critical thickness, breaking of this oxide film (cracks in Fig. 4a) occur as debris formation. Consequently the first step of wear mechanism for the cemented samples sliding against a wood pin is an oxidative wear and the second step is a mild abrasive wear mechanism.

Quantitative analysis. From the wear track profile obtained by 3D profilometry, the volume loss and wear rate of disc were calculated, for all the samples. The wear scar of the counterpart (pin wood), is an ellipse. Then major and minor semi-axes were measured by profilometry and to calculate the volume loss CATIAV5 software was used (see the inserted image in Fig. 4b). The results are presented in Fig. 7.

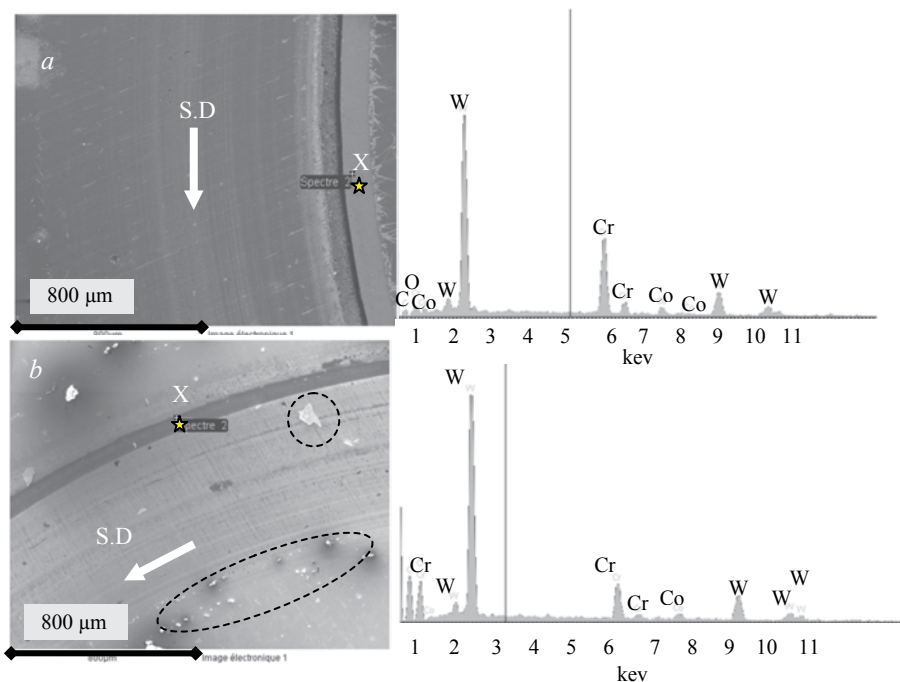
All of the duplex treated samples sliding against pin wood showed the largest wear scar but not very deep (Fig. 5a,b). The coatings are then efficient and well protected by the cemented steel. Few of particles inside circular wear track were observed for both coatings F101 and F102 (Fig. 5b). Based on SEM micrographs, no difference was evident between F101 and F102 coating wear tracks was shown and can explain the coefficient of friction evolution in Fig. 3. EDS analysis of the

Fig. 5. Duplex treated samples: example of SEM micrographs of wear tracks and corresponding EDS spectra at point 'x': C1+F101 (a) and C1+F102 (b)

worn surface and the debris inside wear scar (Fig 5 *a,b*) reveals only the presence of elements of coating (Cr, W, Co): no iron (Fe) signal or oxygen (O) were found, consequently the wear track is free of oxides. In comparison to the carburised samples and according to the above mentioned results, it can be concluded that the wear mechanism undergone by discs was only a slight abrasion wear.

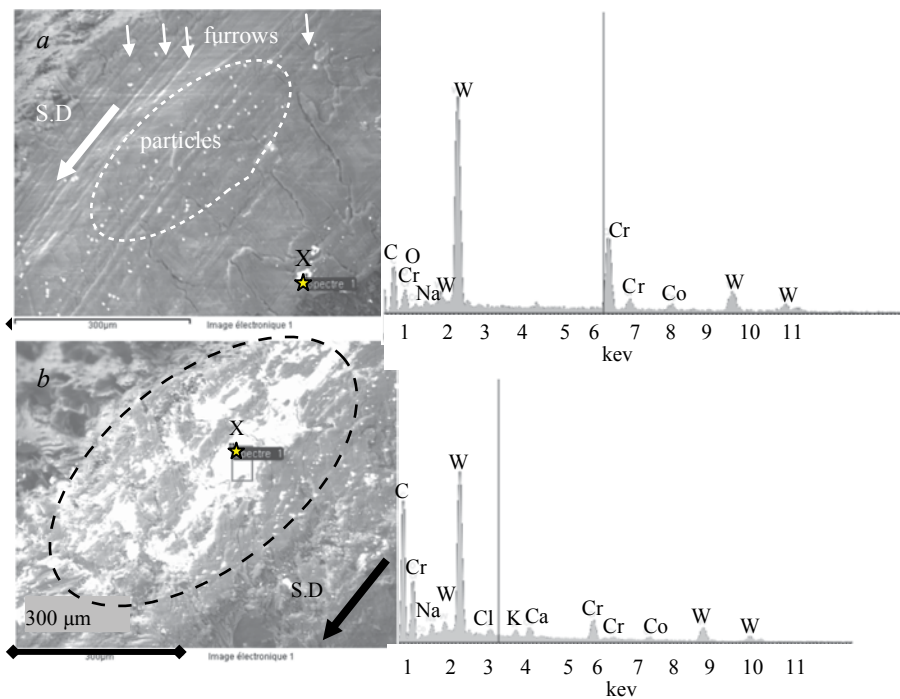
Figure 6 shows the wear scar on wood pin after 200 m sliding distance against duplex treated samples. Considerable difference exists between surface morphology of pin edge after sliding against F101 (Fig. 6a) and F102 (Fig. 6b) coatings. The wear scar of the pin in the case of the F101 coating shows few quantities of particles, dispersed on a smooth wood surface. These particles contain metallic and organic elements of wood as revealed by EDS analysis spectra. Again, no iron peak (Fe) or oxygen (O) were detected; that proves that coating is not entirely destroyed yet. Therefore, the detachment of the coating was presented in the form of wear debris. Some scratches (furrows) parallel to sliding direction are also present and are caused by particles (no oxides) between the contact surfaces. The small amount and size of the observed particles are not sufficient to cause an abrasive wear mechanism. Besides, the COF evolution curve of the F101 coating (Fig. 3), regardless the substrate, indicated that was a mild wear compared to the

Fig. 6. Example of SEM micrographs of worn surfaces of wood pins against C1+F101 (a) and against (C1+F102) (b). EDS analysis spectra carried out the particles indicate by X

F102 one. As a consequence, no evidence of abrasive wear was found. We suppose that movement of particles during sliding can be due to rotation or rolling as reported in literature⁸⁻¹⁰. The coatings are worn gradually, slowly and with continuous wear with micro-chipping of small coating fragments in connection to surface defects. The SEM micrographs of the pin worn surface sliding against F102 is shown in Fig. 6b. This part of the wear scar shows a significant amount of adhered counter material which indicates a stronger adhesion between contact surfaces. This is in agreement with the corresponding friction curve in Fig. 4, which shows significantly higher and more fluctuating values as compared with the friction curve displayed by F101 coating. The wear mechanism in this case is adhesive.

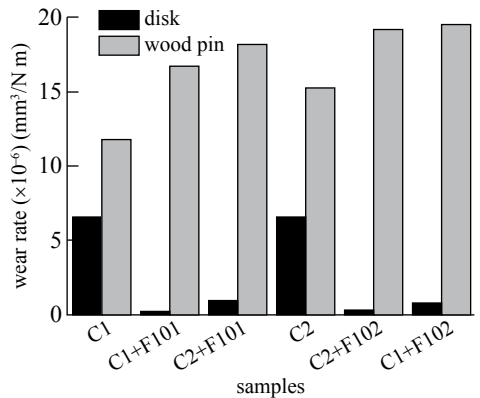
The highest wear rate was obtained for wood pin and the lowest for the duplex treated samples. An intermediate wear rate is observed for the cemented samples. This is probably due to the softer hardness of the wood pin in comparison to the cemented and duplex treated steel samples. Besides, the cemented samples showed a similar wear rate value as the duplex C1/F101 and C2/F101 or C1/F102 and C2/F102 treated samples. Nevertheless, the duplex treated samples (wear rates K of about 1 to $2 \times 10^{-6} \text{ mm}^3/\text{N m}$) were much more wear resistant than the only cemented ones (wear rates K of about $7 \times 10^{-6} \text{ mm}^3/\text{N m}$).

Fig. 7. Estimated wear rates of the tribological couple wood pin/disc
