The 21 February 2005, catastrophic waste avalanche at Leuwigajah dumpsite, Bandung, Indonesia

Abstract

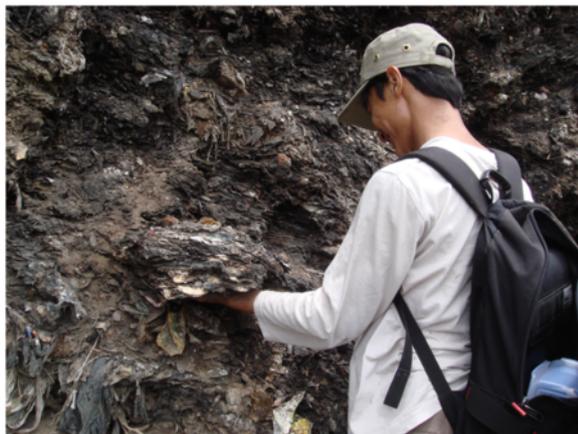
Figure 3 Sampling of the waste deposits (photo: F. Lavigne, February 2007).

transport mechanisms. Field investigation was carried out in the medial part of the deposit where the material had not been disturbed after the event, i.e. upstream from the location of the buried villages. However, heterogeneous waste composition (Figure 3), obstacles in determining waste strength parameters, and a lack of knowledge about the principles of waste mechanics result in considerable uncertainties in stability calculations. Therefore such calculations were not considered in this study.

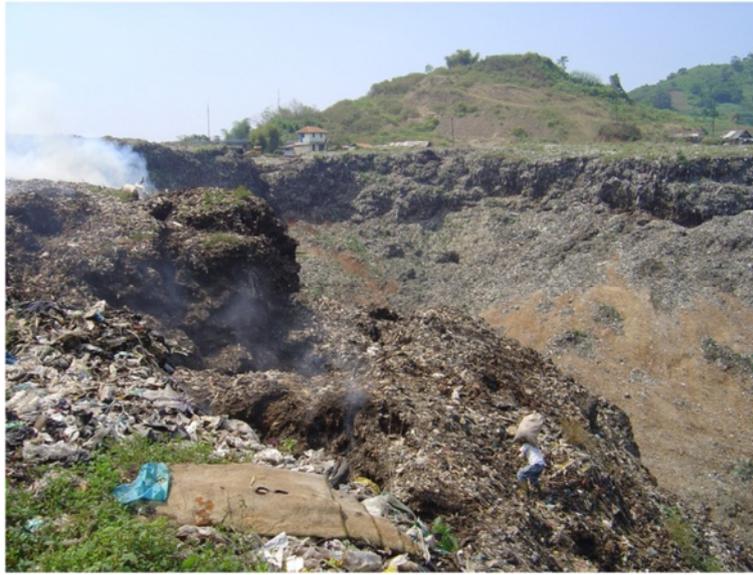
Figure 4 Scarp of the dumpsite after the February 2005 disaster. In the foreground, a scavenger carrying reusable material from the dumpsite. In the background, the steep natural slope in brown color (photo: F. Lavigne, July 2005).

Five months after the February 2005 disaster, the upstream part of the dumpsite displays a 10 m-high scarp cutting the waste accumulation (Figure 4). At the base of the scarp, the waste deposits are very thin or absent because they have been washed away during the 2005

event. The Figure 4 clearly shows that the gradient of the natural slope was very high, in the order of 45?.

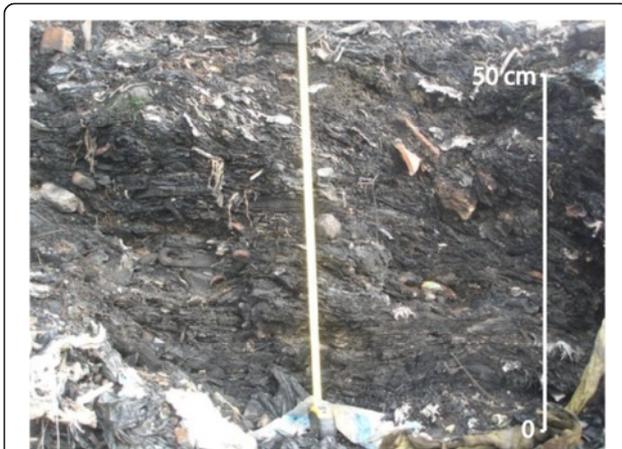
Figure 6 Internal structure of the deposit showing undulating discontinuities and foliated layers (photo: P. Wassmer, February 2007).

Below the surface, the layers comprise plastic bags remnants mixed with soil and a fine-grained matrix of decomposed organic garbage. Other materials found within the deposits were plastic pieces, stones, pieces of wood, metallic material etc. The main part of the deposit displays a finely foliated structure generally underlain by remainders of plastic bags. All the material shows a preferential fabric rather parallel to the previous topography. Outcrops conform to the displacement direction are showing undulating discontinuities that delimit 5 to 30 cm thick stratified layers (Figure 6).

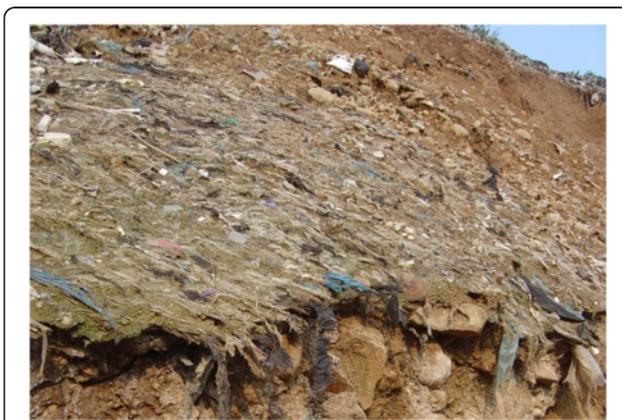
Figure 7 Pieces of plastic bags displaying horizontal orientations along the post-disaster scarp of the dump (Photo: F. Lavigne, July 2005).
