# The 21 February 2005, catastrophic waste avalanche at Leuwigajah dumpsite, Bandung, Indonesia

**Background:** On 21 February 2005 the Leuwigajah dumpsite, Bandung (Java, Indonesia) was affected by a large slide after heavy rainfalls. Second deadliest waste slide in history, it buried 71 houses and killed 143 people. Amongst the contemporary disastrous events of this type, only a few have been documented. We explored failure preconditions, triggering mechanisms and local context that conducted to this disaster. We carried on four field investigations on the site. A series of aerial photographs were acquired and completed by topographical measures on the ground. The morphology of the slide and its trajectory were reconstructed. To constrain the movement condition, we studied the internal structure of the source area and realized surveys among stakeholders of the dumpsite and citizen.

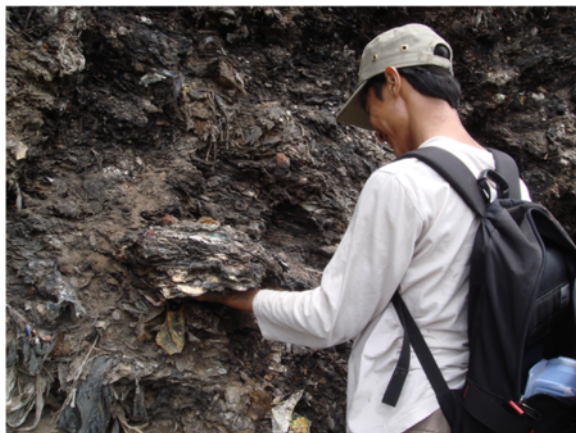
**Figure 3** Sampling of the waste deposits (photo: F. Lavigne, February 2007).

transport mechanisms. Field investigation was carried out in the medial part of the deposit where the material had not been disturbed after the event, i.e. upstream from the location of the buried villages. However, heterogeneous waste composition (Figure 3), obstacles in determining waste strength parameters, and a lack of knowledge about the principles of waste mechanics result in considerable uncertainties in stability calculations. Therefore such calculations were not considered in this study.

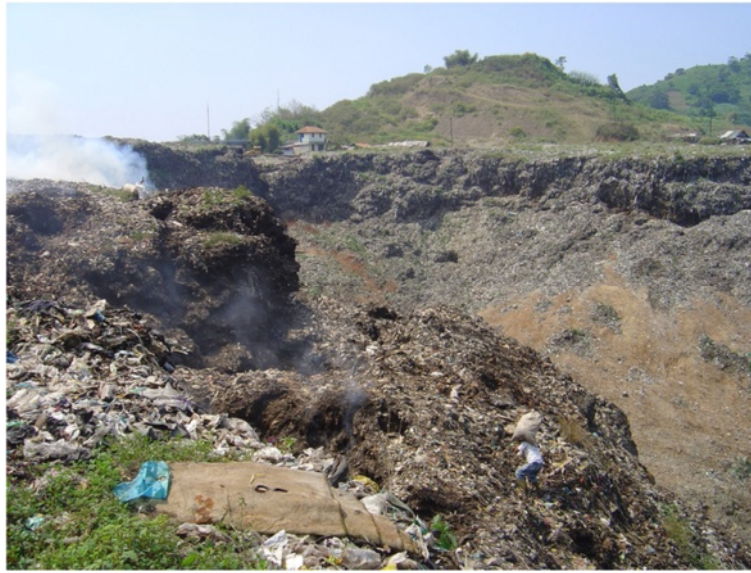
**Figure 4 Scarp of the dumpsite after the February 2005 disaster.** In the foreground, a scavenger carrying reusable material from the dumpsite. In the background, the steep natural slope in brown color (photo: F. Lavigne, July 2005).

Five months after the February 2005 disaster, the upstream part of the dumpsite displays a 10 m-high scarp cutting the waste accumulation (Figure 4). At the base of the scarp, the waste deposits are very thin or absent because they have been washed away during the 2005

event. The Figure 4 clearly shows that the gradient of the natural slope was very high, in the order of 45?.

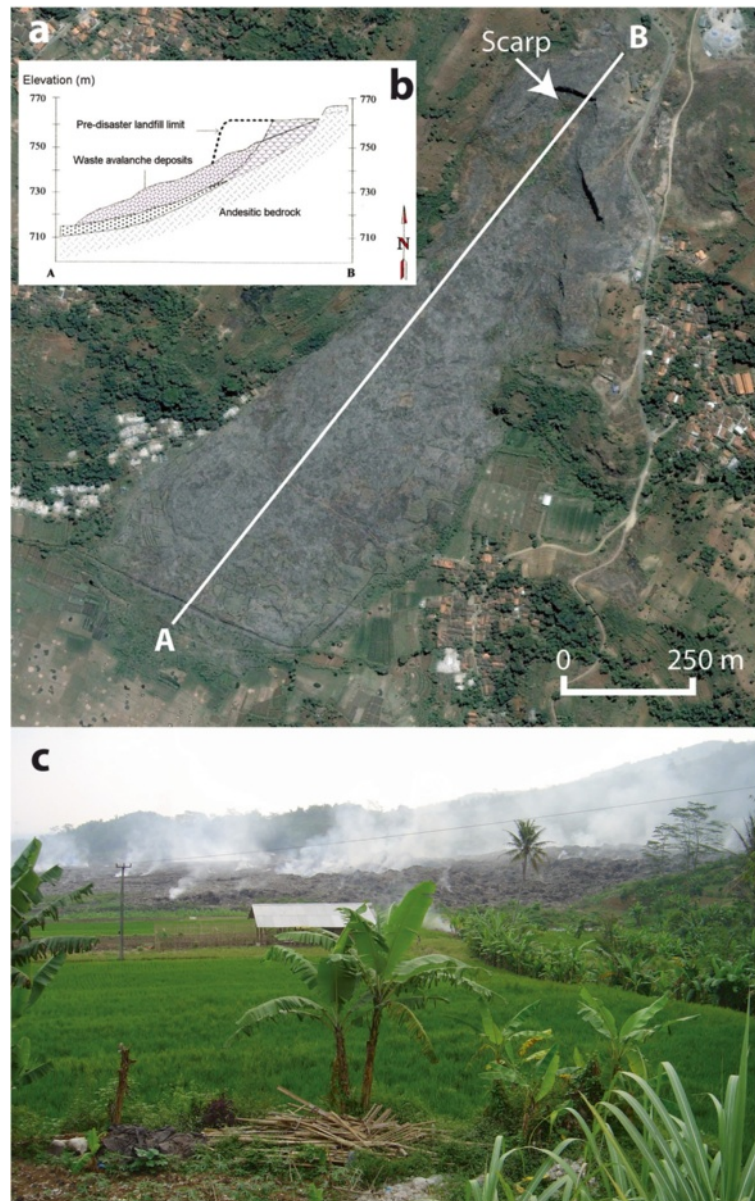
**Figure 5** Deposits of the 21 May 2005 waste avalanche at Leuwigajah. **(a)** Aerial view on 3 August 2006 (source: GoogleEarth). **(b)** Longitudinal profile. Dotted area: regolith and soil; **(c)** Picture of solid waste deposits overlapping rice fields. Notice the smoke emissions attesting permanent deep combustion (photo: F. Lavigne, 22 July 2005).

The whole mass of waste spread 1000 m from the source and covered a 180 340 m wide strip in the rice fields (Figure 5), with an average thickness of about 10 m, although the thickness varied greatly. The overall volume of the displaced waste was initially estimated at  $1 \times 10^6 \text{ m}^3$  (Sub-Direktorat Mitigasi Bencana Geologi 2005), before being reviewed from  $2.7 \times 10^6 \text{ m}^3$  (Koelsch et al. 2005) to  $3.5 \times 10^6 \text{ m}^3$  (Yachiyo Engineering Co. 2009). The morphology of the deposit is similar to an alluvial fan, but with margins characterized by steep slopes with lateral ridges.

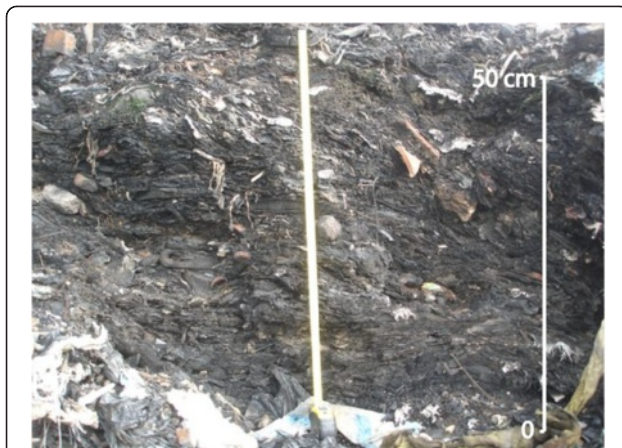
**Figure 6** Internal structure of the deposit showing undulating discontinuities and foliated layers (photo: P. Wassmer, February 2007).

Below the surface, the layers comprise plastic bags remnants mixed with soil and a fine-grained matrix of decomposed organic garbage. Other materials found within the deposits were plastic pieces, stones, pieces of wood, metallic material etc. The main part of the deposit displays a finely foliated structure generally underlain by remainders of plastic bags. All the material shows a preferential fabric rather parallel to the previous topography. Outcrops conform to the displacement direction are showing undulating discontinuities that delimit 5 to 30 cm thick stratified layers (Figure 6).

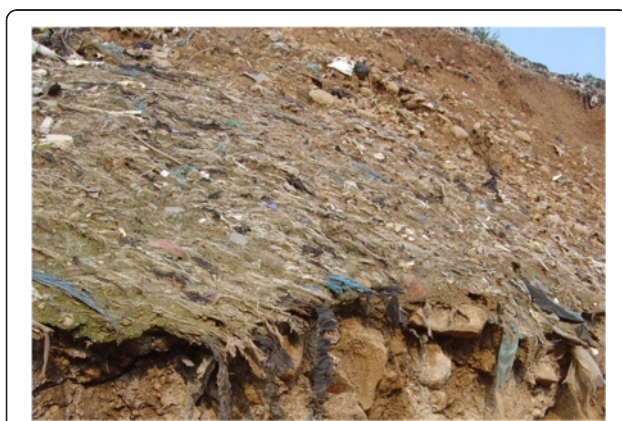
**Figure 7** Pieces of plastic bags displaying horizontal orientations along the post-disaster scarp of the dump (Photo: F. Lavigne, July 2005).

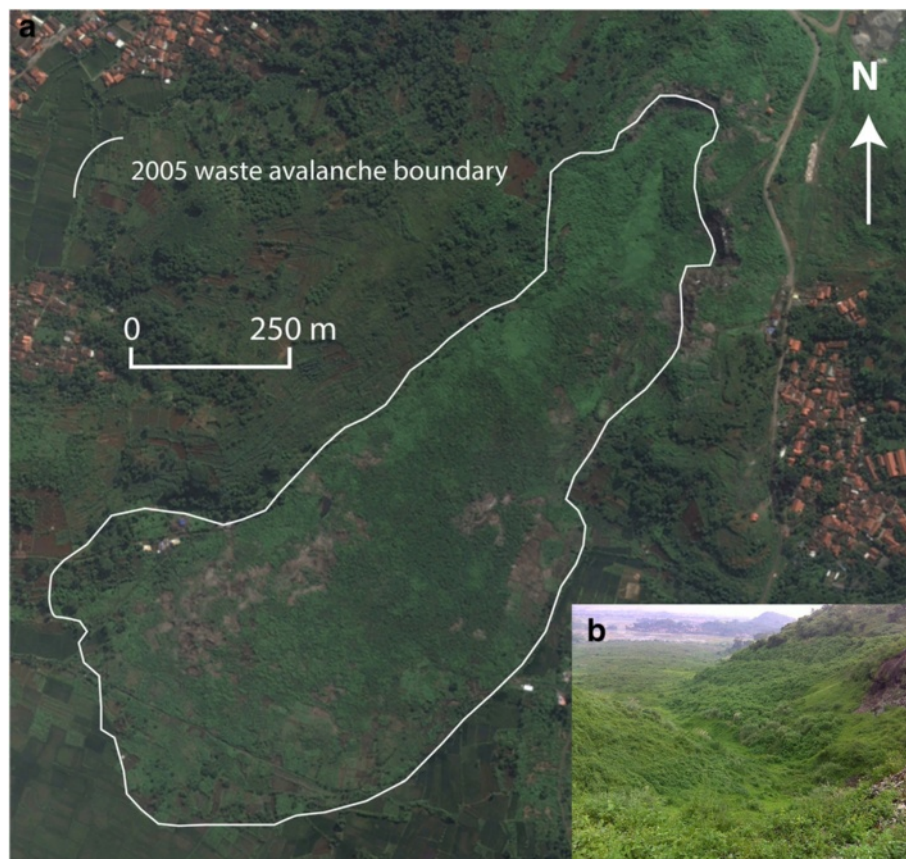
**Figure 8** Post-disaster greening of the Leuwigajah dump site in 2010. **a.** Aerial view of the waste avalanche deposits on 13 June 2010 (source: GoogleEarth). **b.** Oblic photograph taken from the scarp to the Southwest on 20 March 2010 (Courtesy: admbang setdaprovjabar on <http://www.panoramio.com/photo/33538781>).

Since to the 2005 disaster, the Leuwigajah dump site has been abandoned, and progressively recovered by the natural vegetation (Figure 8), thanks to the high content of organic material in the waste deposits that allowed the formation of a soil. Since the 2005 disaster, the Bandung municipality lacks a suitable site and finances to construct a new sanitary landfill. Therefore West Java Province has planned to construct two new sanitary landfills outside Bandung Municipality at Legok Nangka (30 ha) and Leuwigajah (40 ha) to be used by Bandung Municipality. The contract has been signed in
