The 21 February 2005, catastrophic waste avalanche at Leuwigajah dumpsite, Bandung, Indonesia

Abstract

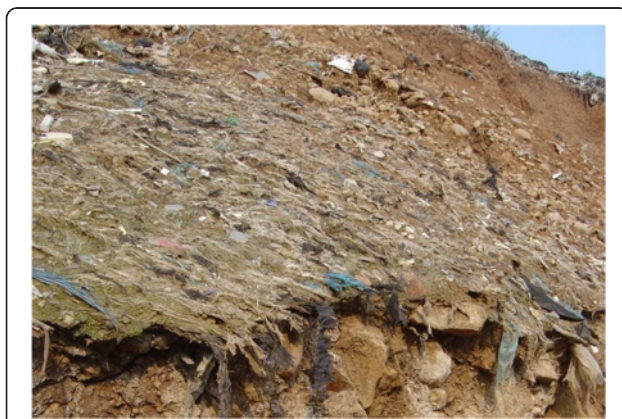
Figure 7 Pieces of plastic bags displaying horizontal orientations along the post-disaster scarp of the dump (Photo: F. Lavigne, July 2005).
