# The 21 February 2005, catastrophic waste avalanche at Leuwigajah dumpsite, Bandung, Indonesia

**Background:** On 21 February 2005 the Leuwigajah dumpsite, Bandung (Java, Indonesia) was affected by a large slide after heavy rainfalls. Second deadliest waste slide in history, it buried 71 houses and killed 143 people. Amongst the contemporary disastrous events of this type, only a few have been documented. We explored failure preconditions, triggering mechanisms and local context that conducted to this disaster. We carried on four field investigations on the site. A series of aerial photographs were acquired and completed by topographical measures on the ground. The morphology of the slide and its trajectory were reconstructed. To constrain the movement condition, we studied the internal structure of the source area and realized surveys among stakeholders of the dumpsite and citizen.

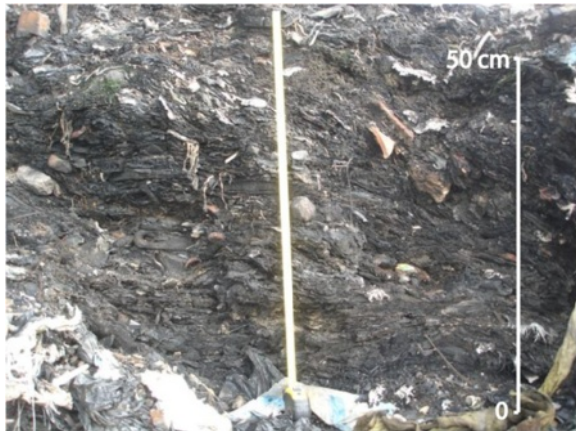
**Figure 6** Internal structure of the deposit showing undulating discontinuities and foliated layers (photo: P. Wassmer, February 2007).

Below the surface, the layers comprise plastic bags remnants mixed with soil and a fine-grained matrix of decomposed organic garbage. Other materials found within the deposits were plastic pieces, stones, pieces of wood, metallic material etc. The main part of the deposit displays a finely foliated structure generally underlain by remainders of plastic bags. All the material shows a preferential fabric rather parallel to the previous topography. Outcrops conform to the displacement direction are showing undulating discontinuities that delimit 5 to 30 cm thick stratified layers (Figure 6).

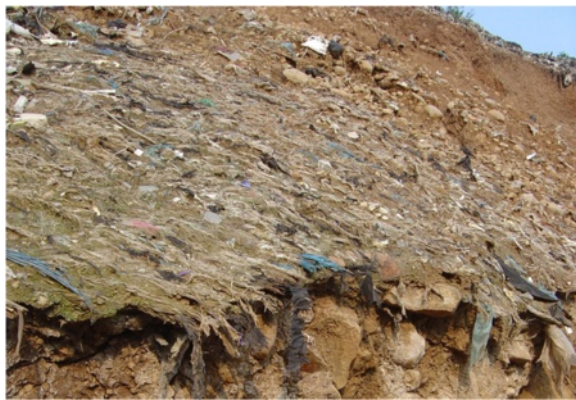
**Figure 7** Pieces of plastic bags displaying horizontal orientations along the post-disaster scarp of the dump (Photo: F. Lavigne, July 2005).
