# Damage detection in CFRP by coupling acoustic emission and infrared thermography

## A B S T R A C T

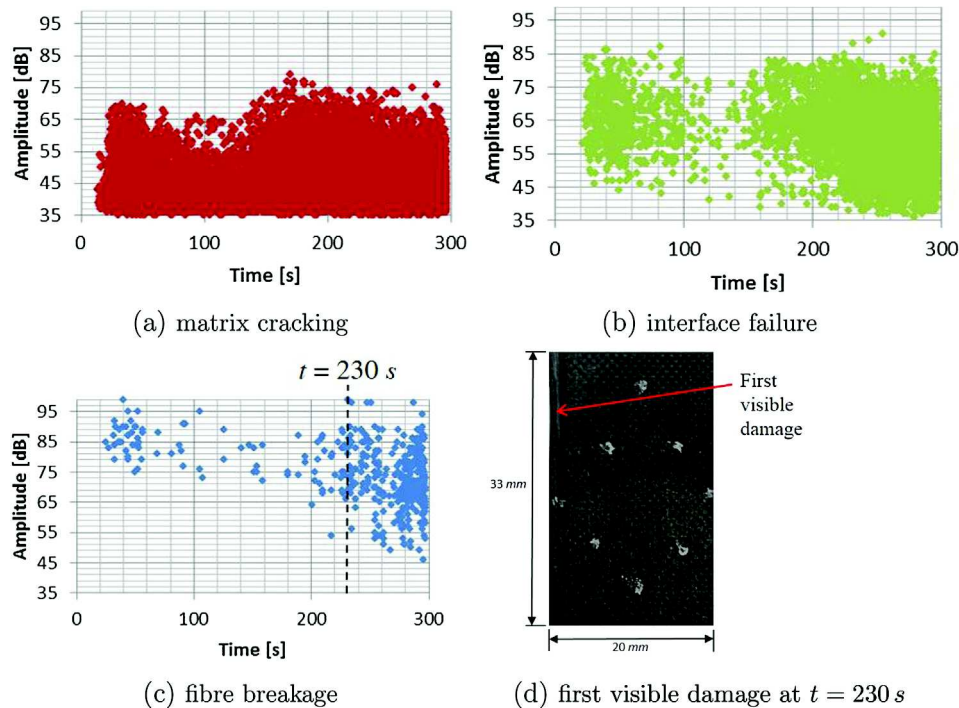
Fig. 2. Clustering results according to amplitude and time related to identified damage mechanisms for the 0° tensile test (k-means algorithm, 4 descriptors, 3 classes).

clusters. Lowest amplitudes and energies are usually related to matrix cracking. The highest amplitudes and the group with fewer signals are related to fibre breakage. The intermediate group corresponds to interface failure. In this way Fig. 2 shows the amplitude versus time for the 3 classes of AE data obtained for the 0° tensile test. The first group with the lowest amplitudes corresponds to the matrix cracking (Fig. 2a), the second group refers to the debonding and interface failure (Fig. 2b) and the last group with highest amplitudes corresponds to the fibre breakage (Fig. 2c). Generated cluster corresponding to fibre breakage is in accordance with the first visual crack (at  $t = 230$  s) provided by the DIC observed in Fig. 2d. Especially, the number of AE events related to fibre breakage increases notably before the final failure of the composite, that is from time  $t = 200$  s to  $t = 300$  s. Fig. 3 presents also the classified signals for the 90° tensile test. The lowest amplitudes correspond to the matrix cracking (Fig. 3a) and highest ones to the

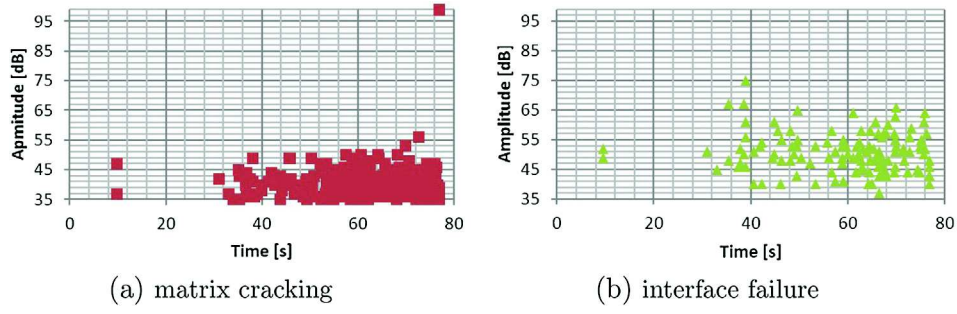
Fig. 3. Clustering results according to amplitude and time and related to identified damage mechanisms for the 90° tensile test (k-means algorithm, 3 descriptors, 2 classes).

interface failure (Fig. 3b). These results stand in agreement with existing works on same material [22].

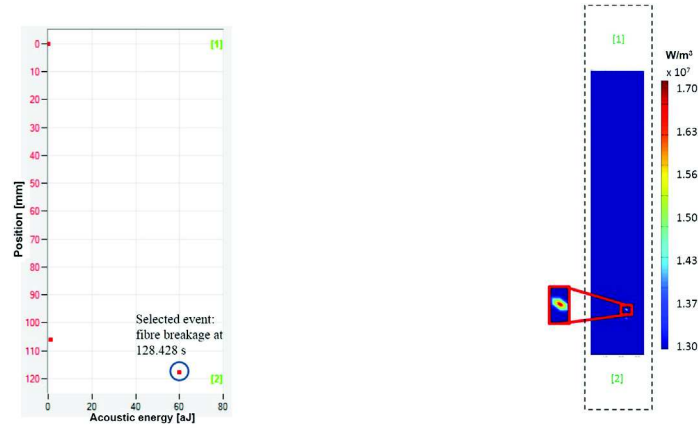
(a) acoustic events energy during interval  $t = 128.428 \pm 0.5 s$  (b) heat source field at  $t = 128.407 s$

Fig. 6. Analysis of the correlation between high acoustic energy and heat source ( $0^\circ$  tensile test).

Let us consider now the noteworthy AE event of the  $0^\circ$  tensile test depicted on Fig. 6a. This event occurs at time  $t = 128.428$  s (around 45% of the failure stress) and exhibits an energy of 60 aJ for an amplitude of 79 dB. Pattern recognition identifies such acoustic

event as a fibre breaking. Following the same approach as before, Fig. 6b shows the field with maximum heat source in the interval of 1 s around that time, precisely obtained at  $t = 128.407$  s (error of 0.02%), which confirms the good concordance in time of acoustic and thermal phenomena. Moreover, we can see that the acoustic event and maximum heat source are both located in the bottom part of the specimen, near sensor [2] (Fig. 6). The difference in location between AE and source events, of about 25%, may be explained by the influence of the mechanical solicitation. Indeed, the location of acoustic events is derived from data given by the two sensors by considering the velocity of the wave in the initial state. Load applied and induced damage may thus affect the wave velocity and the estimation of the AE location.

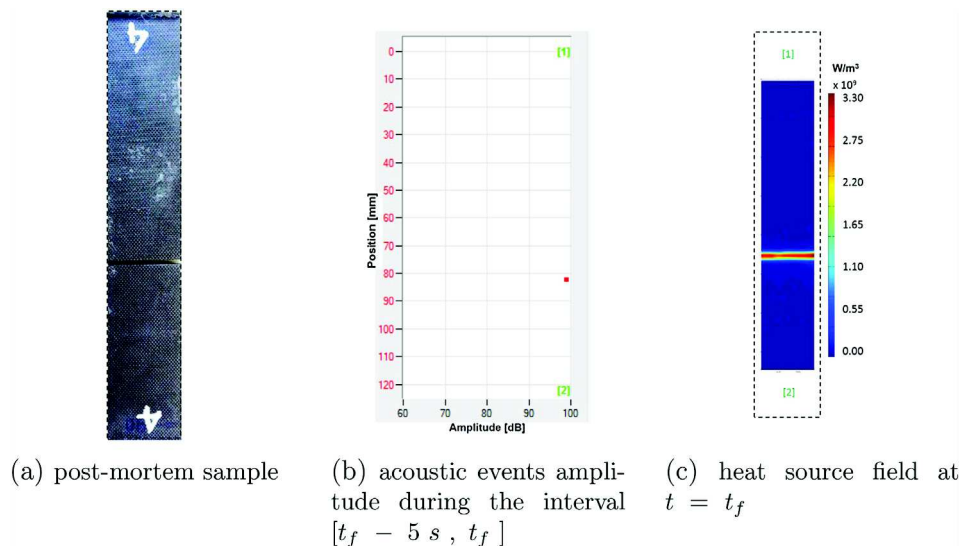
Fig. 9. Analysis of the correlation between AE and IT around breaking time  $t_f$  (90° tensile test).
