## Sediment transport and morphodynamics in an urbanized river: the effect of restoration on sediment fluxes

Margot Chapuis, Vernon Bevan, Bruce Macvicar, André Roy

Margot Chapuis, Vernon Bevan, Bruce Macvicar, André Roy. Sediment transport and morphodynamics in an urbanized river: the effect of restoration on sediment fluxes. River Flow 2014 International Conference on Fluvial Hydraulics, Sep 2014, Lausanne, Switzerland. pp.2119-2126. hal-01285798

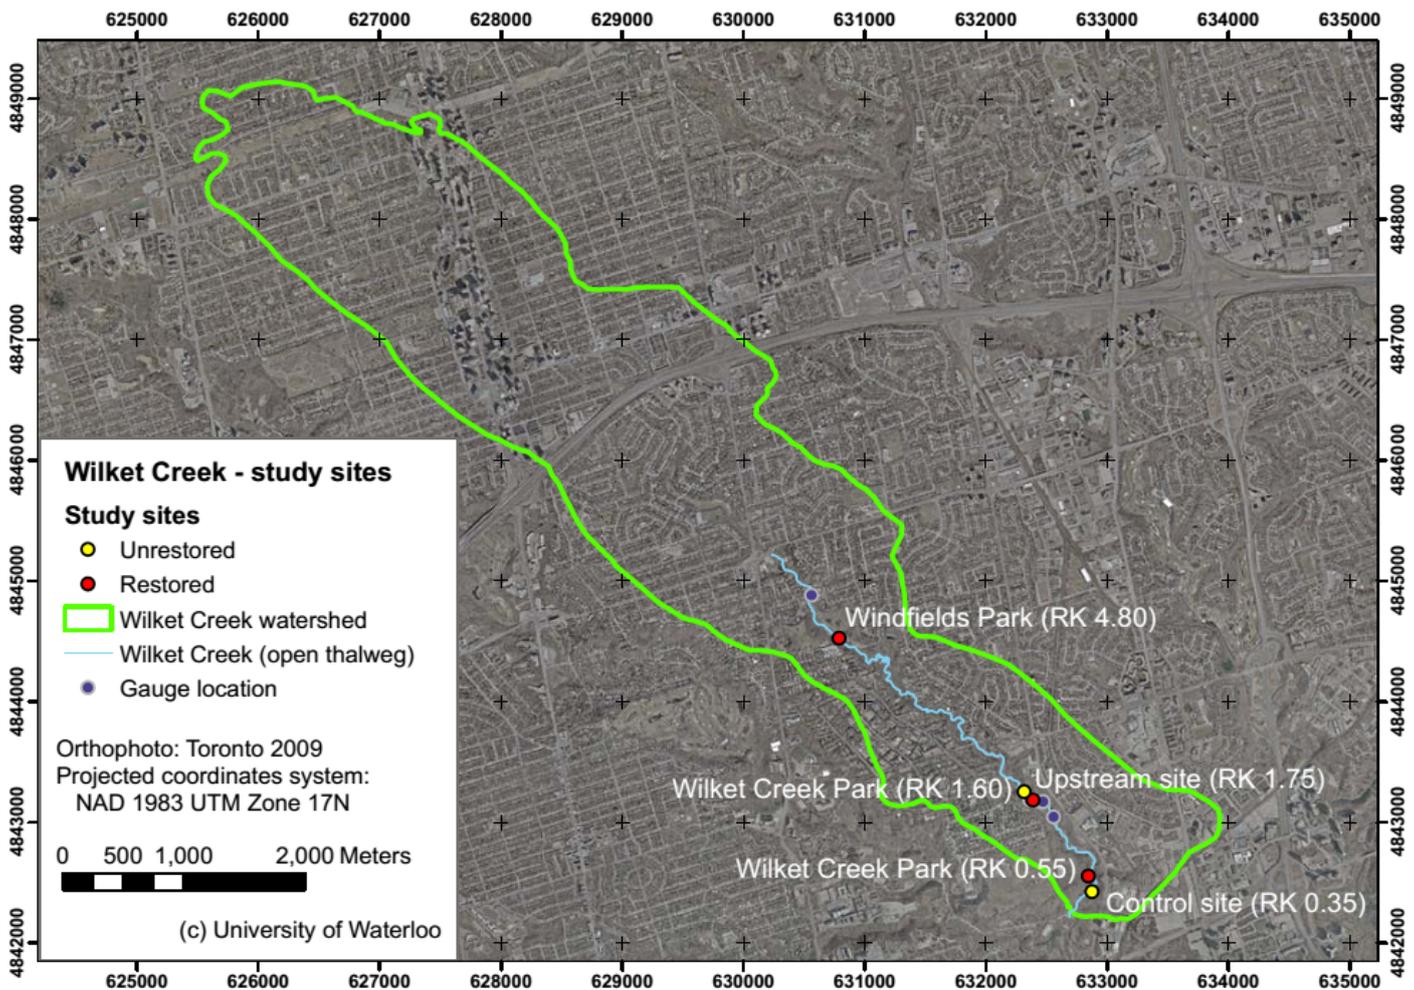
Figure 1. Location of the five study sites within the Wilket Creek catchment and indication of their river kilometer (RK). Wilket Creek is located within the suburban area of Toronto.

Wilket Creek is a small river (14.5 km<sup>2</sup> drainage area, 12 m width, 1% slope) located in the urban area of Toronto (Ontario, Canada, Fig. 1). The bed material consists of a gravel and sand mix ( $D_{50} = 0.039$  m) with some local exposure of a compact glacial till. The watershed has been intensively urbanized between the 50's and the 60's. As observed in similar systems (McDonald 2011), the increase of impervious area associated with a lack of stormwater management increased the intensity and the frequency of flood events (Galster 2008). This

modification of the hydrological regime led to a flashier and more intense hydrograph. This resulted in a 34% increase of mean channel width (maximum width increase = 15 m) between 1947 and 2009 and riverbed degradation that could be up to 2 m. The study reach, which comprises 5 study sites (Fig. 1), is located in a naturalized park with extensive forest cover. The channel is vertically and laterally constrained by a sanitary sewer system located underneath the river bed and a paved foot path with several bridged crossings.

Three reaches have been restored in Wilket Creek since 2008 (Fig. 1). The restoration works attempt to stop lateral erosion and bed degradation. Their meandering riffle-pool design is expected to dissipate excess water energy and thus to help prevent further erosion of the bed. The two newest restored sites are part of a more comprehensive plan undertaken by the City of Toronto to restore 10 degraded reaches in Wilket Creek (Parish Geomorphic 2011).

As part of the study, the sediment mobility of two ‘natural’ sites will be compared with the three restored sites (Fig. 1). The unrestored reaches are 60 m in length. One (Upstream site, RK 1.75) is located upstream of the second restored site and is partially constrained laterally by gabions in its upstream part. It is morphologically typical of the whole creek. The other natural site (Control site, RK 0.35) is located downstream of the downstream restored site and is free of human-made lateral constraint.

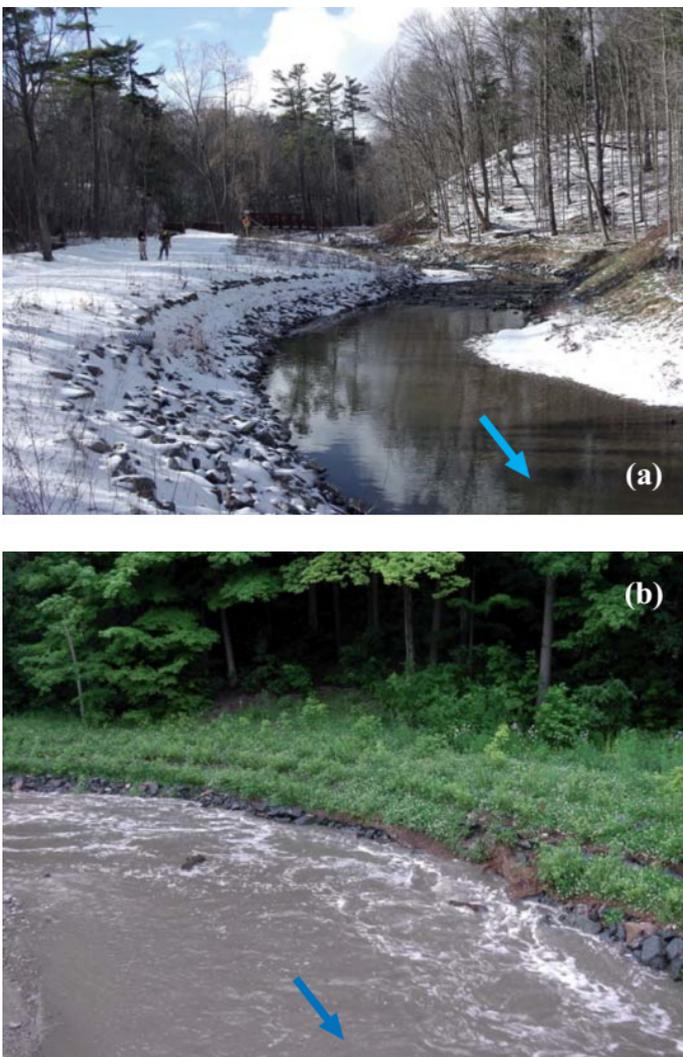
Figure 2. (a) Example of the restoration works in the main study site (Edwards Gardens, RK 1.60). The designed channel corresponds to a sinuous planform channel with riffle-pool features. Both embankments and riffles are made from exogenous material which size is greater than natural bed material. (b) Solicitation of the outer river bank by logs during a flashy flood (2013/06/13, Edwards Gardens, RK 1.60). Blue arrow indicates flow direction.

Each restored reach corresponds to a sinuous planform designed with riffle-pool features (Fig. 2). Both embankments and riffles are made from exogenous material which is greater in size than the natural bed material (in the upstream Wilket Creek Park site, RK 1.60:  $D_{50} = 0.048$  m and 0.056 m before and after the restoration works, respectively; design  $D_{50} = 0.700$  m). In addition riffles are strengthened by transversal ribs corresponding to large ( $>1$  m  $b$ -axis) boulders embedded in the streambed immediately upstream from the riffle crest.

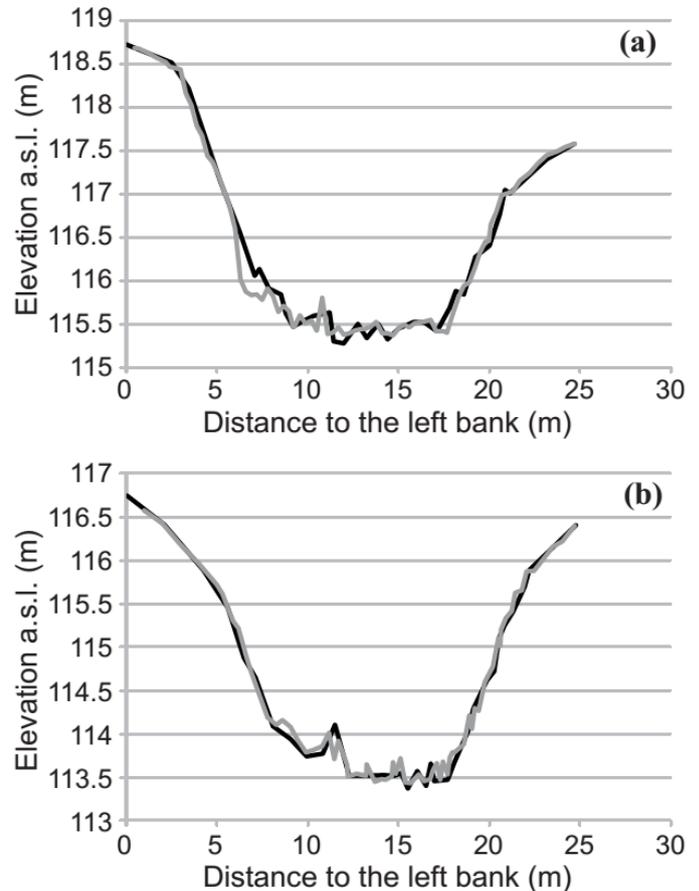
Figure 3. Topographic evolution of cross-sections 8 (subplot a) and 14 (subplot b) of the Wilket Creek Park site (RK 1.60) before (2013/02/01, black line) and after (2013/07/25, grey line) May 29<sup>th</sup> flood. These results show overall stability of the designed channel with some lateral adjustments on cross-section 8.

Following the two over bankfull events, the Wilket Creek Park restored site (RK 1.60) exhibited vertical stability although some lateral adjustments did occur (Fig. 3).

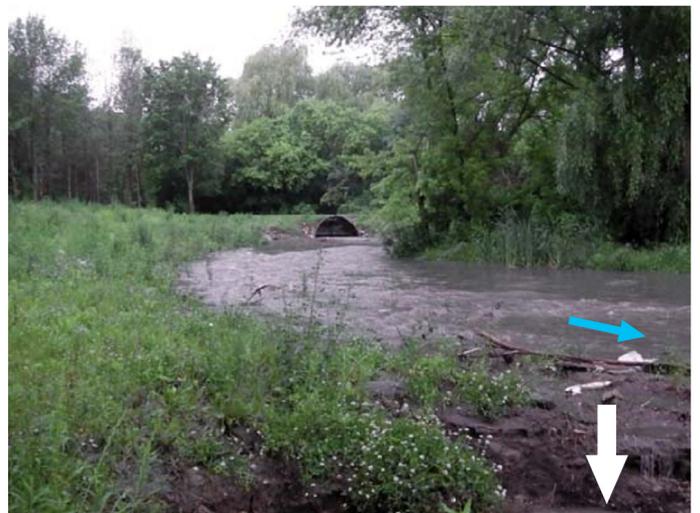
Figure 4. Cut-off (white arrow) of the meander on the upstream restored site (Windfields Park, RK 4.80). Blue arrow indicates flow direction.

The upstream and downstream restored sites showed different trends. In the upstream reach in Windfields Park (RK 4.80, Fig. 4) where there is an ongoing cut-off of the meander, our observations showed an increase in the degradation of the channel. The cut-off accelerated channel incision in the

bend behind the embankment. In contrast, the downstream restored site (Wilket Creek Park, RK 0.55) remained stable, showing only a slight destabilization of the embankment at the downstream end due to the confluence with a small tributary.

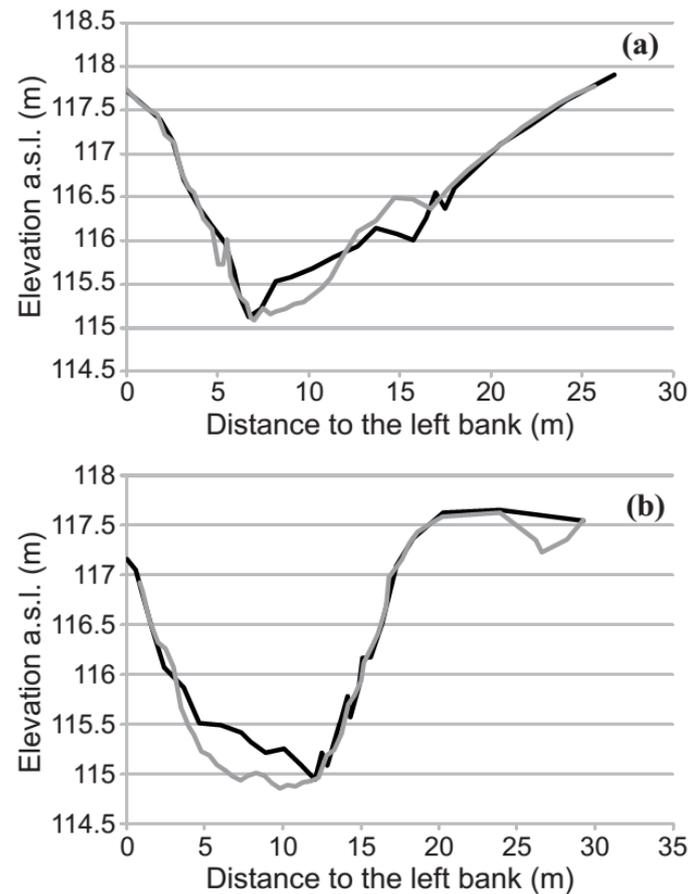
Figure 5. (a) Internal reworking of sediment (cross-section 6) between 2013/02/01 (black line) and 2013/07/25 (grey line) illustrating the effects of two over bankfull floods. (b) Flushing of fine sediments in pools (cross-section 9) between the same survey dates.

The May 29<sup>th</sup> and July 8<sup>th</sup> floods led to the flushing of bed material within the Wilket Creek Park restored site (RK 1.60). The removal of bed material occurred over a depth  $\leq 0.50$  m, uncovering the underlying glacial till (Fig. 5). We observed a fine gravel bedload sheet prograding at the upstream end of the reach. This corresponds to a gravel input on the Wilket Creek Park reach (RK 1.60). Within the central part of the reach, gravel and sand were flushed from the upstream pool of the reach. The bed material resulting from this erosion probably led to the growth of a bar that was observed 200 m downstream.

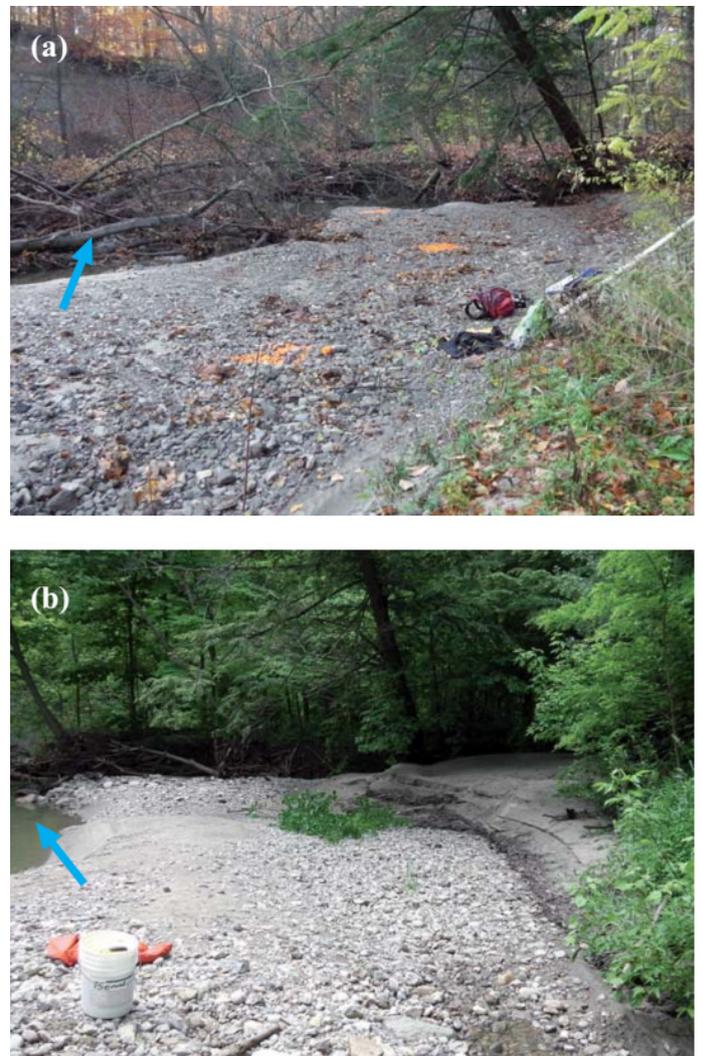
Figure 6. Strong modification of the bed on the upstream unrestored site (Control site, RK 0.35) before (a) and after (b) the May 29<sup>th</sup> flood. (a) Picture taken on the 2012/10/26. (b) Picture taken on the 2013/06/13. Blue arrow indicates flow direction.

The bed in the downstream unrestored reach (Control site, RK 0.35) exhibited extensive mobility vertically and laterally with both deposition of sand on the bar (Fig. 6) and strong lateral erosion of the bank (bank retreat of 1.7 m along the monitored cross-section). Generally speaking, the river experienced flushing of the gravel layer uncovering the underlying glacial till.

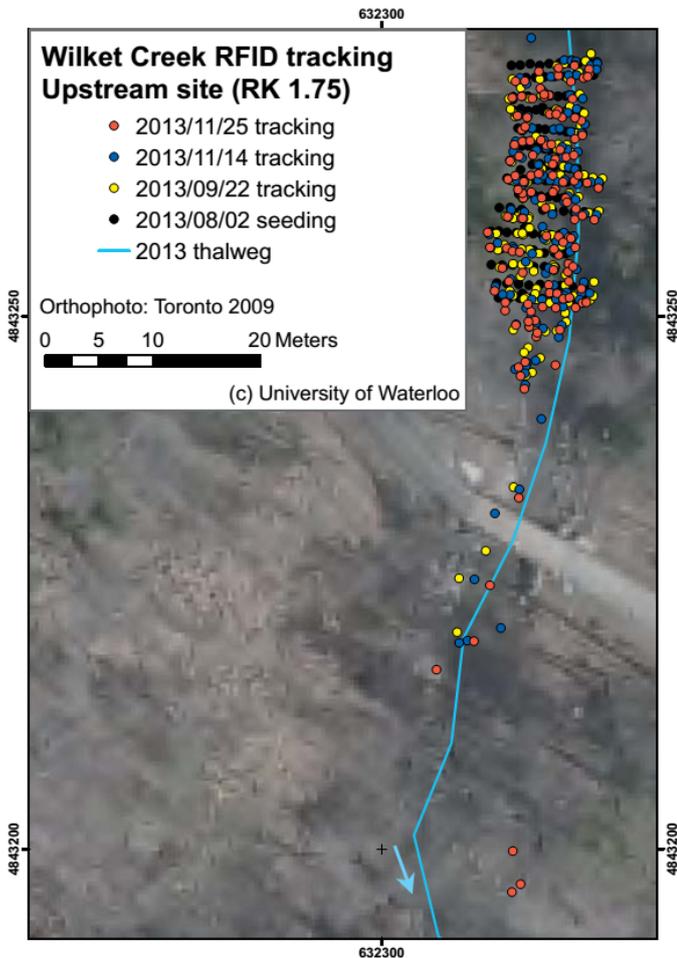
Figure 7. RFID tracking on the Upstream site (RK 1.75). The seeding locations of tracers are indicated. Tracers were naturally reworked between the seeding and the first tracking (2013/09/22) because of four flood events (maximum estimated discharge:  $1.7 \text{ m}^3/\text{s}$  on 2013/08/26). Blue arrow indicates flow direction.

No survey had been undertaken at the upstream site (RK 1.75) when the two over bankfull events occurred. Based on the RFID tracking of subsequent flood events (summer and fall 2013, Fig. 7), the gravel layer within this reach is mobile (more than 80% of the particles constituting each size class were mobile between 2013/09/22 and 2013/11/25) and thus will eventually supply gravel to the downstream restored site (RK 1.60).
