Sediment transport and morphodynamics in an urbanized river: the effect of restoration on sediment fluxes

Margot Chapuis, Vernon Bevan, Bruce Macvicar, André Roy

Margot Chapuis, Vernon Bevan, Bruce Macvicar, André Roy. Sediment transport and morphodynamics in an urbanized river: the effect of restoration on sediment fluxes. River Flow 2014 International Conference on Fluvial Hydraulics, Sep 2014, Lausanne, Switzerland. pp.2119-2126. hal-01285798

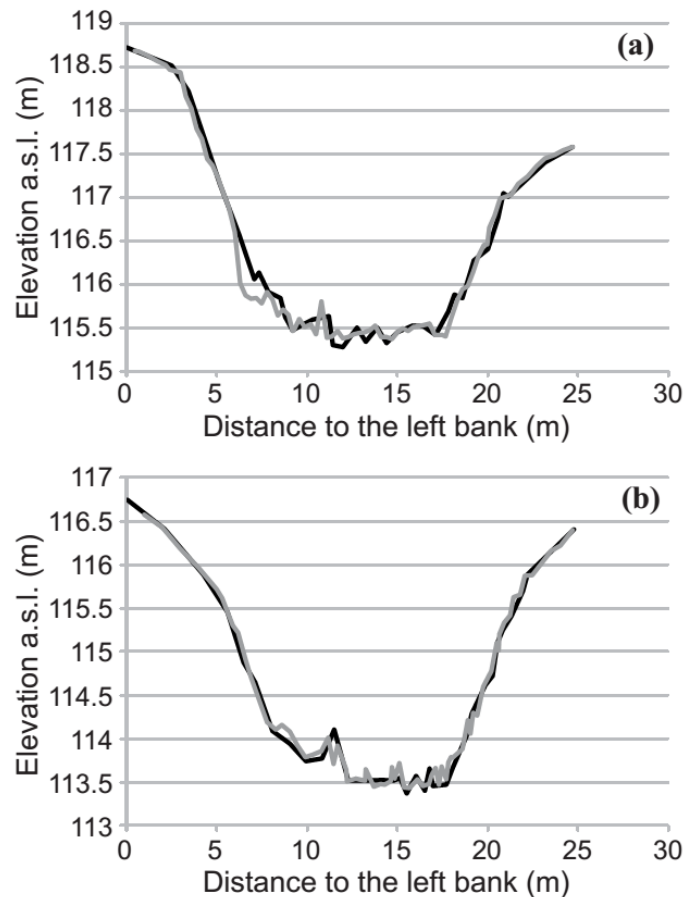
Figure 3. Topographic evolution of cross-sections 8 (subplot a) and 14 (subplot b) of the Wilket Creek Park site (RK 1.60) before (2013/02/01, black line) and after (2013/07/25, grey line) May 29th flood. These results show overall stability of the designed channel with some lateral adjustments on cross-section 8.

Following the two over bankfull events, the Wilket Creek Park restored site (RK 1.60) exhibited vertical stability although some lateral adjustments did occur (Fig. 3).

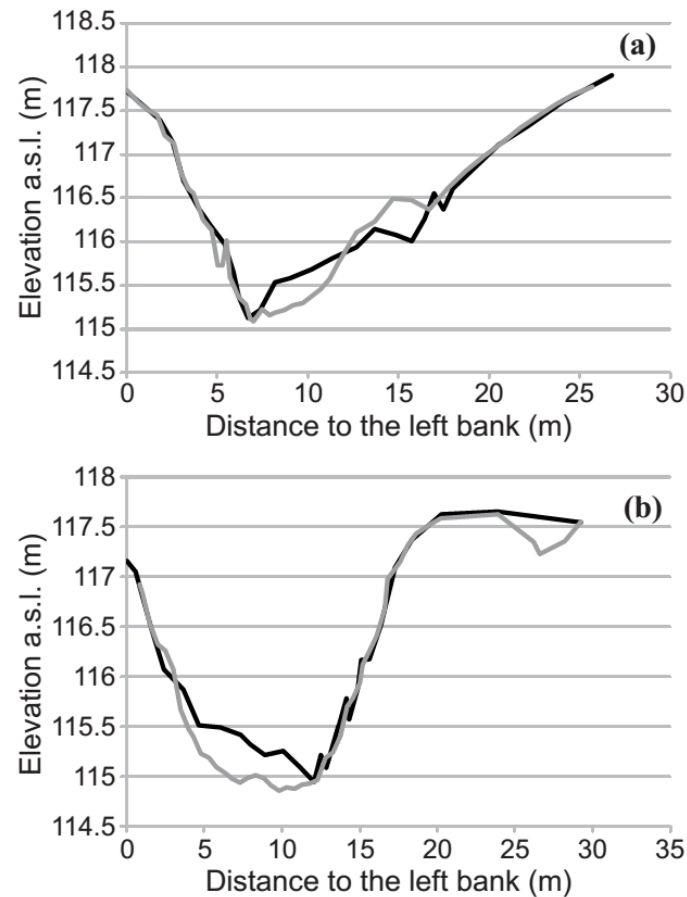
Figure 5. (a) Internal reworking of sediment (cross-section 6) between 2013/02/01 (black line) and 2013/07/25 (grey line) illustrating the effects of two over bankfull floods. (b) Flushing of fine sediments in pools (cross-section 9) between the same survey dates.

The May 29th and July 8th floods led to the flushing of bed material within the Wilket Creek Park restored site (RK 1.60). The removal of bed material occurred over a depth ≤ 0.50 m, uncovering the underlying glacial till (Fig. 5). We observed a fine gravel bedload sheet prograding at the upstream end of the reach. This corresponds to a gravel input on the Wilket Creek Park reach (RK 1.60). Within the central part of the reach, gravel and sand were flushed from the upstream pool of the reach. The bed material resulting from this erosion probably led to the growth of a bar that was observed 200 m downstream.
