# Sediment transport and morphodynamics in an urbanized river: the effect of restoration on sediment fluxes

M. Chapuis, V. Bevan & B. MacVicar

**ABSTRACT:** Urbanized rivers are heavily impacted by human activities that modify their hydrology and morphodynamics. This study focuses on Wilket Creek, a small gravel-bed river (14.5 km<sup>2</sup> drainage area, 12 m width, 1% slope, D50 = 0.039 m) located in the suburban area of Toronto. Existing infrastructures are threatened by incision and lateral migration of the channel. In 2012, a 400 m long reach has been restored with a riffle-pool design that was assumed to be the most efficient to dissipate flow energy. This project investigates the interactions between hydrology, sediment transport and morphodynamics to assess the stability of the restoration design. We used topographic surveys and RFID tracking to assess the sediment mobility and morphodynamics changes in unrestored and restored sections. After two bankfull events, adjustments of the riffle-pool design consist primarily of local bank erosion and local exposure of the underlying glacial till.

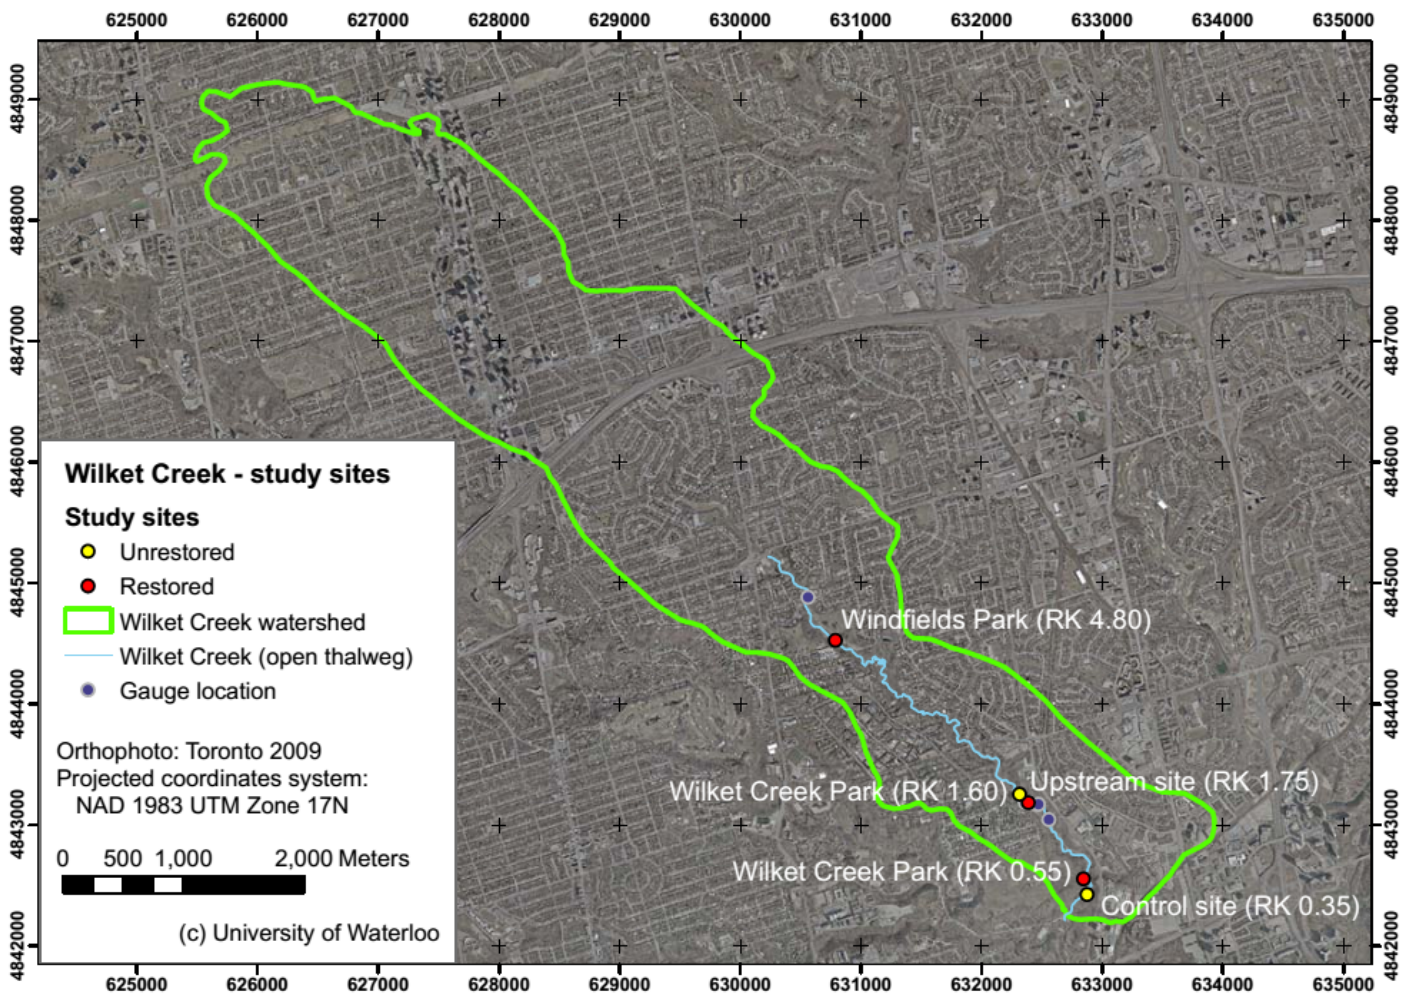
Figure 1. Location of the five study sites within the Wilket Creek catchment and indication of their river kilometer (RK). Wilket Creek is located within the suburban area of Toronto.

Wilket Creek is a small river (14.5 km<sup>2</sup> drainage area, 12 m width, 1% slope) located in the urban area of Toronto (Ontario, Canada, Fig. 1). The bed material consists of a gravel and sand mix ( $D_{50} = 0.039$  m) with some local exposure of a compact glacial till. The watershed has been intensively urbanized between the 50's and the 60's. As observed in similar systems (McDonald 2011), the increase of impervious area associated with a lack of stormwater management increased the intensity and the frequency of flood events (Galster 2008). This

modification of the hydrological regime led to a flashier and more intense hydrograph. This resulted in a 34% increase of mean channel width (maximum width increase = 15 m) between 1947 and 2009 and riverbed degradation that could be up to 2 m. The study reach, which comprises 5 study sites (Fig. 1), is located in a naturalized park with extensive forest cover. The channel is vertically and laterally constrained by a sanitary sewer system located underneath the river bed and a paved foot path with several bridged crossings.

Three reaches have been restored in Wilket Creek since 2008 (Fig. 1). The restoration works attempt to stop lateral erosion and bed degradation. Their meandering riffle-pool design is expected to dissipate excess water energy and thus to help prevent further erosion of the bed. The two newest restored sites are part of a more comprehensive plan undertaken by the City of Toronto to restore 10 degraded reaches in Wilket Creek (Parish Geomorphic 2011).

As part of the study, the sediment mobility of two ‘natural’ sites will be compared with the three restored sites (Fig. 1). The unrestored reaches are 60 m in length. One (Upstream site, RK 1.75) is located upstream of the second restored site and is partially constrained laterally by gabions in its upstream part. It is morphologically typical of the whole creek. The other natural site (Control site, RK 0.35) is located downstream of the downstream restored site and is free of human-made lateral constraint.

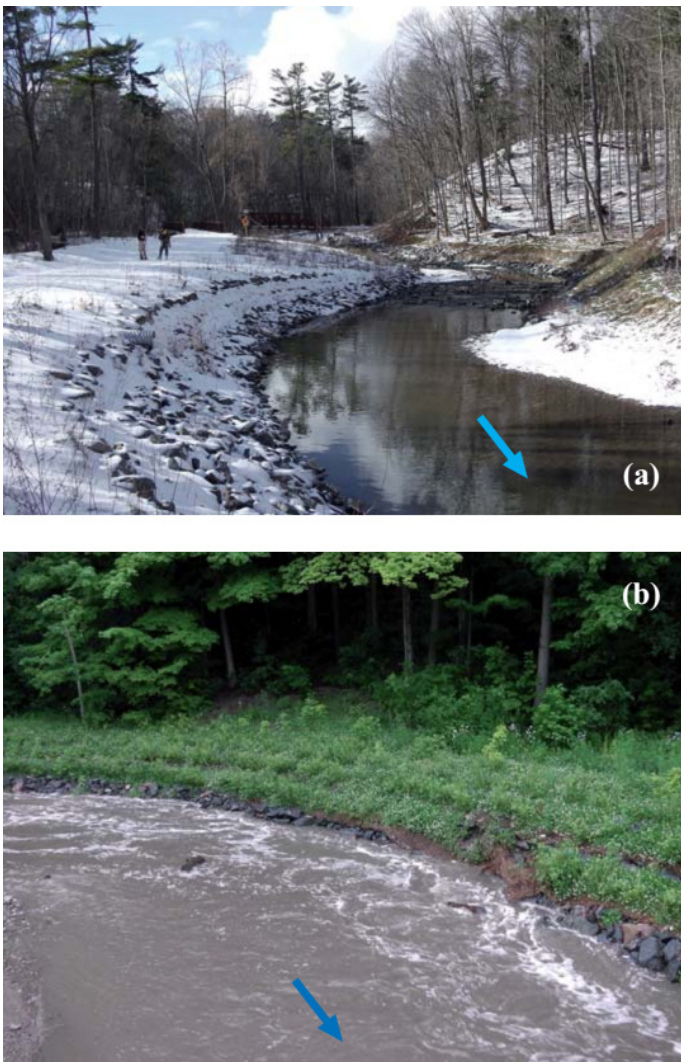
Figure 2. (a) Example of the restoration works in the main study site (Edwards Gardens, RK 1.60). The designed channel corresponds to a sinuous planform channel with riffle-pool features. Both embankments and riffles are made from exogenous material which size is greater than natural bed material. (b) Solicitation of the outer river bank by logs during a flashy flood (2013/06/13, Edwards Gardens, RK 1.60). Blue arrow indicates flow direction.

Each restored reach corresponds to a sinuous planform designed with riffle-pool features (Fig. 2). Both embankments and riffles are made from exogenous material which is greater in size than the natural bed material (in the upstream Wilket Creek Park site, RK 1.60:  $D_{50} = 0.048$  m and 0.056 m before and after the restoration works, respectively; design  $D_{50} = 0.700$  m). In addition riffles are strengthened by transversal ribs corresponding to large ( $>1$  m  $b$ -axis) boulders embedded in the streambed immediately upstream from the riffle crest.

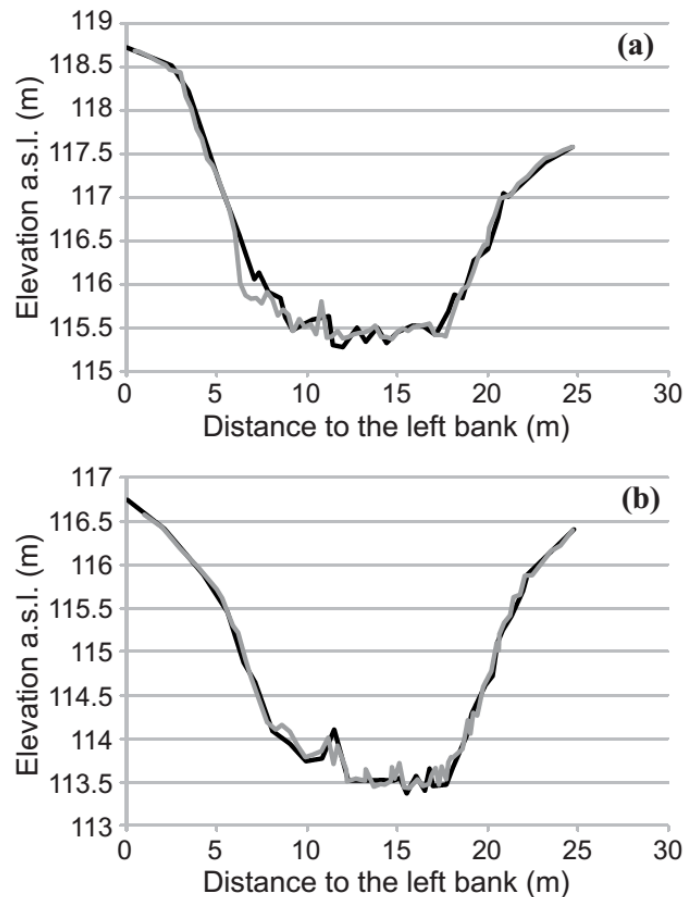
Figure 3. Topographic evolution of cross-sections 8 (subplot a) and 14 (subplot b) of the Wilket Creek Park site (RK 1.60) before (2013/02/01, black line) and after (2013/07/25, grey line) May 29<sup>th</sup> flood. These results show overall stability of the designed channel with some lateral adjustments on cross-section 8.

Following the two over bankfull events, the Wilket Creek Park restored site (RK 1.60) exhibited vertical stability although some lateral adjustments did occur (Fig. 3).

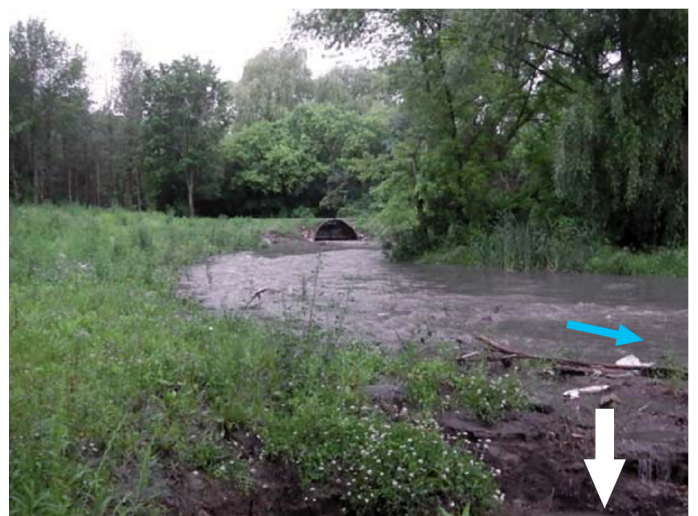
Figure 4. Cut-off (white arrow) of the meander on the upstream restored site (Windfields Park, RK 4.80). Blue arrow indicates flow direction.

The upstream and downstream restored sites showed different trends. In the upstream reach in Windfields Park (RK 4.80, Fig. 4) where there is an ongoing cut-off of the meander, our observations showed an increase in the degradation of the channel. The cut-off accelerated channel incision in the

bend behind the embankment. In contrast, the downstream restored site (Wilket Creek Park, RK 0.55) remained stable, showing only a slight destabilization of the embankment at the downstream end due to the confluence with a small tributary.

The Windfields Park restored site (RK 4.80) is failing because of its cut-off but the downstream Wilket Creek Park restored reach (RK 0.55) is fairly stable after the two bankfull events. Our observations also suggest that the lateral planform of the Wilket Creek Park restored reach (RK 1.60) may not remain stable over the long term. This triggers the question about the relevance of the restoration works in relation to their cost and longevity. Efficiency of the ‘vertical’ restoration seems able to protect the sewage system underneath, even if the downstream end of the restoration seems to be weakened by these two bankfull events.

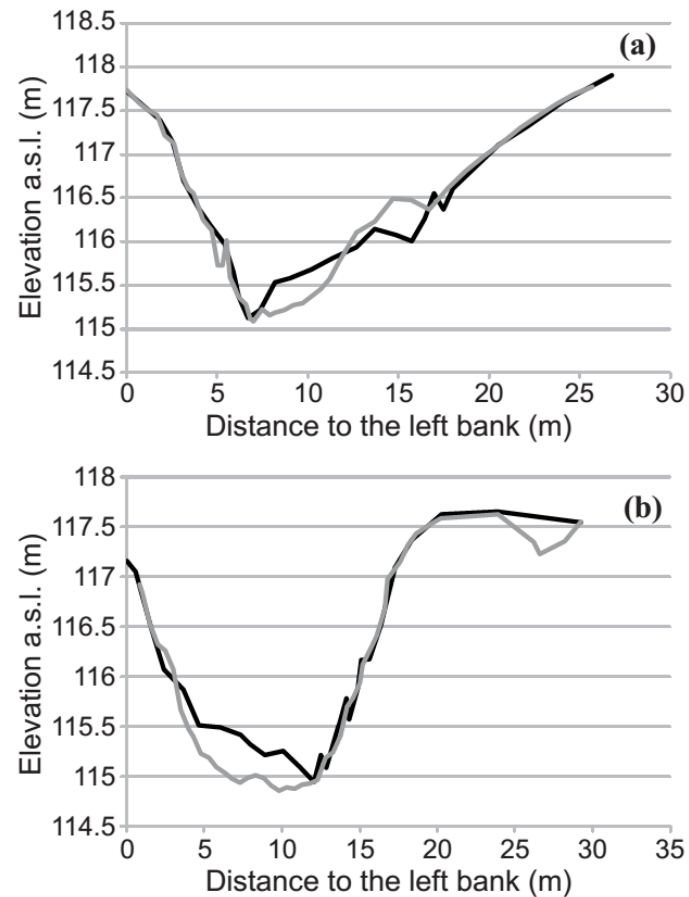
Figure 5. (a) Internal reworking of sediment (cross-section 6) between 2013/02/01 (black line) and 2013/07/25 (grey line) illustrating the effects of two over bankfull floods. (b) Flushing of fine sediments in pools (cross-section 9) between the same survey dates.

The May 29<sup>th</sup> and July 8<sup>th</sup> floods led to the flushing of bed material within the Wilket Creek Park restored site (RK 1.60). The removal of bed material occurred over a depth  $\leq 0.50$  m, uncovering the underlying glacial till (Fig. 5). We observed a fine gravel bedload sheet prograding at the upstream end of the reach. This corresponds to a gravel input on the Wilket Creek Park reach (RK 1.60). Within the central part of the reach, gravel and sand were flushed from the upstream pool of the reach. The bed material resulting from this erosion probably led to the growth of a bar that was observed 200 m downstream.

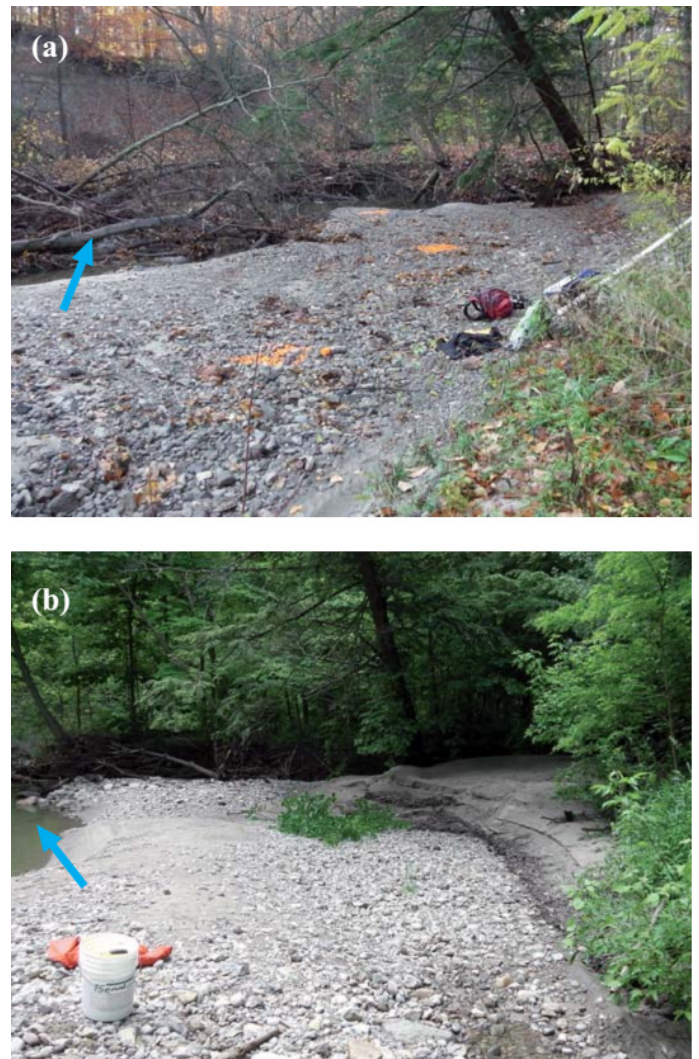
Figure 6. Strong modification of the bed on the upstream unrestored site (Control site, RK 0.35) before (a) and after (b) the May 29<sup>th</sup> flood. (a) Picture taken on the 2012/10/26. (b) Picture taken on the 2013/06/13. Blue arrow indicates flow direction.

The bed in the downstream unrestored reach (Control site, RK 0.35) exhibited extensive mobility vertically and laterally with both deposition of sand on the bar (Fig. 6) and strong lateral erosion of the bank (bank retreat of 1.7 m along the monitored cross-section). Generally speaking, the river experienced flushing of the gravel layer uncovering the underlying glacial till.

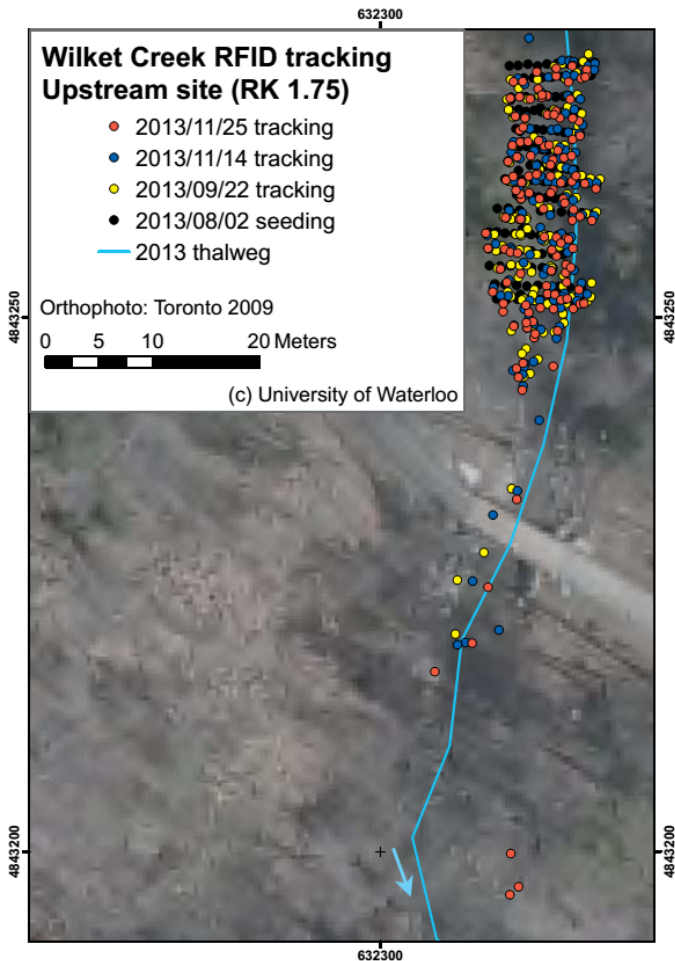
Figure 7. RFID tracking on the Upstream site (RK 1.75). The seeding locations of tracers are indicated. Tracers were naturally reworked between the seeding and the first tracking (2013/09/22) because of four flood events (maximum estimated discharge:  $1.7 \text{ m}^3/\text{s}$  on 2013/08/26). Blue arrow indicates flow direction.

No survey had been undertaken at the upstream site (RK 1.75) when the two over bankfull events occurred. Based on the RFID tracking of subsequent flood events (summer and fall 2013, Fig. 7), the gravel layer within this reach is mobile (more than 80% of the particles constituting each size class were mobile between 2013/09/22 and 2013/11/25) and thus will eventually supply gravel to the downstream restored site (RK 1.60).
