Static and dynamic testing of a damaged post tensioned concrete beam

Maria Pina Limongelli, Dominique Siegert, Eric Merliot, R Vidal, Julien Waeytens, Frédéric Bourquin, Véronique Le Corvec, Ivan Gueguen, Louis Marie Cottineau

Abstract. In this paper are reported the results of an experimental campaign carried out on a post tensioned concrete beam with the aim of investigating the possibility to detect early warning signs of deterioration basing on static and/or dynamic tests. The beam was tested in several configurations aimed to reproduce several different phases of the ‘life’ of the beam: the original undamaged state, increasing loss of tension in the post tensioning cables, a strengthening intervention carried out by means of a second tension cable, formation of further cracks on the strengthened beam. Responses of the beam were measured by an extensive set of instruments consisting of accelerometers, inclinometers, displacement transducers, strain gauges and optical fibres. The paper discusses the tests program and the dynamic characterization of the beam in the different damage scenarios. The modal properties of the beam in the different phases were recovered basing on the

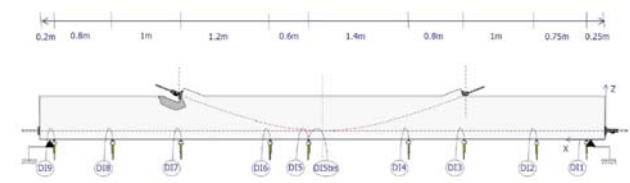
Figure 2: Location of the second network of displacement transducers

An extensive set of sensors was deployed on the beam to measure its response: labels and locations of the sensors are reported in Figure 1 and Figure 2.

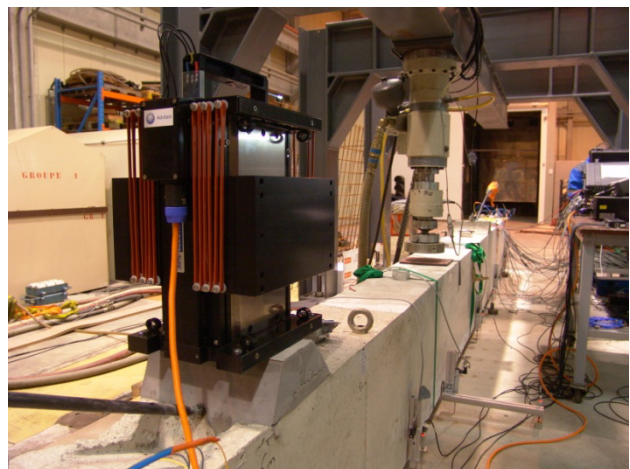
Figure 3: The specimen on the test bench with the shaker and the hydraulic jack.

Both three point bending static tests and sine sweep and hammer dynamic tests were carried out on the beam. The loads for the static tests were generated by an hydraulic jack of 100kN capacity and transferred to the beam via a steel plate (see Figure 3). The hammer tests were performed using a hammer Kiang Swiss 906B with a mass of 9kg mass to impact the beam. Sine sweep tests were carried out using a shaker APS 400 Electro-seis shaker.

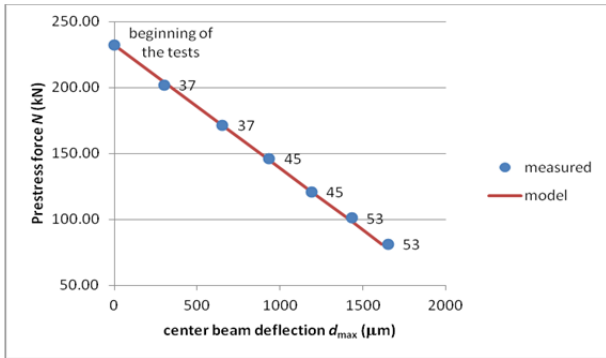
Figure 4: Center-span deflection vs prestress force N

On the contrary, the values of the center-span deflection measured during this phase (T37, T45, T53 in Table 3) decrease linearly with the prestress force N , fitting very well the values given by the simple model of a beam on fix end supports under the dead load q and the tension N in the cables.

It must be noted that the deflections during the tests were measured assuming as a reference configuration the one under the dead load q and the initial value of the prestress ($N_0=232\text{kN}$): the center span deflection d_{max} reported in Figure 4 is thus the decrease of the deflection due to the reduction of the prestress load, with respect to the reference value at mid span:

$$d_{\text{max}} = \frac{eL^2}{8E_b I_b} (N - N_0) \quad (2)$$

A perfect fit of the results of these static tests is obtained assuming in equation (2) a value of the elastic modulus E_b of the concrete equal to 26Gpa.

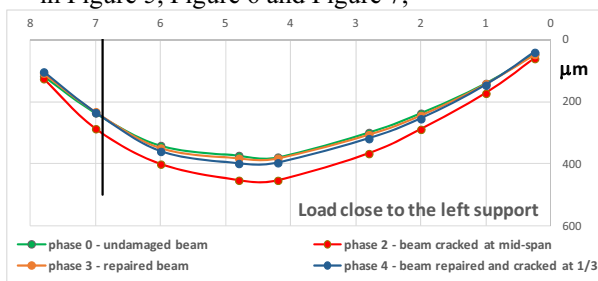
Figure 5: Deflections under three-point bending at the left support

As already shown in section 3.2 for the phase 2, the decrease of the prestress force in the tendons induces an increase of the static deflection of the beam that can be denoted as a decrease of the ‘apparent stiffness’ of the beam. This occurred also during the other phases of tests as shown by the comparison Figure 5, Figure 6 and Figure 7 showing that:

- the cracking of the beam both at mid span (phase 2) and at $1/3L$ from the left support (phase 4) reduces the ‘apparent stiffness’ of the beam that is there is an increase in deflection under the same load condition;
- after the ‘repair’ in phase 3 the beam recovers its original apparent stiffness as shown by the comparison between the deflected shapes relevant to phase 0 and phase 3 which are almost superimposed in Figure 5, Figure 6 and Figure 7;

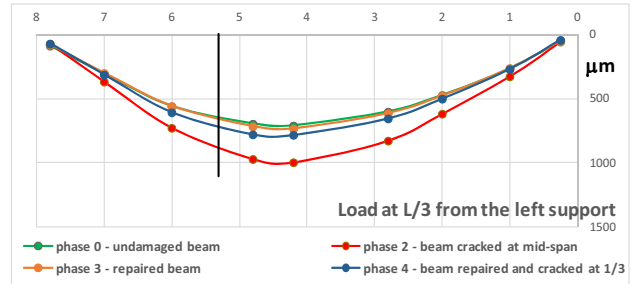
Figure 6: Deflections under three-point bending $L/3$ from the left support

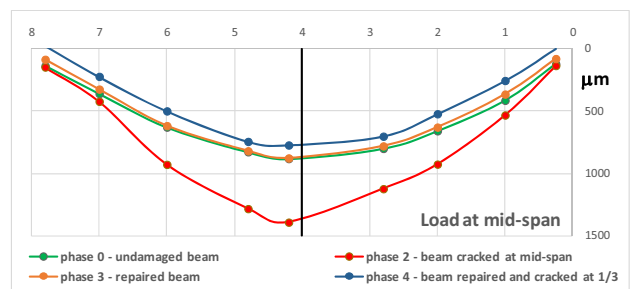
Figure 7: Deflections under three-point bending at mid-span

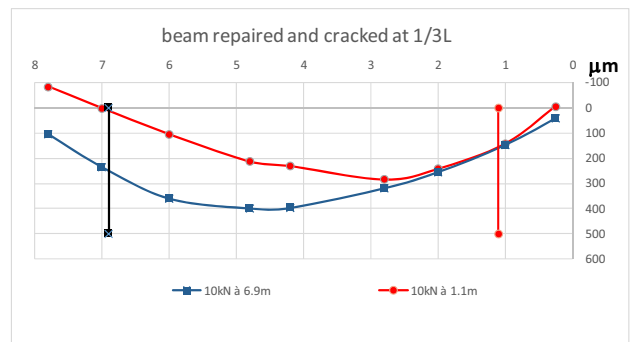
Figure 8: Non symmetric deflection under symmetric loading

- the cracking at $1/3L$ in the repaired beam induces a non symmetric behaviour of the beam (see Figure 8);
- the cracking at $1/3L$ induces a lower reduction of apparent stiffness on the repaired beam with respect to the cracking at mid-span on the original beam as

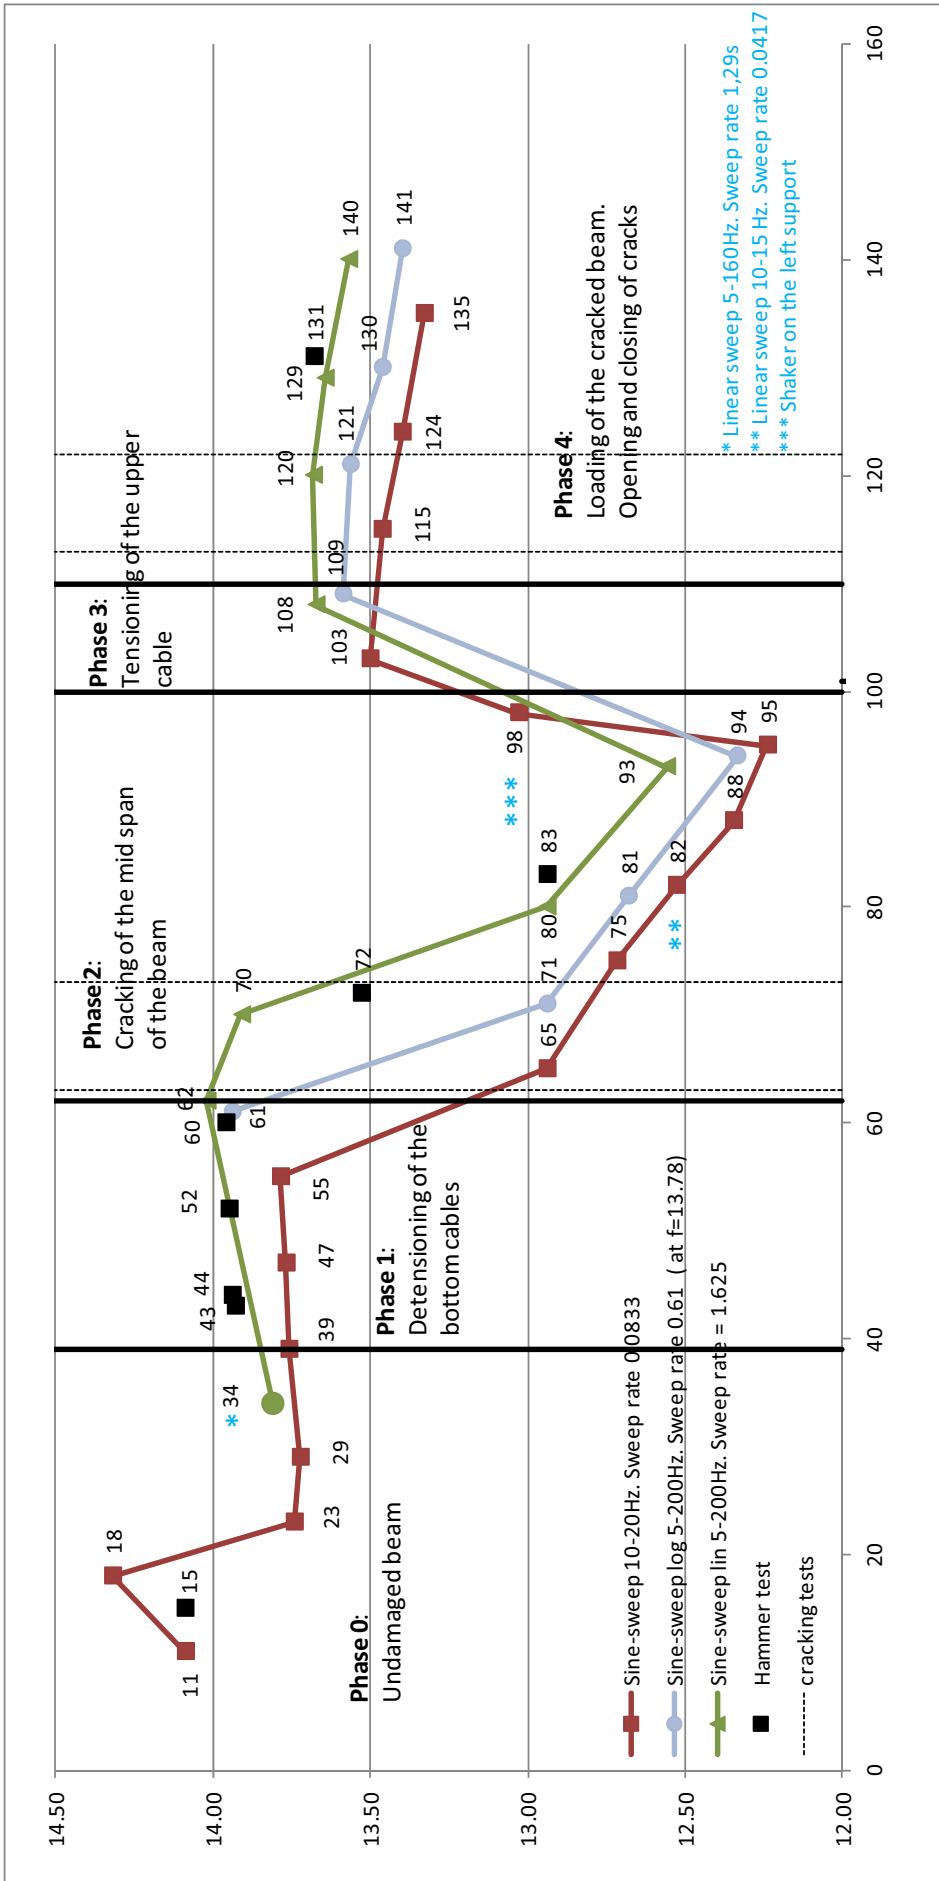
Figure 9. Variation of the first modal frequency during the 5 phases of test

In phase 1 the tension N in the cables was gradually reduced by releasing separately each of the two cables from about 120kN to about 40kN each. As shown in Figure 9 the first modal frequency stays pretty constant at the decrease of the tension in the bottom cables, whatever the type of dynamic test. It must be noted that during test 34 a lower sweep rate was used with respect to the other linear sweeps hence a respectively lower value of frequency was estimated. The scarce influence of N on the modal frequencies in the cables is consistent with the findings of several experimental tests carried out on prestressed beams [1], [5], [10] and can be explained considering a very simple mechanical model of a supported beam of mass per unit length m , length L , subjected to a prestress force N . The n -th natural frequency of vibration is given by [11]:

being E_b and I_b the elastic modulus and the moment of inertia of the beam, E_c and I_c the elastic modulus and the moment of inertia of the cable. Assuming $E_b=26\text{GPa}$, $I_b=0.0054\text{m}^4$ and $L=7.9\text{m}$ the value of the first modal frequency ($n=1$) is 13.92Hz (fitting very well the experimental values reported in Figure 9) for all the values of the tension force N .
