1 **Geomorphic and vegetation changes in a meandering dryland river regulated by a large**
2 **dam, Sauce Grande River, Argentina**

36 *Keywords:* flow regulation; geomorphic changes; vegetation changes; dryland rivers; Sauce
37 Grande River; Paso de las Piedras Dam

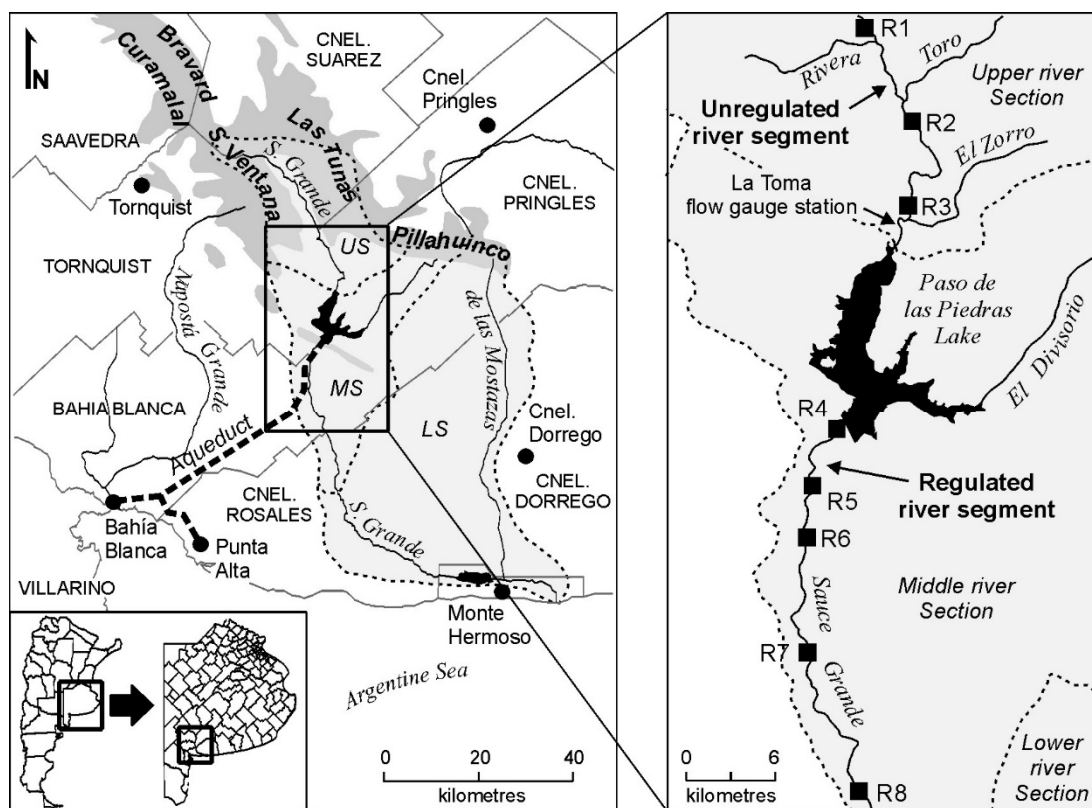
109
110 Fig. 1. Map of the Sauce Grande River basin showing main regional features (left) and the
111 river segments selected for analysis (right). The location of reference river reaches (R)
112 each river segment is also illustrated. US, MS and LS in the left map designate the upper,
113 middle, and lower river sections, respectively.

180 present channel conditions (2011-2012) were performed for eight reference reaches of 1-km
 181 length located above (3 reaches) and below (5 reaches) the dam (Fig. 1).

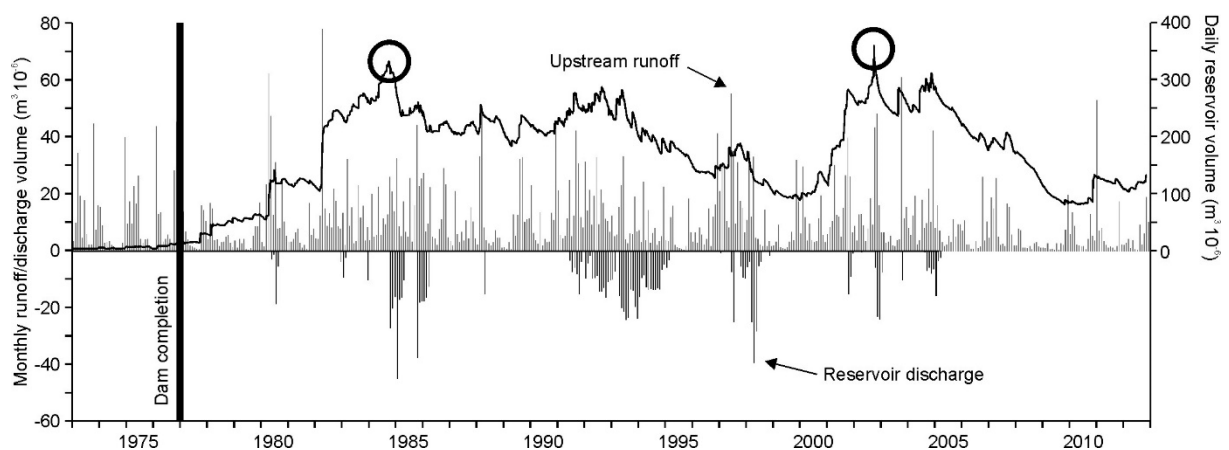
137
 138 Fig. 2. Monthly runoff volume upstream from the dam and monthly volumes of reservoir
 139 discharge over the period 1973-2012. Upstream runoff volumes were estimated from rainfall
 140 using the GR2M model (Makhlouf and Michel, 1994). Monthly volumes of reservoir
 141 discharge over the period 1973-1988 were calculated by solving the reservoir water balance

142 equation (missing data). Daily reservoir volumes were illustrated to provide an idea of the
 143 hydrological magnitude of the dam relative to that of the river. Circles indicate episodes of
 144 overflow spills.

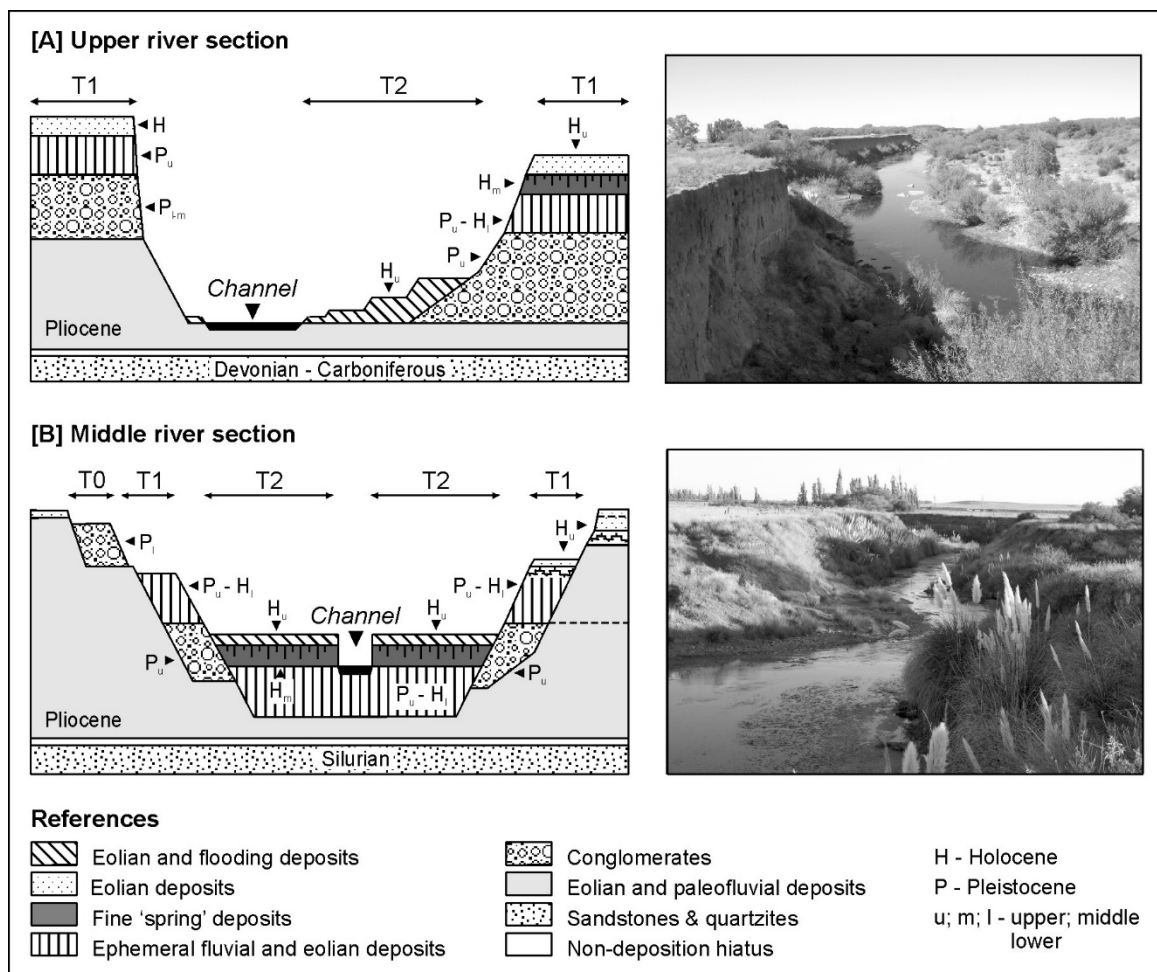
153
 154 Fig. 3. Schematic cross sections of the Sauce Grande River showing typical geomorphic and

155 geologic characteristics within the upper and middle river sections. Geologic features were
156 modified from Borromei (1991), Zavala and Quattrocchio (2001), and Quattrocchio et al.
157 (2008). Not to scale.

158 Downstream variations in channel forms and size are apparent (Fig. 3) and conceivably linked
159 to the attenuation of floods and flow transmission losses characteristic of dryland
160 environments (Tooth, 2000a). In the upper section, the river channel is wide, shallow, and
161 develops on the bottom of the incised valley. Migration of the meanders and point bar
162 building outward led to formation of small terrace steps that have changed the original
163 configuration of the valley bottom. In the middle river section, the valley broadens markedly,
164 the terraces lose altitude, and the degree of confinement decreases. The river flows through a
165 narrow, deep, and tortuous channel that constitutes a remnant of an ancient braided
166 morphology (Borromei, 1991). Former braids were covered by aeolian deposits, and the
167 present floodplain constitutes an abandoned portion of the original braided channel.

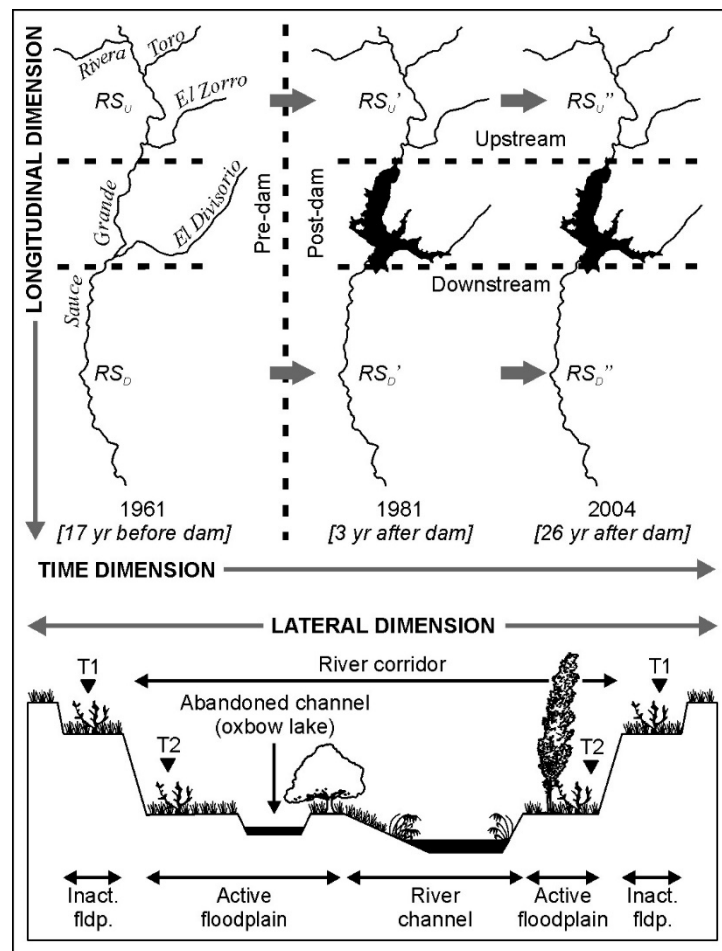
183 Fig. 4. Spatial and temporal scales used in geomorphic and vegetation analysis. Quantification
 184 of change within the regulated river segment (RS_D) is performed with time ($RS_D \rightarrow RS_D''$) and
 185 with respect to the unregulated river segment upstream (RS_U). Upstream and downstream
 186 river segments were delineated by the extent of the river corridor in each time step.

170 This paper quantifies post-dam geomorphic and vegetation changes across multiple scales
171 (Fig. 4). Changes with time were inspected using a chronological sequence of historical aerial
172 photographs (1961, 1981) and high-resolution imagery (Ikonos, 2004) defining two
173 comparative periods. The first period (1961-1981) spans a pre-disturbance phase,
174 characterized by unregulated flow conditions, and a phase of early disturbance linked to dam
175 completion in 1978 and initial filling of the reservoir (Fig. 2). The second period (1981-2004)
176 spans the post-disturbance phase where the dam controls the magnitude, frequency, duration,
177 and variability of downstream flows. Changes from unregulated to regulated river conditions
178 for a given time step were inspected by contrasting two river segments located above and
179 below the dam (~26- and 41-km length, respectively). In addition, field-based descriptions of

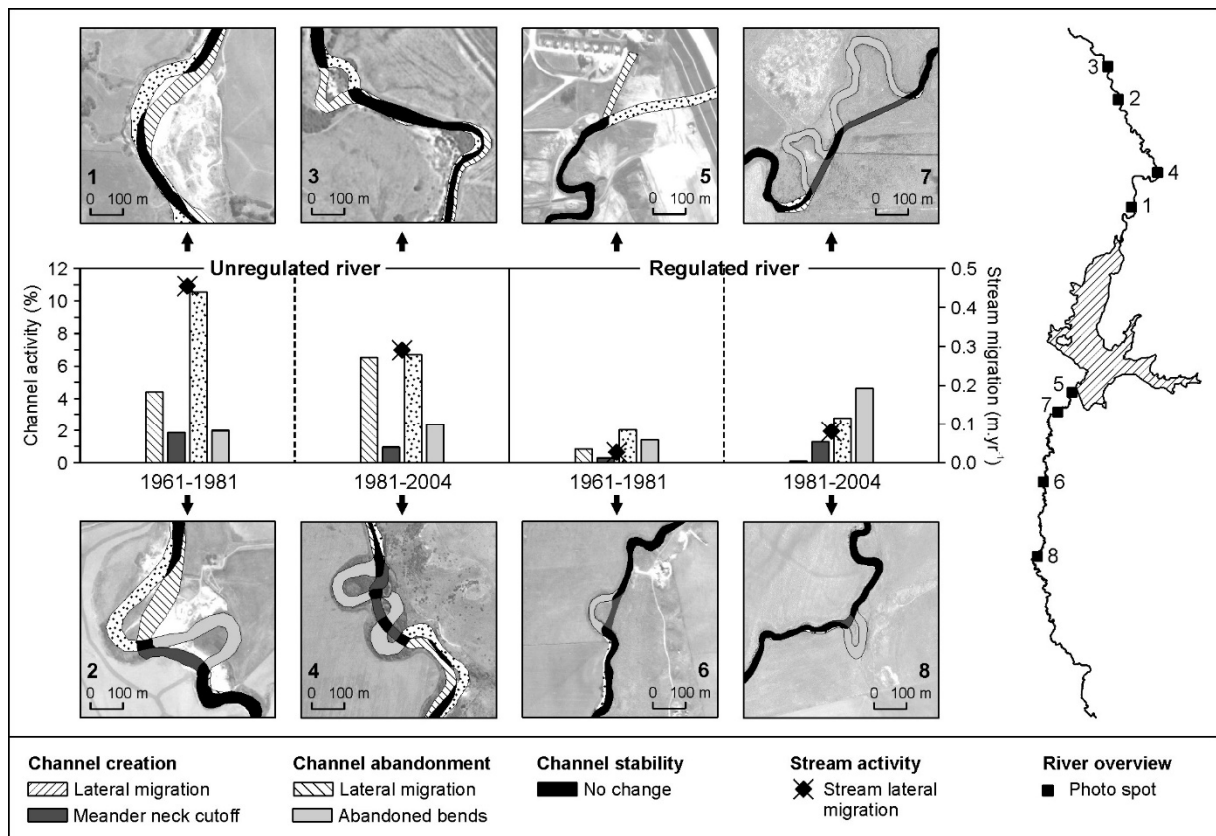
301
 302 Fig. 5. Channel and stream activity within the unregulated and regulated river segments by

303 comparative period. Boxes provide an overview of major planform changes above and below
 304 the dam per comparative period. The scheme on the right shows the relative situation of major
 305 planform changes within each river segment.
 306

258 The unregulated river exhibited marked channel activity (Table 1; Fig. 5). Although new
259 channel surfaces were created by meander migration (10.6%) and cutoff (2.1%), the period
260 1961-1981 was characterized by abandonment of channel surfaces owing to meander
261 translation (15.1%; Fig. 5, Ex. 1) and abandonment of meander bends (3.1%; Fig. 5, Ex. 2).
262 Channel activity during the period 1981-2004 was clearly dominated by meander extension
263 and translation. High percentages of channel abandonment (19.8%) indicate a tendency to
264 channel straightening. Yet increased bend amplitude in some river sections was notable (Fig.
265 5, Ex. 3), and three major cutoffs in the middle-lower river segment (Fig. 5, Ex. 4) give
266 evidence of the geomorphic effectiveness of floods during the second comparative period.

271 Conversely, the river channel below the dam exhibited marked planform stability during both
 272 comparative periods (93 to 97%). Channel activity during the period 1961-1981 was closely
 273 related to waterworks conducted in the vicinity of the dam (e.g., deviation of the river course
 274 from its original position to the dam outlet; Fig. 5, Ex. 5). Localized translation of meander
 275 bends occurred in the middle-upper river segment, and two abandoned bends were observed
 276 at river km 2 and 13 below the dam. Whereas the cutoff morphology in the first case suggests
 277 a human-related origin, the latter was conceivably cutoff by high flows occurring during the
 278 pre-disturbance phase (Fig. 5, Ex. 6). Meander cutoff and abandonment of meander bends
 279 were dominant processes during the post-disturbance phase (1981-2004). Yet four out of five
 280 cutoffs displayed a human-related origin (e.g., two major cutoffs facilitate canalization of dam

281 spills; Fig. 5, Ex. 7). Percentage of channel abandonment was five times that of channel
 282 creation (7.4 and 1.4%, respectively), and the channel sinuosity was reduced by 2.7%.

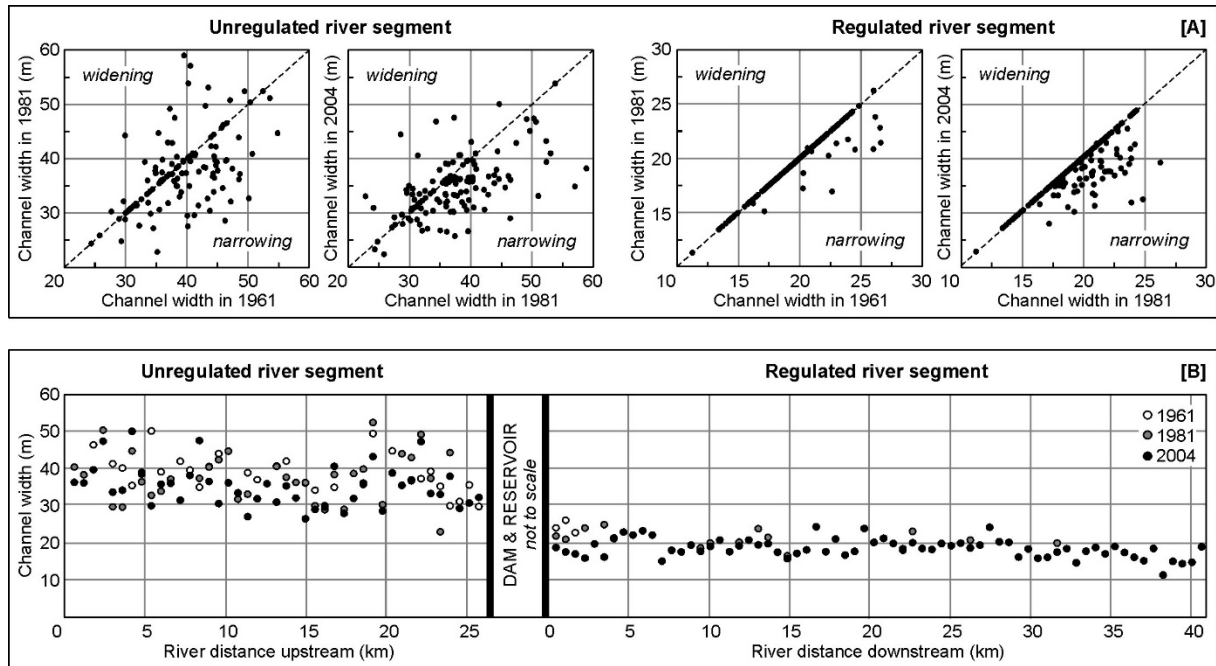
307
 308 Fig. 6. [A] Scatterplots comparing the river channel width between consecutive time steps,
 309 and [B] river channel width as a function of time and distance downstream. Channel width
 310 was calculated as a function of channel area divided by 200-m length along each river
 311 segment. The hashed central line in [A] indicates a situation of no change between
 312 consecutive time steps. Data in [B] were reduced to improve readability (1 point every 600 m
 313 of channel length). The error margin for an exceedance probability of 10% is 4.8 m.

284 Upstream from the dam, coupled channel widening and narrowing occurred during both
 285 comparative periods with a tendency to narrowing during the second comparative period (Fig.
 286 6). Width changes occurred most likely in river sections exhibiting active lateral migration.
 287 Thus, many channel sections narrowed owing to lateral accretion and outward migration of

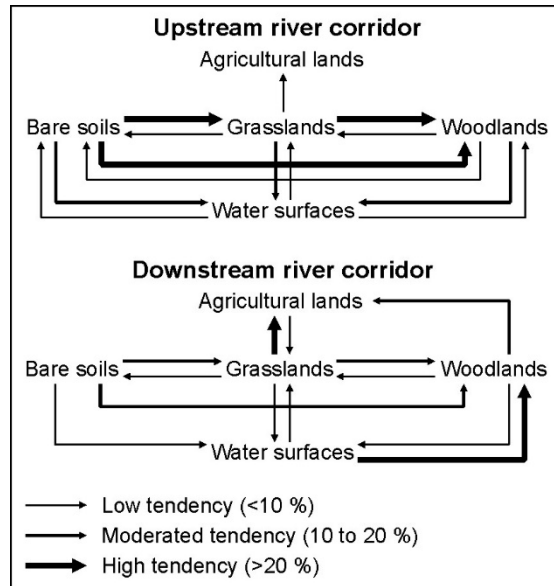
340
 341 Fig. 7. Trends in vegetation dynamics within the river corridors upstream and downstream
 342 from the Paso de las Piedras Dam. Trends were calculated from transitional diagrams of
 343 landscape units by comparative period.

330 Second, the river corridors upstream and downstream from the dam revealed contrasting
 331 trends in vegetation dynamics (Fig. 7). Other than the expansion of agricultural lands over
 332 grasslands (583% between 1961 and 2004; Table 2), the most important transitions
 333 downstream occurred from water surfaces to woodlands (38%). This suggests a tendency for
 334 woody vegetation establishment within the river channel, near to the water surface. A
 335 moderated tendency for woody vegetation growth over former bare banks (18%) and

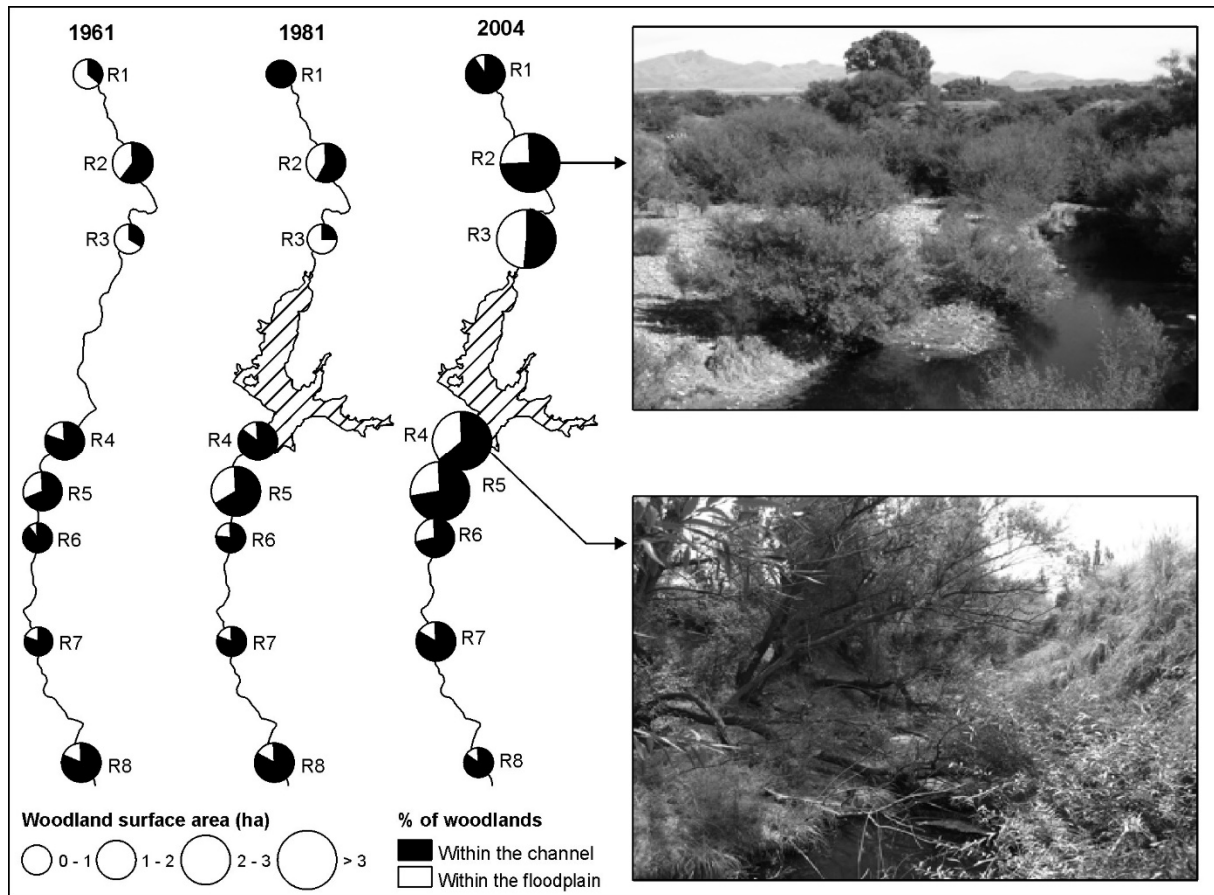
355 Fig. 8. Surface area occupied by woodlands by river reach (R) and time step. Pie charts
 356 differentiate percentages of woody vegetation developing within the river channel and the
 357 floodplain. Photos provide an example of vegetation encroachment within the channel
 358 upstream and downstream from the dam.

344 Third, woody vegetation establishment within the river corridor downstream from the dam
 345 was discontinuous, decreased in the downstream direction, and constrained almost exclusively
 346 to the river channel. Analysis at the scale of the reference reaches (Fig. 8) revealed three
 347 distinct patterns of woody vegetation establishment with distance from dam closure: (i)
 348 immediately downstream from the dam and over ~10 river km, woody vegetation develops
 349 within the channel and adjacent to the water surface forming extensive and continuous
 350 alignments (e.g., R4 and R5); (ii) downstream thereafter, woody vegetation develops in a
 351 narrow and discontinuous strip along the stream over ~20 river km (e.g., R6 and R7); (iii)
 352 downstream from river km 30, channel vegetation is dominated by grasslands and alternating
 353 alignments of young willows developing near the water surface (e.g., R8).

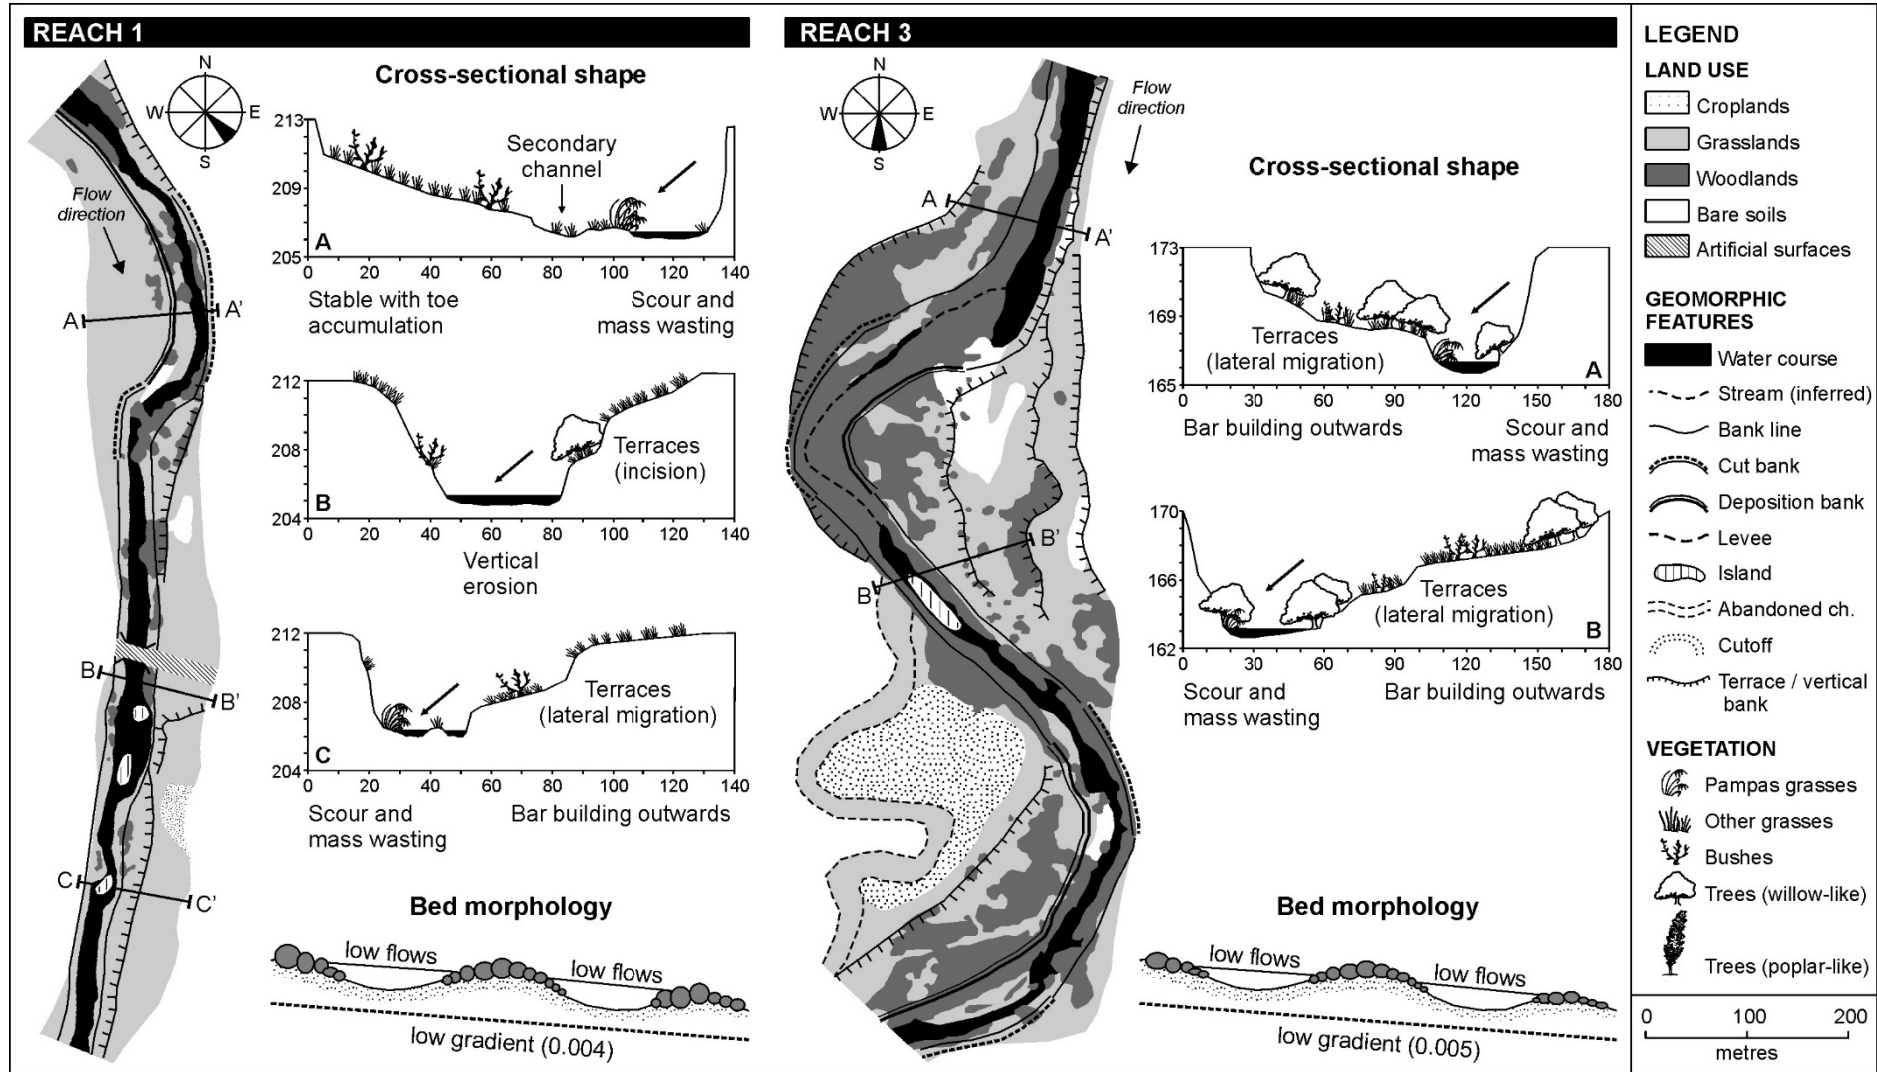
Fig. 9. Geomorphic features, land cover types, and representative cross sections for two reference reaches located upstream from the Paso de las Piedras Dam. The locations of the reference reaches along the unregulated river segment upstream are shown in Fig. 1.

362 The river channel above the dam (Fig. 9) is broad and shallow ($27 < w:d < 37$), and the

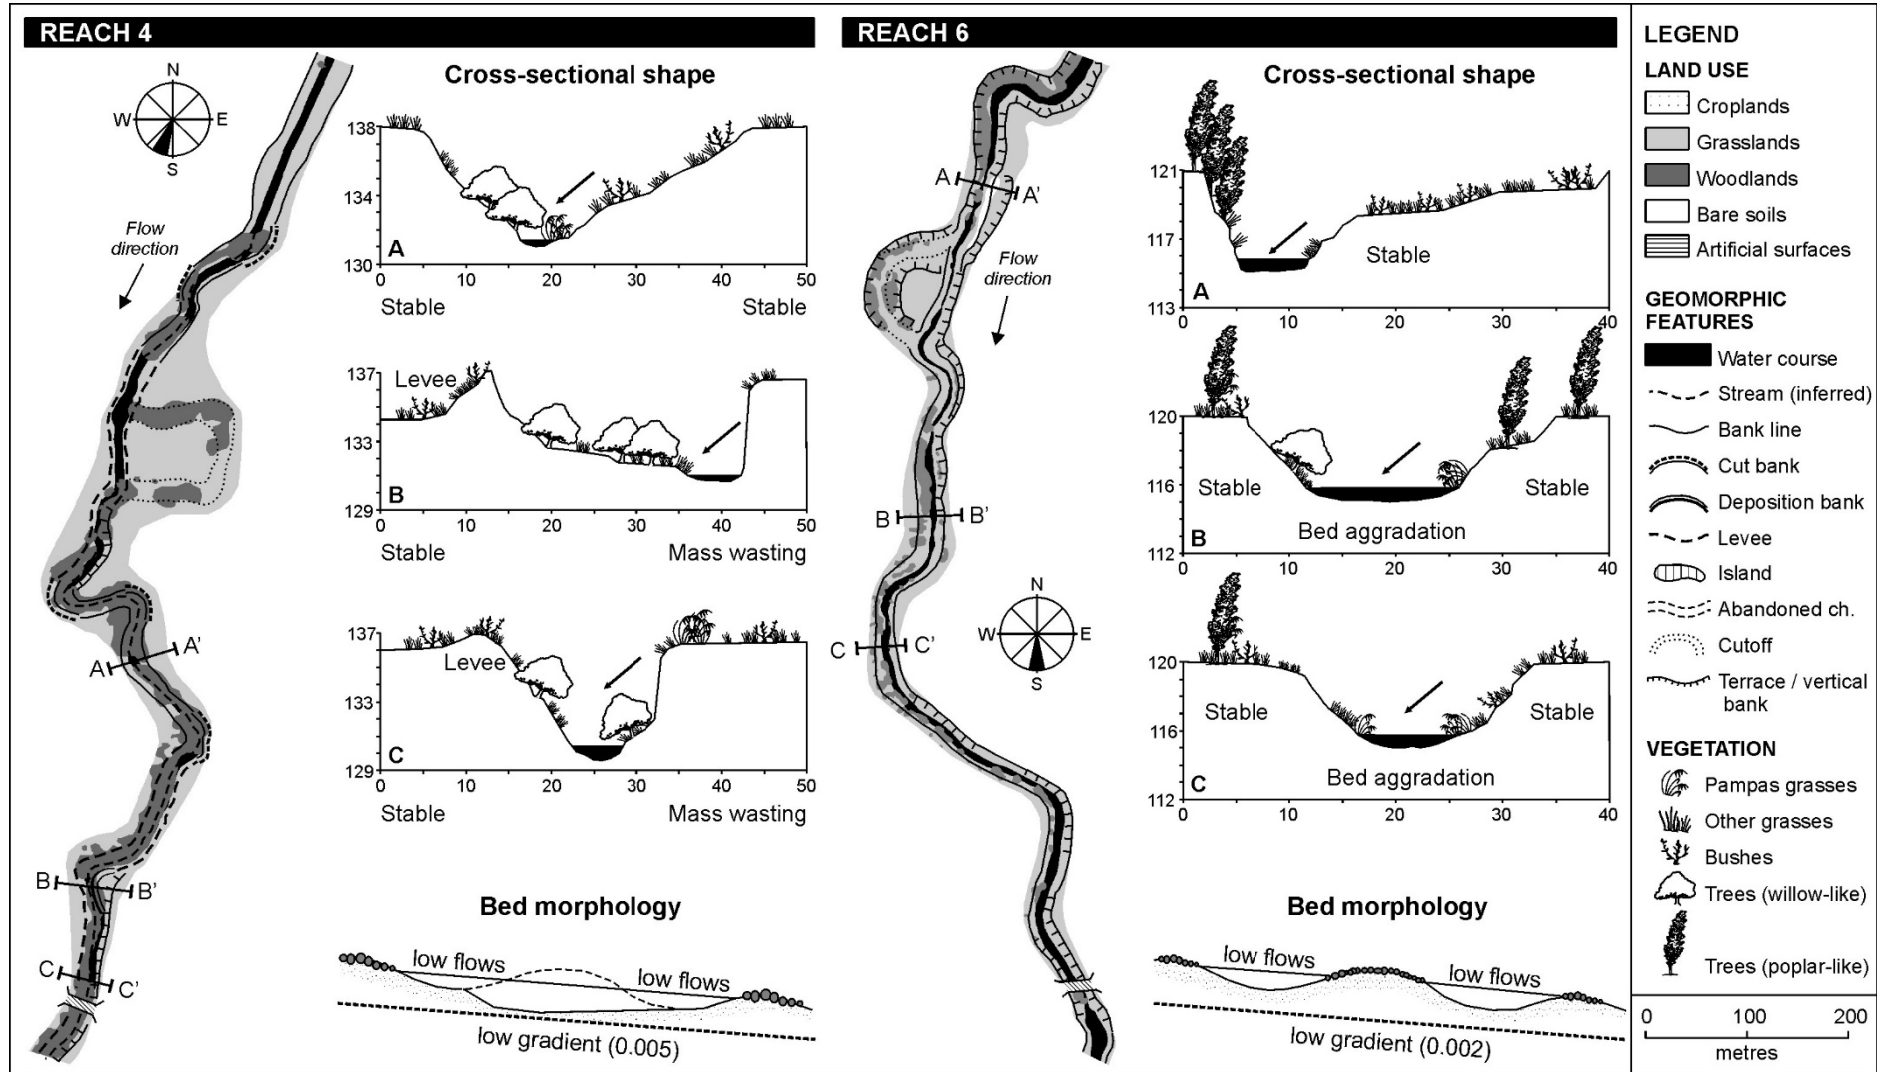
Fig. 10. Geomorphic features, land cover types, and representative cross sections for two reference reaches located downstream from the Paso de las Piedras Dam. The locations of the reference reaches along the regulated river segment downstream are shown in Fig. 1.

376 The river channel below the dam is narrow and deep ($7 < w:d < 10$), and the floodplain is
377 much reduced (Fig. 10). Mean channel width is 21 m (± 6 m), and mean floodplain width is 53
378 m (± 30 m). Except for R5 where meanders are very tortuous ($S = 2.8$), sinuosity increases in
379 the downstream direction from 1.3 to 2.2. Bed material is composed of small gravel in riffles
380 and of silt/clay in pools; banks exhibit cohesive layers of fine 'spring' and ephemeral fluvial-
381 aeolian deposits. Bank profiles display stable conditions for most river reaches, except for R4
382 where mass wasting occurs in vertical banks with little vegetation cover. Immediately below
383 the dam, any evidence of channel activity is related to human intervention. For example,
384 artificial bed deepening in R4 facilitates evacuation of dam outlets and spills, and artificial
385 levees (built by dredging floodplain material) prevent bank overflowing. Outside the vicinity

386 of the impoundment, bed deposition of very fine materials (silt/clay and organic matter) leads
387 to localized reduction of the channel depth (e.g., R6; Fig. 10).

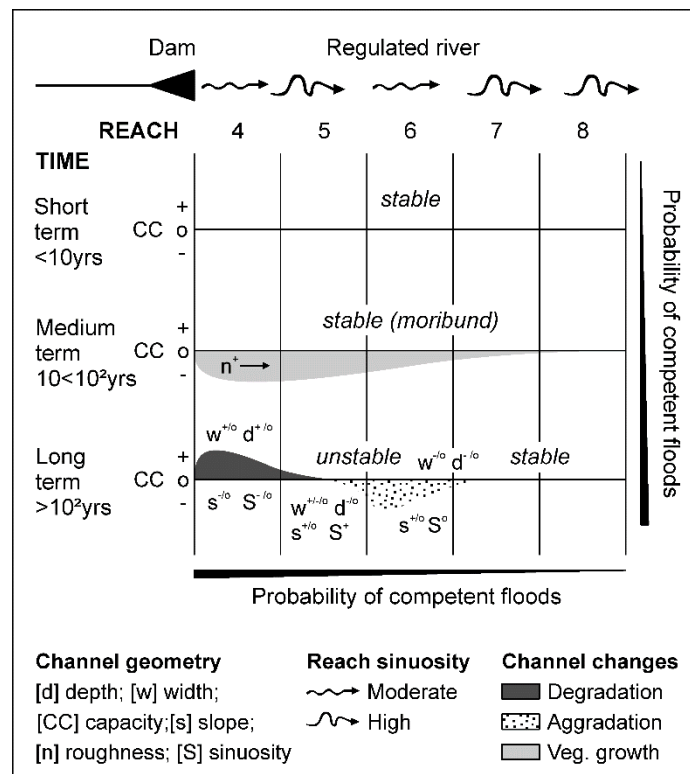
561 Fig. 11. Adjustment of the channel morphology to extreme flow regulation below water-
 562 storage reservoirs in drylands. The model of adjustment (modified from Petts, 1979) considers

563 the potential for change relative to the frequency and intensity of competent floods with time
 564 and distance from dam closure. The direction of change is indicated by [o] no significant
 565 change, [+] increase, and [-] decrease.

558 the frequency and intensity of competent floods with time and distance from dam closure
 559 (Fig. 11).

566 The unregulated Sauce Grande is in a transient, unstable state (sensu Tooth and Nanson,
 567 2000) where complete adjustment of form to process is inhibited until a geomorphically
 568 significant flood event occurs. After impoundment by a large surface-area, water-storage
 569 reservoir such as Paso de las Piedras, competent floods downstream are unlikely. The channel
 570 morphology will not change, and downstream flows will simply accommodate within the
 571 existing channel form. As the regulated Sauce Grande receives no major tributaries, the
 572 probability of competent floods decreases with distance downstream and so stability will
 573 prevail throughout all reaches (Fig. 11).

600 Yet a geomorphically significant flood is likely to occur with time (Fig. 11). If so, degradation
601 may occur immediately below the dam (reach 4) increasing channel depth and width.

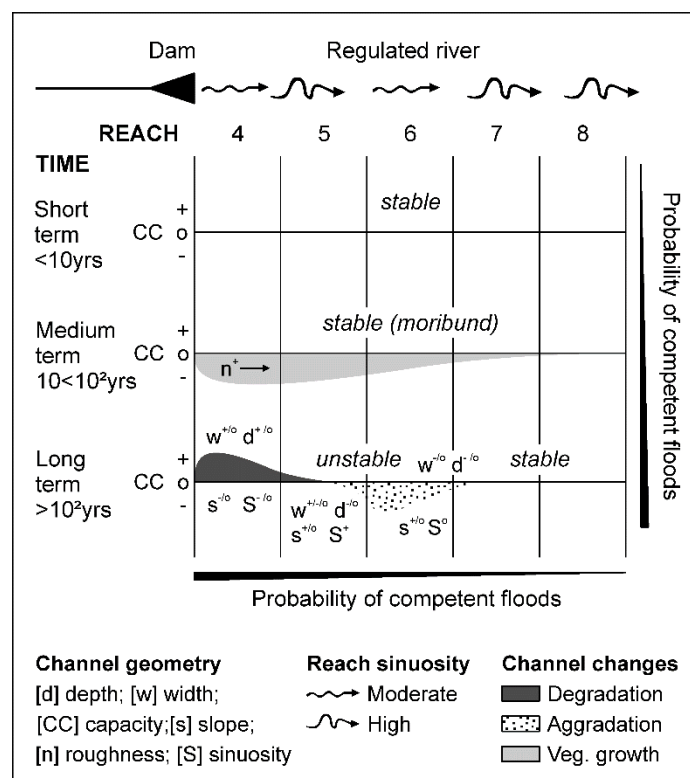
575 Fig. 11. Adjustment of the channel morphology to extreme flow regulation below water-
 576 storage reservoirs in drylands. The model of adjustment (modified from Petts, 1979) considers
 577 the potential for change relative to the frequency and intensity of competent floods with time
