Geomorphic changes induced by the April-May 2015 earthquake sequence in the Pharak-Khumbu area (Nepal)

Monique Fort

Monique Fort. Geomorphic changes induced by the April-May 2015 earthquake sequence in the Pharak-Khumbu area (Nepal). EGU General Assembly 2016, Apr 2016, Vienna, Austria. 2014. hal-01373222

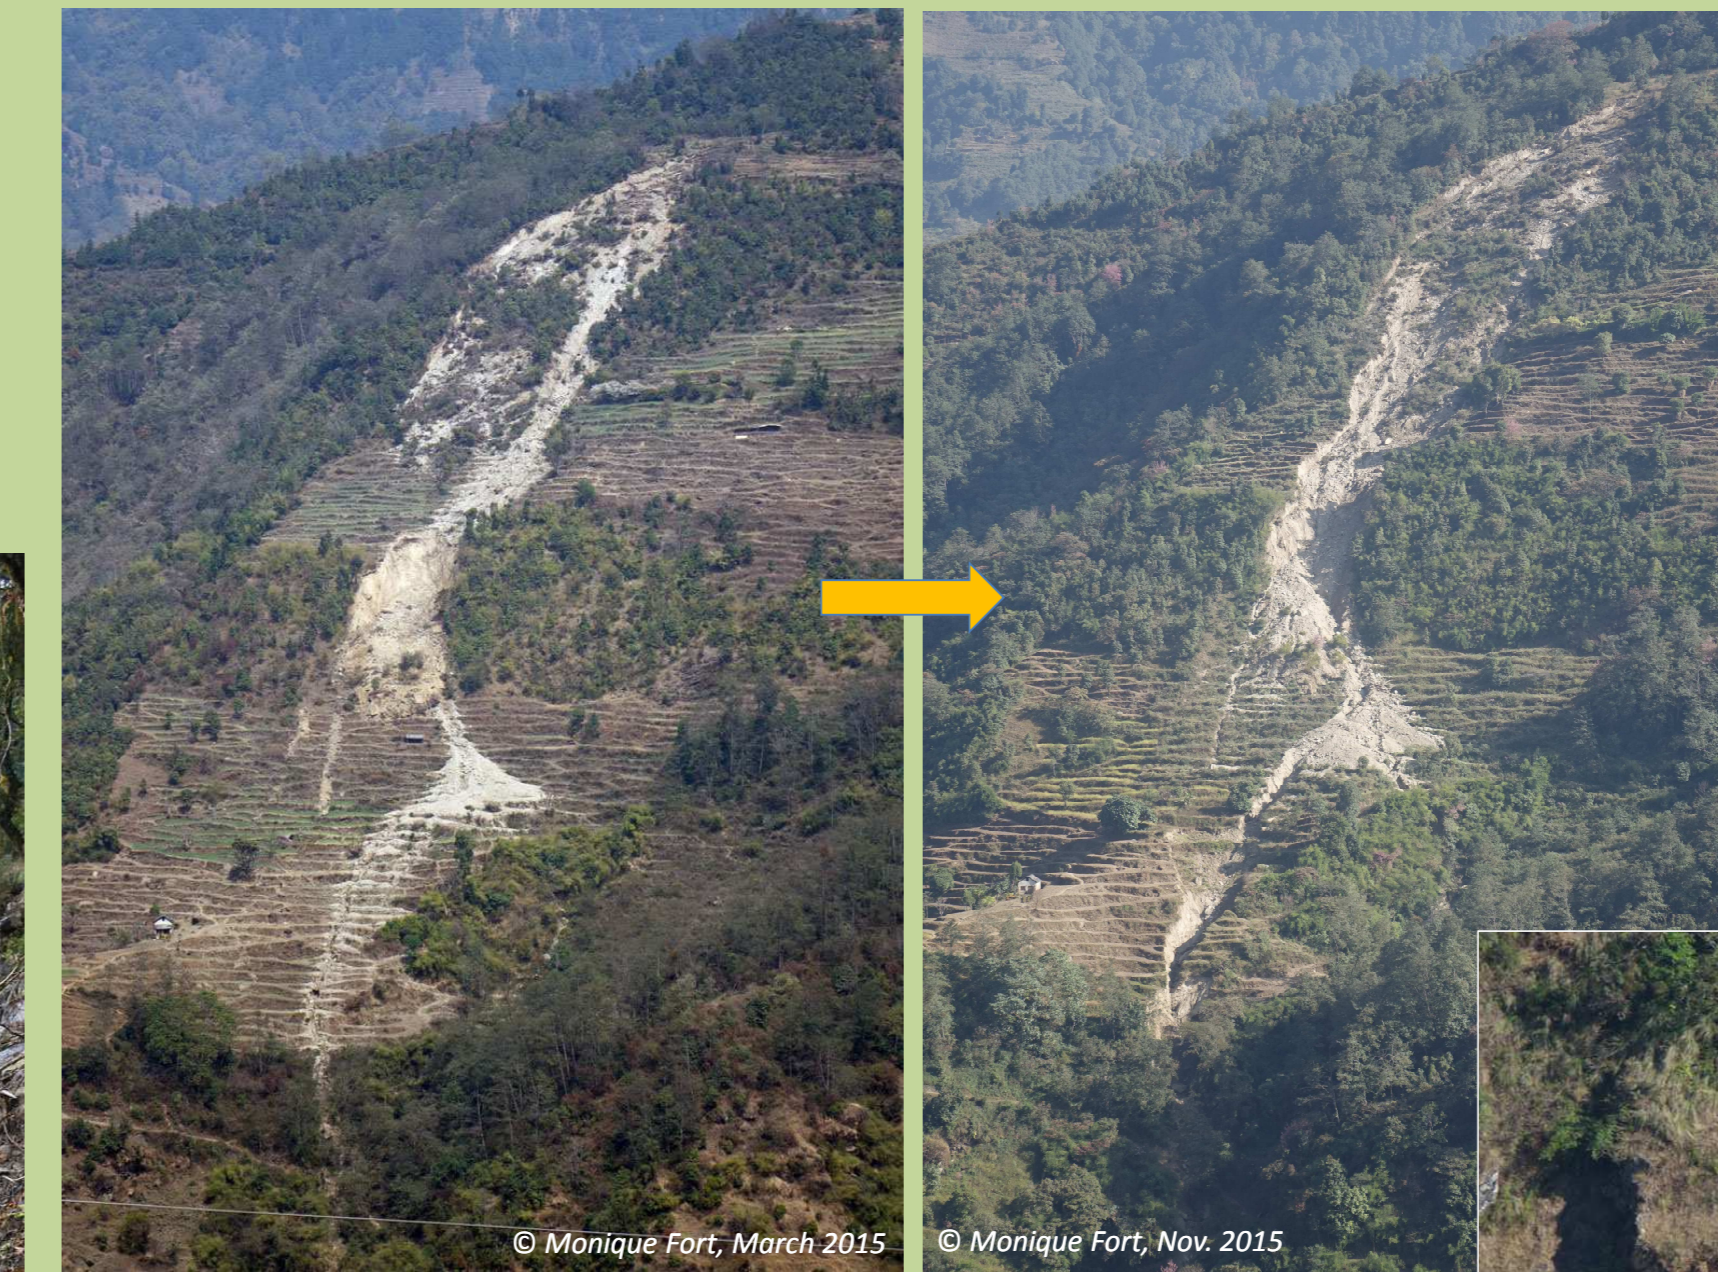
Near Paya (left), slope collapse was controlled by the talweg. Older, very coarse debris were removed, destroyed the foot trail and filled in the talweg.

The second control factor - **lithology** - also appears significant: weak fractured bedrock supplied rock falls (upper Khari khola catchment), whereas superficial deposits (alluvial, lacustrine, and colluvial soils, including landslide failure material) favoured larger failures (Paya, Cheubas), particularly because of the **proximity of the deeply incised stream network** (third control factor).

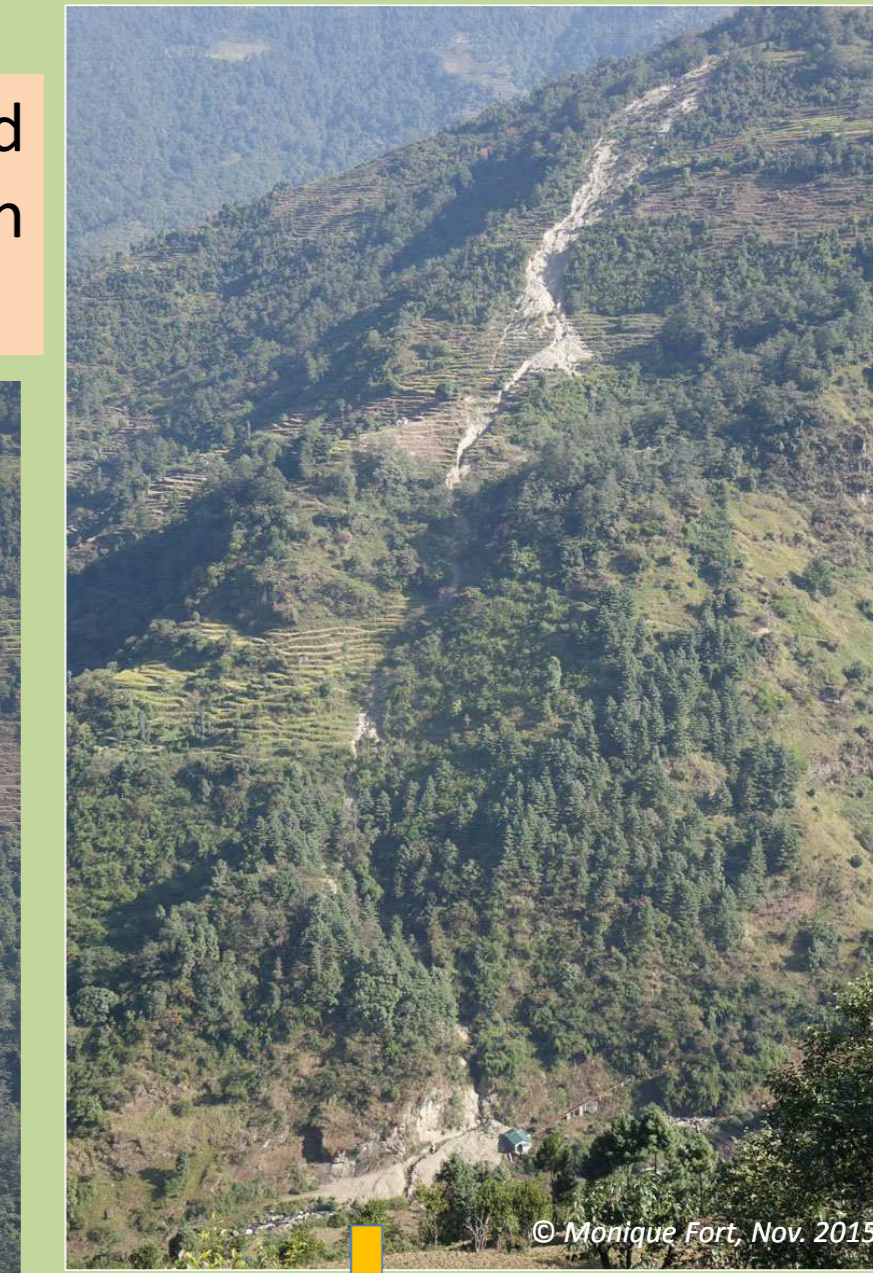
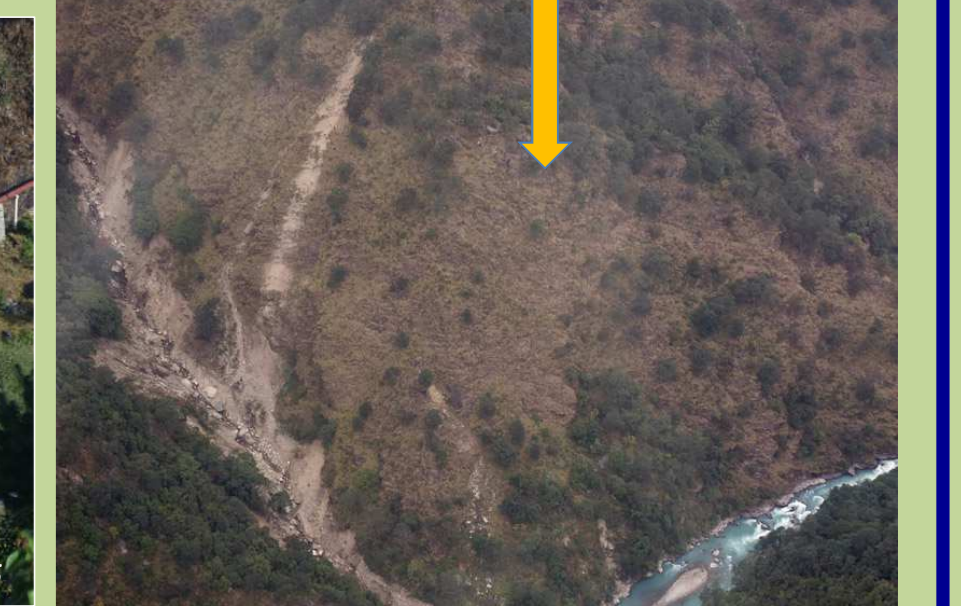
Cascading processes often result in temporary valley damming, as observed upstream of Jubing (right) and near Bupsa (above), with the new hydropower station damaged).

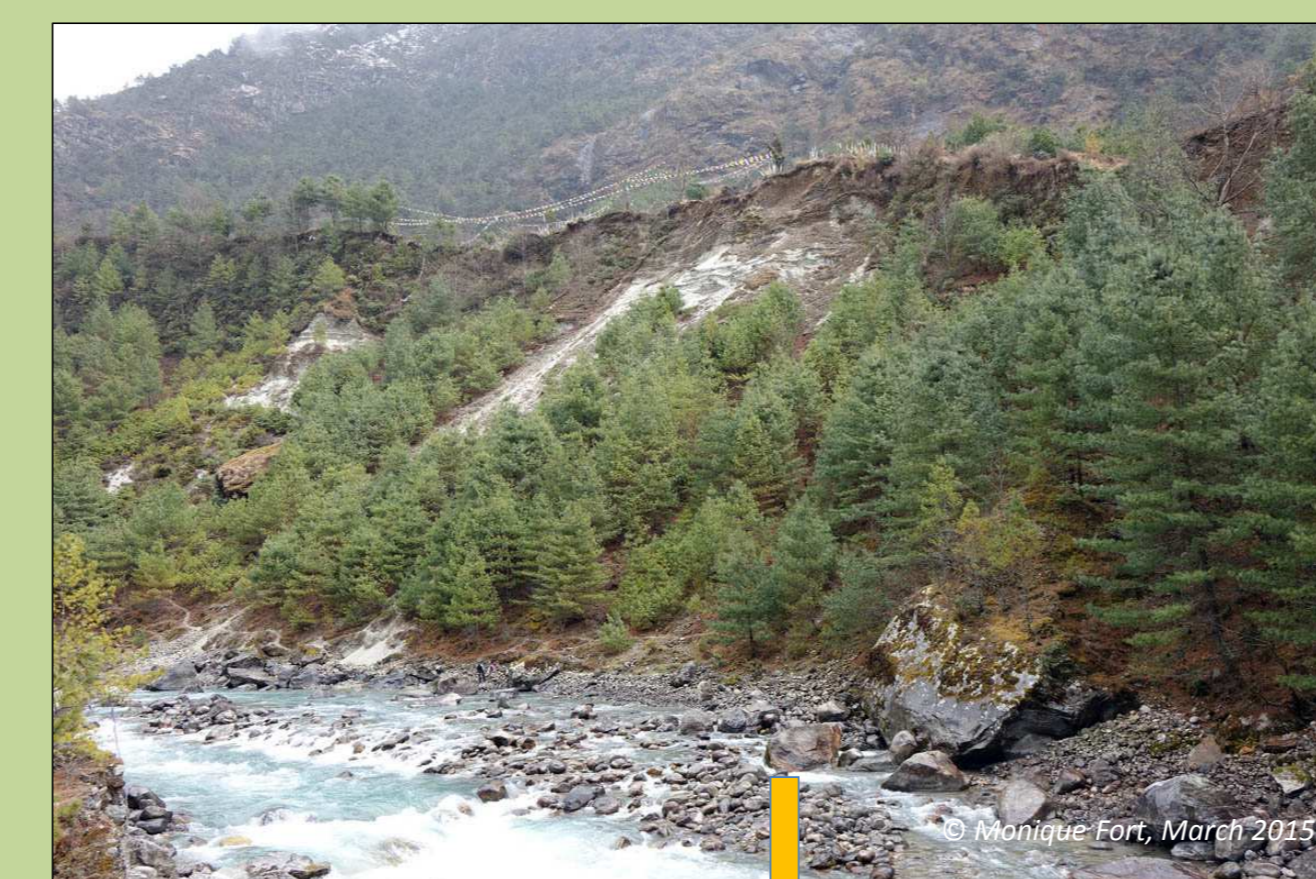
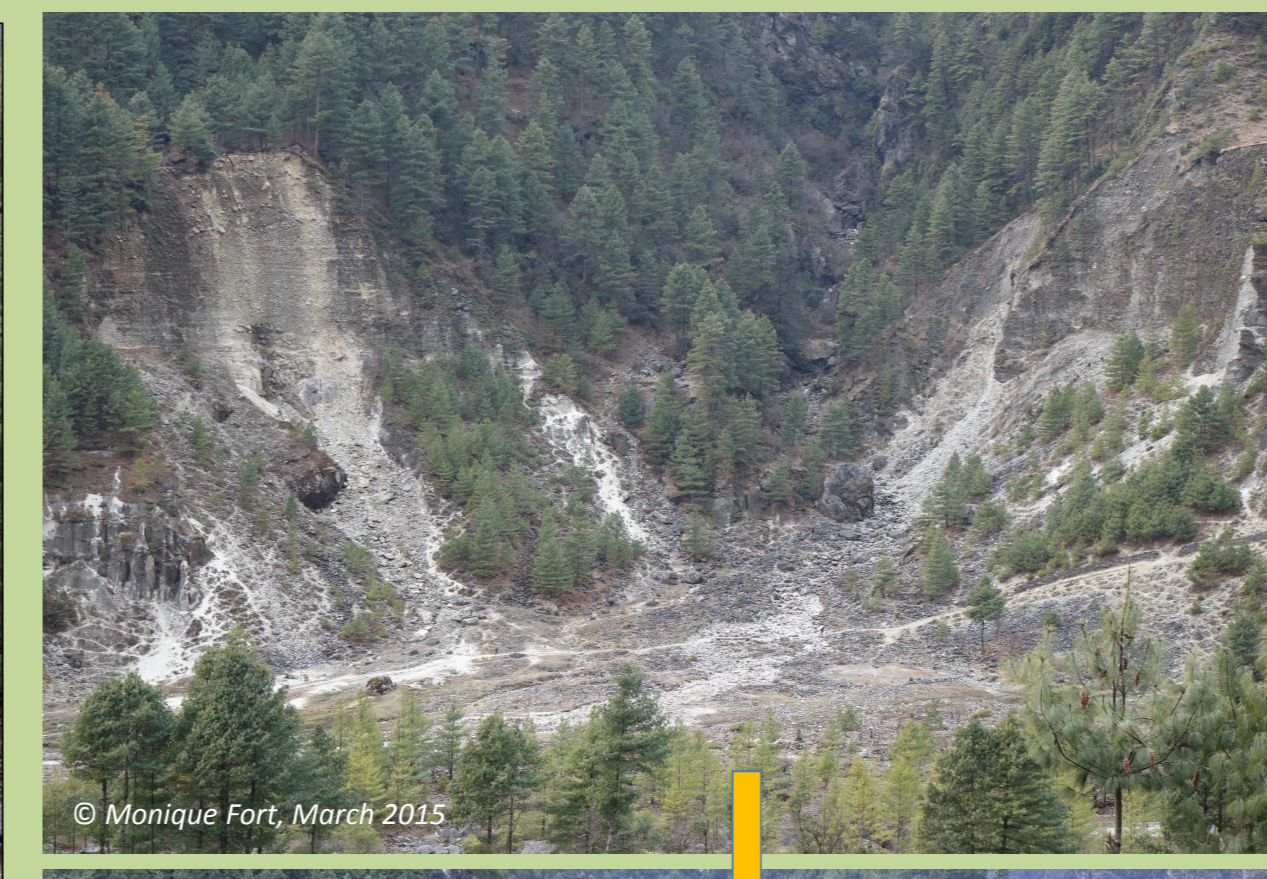
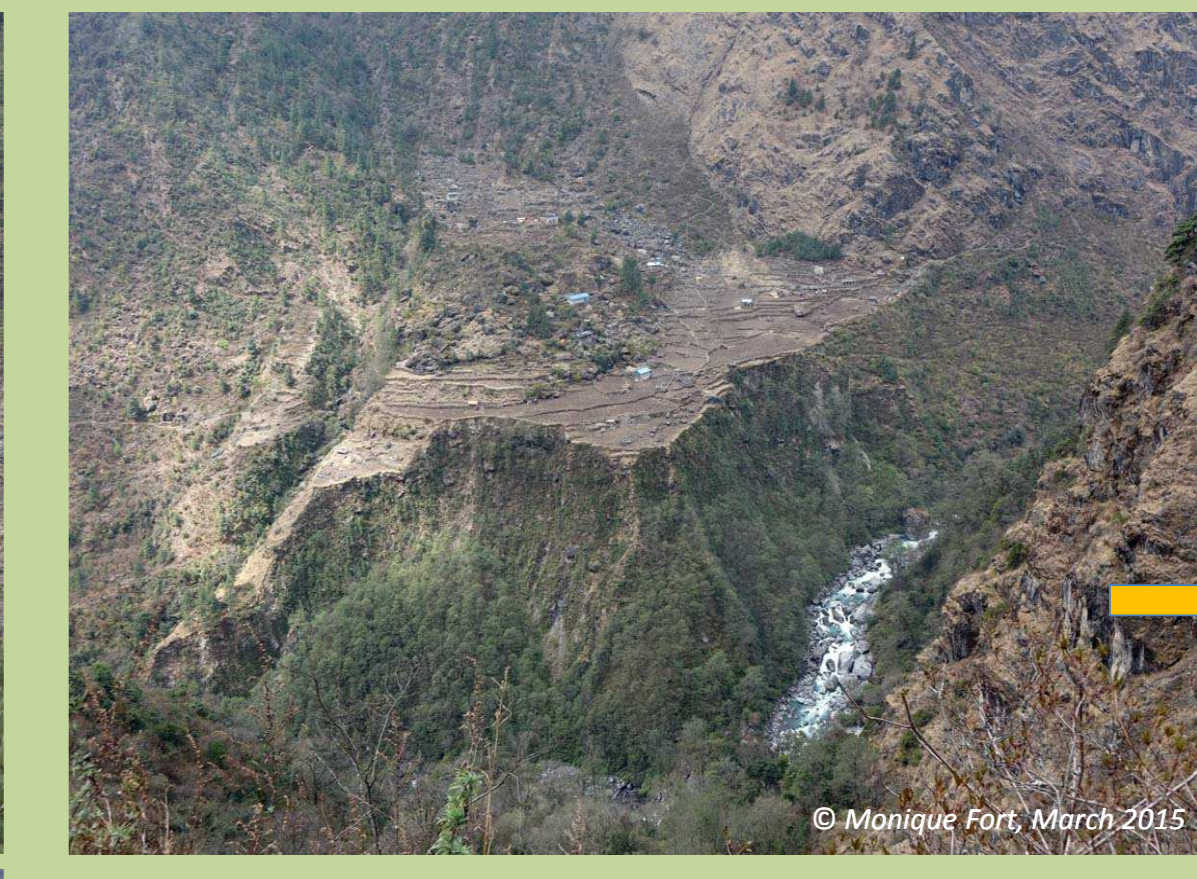
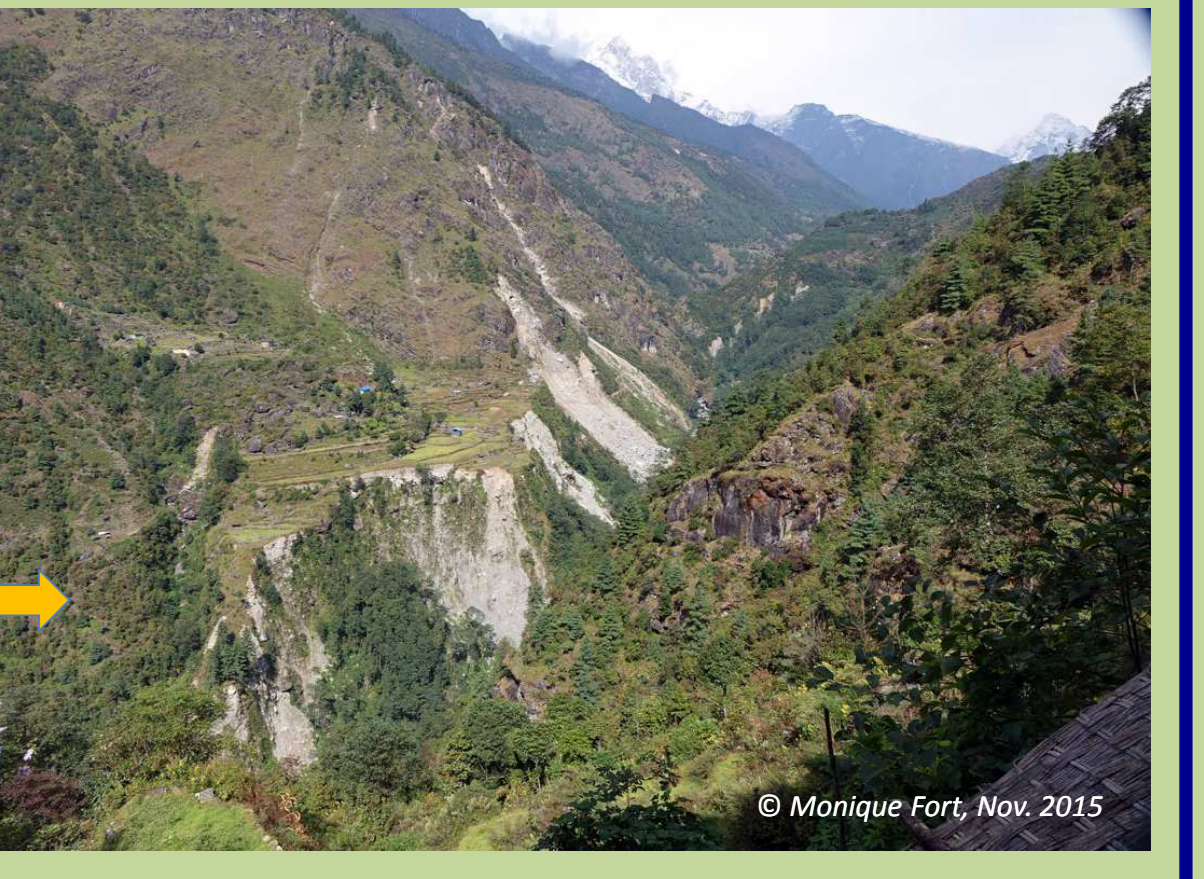
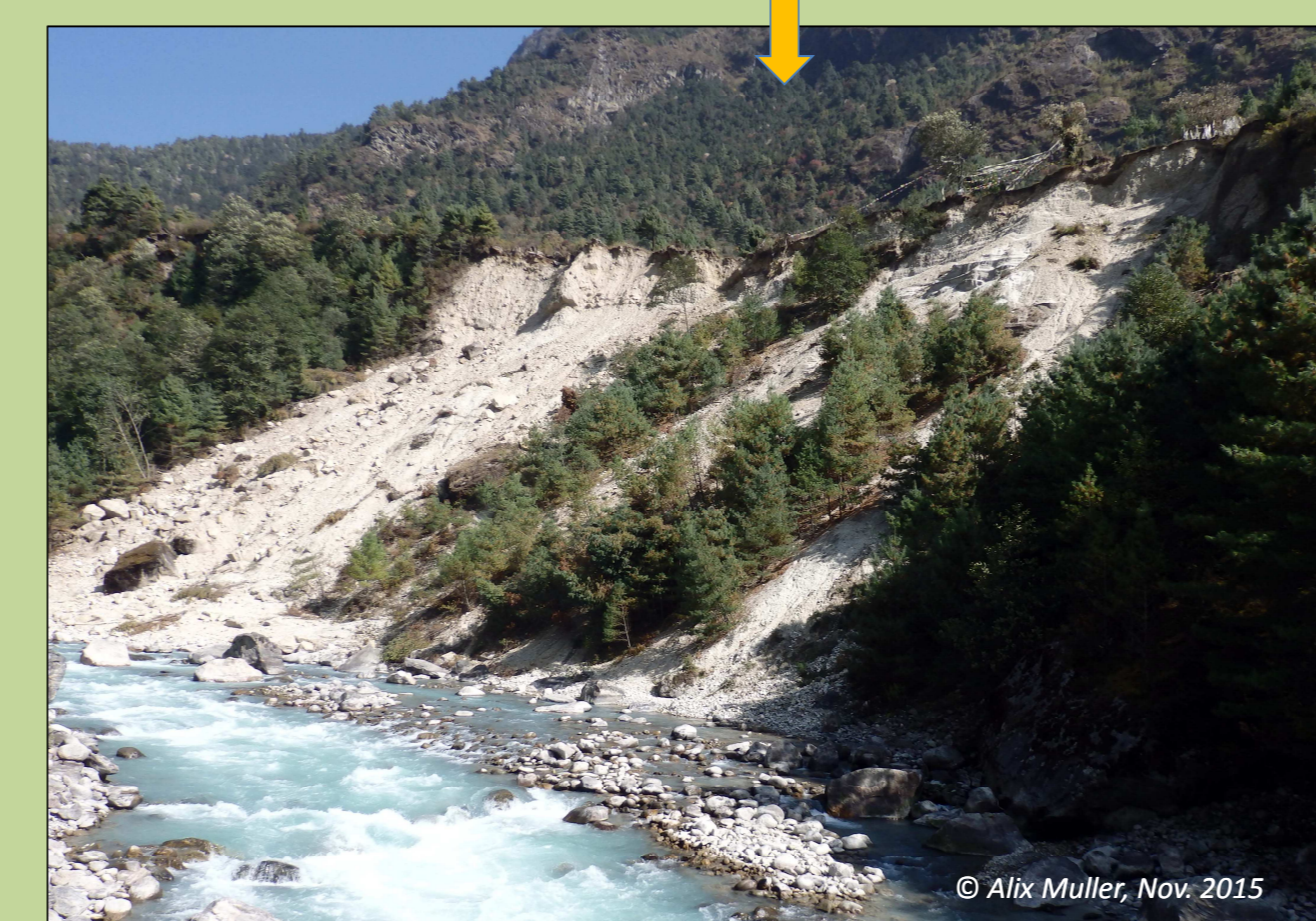
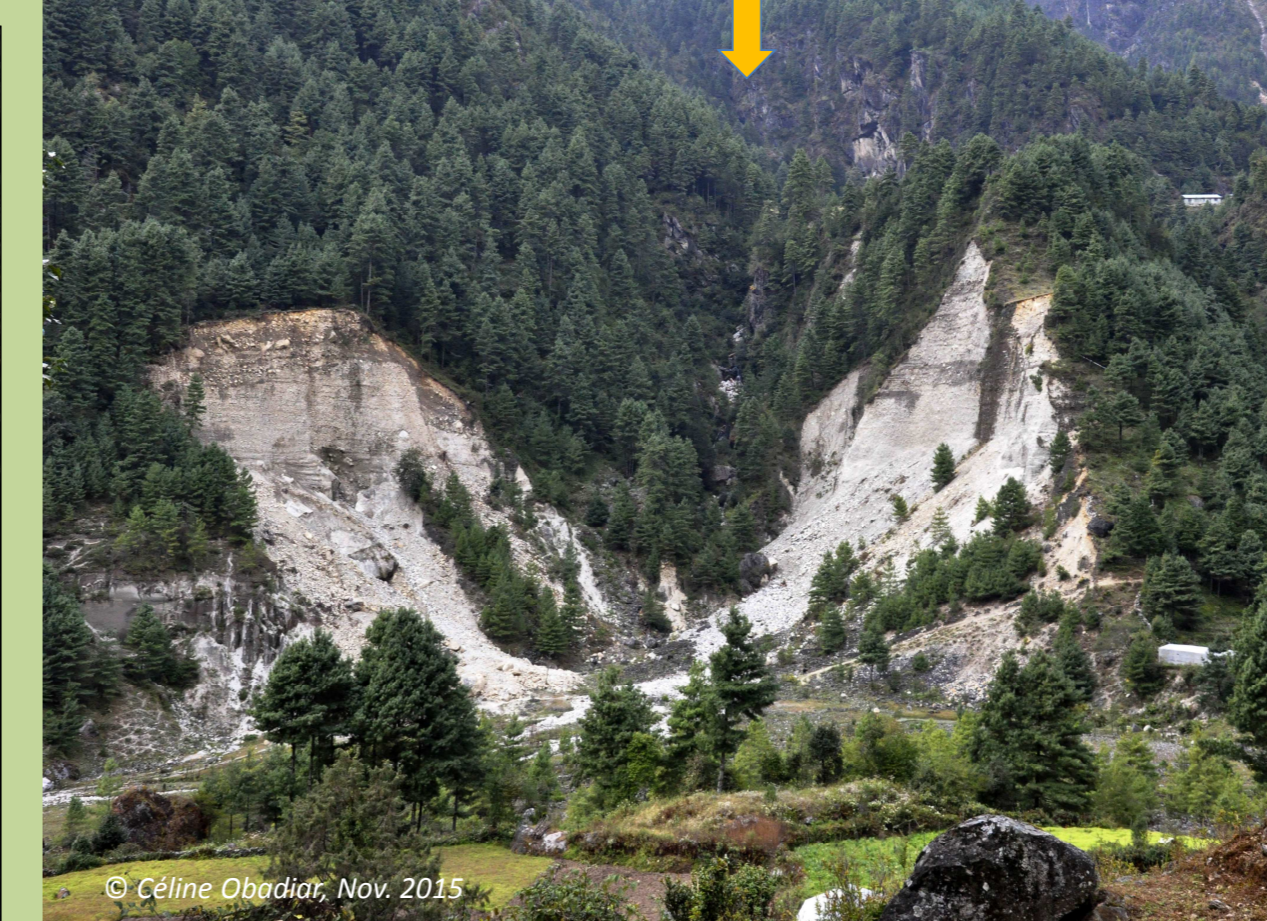
Nakchun (above and right) was very affected. The former debris-alluvial terrace was severely eroded along the Dudh Kosi side. The village remained isolated for several months, due to the rockfalls and debris slides which developed along the the right bank of the river and destroyed the trail (still very dangerous).
