# Damage from the april-may 2015 gorkha earthquake sequence in the Solukhumbu district (Everest region), Nepal

David R. Lageson, Monique Fort, Roshan Raj Bhattarai, Mary Hubbard

# DAMAGE FROM THE APRIL-MAY 2015 GORKHA EARTHQUAKE SEQUENCE IN THE SOLUKHUMBU DISTRICT (EVEREST REGION), NEPAL

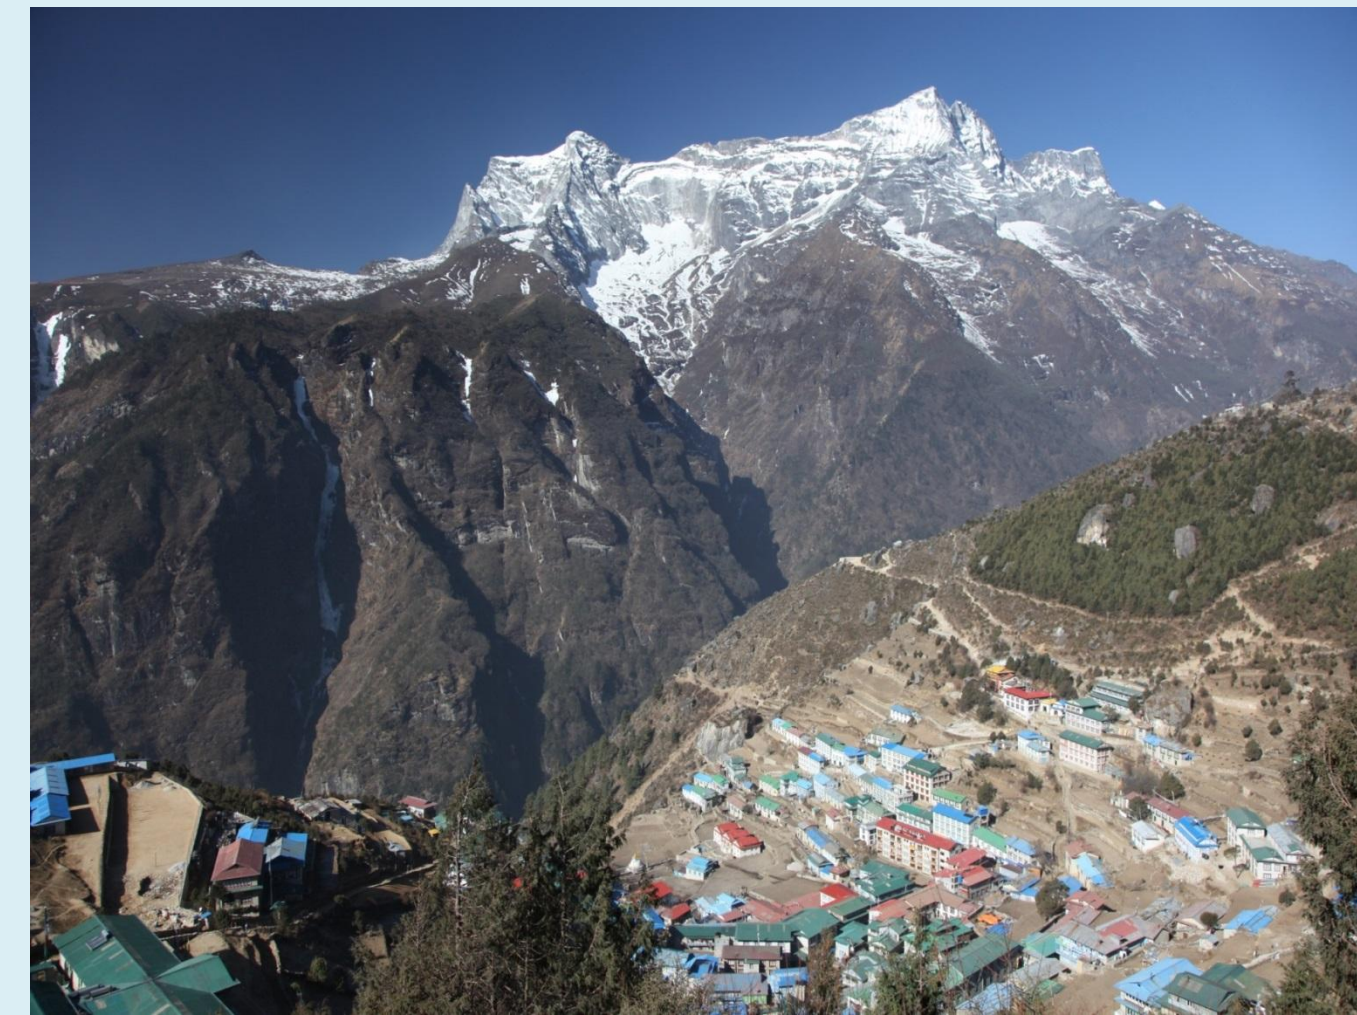
The photo above shows the iconic Sherpa village of Namche Bazaar with Kongde Ri (6,187 m, 20,299 ft) in the back-ground. One of the most dramatic aspects of the geomorphology of the Greater Himalaya in general and the Khumbu specifically is the spectacular convexity of deeply incised river valleys. Valley profiles are steepest (nearly vertical) right above river channels, but gradually “lay-back” at higher elevations. This gives the impression that erosion is barely keeping up with tectonic uplift. Also note extreme gradients of tributary “channels” (most are avalanche chutes) above the Bhoté Koshi River cut into bedrock below Namche Bazaar.

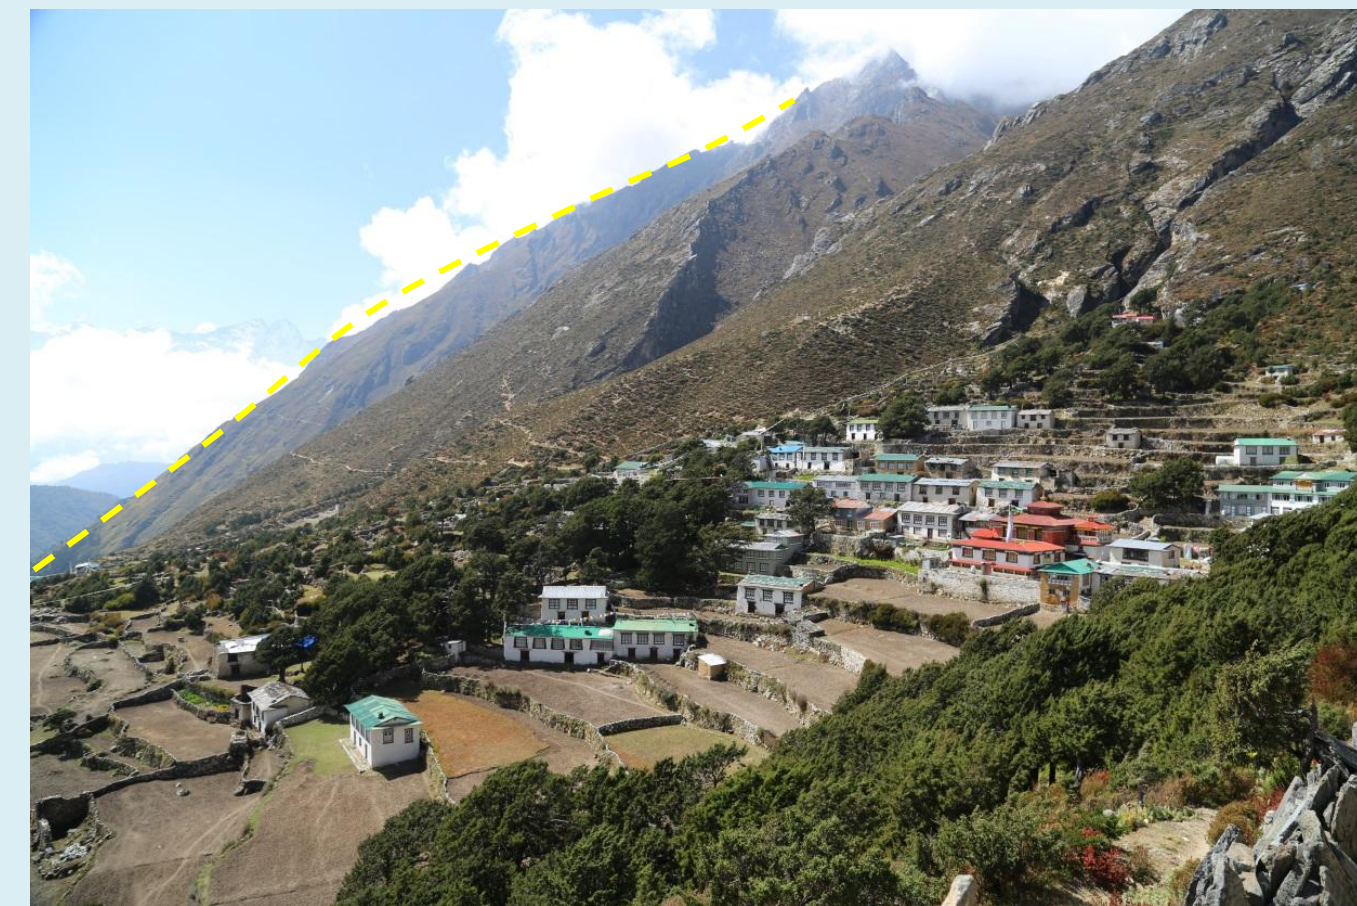
View looking southward over the village of upper Pangboche at steep east-dipping metamorphic foliation in the Namche orthogneiss which controls valley profile convexity in this area. Valley profile convexity is most apparent in distant profiles.

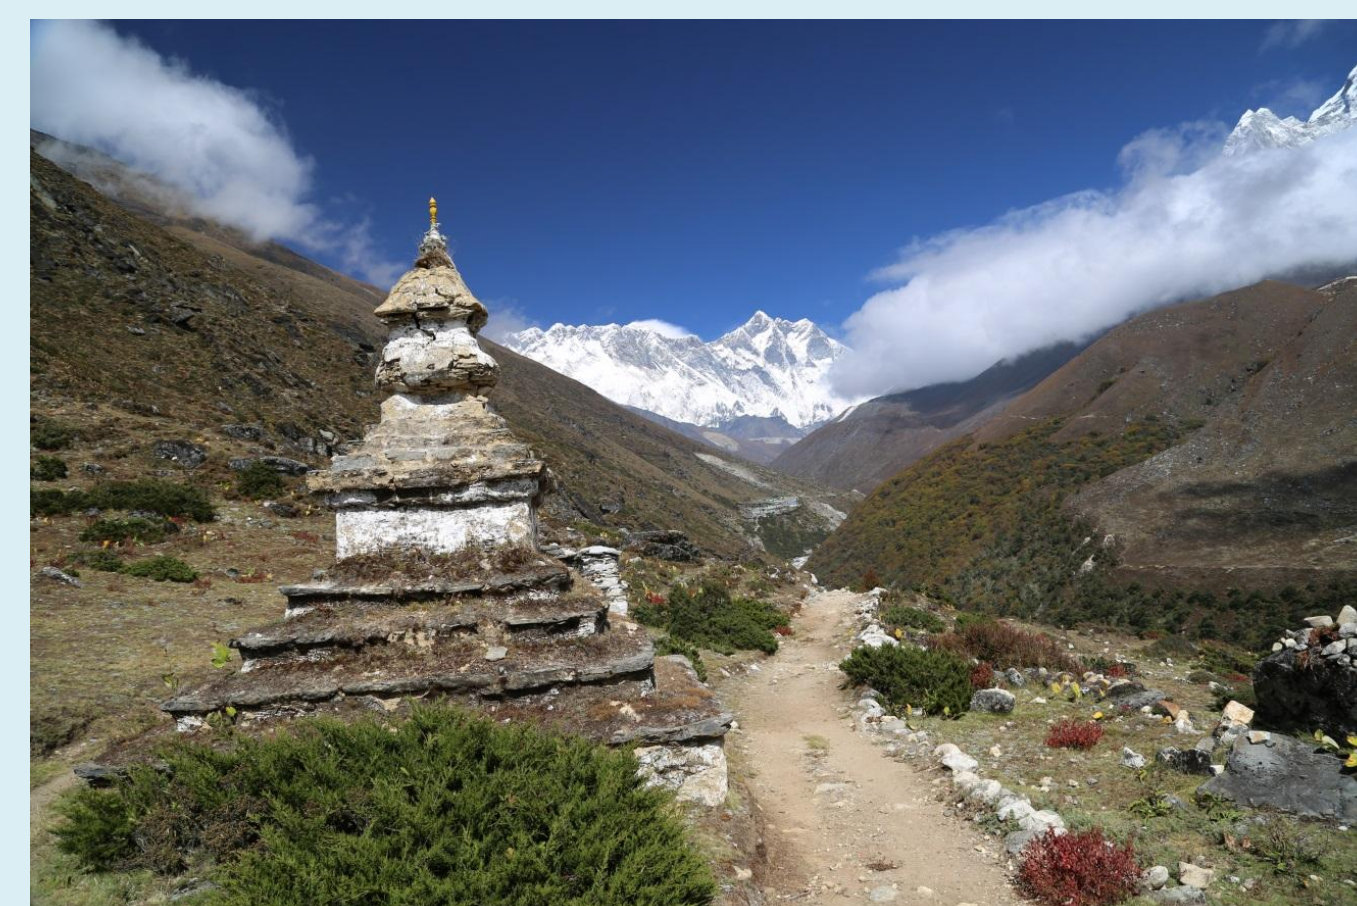
Valley profile convexity dramatically lessens north of Phortse where the effects of alpine glaciation have modified the landscape. Nevertheless, extreme hazards associated with ground shaking exist, including rock falls, glacial outburst floods (GLOFs), avalanches from perched glaciers, and failure of steep glacial moraine deposits, to name a few. This photo shows the Everest massif, with Nuptse, Everest and Lhotse (left-to-right) in the distance, with the Imja Khola River in the channel.

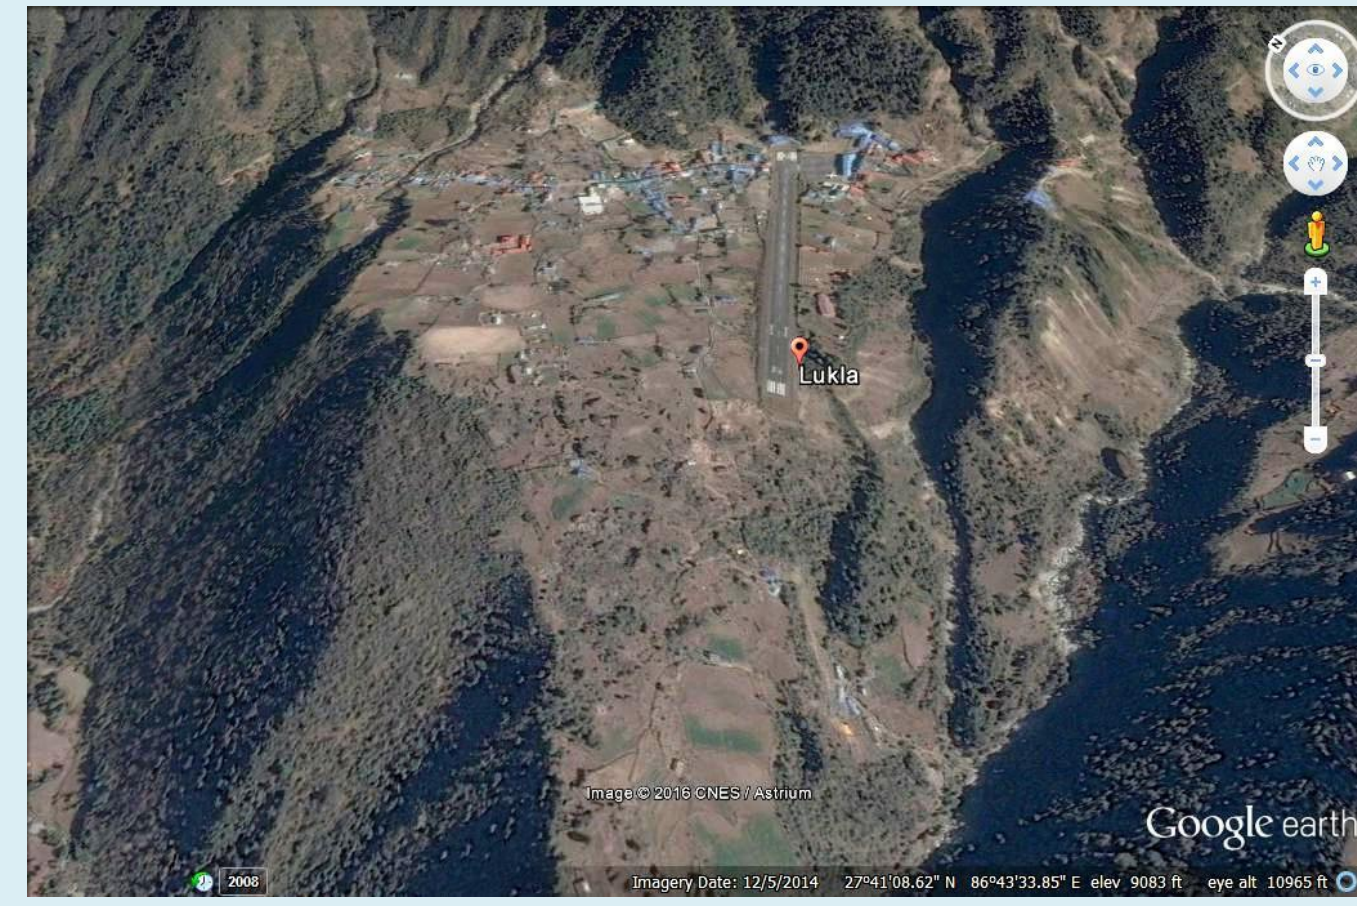
Evidence of past compound landslides and slump deposits, some massive, are common along the flanks of the Dudh Koshi River north of Lukla. The bench on which Lukla is built is riddled with enormous angular boulders adjacent to the Hillary landing strip; this large landslide likely dammed the Dudh Koshi River (Götz et al., 2015).

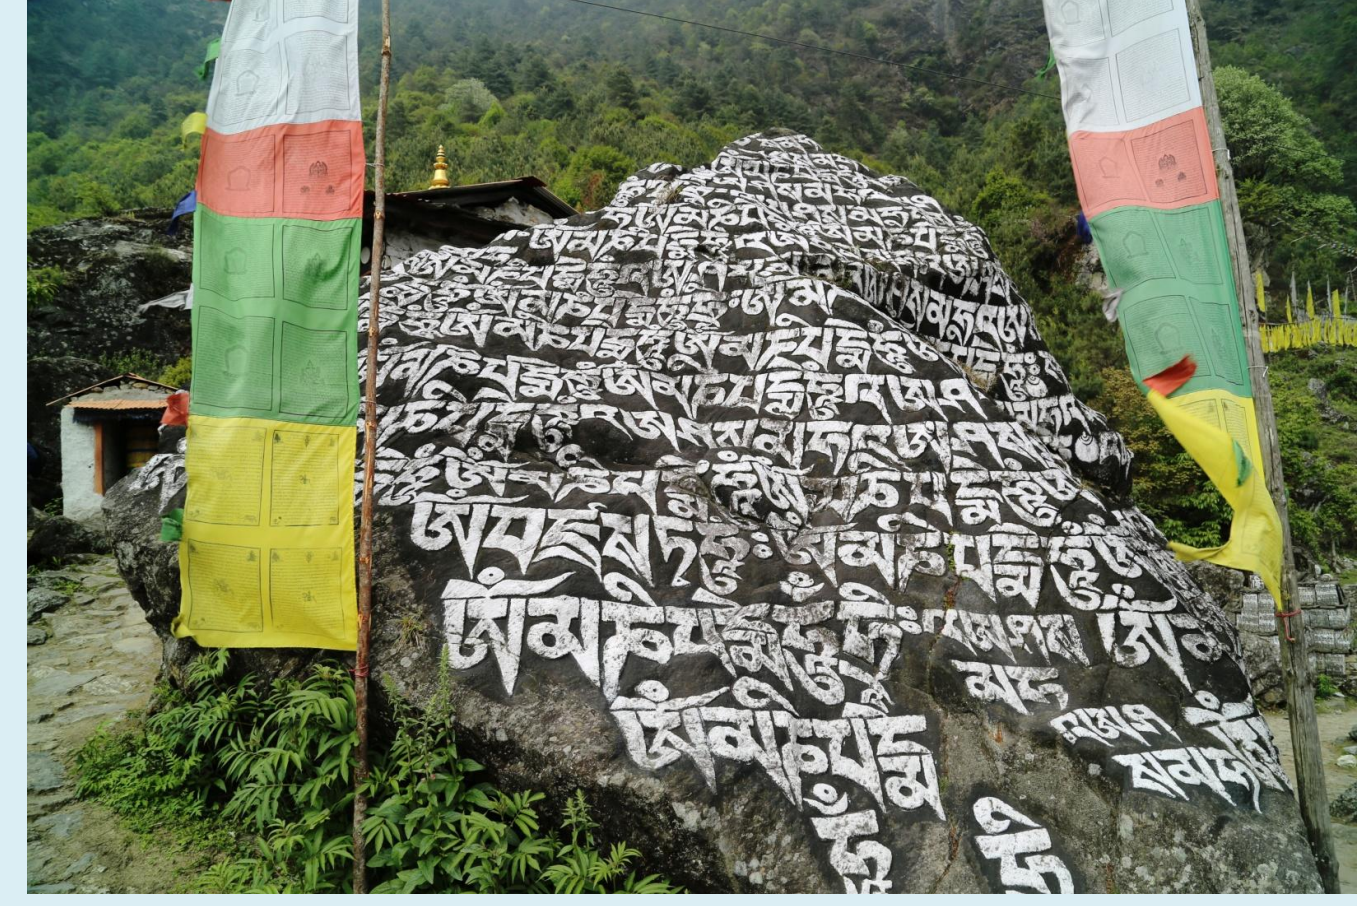
This boulder (photo above) lies along the main trekking trail that passes through Ghat, the many painted mani stones at Ghat are debris from a massive paleo-landslide. Unconsolidated, hummocky and often water-saturated deposits like this form a poor substrate for field-stone buildings when earthquakes strike. Other villages that are constructed on unconsolidated landslide debris, perched high above adjacent rivers, include Khumjung and Namche Bazaar.

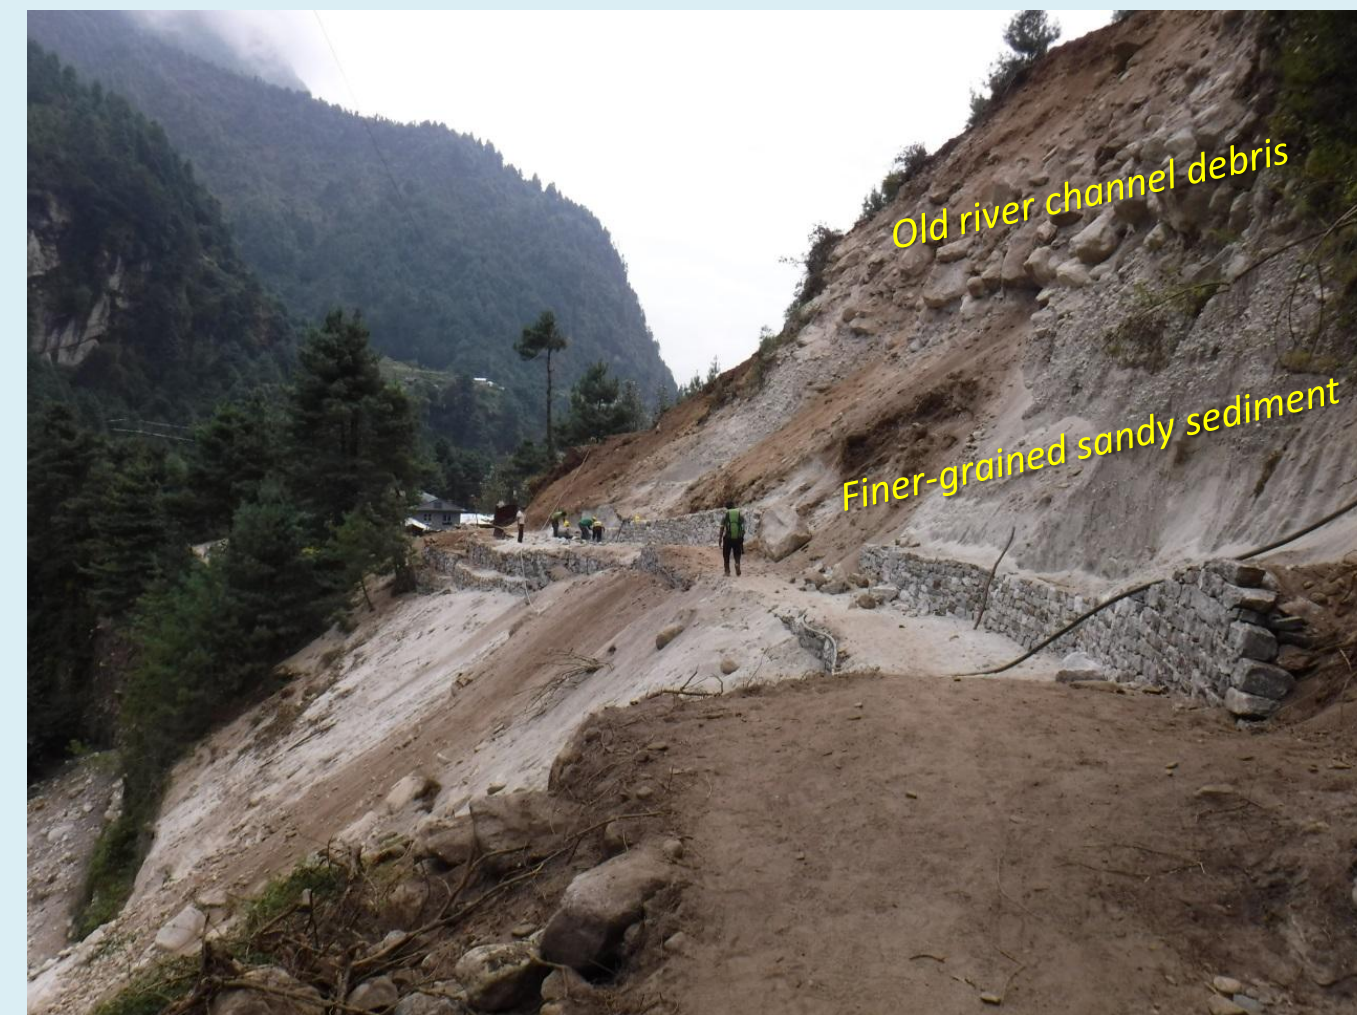
Large earthquake-induced landslide on the west flank of the Dudh Koshi River immediately north of Phakding above the Dudh Koshi River. Workers have started rebuilding the trail across the slide-path (Oct. 2015), despite obvious unstable perched boulders above. The unconsolidated and heterogeneous nature of the coarsely-stratified sediment is obvious.

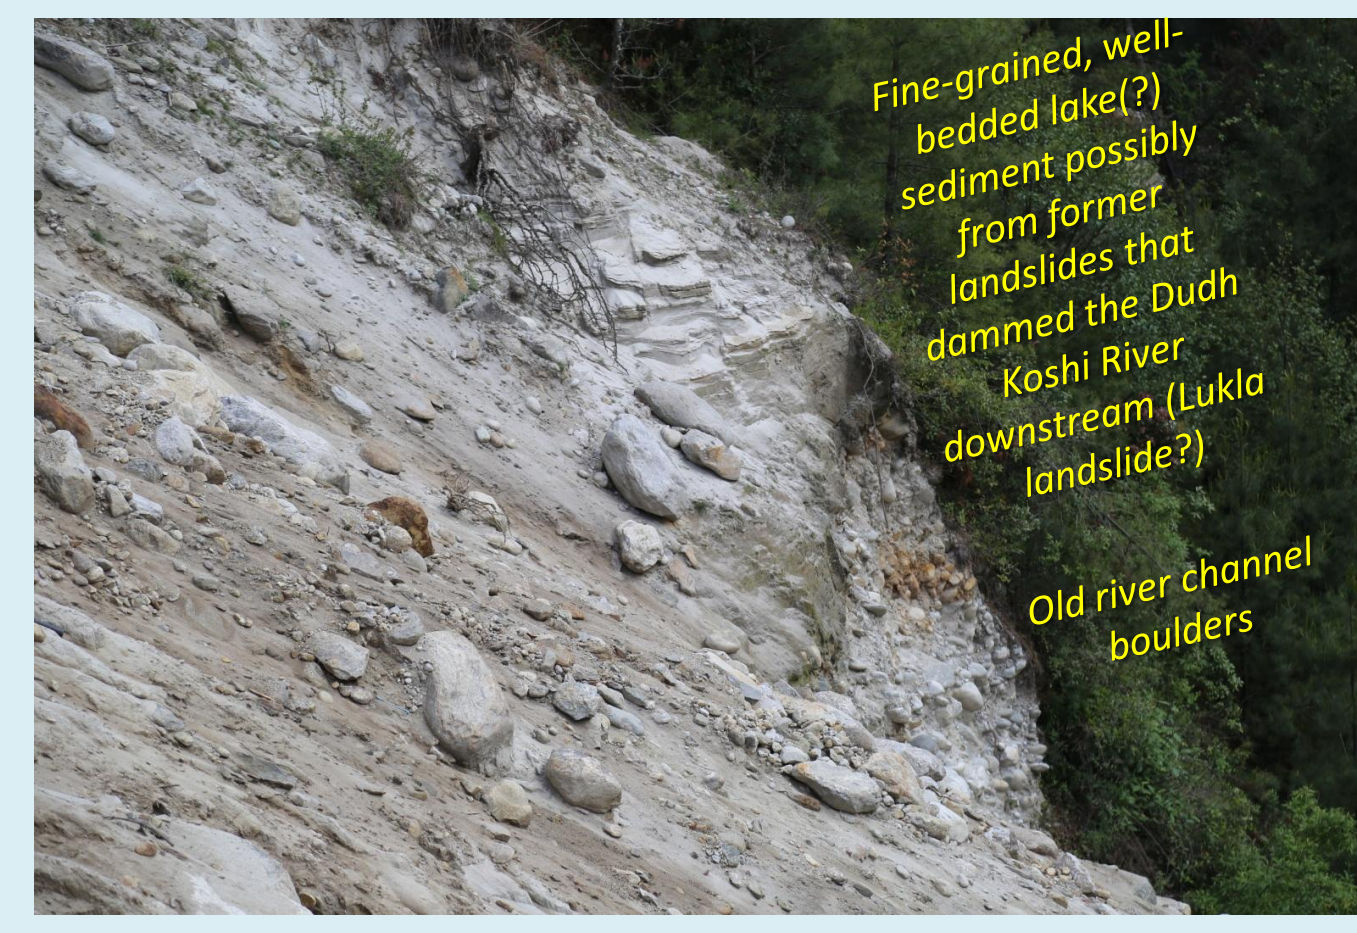
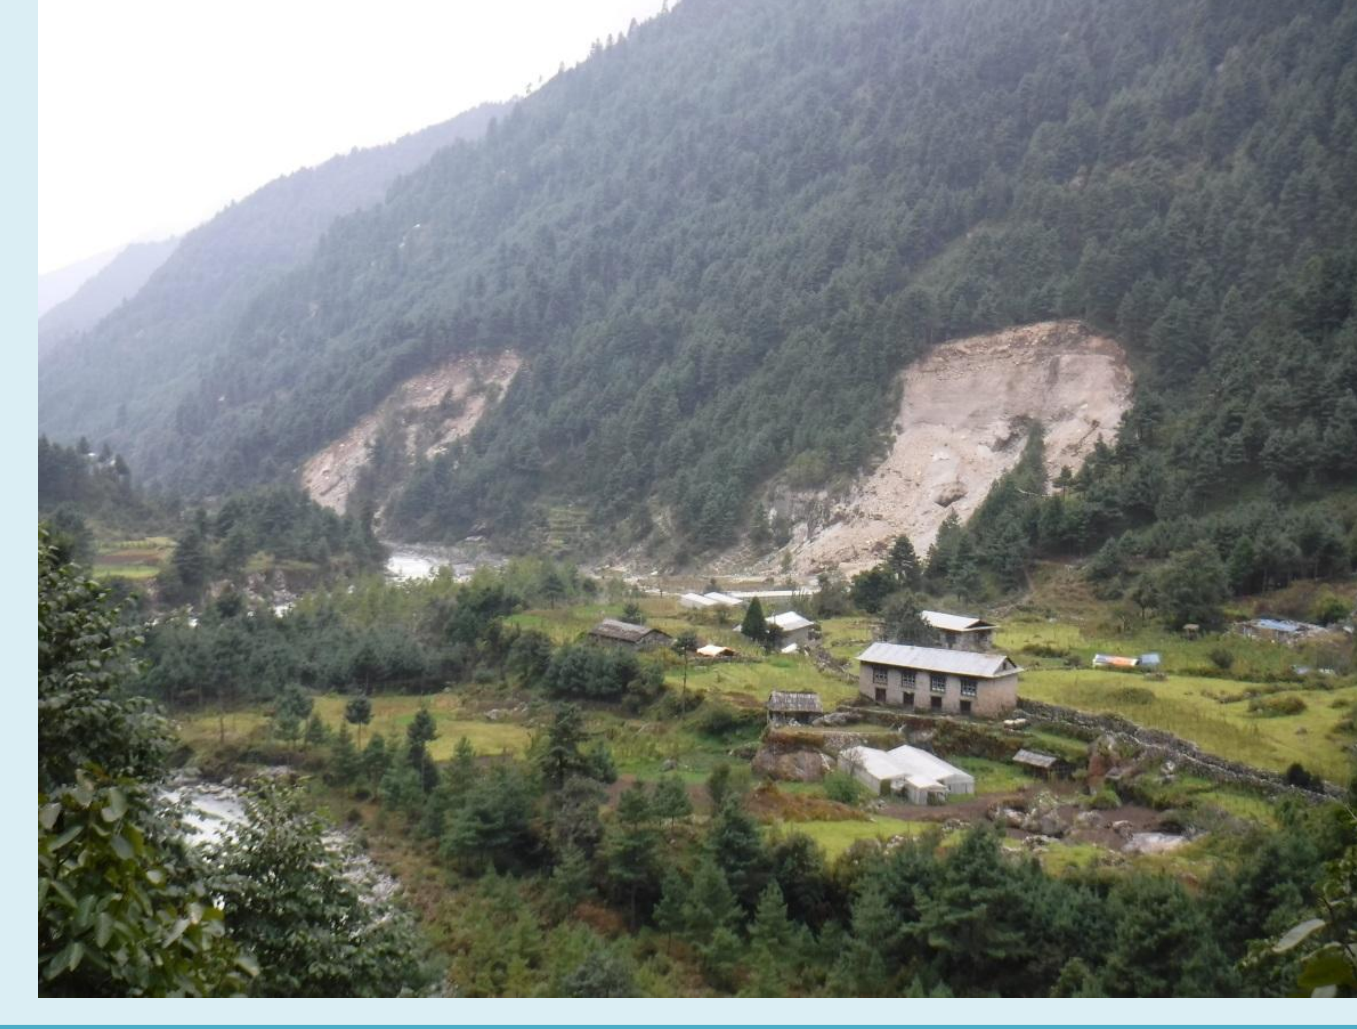
ABOVE: Lower portion of the landslide scar (see photo above) on the west flank of the Dudh Koshi River immediately north of Phakding above the Dudh Koshi River. Heterogeneity of the sediment is a mirror image of that higher up. BELOW: Twin landslides from the 25 April 2015 earthquake in perched unconsolidated sediment of mixed sources along the bridge over the Dudh Koshi River between Ghat and Phakding.

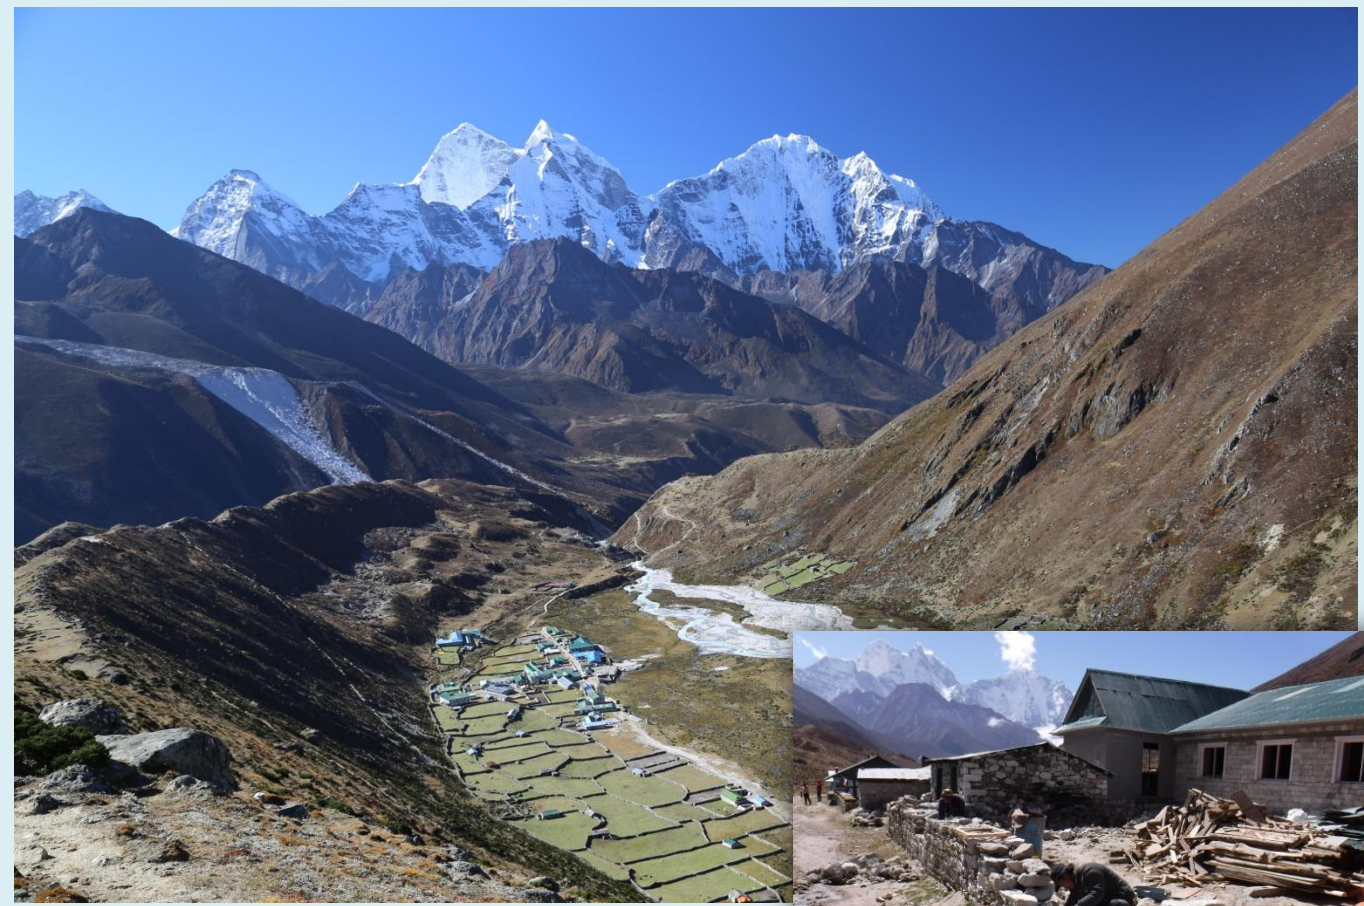
The high Sherpa village of Pheriche is located on a glacial ground moraine surrounded by high lateral moraines. Ground shaking of water-saturated glacial sediment resulted in significant damage (inset photo).

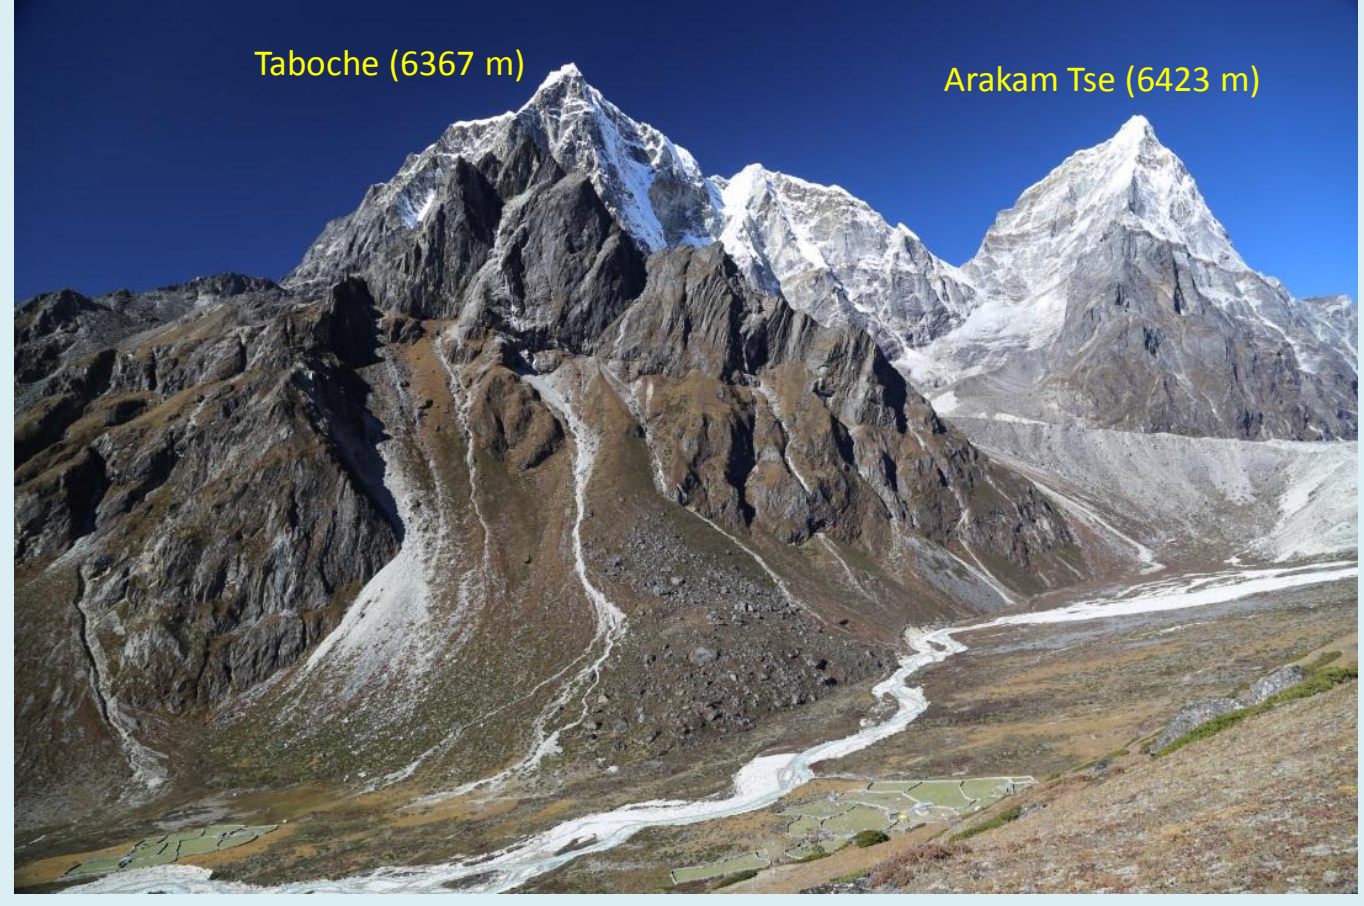
Coalesced coarse talus/scree/alluvial cones at the base of Taboche Peak (6367 m, 20,889 ft.), overlain by a massive rock-avalanche deposit that has been truncated at its toe by the Lobuche Khola River (which drains directly from the Khumbu Glacier at the foot of Mount Everest). Although this deposit was not triggered by the 25 April 2015 Gorkha earthquake, ancient rock-avalanche deposits of this magnitude are good analogues for earthquake hazard analysis in the high alpine valleys of the Greater Himalaya. Note the yak pastures and huts below the slide. A major GLOF hazard lies just behind the terminus of Chola Glacier at the base of Arakam Tse.

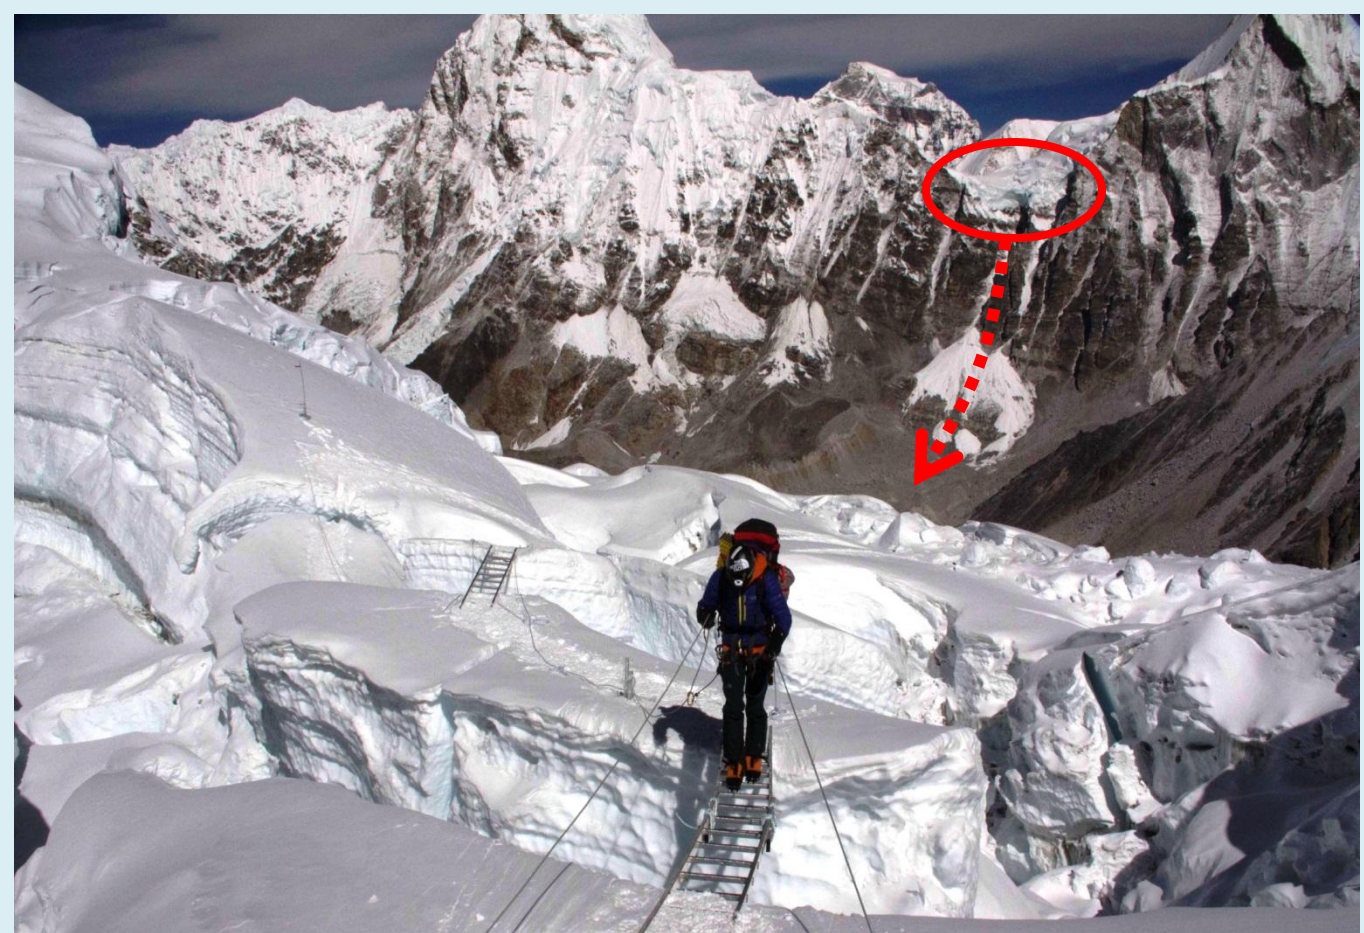
ABOVE: Ladder crossing of crevasses in the Khumbu icefall above Everest Base Camp. Shown in red is the break-away zone (between Pumori and Ligtren) and run-out path (air blast zone) of the massive ice/snow avalanche on 25 April 2015 that swept across Base Camp and killed over 20 people. Photo taken in April 2012 during the MSU/Nat Geo/TNF Everest Expedition. BELOW: Prayer flags on the bridge over the Dudh Koshi River below the Sherpa village of Phortse.

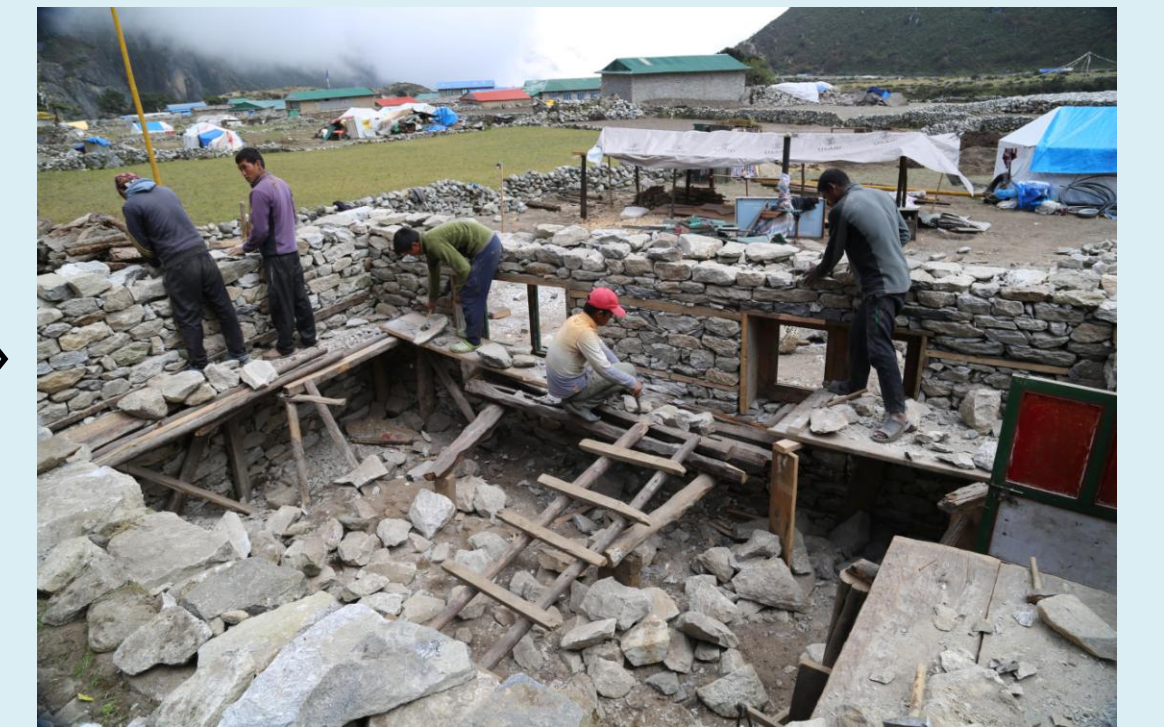
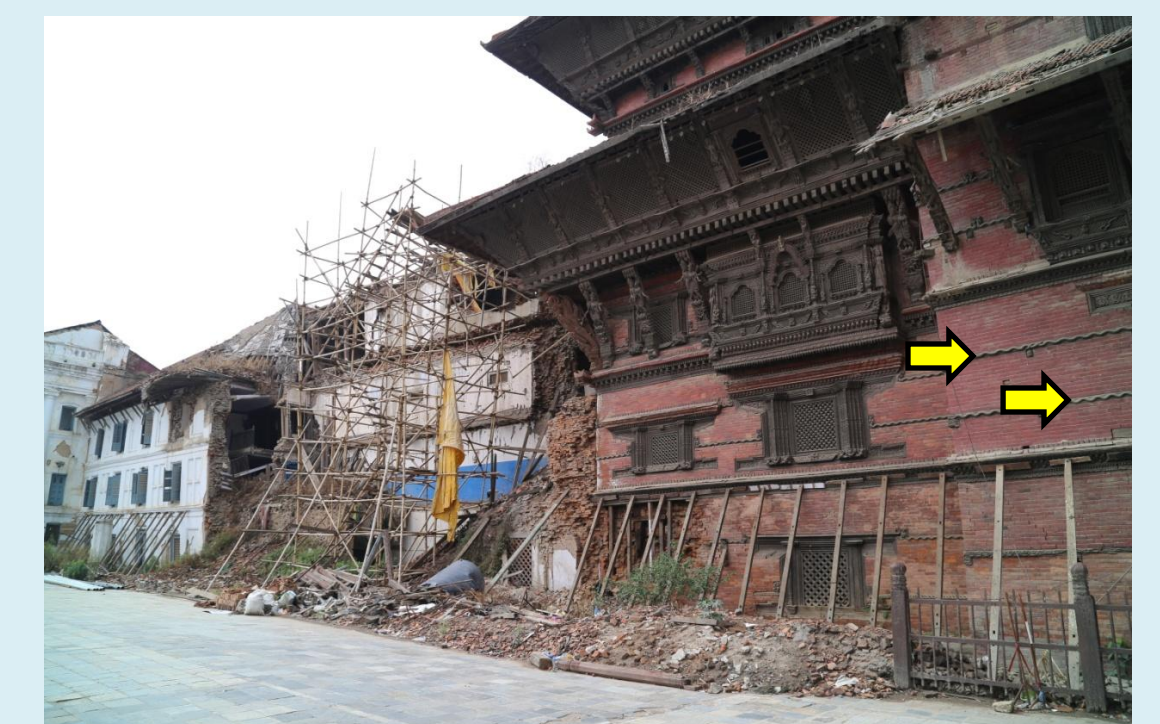
Example of insufficient timber banding in the wall in a small structure in Phakding; the wood boards do not go through the entire wall and did not support the wall during seismic shaking, resulting in catastrophic failure.

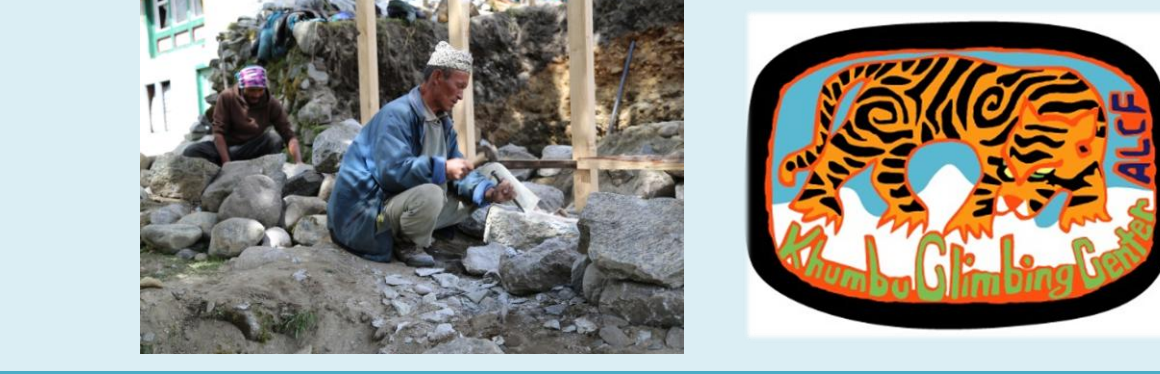
Wire-mesh gabion walls are used in conjunction with expensive steel-frame construction at the Khumbu Climbing Center in the Sherpa village of Phortse, resulting in a reasonably strong structure that withstood seismic shaking in 2015.

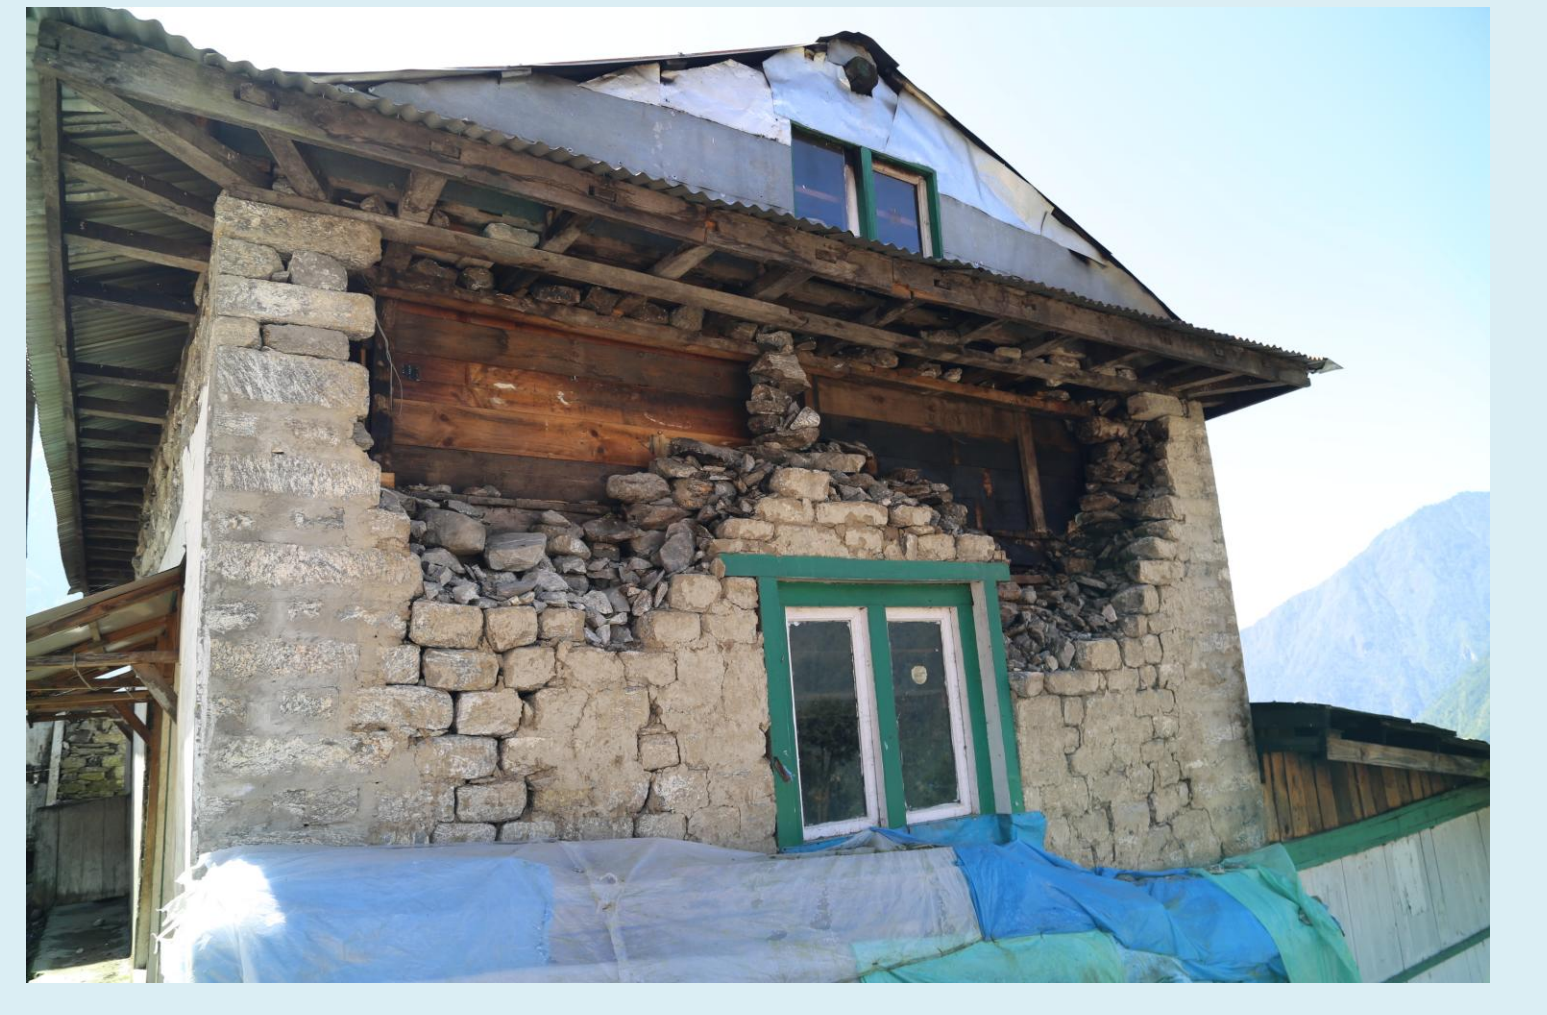
This is typical of structural damage in the Khumbu region. Failure occurred at the top of external rock walls (unreinforced masonry), leaving inside wood paneling exposed but relatively intact. It is likely that this rock wall will be rebuilt in the same style as before the earthquake, due to lack of resources.

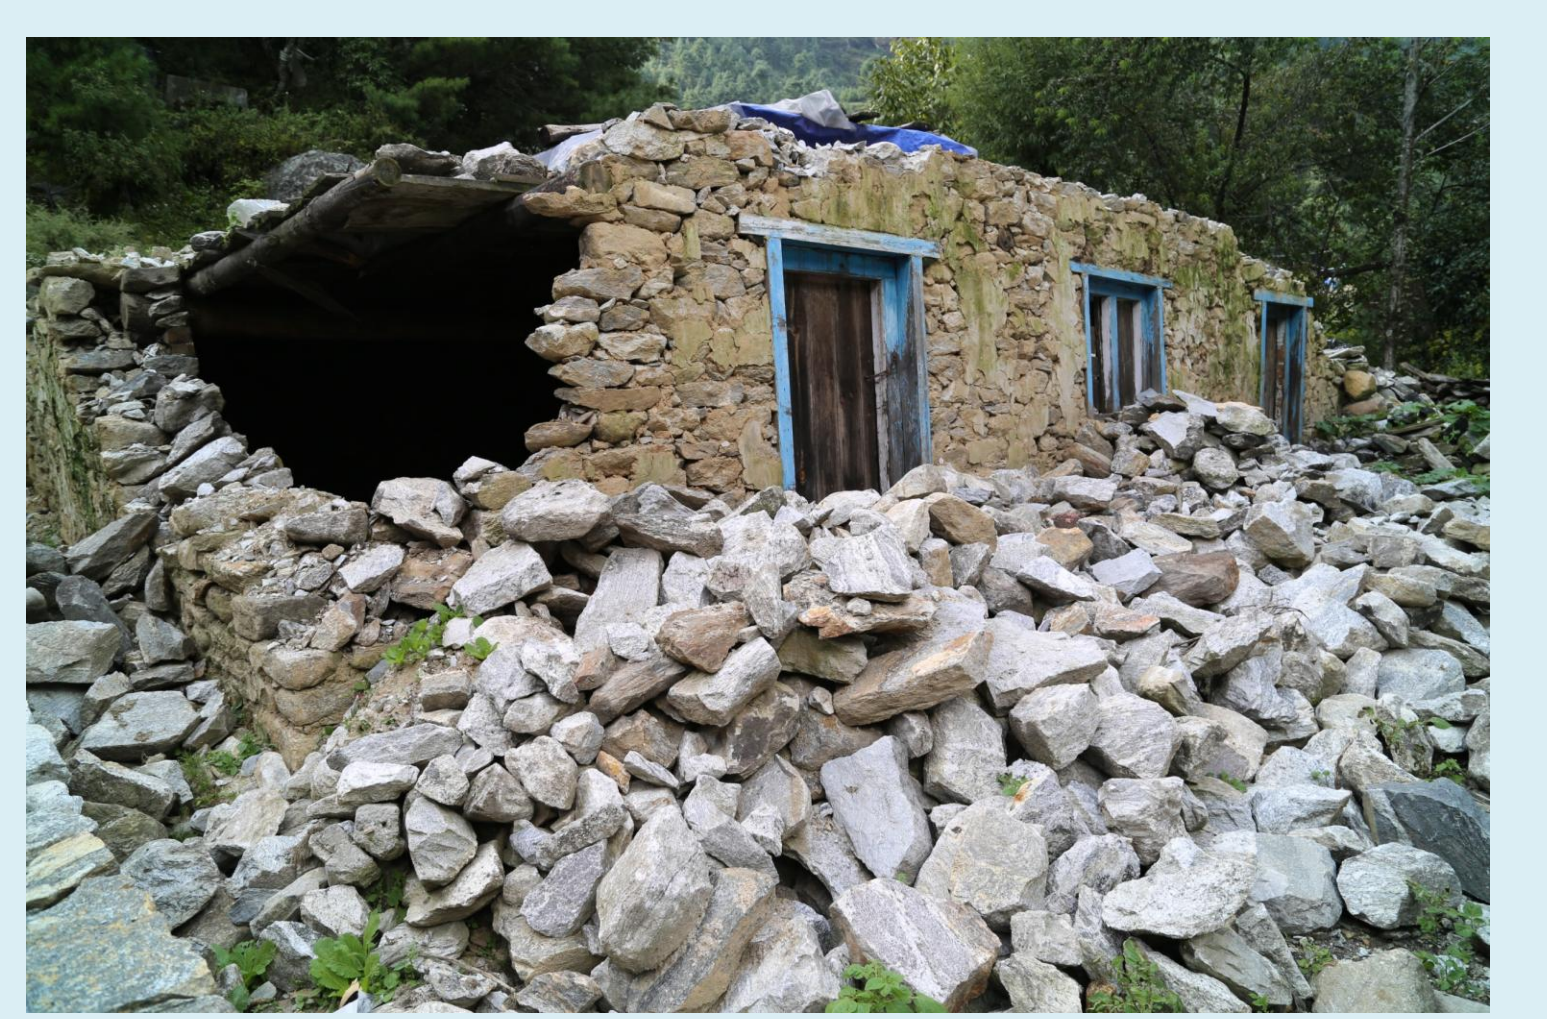
Catastrophic failure of a traditional Khumbu building (stacked field stone – URM).

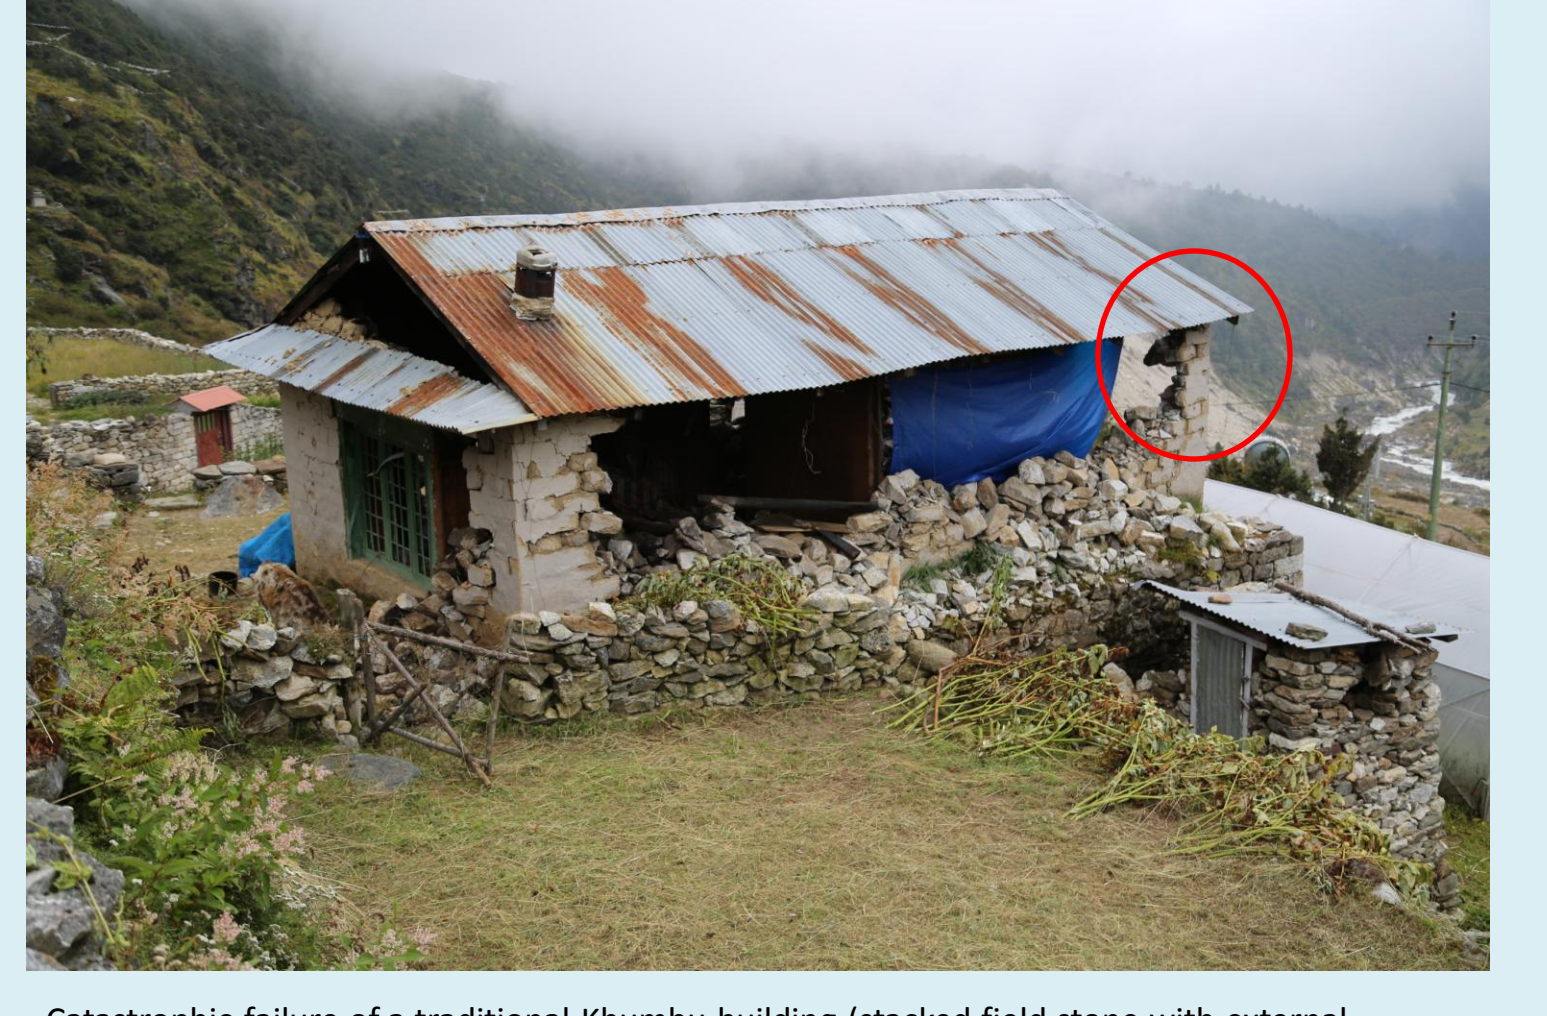
Catastrophic failure of a traditional Khumbu building (stacked field stone with external plaster) near Thame. The entire structure is on the verge of collapse (red circle). An elderly man lives here with a young yak, residing in a small tent on the opposite side of the building.
