# Damage from the april-may 2015 gorkha earthquake sequence in the Solukhumbu district (Everest region), Nepal

David R. Lageson, Monique Fort, Roshan Raj Bhattarai, Mary Hubbard

# DAMAGE FROM THE APRIL-MAY 2015 GORKHA EARTHQUAKE SEQUENCE IN THE SOLUKHUMBU DISTRICT (EVEREST REGION), NEPAL

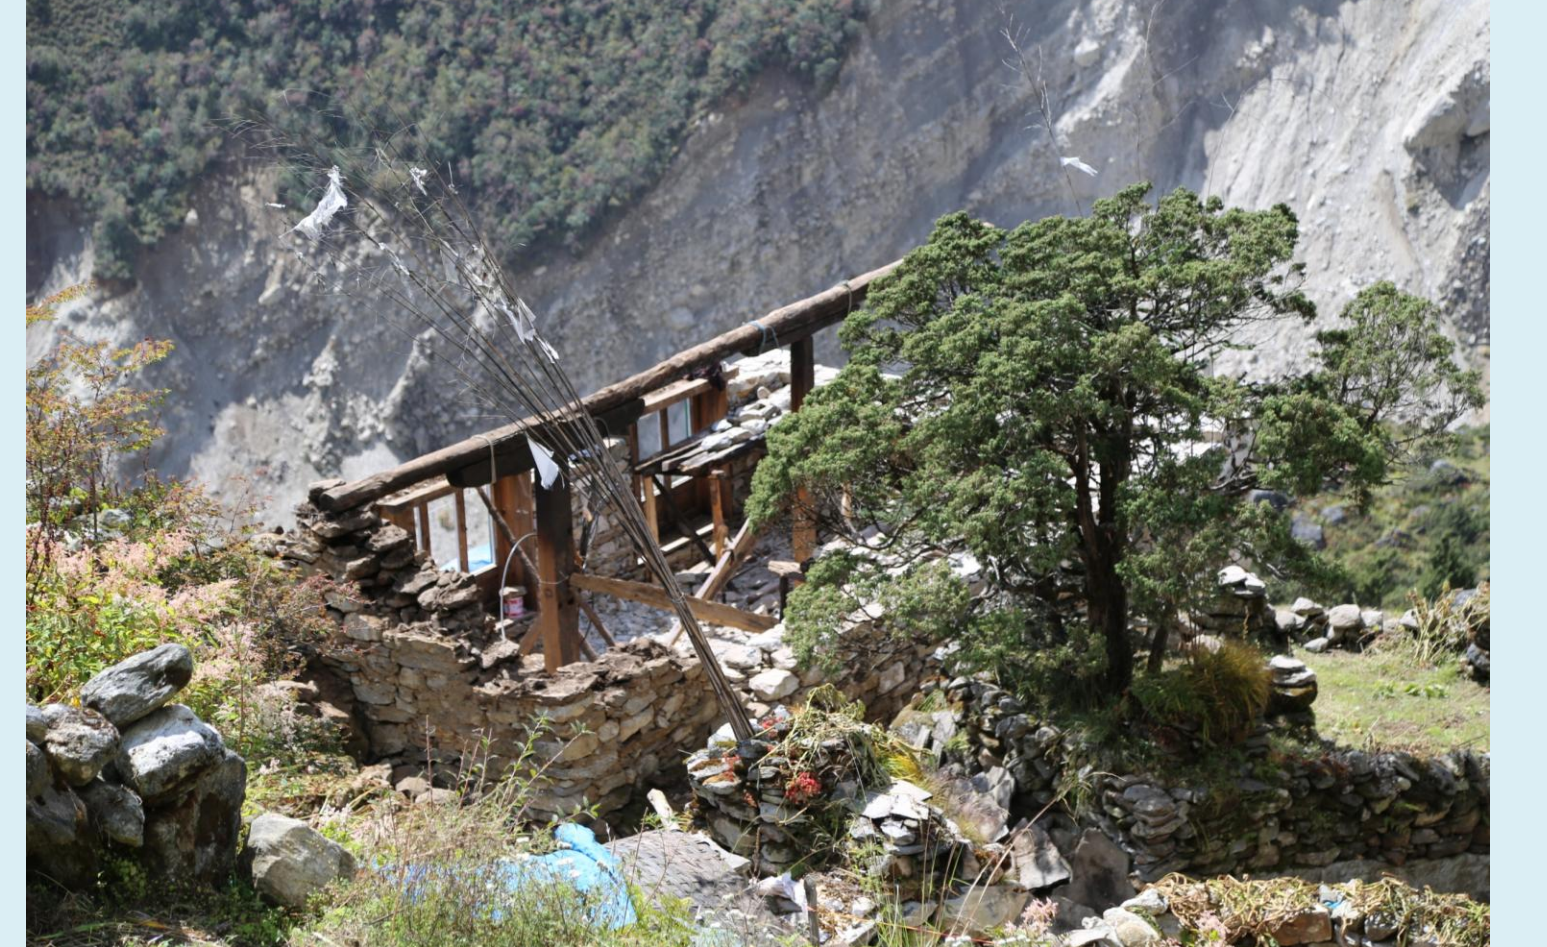
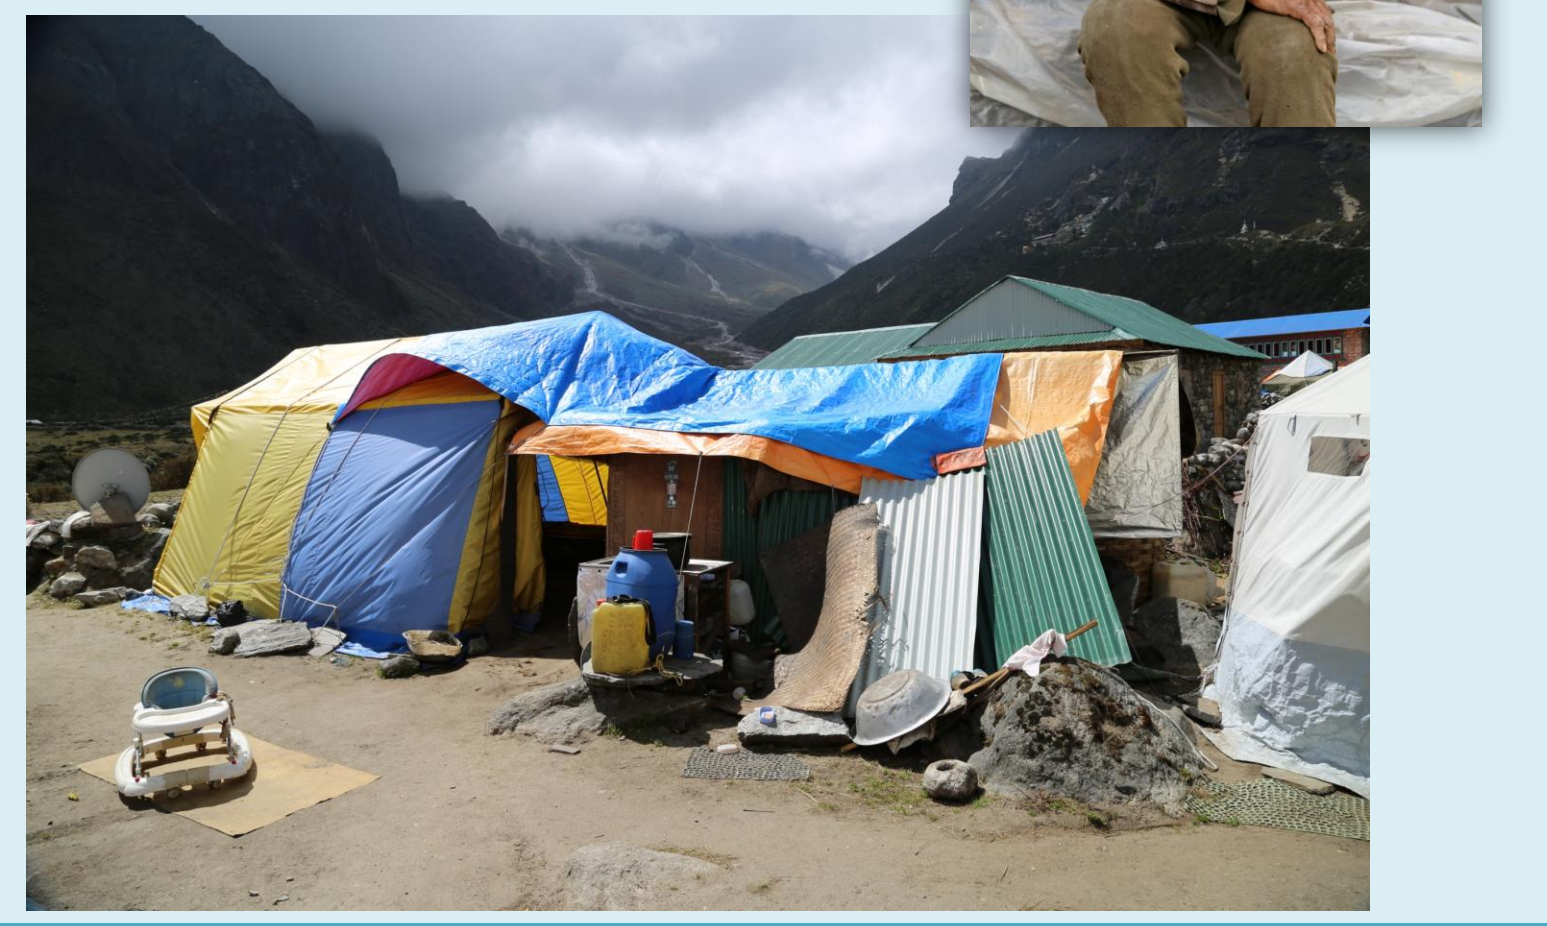
ABOVE: Catastrophic failure of roof and walls of a traditional Khumbu building (stacked field stone with external plaster) near Thame. BELOW: Thame experienced massive damage during the Gorkha earthquake and its aftershock sequence; this famous Sherpa village was constructed on water-saturated ground moraine and outwash between high lateral moraines. Many people still live in make-shift shelters of tarps, sheet metal, or whatever else can be salvaged.
