# Experimental Investigation on the Significance of the Conventional Endurance Limit of a Spheroidal Graphite Cast Iron

Thierry Palin-Luc, S. Lasserre, J-Y. Bérard

Thierry Palin-Luc, S. Lasserre, J-Y. Bérard. Experimental Investigation on the Significance of the Conventional Endurance Limit of a Spheroidal Graphite Cast Iron. Fatigue and Fracture of Engineering Materials and Structures, 1998, 21 (2), pp.191-200. 10.1046/j.1460-2695.1998.00409.x. hal-01375929

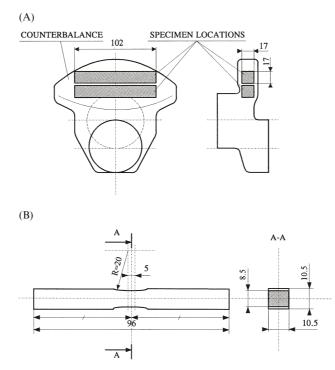
Fig. 2. (A) specimen locations in the crankshaft counterbalance; (B) geometry of specimens (dimensions in mm).

All the specimens used in this study were machined from the counterbalances of crankshafts after casting and the heat treatment described above. Parallelepiped blocks were cut in the counterbalances as indicated in Fig. 2(A) and then specimens were machined from these blocks to dimensions shown in Fig. 2(B). The testing area was ground and polished with emery paper of 1000 grade and finished with diamond powder (2  $\mu$ m grain size).

Five specimens of square cross-section (Fig. 2(B)) were loaded in fully reversed four point plane bending under constant stress amplitude. Their conventional endurance limit (infinite life) under this loading is Sd(sq) = 268 MPa. Four stress amplitudes were chosen: 280, 268, 230 and 180 MPa. According to the *S*–*N* curve of the material the probabilities of failure before 10<sup>6</sup> cycles under the stress amplitudes 280 and 268 MPa, respectively, are: 0.50 and 0.12. For 230 and 180 MPa these probabilities of failure are less than  $3 \times 10^{-6}$  which are low enough to consider that the behaviour of the specimens loaded under these amplitudes was not representative of any phenomenon linked with the endurance limit. Each specimen was loaded under one of these stress amplitudes and then observed in the SEM during test interruptions. However, under 268 MPa two specimens were tested.

specimens were cut from the crankshafts. Specimens were produced from cast iron which was located far from the geometric centre of the crankshaft (Fig. 2). In such an area of the component, which is not the last solidification area of liquid metal, there is very little chance to find microporosities. On the contrary, when the specimens are machined at the centre of cast rods [4,6,12] or from large blocks [7] there is a greater probability to have porosities because specimens are made with the last solidified metal.

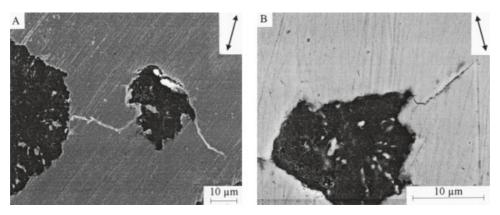
Fig. 3. SEM observations of a specimen surface loaded at (A) 280 MPa, (B) 268 MPa; each after 50,000 cycles. Arrows indicate loading direction.

- (i) either the distance between two spheroids is less than 20 μm which is approximately the diameter of spheroids (Fig. 3(A));
- (ii) or the shape of the spheroid is very irregular and a micro-crack initiated at a spheroid sharp edge (Fig. 3(B)).

The high stress concentrations generated by the spheroids in these two cases explained the crack initiation behaviour.

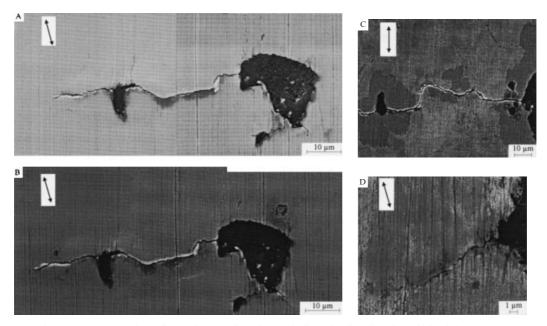
Fig. 4. SEM observations of a specimen surface. Arrows indicate loading direction. (A) loaded at 268 MPa for 150,000 cycles, (B) loaded at 268 MPa for 10<sup>6</sup> cycles. (C) 268 MPa for 10<sup>6</sup> cycles; after a nital etching. (D) 180 MPa for 10<sup>6</sup> cycles; after a nital etching.

Under the three higher stress levels (280, 268 and 230 MPa) several micro-cracks initiated and propagated between zero and 150,000 cycles. After this number of cycles, micro-cracks did not evolve significantly (see Fig. 4(A) and (B)). On the specimen loaded at 180 MPa, the micro-cracks which appeared between 150,000 and 300,000 cycles did not grow, even after  $10^6$  cycles. They were always very small (Fig. 4(D)).

The observations on specimens after a nital etching showed that micro-cracks had propagated across the pearlitic matrix of the material when the specimens were loaded at the three higher stresses (see example in Fig. 4(C)). On the specimen loaded at the lower stress amplitude, 180 MPa, micro-cracks never propagated across the matrix, i.e. they never propagated through the boundary between ferrite and pearlite even after  $10^6$  cycles of loading (Fig. 4(D)).
