Damage of woven composite under translaminar cracking tests using infrared thermography

Teddy Lisle, Marie-Laetitia Pastor, Christophe Bouvet, Philippe Marguerès

Teddy Lisle, Marie-Laetitia Pastor, Christophe Bouvet, Philippe Marguerès. Damage of woven composite under translaminar cracking tests using infrared thermography. *Composite Structures*, 2017, vol. 161, pp. 275-286. 10.1016/j.compstruct.2016.11.030 . hal-01430344

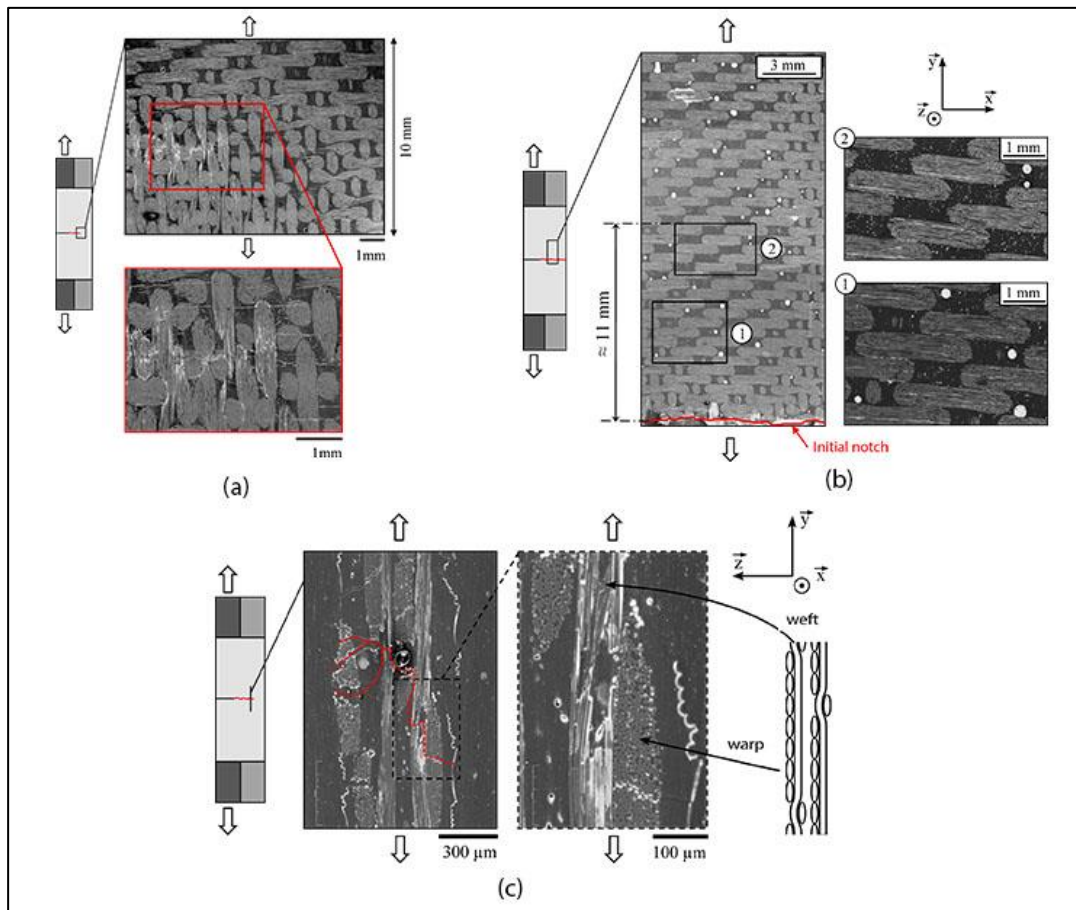
Figure 3: Micrographic views of the warp face (a) in notch tip, (b) after specimen failure and (c) transverse view in notch tip

A lot of studies [23-24, 27] have shown that the crack propagates in the notch axis following the weaving points. In our study, the notch tip damage corresponds to intralaminar failure of the weft woven but also propagation of vertical cracks in the warp woven (see **Figure 3**).

Figure 3(b) shows that intralaminar cracks are observed in weft woven until 11 mm above the notch. When the notch propagates, the specimen is completely cracked in the thickness with the failure of the warp woven (**Figure 3(c)**). Moreover, few of meta-delaminations and inter-ply delaminations are observed. The interlaminar cracks of warp woven contain "cups", typical features of shear failures (see **Figure 4**).

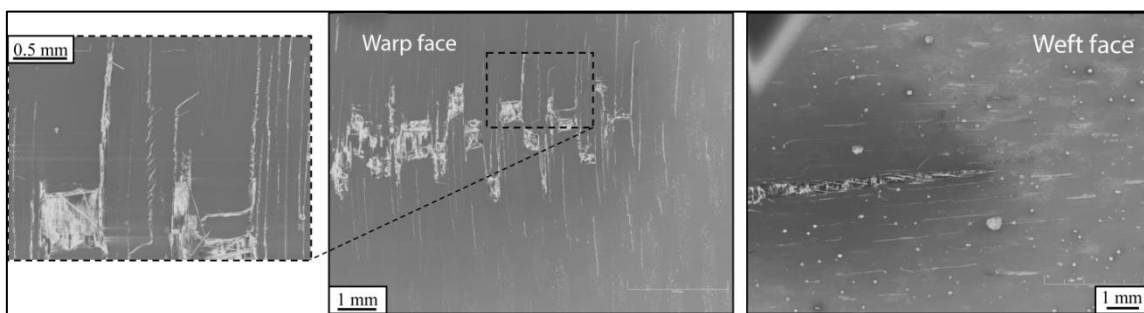
Figure 4: Micrographic views in notch tip obtained under SEM [Garcia, 2013]

Garcia [28] notices a lot of intralaminar cracks in transverse woven on the weft face. So the notch tip damage is the combination of the tensile damage and the shear damage. In order to characterize the size of the damaged zones, the heat source fields are calculated from thermal images (the post-treatment zone is presented in **Figure 2**). **Figures 5** and **6** show the results obtained from a test on weft and warp face.
