Damage of woven composite under translaminar cracking tests using infrared thermography

Teddy Lisle, Marie-Laetitia Pastor, Christophe Bouvet, Philippe Marguerès

Teddy Lisle, Marie-Laetitia Pastor, Christophe Bouvet, Philippe Marguerès. Damage of woven composite under translaminar cracking tests using infrared thermography. *Composite Structures*, 2017, vol. 161, pp. 275-286. 10.1016/j.compstruct.2016.11.030 . hal-01430344

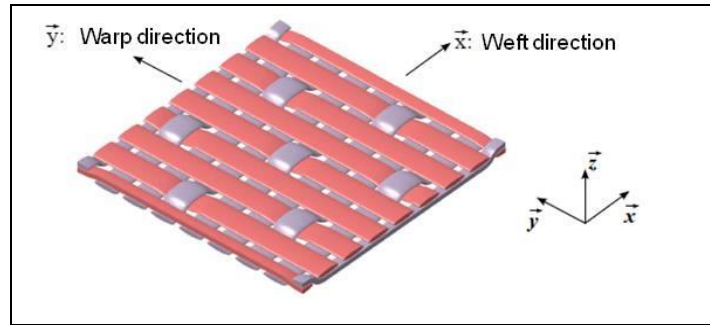
Figure 1: Weave pattern

The crack propagation is studied in glass/epoxy woven composite. These laminates are made of 8-harness satin balanced woven fabric (8-HS) pre-pegs plies with a fibre volume fraction of 50% (see **Figure 1**). The yarn size is 0.5 mm-width and 0.1 mm-thickness. The elastic moduli are 21.5 and 20.5 GPa, the limit strength 385 and 280 MPa, respectively in the warp and weft directions, the shear modulus is 3.5 GPa and the shear strength 65 MPa. The samples are always manufactured with the warp woven face on the top of the thickness, so the top face is a warp side and the underside face a weft one. The samples are made of 2 glass/epoxy woven plies surrounded with 2 unidirectional carbon plies (see **Figure 2**) [23-24]. The carbon plies allow increasing the specimen stiffness. A finite element study has been performed in order to determine the limit conditions and the crack length in order to obtain propagation stabilization ($dG/da < 0$). So the specimen geometry is given in **Figure 2**. The crack length is equal to 20 mm and is carried out with a diamond wire saw.

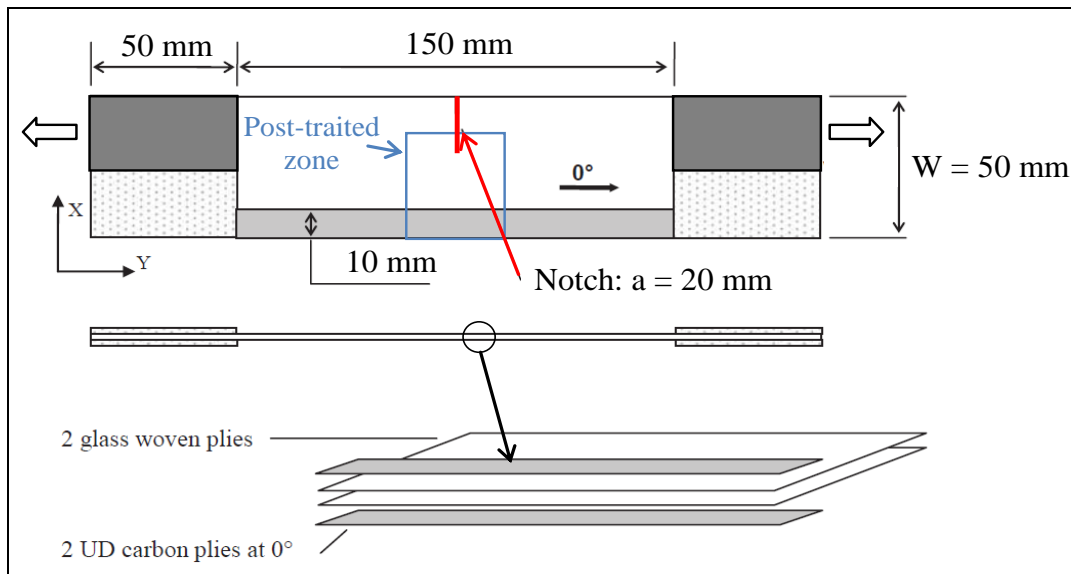
Figure 2: Geometry of the specimen

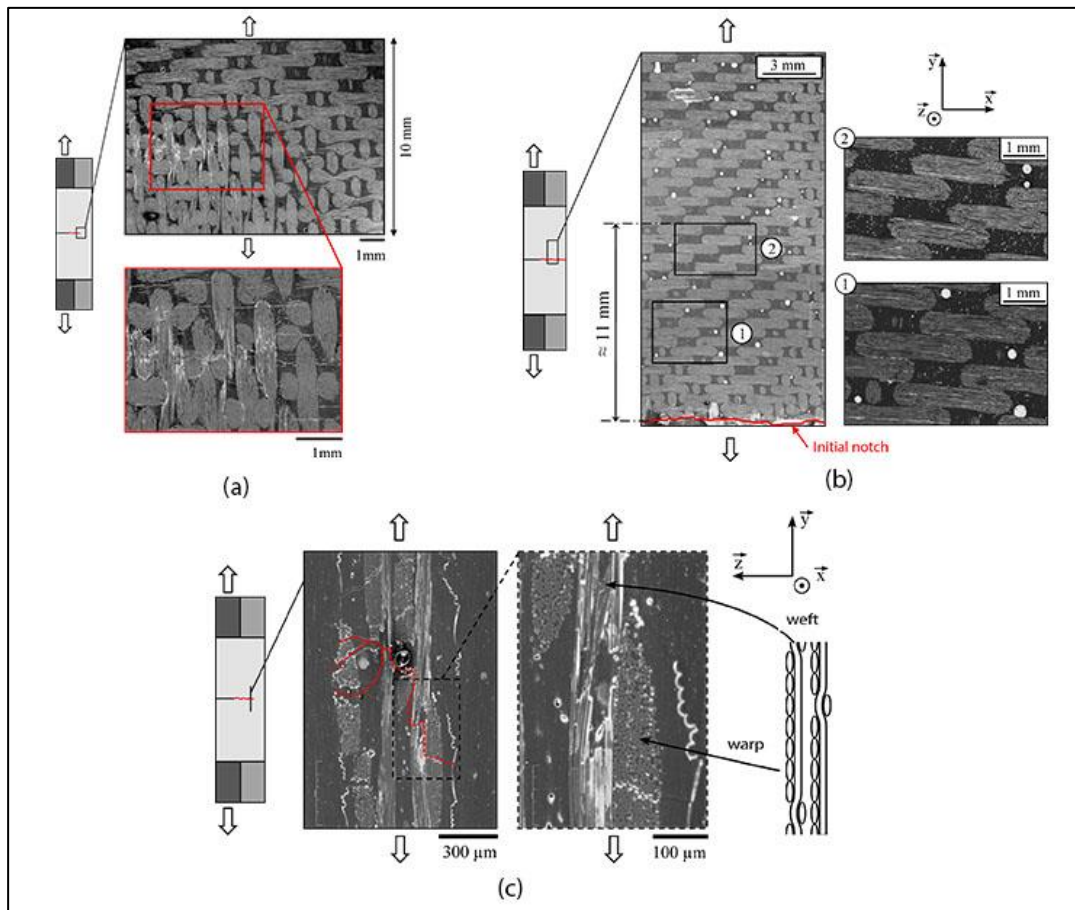
Figure 3: Micrographic views of the warp face (a) in notch tip, (b) after specimen failure and (c) transverse view in notch tip

A lot of studies [23-24, 27] have shown that the crack propagates in the notch axis following the weaving points. In our study, the notch tip damage corresponds to intralaminar failure of the weft woven but also propagation of vertical cracks in the warp woven (see **Figure 3**).

Figure 3(b) shows that intralaminar cracks are observed in weft woven until 11 mm above the notch. When the notch propagates, the specimen is completely cracked in the thickness with the failure of the warp woven (**Figure 3(c)**). Moreover, few of meta-delaminations and inter-ply delaminations are observed. The interlaminar cracks of warp woven contain "cups", typical features of shear failures (see **Figure 4**).

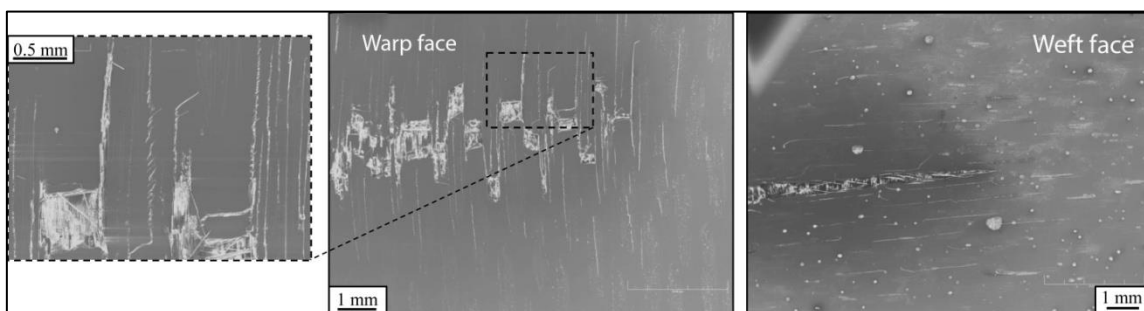
Figure 4: Micrographic views in notch tip obtained under SEM [Garcia, 2013]

Garcia [28] notices a lot of intralaminar cracks in transverse woven on the weft face. So the notch tip damage is the combination of the tensile damage and the shear damage. In order to characterize the size of the damaged zones, the heat source fields are calculated from thermal images (the post-treatment zone is presented in **Figure 2**). **Figures 5** and **6** show the results obtained from a test on weft and warp face.

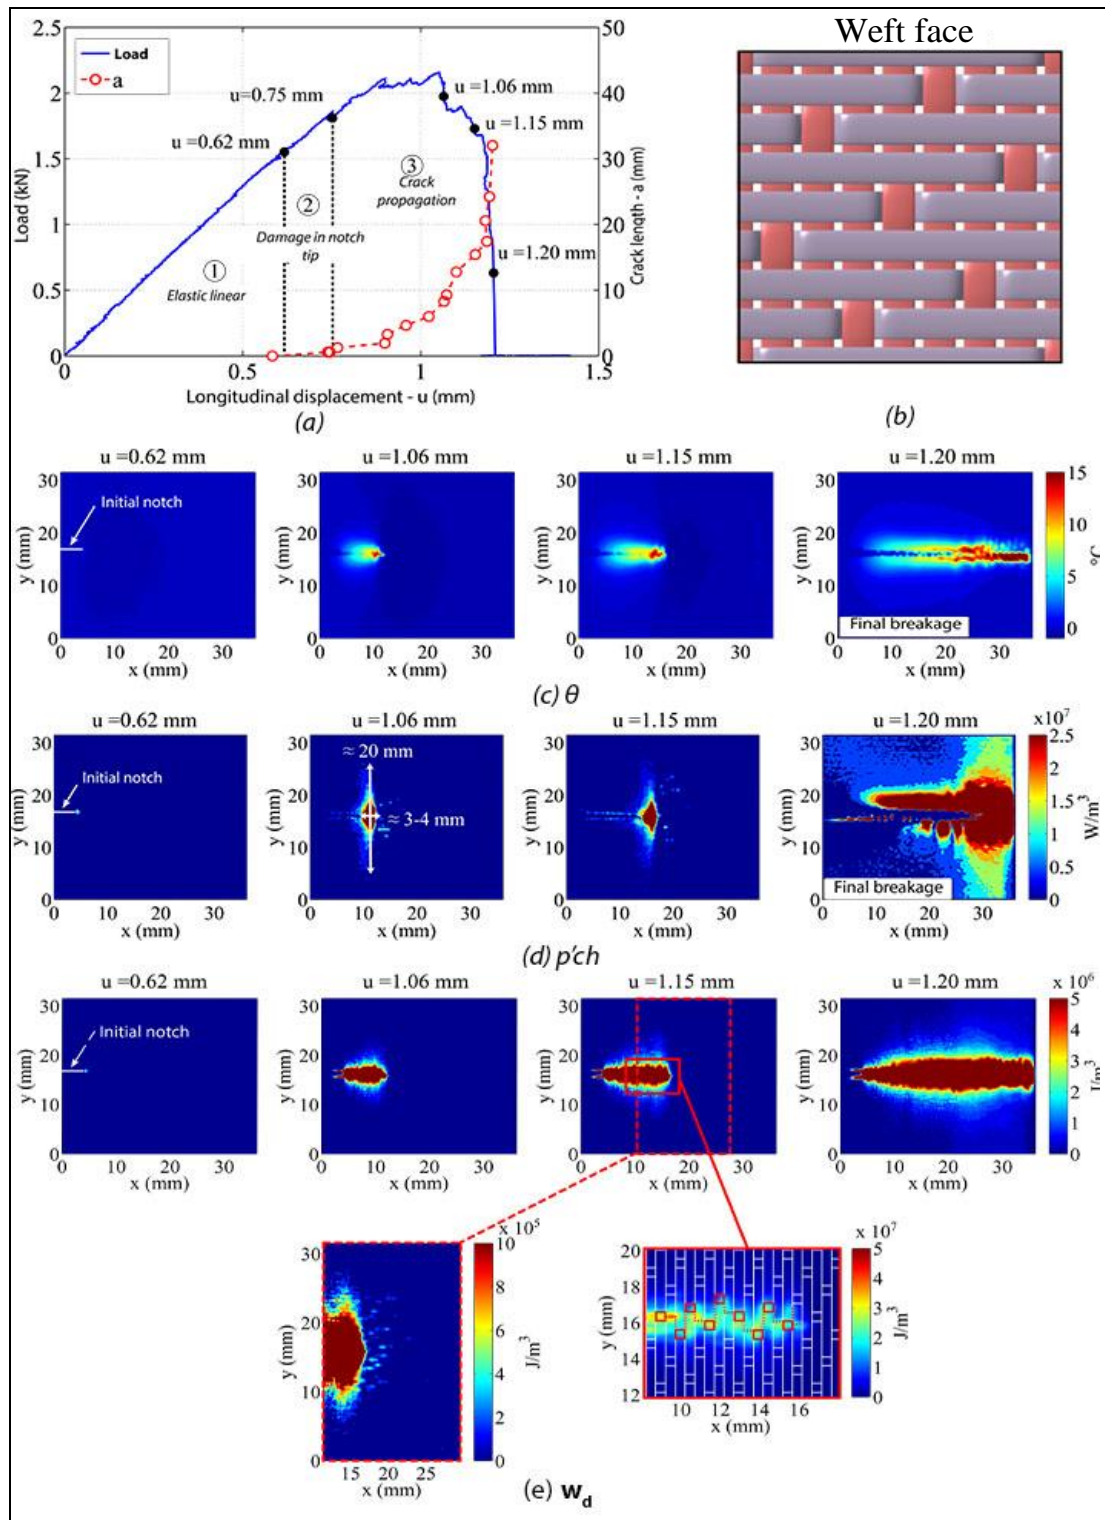
Figure 5: (a) strain/displacement curve; (b) weft face pattern; (c) temperature variation field θ ; (d) heat source field p'_{ch} and (e) cumulated heat source field w_d on weft face

For both tests, a strong temperature elevation in notch tip appears firstly follows a thermo-elastic cooling zone. This zone looks like a cardioids showing a tensile state gathered post-damaged zone in notch tip. The damage scenario is decomposed in 3 zones regardless of the observed face (see **Figures 5** and **6**):

- **Zone 1:** this zone corresponds to elastic linear part of the strain/displacement curve. No damage is noted.
- **Zone 2:** damage grows in notch tip without a propagation of the initial crack. The first non-linearities on the strain/displacement curve are observed. For the warp face test, the notch instantly propagates after the damage initiation in notch tip. The space of this damaged zone depends on the position of the pre-cracked tip regarding the woven. In fact, the propagation instantly occurs after the damage beginning if the pre-cracked tip is inside a longitudinal woven. This damage corresponds to shear micro-cracking in longitudinal woven. In the case where the pre-crack is between two woven, the damage firstly propagates in the zones containing resin or transversal woven. **Figures 7(a)** and **7(b)** show that the damaged zone size is the same for both faces. The zones are about 5 mm height and 1 mm width. Positive heat sources on the pre-cracked edges appear due to the displacement of the initial notch tip. The heat source fields (**Figures 5(d)** and **6(d)**) show that the damage appears earlier weft face than warp face. So the cracks propagate firstly in the transversal woven then in the longitudinal woven.

- **Zone 3:** this part corresponds to the propagation of the initial pre-crack. **Figures 5(e)** and **6(e)** show the cumulated heat sources fields w_d . The cumulated heat source fields on weft face at $u = 1.15$ mm show that the initial crack propagates in the transversal direction following the weave, as [23-24] have observed during fatigue tests. During the crack propagation, the source fields p'_{ch} (**Figures 5(d)** and **6(d)**) highlight many micro-cracks in

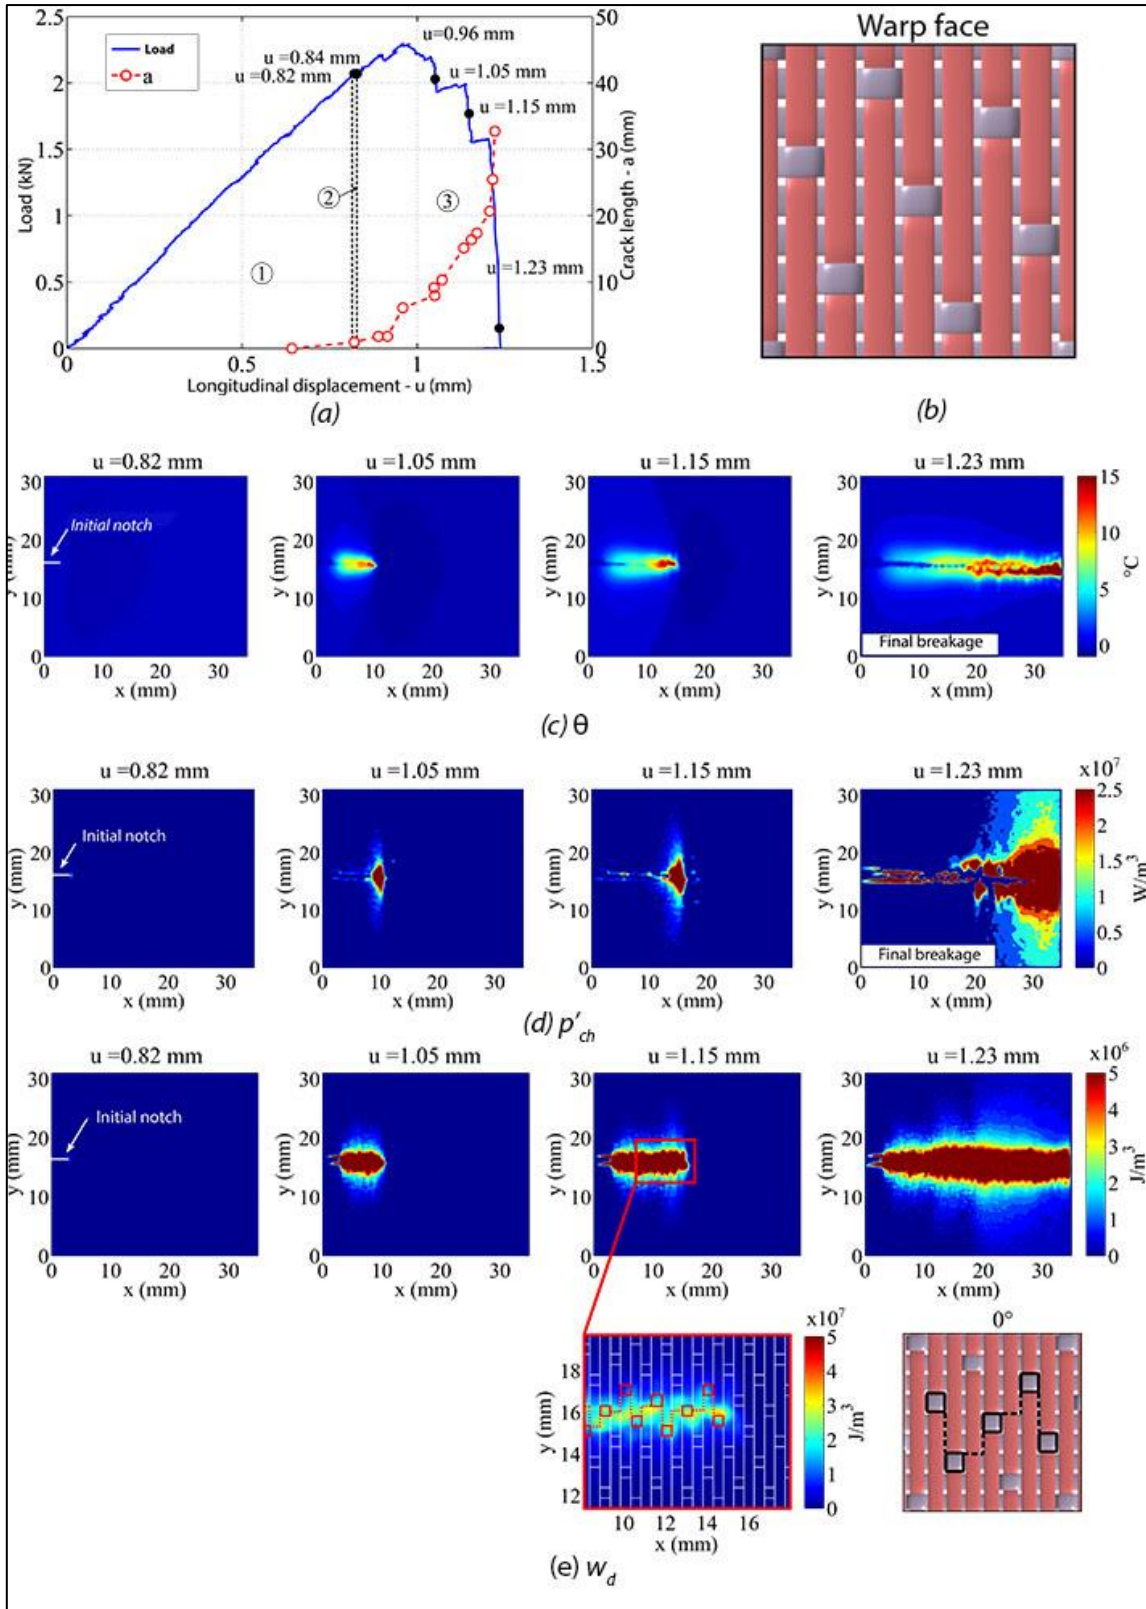
Figure 6: (a) strain/displacement curve; (b) warp face pattern; (c) temperature variation field θ ; (d) heat source field p'_{ch} and (e) cumulated heat source field w_d on warp face

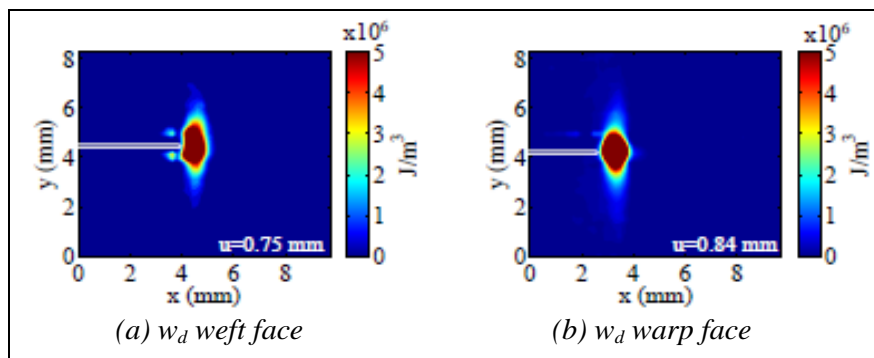
Figure 7: Comparison of the damaged zones size (a) weft face and (b) warp face before the crack propagation

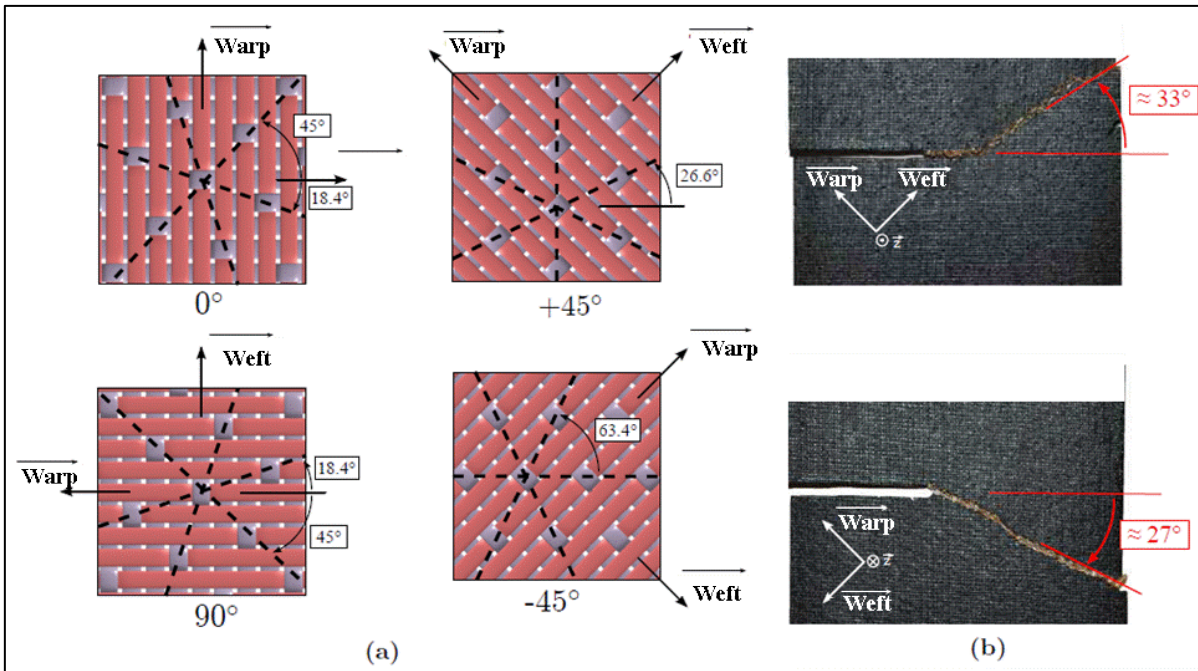
Figure 8: (a) Warp face of the weave pattern oriented in the directions 0° , 90° , $+45^\circ$ and -45° . (b) Photographs of the $\pm 45^\circ$ specimens after spread of the notch

For propagation tests on $[\pm 45^\circ]$ composites the direction of the cut is still governed by the position of weaving points (**Figure 8**). However, depending on the ply which controls the propagation ($+45^\circ$ or -45° ply), the notch path may be variable. **Figure 8a** shows the preferred alignments of weaving points to several directions of the woven ply. For plies oriented at $+45^\circ$ the weaving points have preferred orientations: $\pm 27^\circ$ and 90° relative to the horizontal. For -45° plies the characteristic angles are 0° and $\pm 63^\circ$. **Figure 8b** shows the fracture surfaces obtained for two different tests. The observed disparity reflects the poor reproducibility of the cut paths. Indeed, in the first case the notch is initially propagates horizontally then bifurcates at an angle of about 33° relative to the horizontal, which suggests that the -45° ply and the $+45^\circ$ ply control successively the propagation (see warp face, **Figure 8a**). For the second specimen (weft face, **Figure 8b**), the propagation is totally controlled by the $+45^\circ$ ply since the cut has an orientation at an angle of 27° relative to the horizontal.

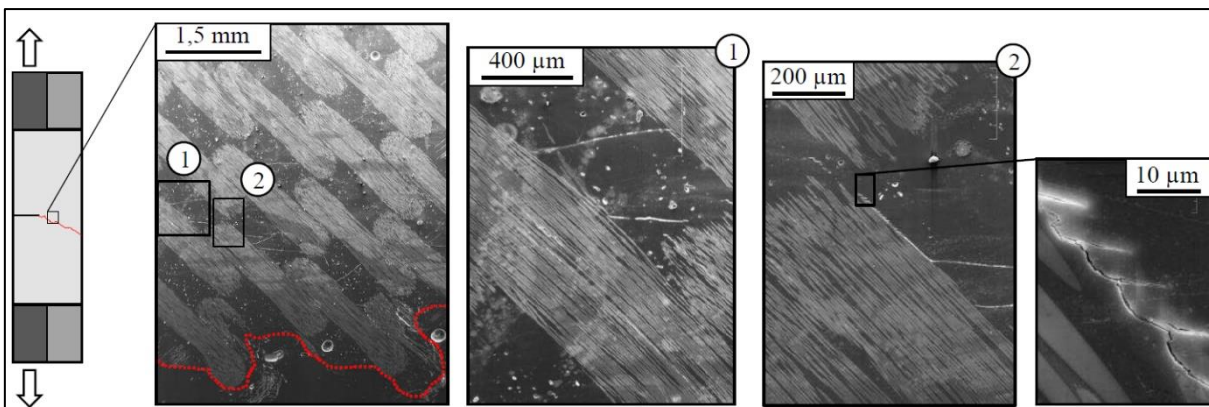
Figure 9: Micrographs after breakage of the warp face of a $\pm 45^\circ$ specimen

The damage observed on a microscopic scale is essentially characterized by shear microcracks in transverse and longitudinal strands (**Figure 9**). These microcracks initially parallel to the fibre direction propagate almost horizontally between two successive strands. The absence of "cups" on these cracks leads us to believe that the spread of intralaminar shear cracks is due to resin breakage.

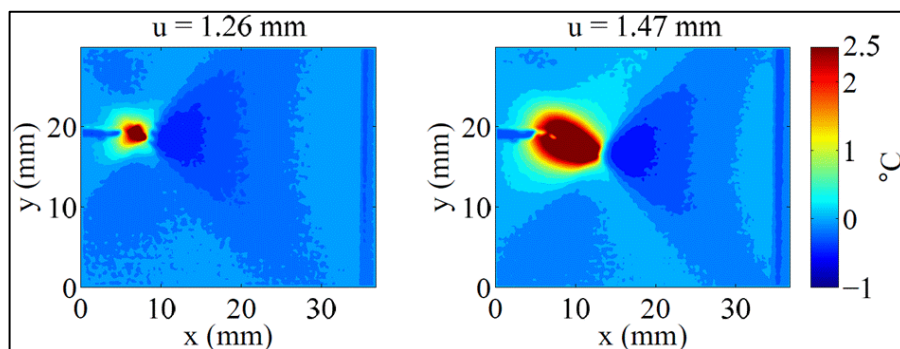
Figure 10: Micrographs after breakage of the warp face of a $\pm 45^\circ$ specimen

cooling is observed in front of the damaged area. The cooling zone is of triangular shape. The sides adjacent to the crack tip are oriented $\pm 45^\circ$ to the horizontal (**Figure 10**). This indicates that the tension zone at the crack tip is bounded by the first $+45^\circ$ and -45° unbroken strands which transmit the load. Furthermore, when the notch approaches the specimen edge, the local field of elastic stresses changes also due to edge effects, affecting the elastic cooling, see **Figure 11c** (weft face, $u = 1.51$ mm) and **Figure 12c** (warp face, $u = 1.76$ mm).

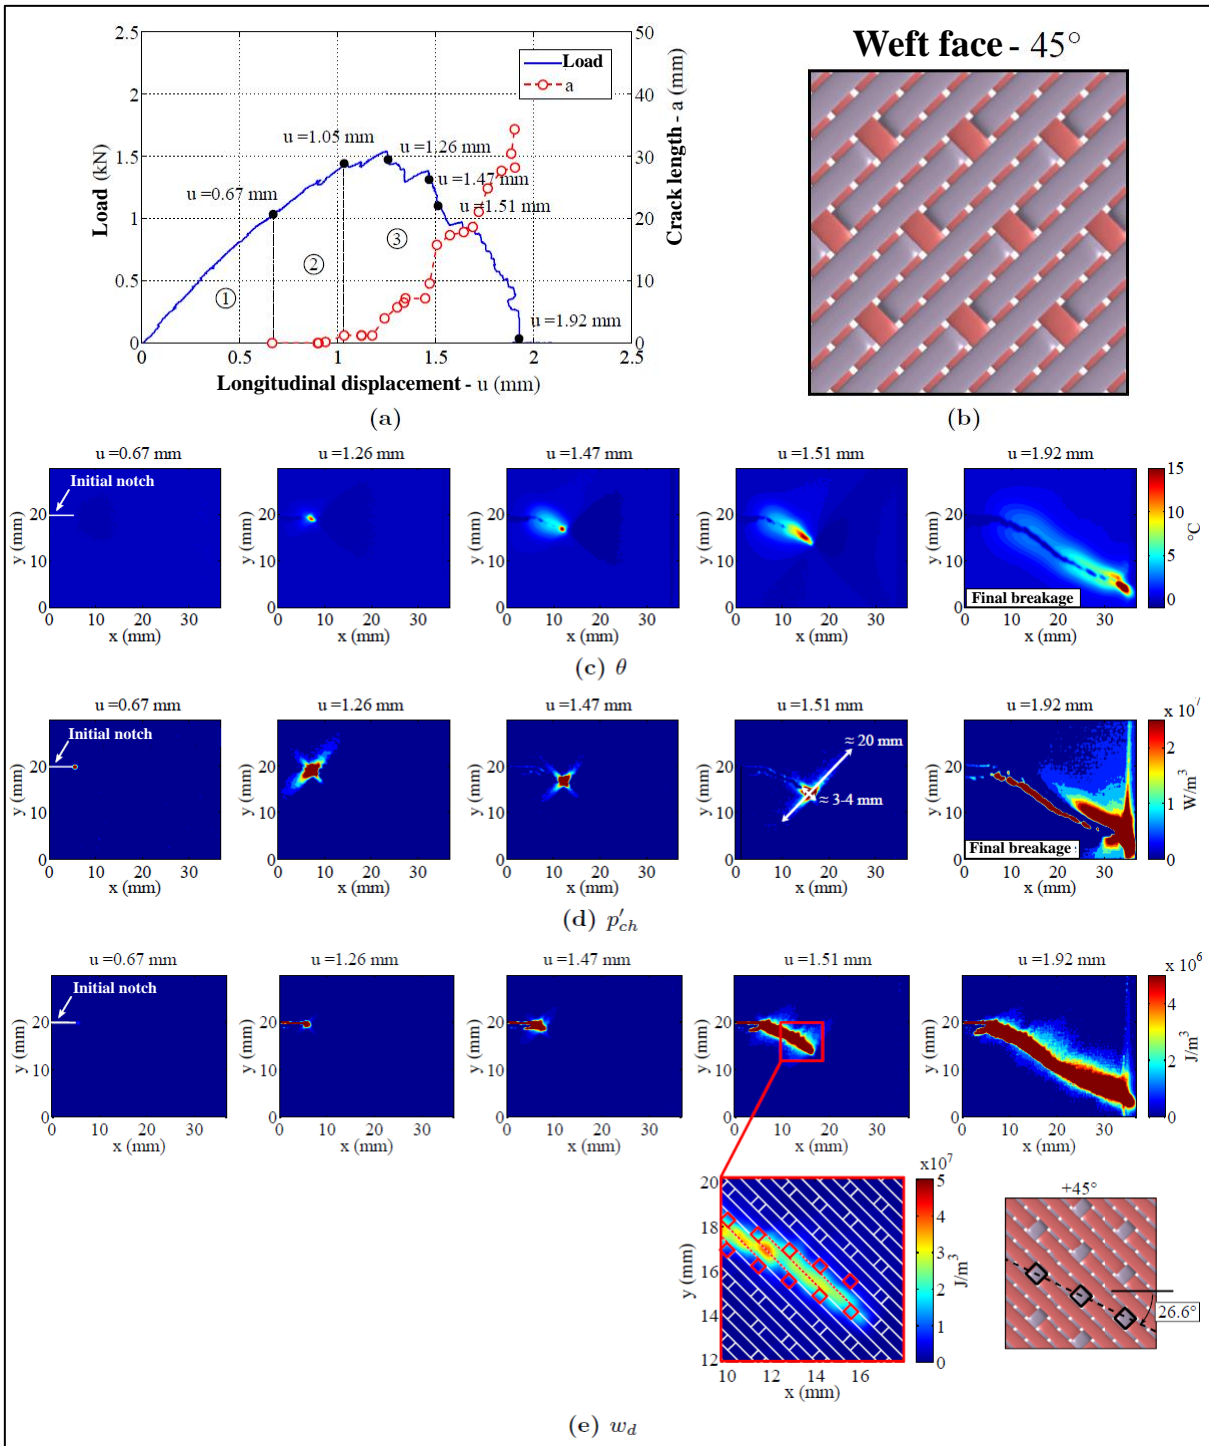
Figure 11: Weft face: (a) load vs displacement; (b) weave pattern; (c) changes in temperature fields ($^{\circ}\text{C}$), (d) heat source fields $p'ch$ (W/m^3) and (e) cumulative heat source fields w_d (J/m^3)

As for $[0^\circ]_2$ specimens, changes in temperature of both faces were monitored by IRT (**Figures 11 and 12**). For both cases, a concentrated heating is observed at the crack tip. A maximum rise in temperature of about 24°C is reached during propagation. A thermo-elastic

As for $[0^\circ]_2$ specimens, **Figures 11** and **12** allow us to define the notch propagation scenario into three zones: a linear elastic region (1), an area where the damage develops tip of the initial notch (2) and a propagation zone (3). Zone 2 begins nearly at the same displacement for both tests. The cumulative heat source fields (**Figures 11-e** and **12-e**) show that just before the crack propagation extensive damage developed in the direction of the warp and weft strands. The shape of the damaged area is comparable to that of a cross on the weft face (**Figures 10-d**). As for $[0^\circ]_2$ specimens, the initial notching conditions may explain this disparity. For both cases damaged area is about 1 to 2mm² and is smaller than those observed for $[0^\circ]_2$ specimens. During crack propagation a field of high intensity sources surrounds its path and more diffuse heat sources develop in the directions of the $+45^\circ$ and -45° yarns. A “cross” is then observed mainly resulting from the spread of intralaminar shear cracks parallel to the direction of the yarn. Comparing the obtained results with those for $[0^\circ]_2$ specimens:

- the damaged area observed during the notch propagation is similar;
- positive heat sources are also detected;
- the extent of the damaged area during the propagation and the resulting cumulative heat source fields (**Figures 11-e** and **12-e**) are also similar.

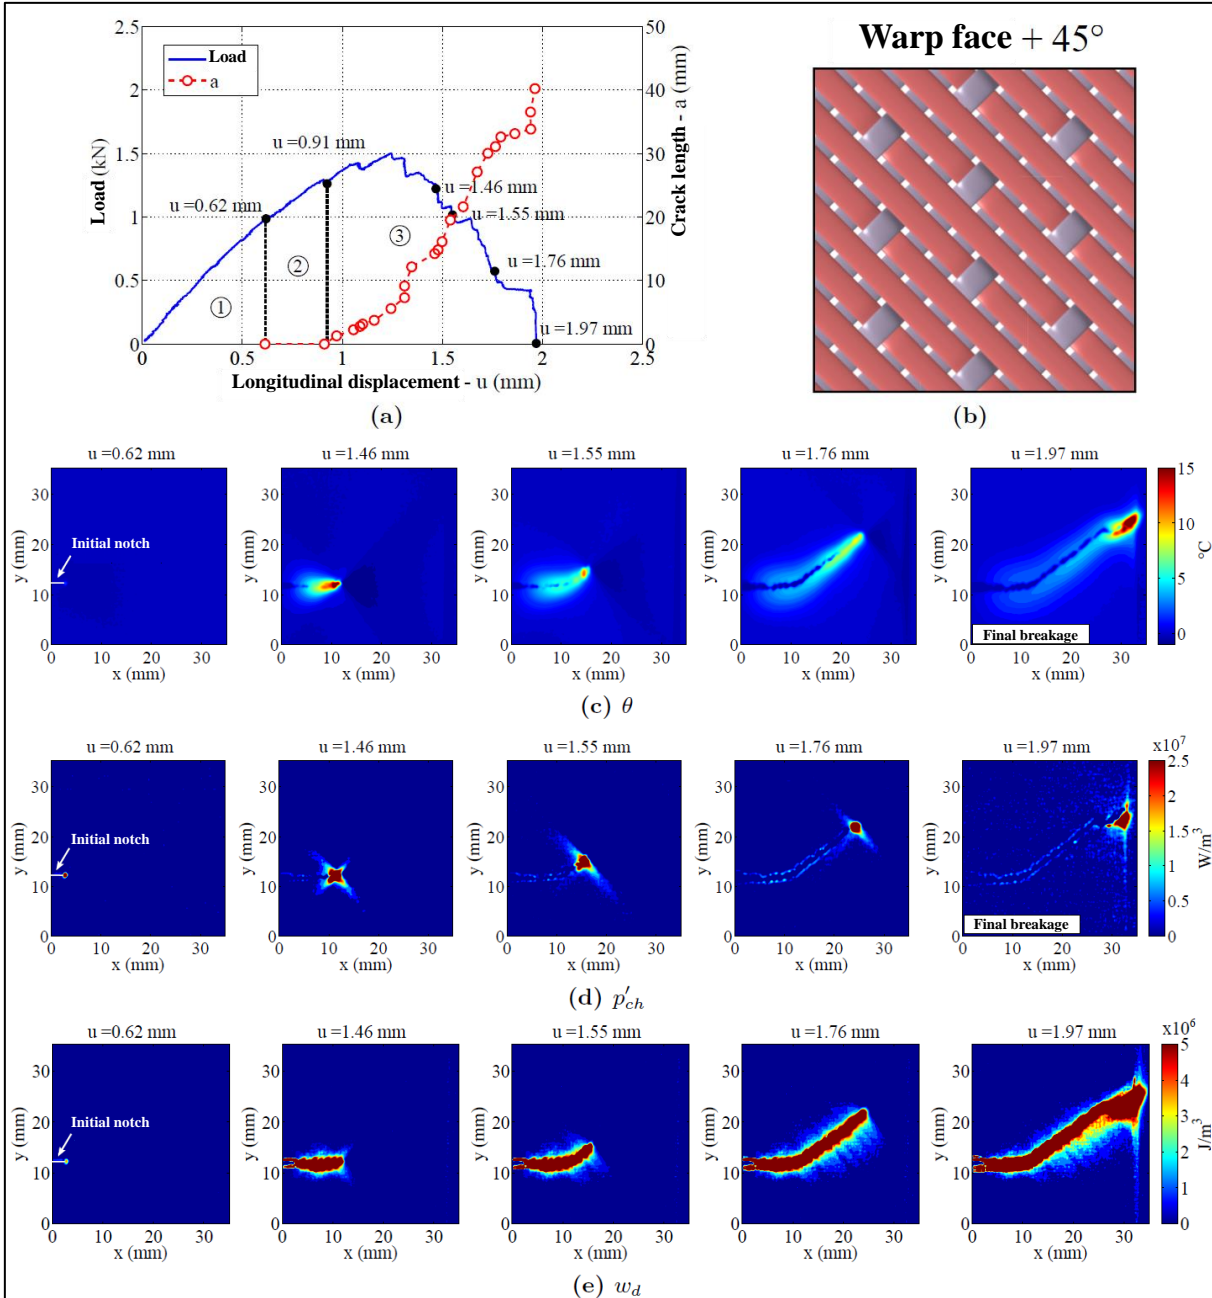
Figure 12: Warp face: (a) load vs displacement; (b) weave pattern; (c) changes in temperature fields ($^{\circ}\text{C}$), (d) heat source fields p'_{ch} (W/m^3) and (e) cumulative heat source fields w_d (J/m^3)

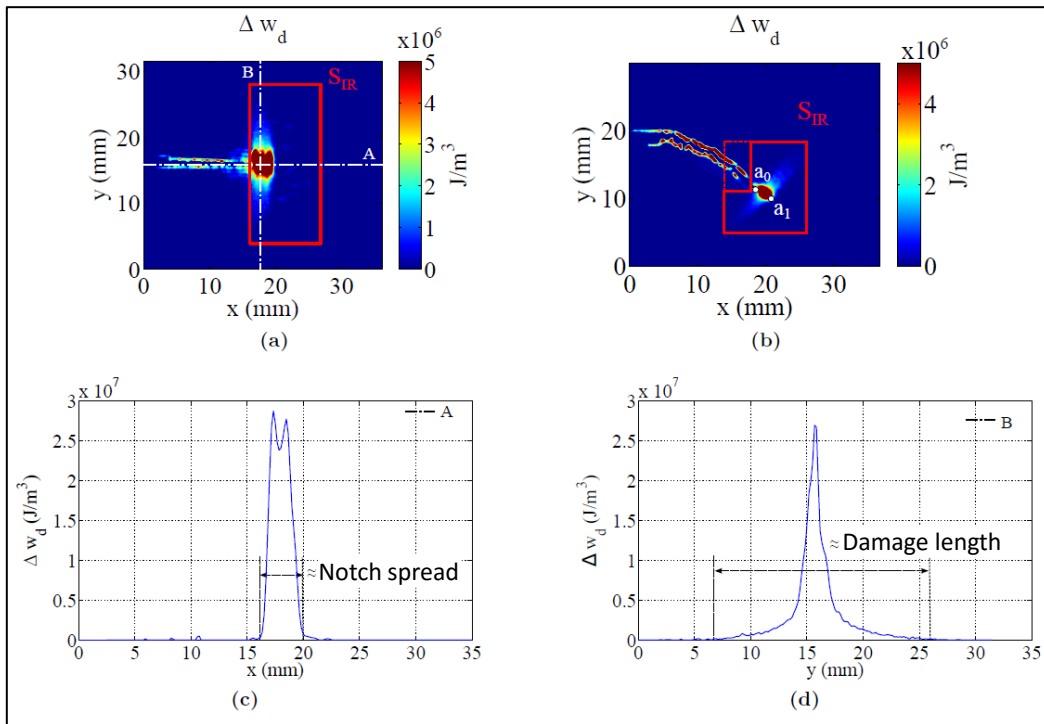
Figure 13: Cumulative source fields Δw_d during a notch propagation: (a) $[0^\circ]_2$ weft side and (b) $[\pm 45^\circ]_2$ weft side. Changes in Δw_d along profile: (c) A and (d) B defined in (a)

Figure 13a shows an example of cumulative heat source fields at crack tip on a $[0^\circ]_2$ specimen. a (**Figure 13c**) is measured using profile A defined in **Figure 13a**. The damage length (**Figure 13d**) is measured using profile A defined in **Figure 12a**. Hence the size of the damaged area is known and sets the minimum size of the integration area S_{IR} (**Figure 13a** and **b**). For $[\pm 45^\circ]_2$ specimens the cut path is not horizontal. Crack length is estimated as the norm of the vector defined by a_0 and a_1 (**Figure 13b**). G is here measured with a modified S_{IR} in order not to take into account the displacements of the crack edges (**Figure 13b**). β is estimated as the ratio of the rate of heat energy release G_{ir} and the energy release rate G (irreversible mechanical energy release rate).

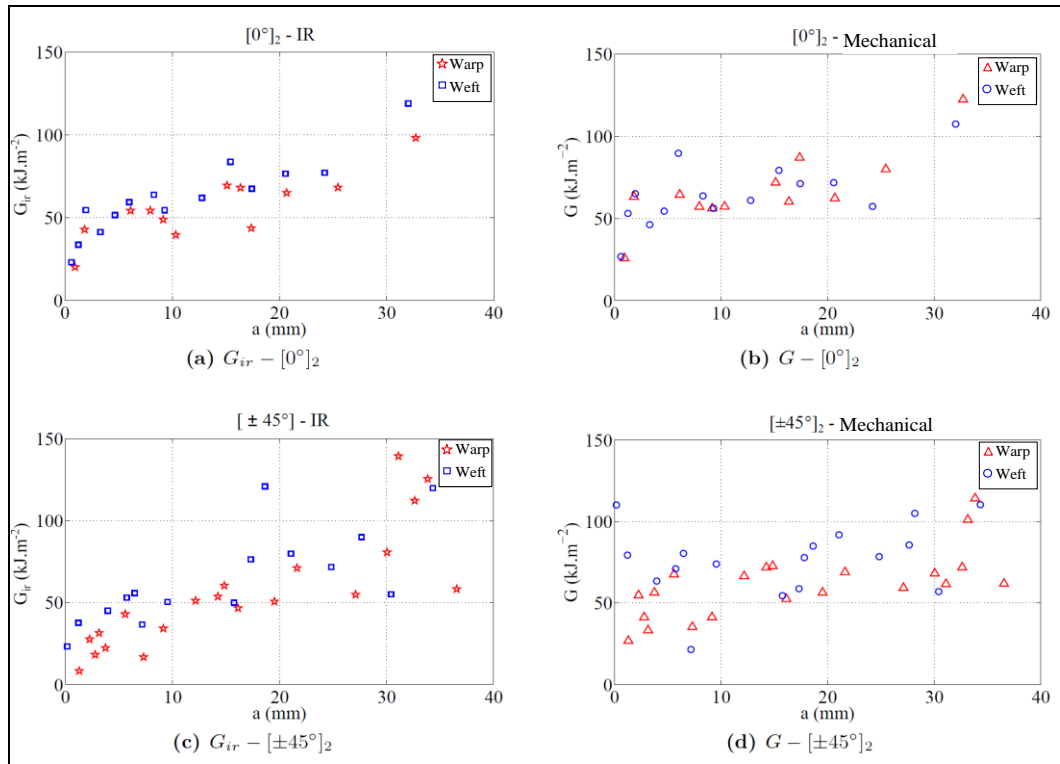
Figure 14: Comparison -on weft and warp faces- of the changes in: (a) G_{ir} and (b) G for $[0^\circ]_2$ specimens and (c) G_{ir} and (d) G for $[\pm 45^\circ]_2$ specimens

Figure 14a shows the changes in G_{ir} depending on cut spread for $[0^\circ]_2$ specimens. Changes in corresponding G -calculated from the areas method- are given in **Figure 14b**. The evolution of G_{ir} is comparable for both sides, even if it is found that values obtained on warp face

are slightly lower. The same trends are observed for propagation tests on $[\pm 45^\circ]_2$ specimens (Figure 14c and d).

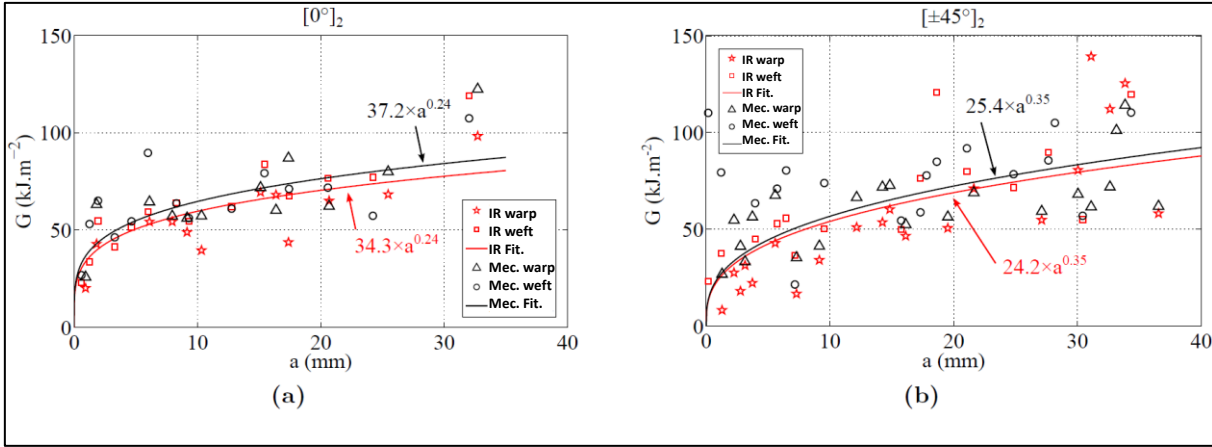
Figure 15: Comparison of energy release rates G and G_{ir} for configurations (a) $[0^\circ]_2$ and (b) $[\pm 45^\circ]_2$

For both configurations, the heat energy release rates *Gir* and mechanical *G*, with associated R-curves (IR fit. and Mec. Fit), are compared in **Figure 15**. R-curves obtained by measuring heat energy remains below those obtained from the estimation of the mechanical energy. For each configuration, an average value of β is then estimated as the ratio between the calorific and the mechanical R-curves. R-curves are approximated using power laws: $G = m.a^n$, where n is respectively set to $n_0 = 0.24$ and $n_{45} = 0.35$ for $[0^\circ]_2$ and $[\pm 45^\circ]_2$ configurations. β is thus the ratio of m coefficients. This set value of n requires that the irreversible mechanical proportion of energy converted to heat remains constant during initiation and propagation of the cut for each configuration. If the spread is stable, notch-tip damages are supposed qualitatively and quantitatively identical and β remains constant. However, define an identical β for propagation and initiation is more debatable. However, areas method is too imprecise to obtain quantitative data when the stiffness variations are small as at the initiation of cracking. β therefore could not be accurately assessed for initiation.

The obtained average values are $\beta_0 = 0.92$ and $\beta_{45} = 0.95$. This indicates that the majority of irreversible mechanical energy is dissipated as heat. As seen previously crack tip damage occurs mainly by multiple microcracks, fibre fractures and interface debonding. With such a high β it can be concluded that the proportion of pseudo-plasticity (shear in the resin) remains low and is mainly localized at the crack tip. It is therefore likely that the damage at the crack tip spreads mainly in the form of longitudinal and transverse microcracks in the yarns, thus relaxing the shear stresses in the resin-rich areas before that they reach their pseudo-hardening threshold.
