# Damage of woven composite under translaminar cracking tests using infrared thermography

Teddy LISLE<sup>1</sup>, Marie-Laetitia PASTOR<sup>1</sup>, Christophe BOUVET<sup>1\*</sup>, Philippe MARGUERES<sup>1</sup>

## Abstract

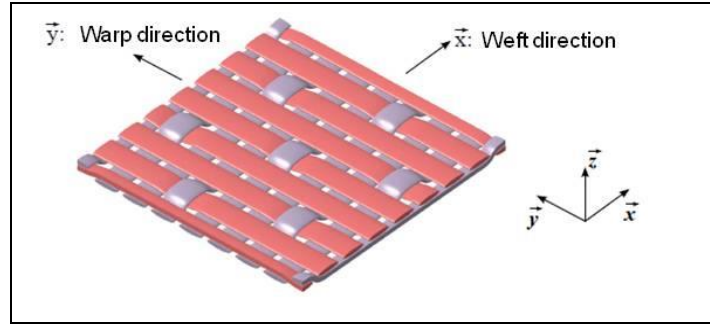
**Figure 1:** Weave pattern

The crack propagation is studied in glass/epoxy woven composite. These laminates are made of 8-harness satin balanced woven fabric (8-HS) pre-pegs plies with a fibre volume fraction of 50% (see **Figure 1**). The yarn size is 0.5 mm-width and 0.1 mm-thickness. The elastic moduli are 21.5 and 20.5 GPa, the limit strength 385 and 280 MPa, respectively in the warp and weft directions, the shear modulus is 3.5 GPa and the shear strength 65 MPa. The samples are always manufactured with the warp woven face on the top of the thickness, so the top face is a warp side and the underside face a weft one. The samples are made of 2 glass/epoxy woven plies surrounded with 2 unidirectional carbon plies (see **Figure 2**) [23-24]. The carbon plies allow increasing the specimen stiffness. A finite element study has been performed in order to determine the limit conditions and the crack length in order to obtain propagation stabilization ( $dG/da < 0$ ). So the specimen geometry is given in **Figure 2**. The crack length is equal to 20 mm and is carried out with a diamond wire saw.

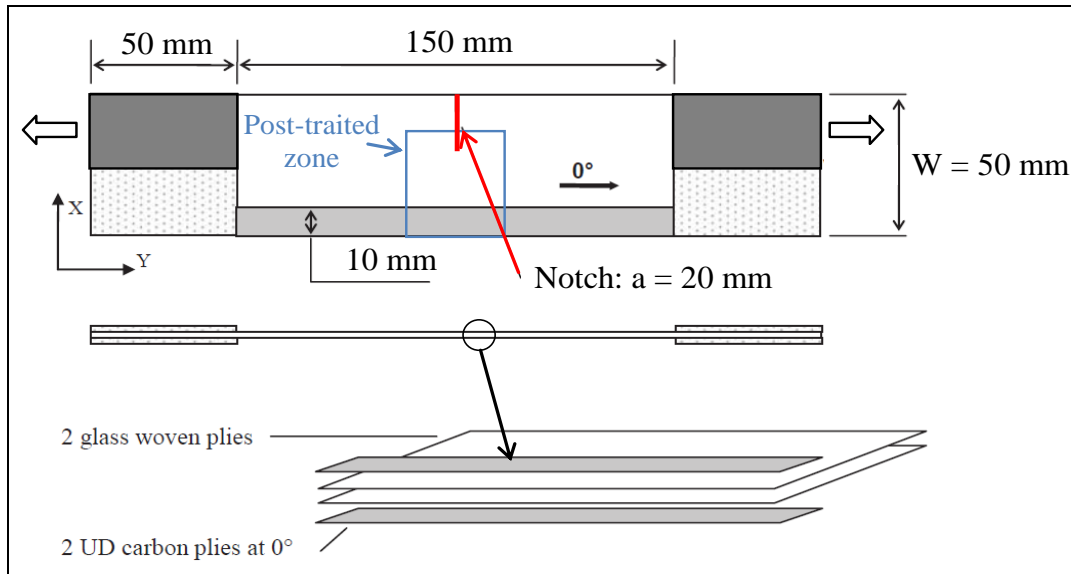
**Figure 2:** Geometry of the specimen

All the tests are performed at ambient temperature and under quasi-static tensile loading at constant speed equal to  $3 \text{ mm} \cdot \text{min}^{-1}$ . An infrared camera (FLIR SC700 MW) is used to monitor the thermal response during the tests. Sample are painted matt black and enclosed in a rectangular box made of expansive foam to measure temperature variation field avoiding external thermal perturbations. The experimental set-up was the following:

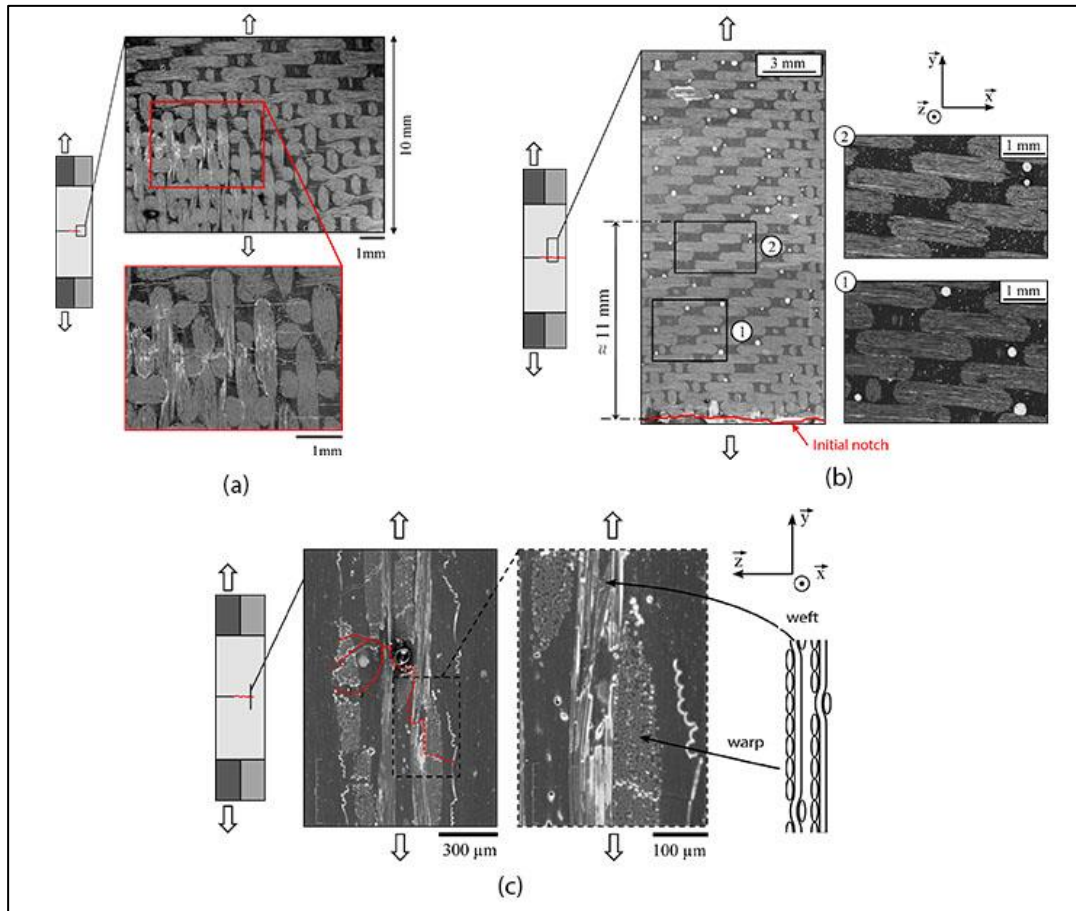
**Figure 3:** Micrographic views of the warp face (a) in notch tip, (b) after specimen failure and (c) transverse view in notch tip

A lot of studies [23-24, 27] have shown that the crack propagates in the notch axis following the weaving points. In our study, the notch tip damage corresponds to intralaminar failure of the weft woven but also propagation of vertical cracks in the warp woven (see **Figure 3**).

**Figure 3(b)** shows that intralaminar cracks are observed in weft woven until 11 mm above the notch. When the notch propagates, the specimen is completely cracked in the thickness with the failure of the warp woven (**Figure 3(c)**). Moreover, few of meta-delaminations and inter-ply delaminations are observed. The interlaminar cracks of warp woven contain "cups", typical features of shear failures (see **Figure 4**).

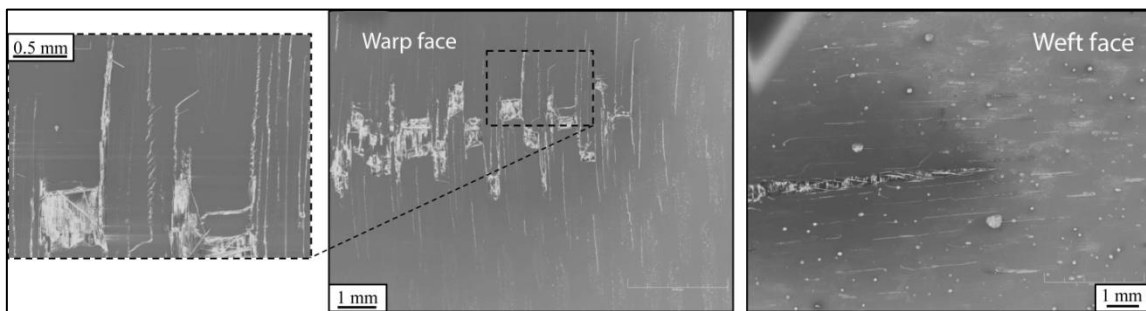
**Figure 4:** Micrographic views in notch tip obtained under SEM [Garcia, 2013]

Garcia [28] notices a lot of intralaminar cracks in transverse woven on the weft face. So the notch tip damage is the combination of the tensile damage and the shear damage. In order to characterize the size of the damaged zones, the heat source fields are calculated from thermal images (the post-treatment zone is presented in **Figure 2**). **Figures 5** and **6** show the results obtained from a test on weft and warp face.

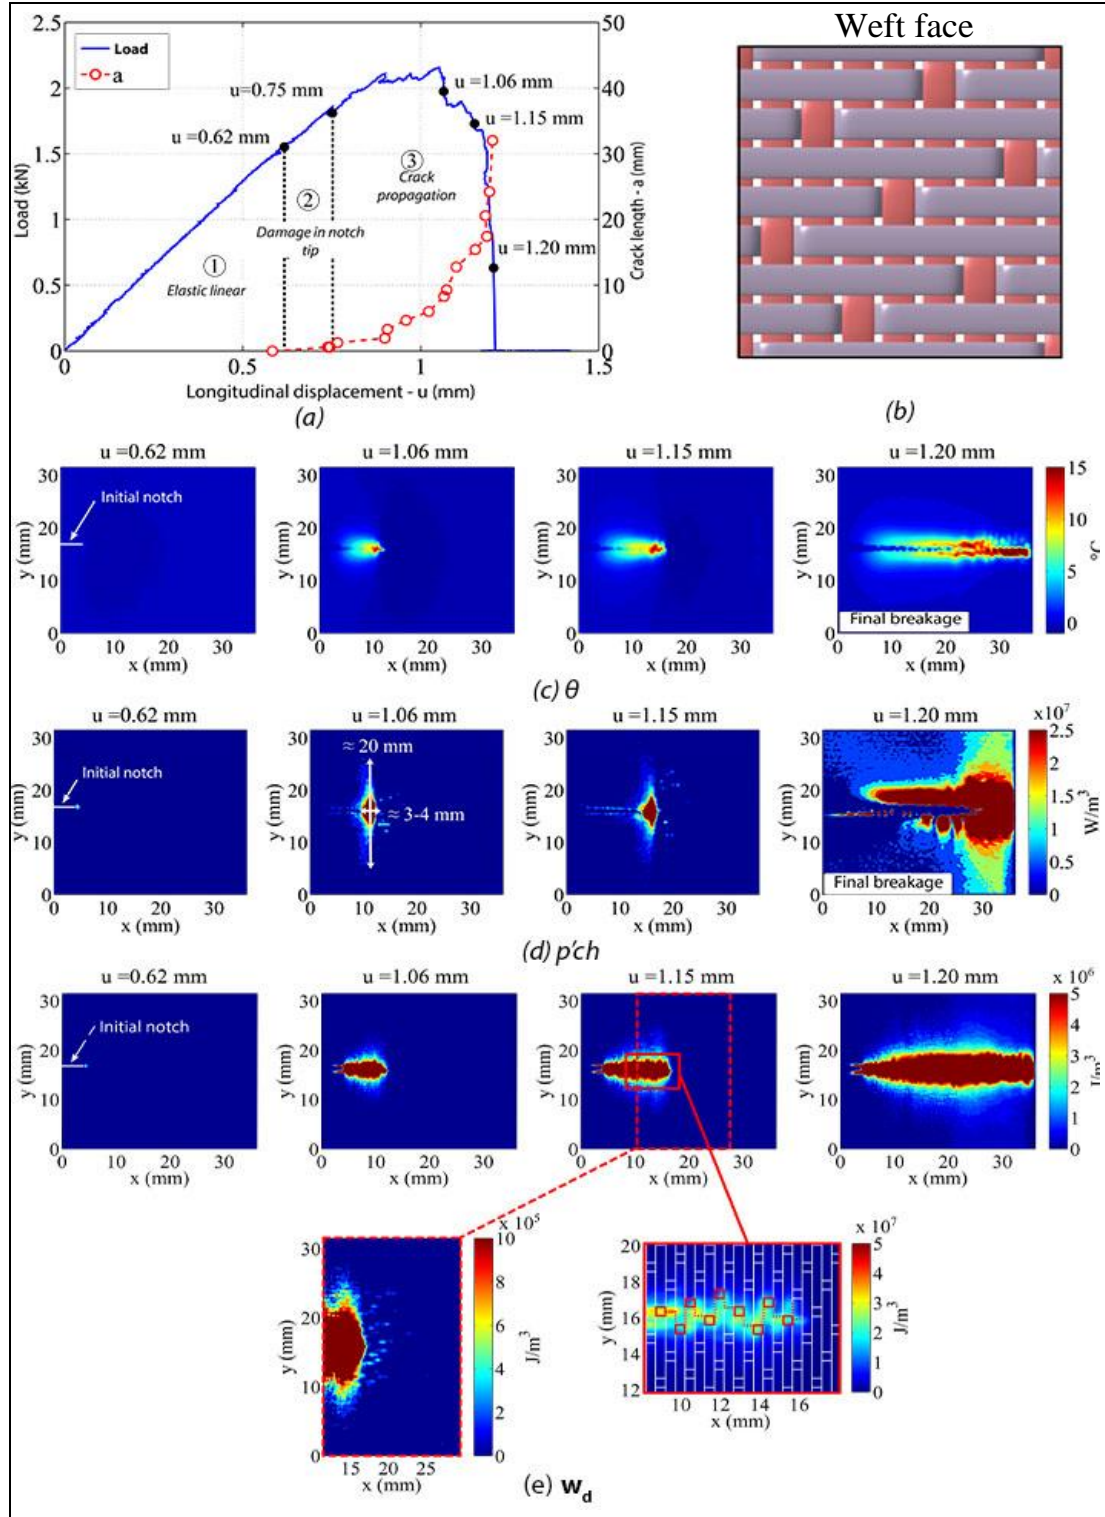
**Figure 5:** (a) strain/displacement curve; (b) weft face pattern; (c) temperature variation field  $\theta$ ; (d) heat source field  $p'_{ch}$  and (e) cumulated heat source field  $w_d$  on weft face

For both tests, a strong temperature elevation in notch tip appears firstly follows a thermos-elastic cooling zone. This zone looks like a cardioids showing a tensile state gathered post-damaged zone in notch tip. The damage scenario is decomposed in 3 zones regardless of the observed face (see **Figures 5 and 6**):

- **Zone 1:** this zone corresponds to elastic linear part of the strain/displacement curve. No damage is noted.
- **Zone 2:** damage grows in notch tip without a propagation of the initial crack. The first non-linearities on the strain/displacement curve are observed. For the warp face test, the notch instantly propagates after the damage initiation in notch tip. The space of this damaged zone depends on the position of the pre-cracked tip regarding the woven. In fact, the propagation instantly occurs after the damage beginning if the pre-cracked tip is inside a longitudinal woven. This damage corresponds to shear micro-cracking in longitudinal woven. In the case where the pre-crack is between two woven, the damage firstly propagates in the zones containing resin or transversal woven. **Figures 7(a) and 7(b)** show that the damaged zone size is the same for both faces. The zones are about 5 mm height and 1 mm width. Positive heat sources on the pre-cracked edges appear due to the displacement of the initial notch tip. The heat source fields (**Figures 5(d) and 6(d)**) show that the damage appears earlier weft face than warp face. So the cracks propagate firstly in the transversal woven then in the longitudinal woven.

- **Zone 3:** this part corresponds to the propagation of the initial pre-crack. **Figures 5(e) and 6(e)** show the cumulated heat sources fields  $w_d$ . The cumulated heat source fields on weft face at  $u = 1.15$  mm show that the initial crack propagates in the transversal direction following the weave, as [23-24] have observed during fatigue tests. During the crack propagation, the source fields  $p'_{ch}$  (**Figures 5(d) and 6(d)**) highlight many micro-cracks in

weft and warp woven, longitudinal fibre failures and interface debonding. A strong dissipative part around the notch underlines a strong damage concentration (concentration of fibre failures, micro-failures and pseudo-plasticity). The heat sources become blurred far from the notch (micro-failures and interface debonding). Smaller heat sources are observed in front of this damaged zone. They are produced by the transversal woven failure. A big number is observed on the weft face where the transverse woven is important. Finally the cumulated heat source fields show that the crack propagation comes with a damage of 10 to 15 mm length around the crack. When the crack is near the specimen edge, the final failure occurs quickly and the heat sources are disrupted by the specimen displacements due to the elastic return of the specimen.

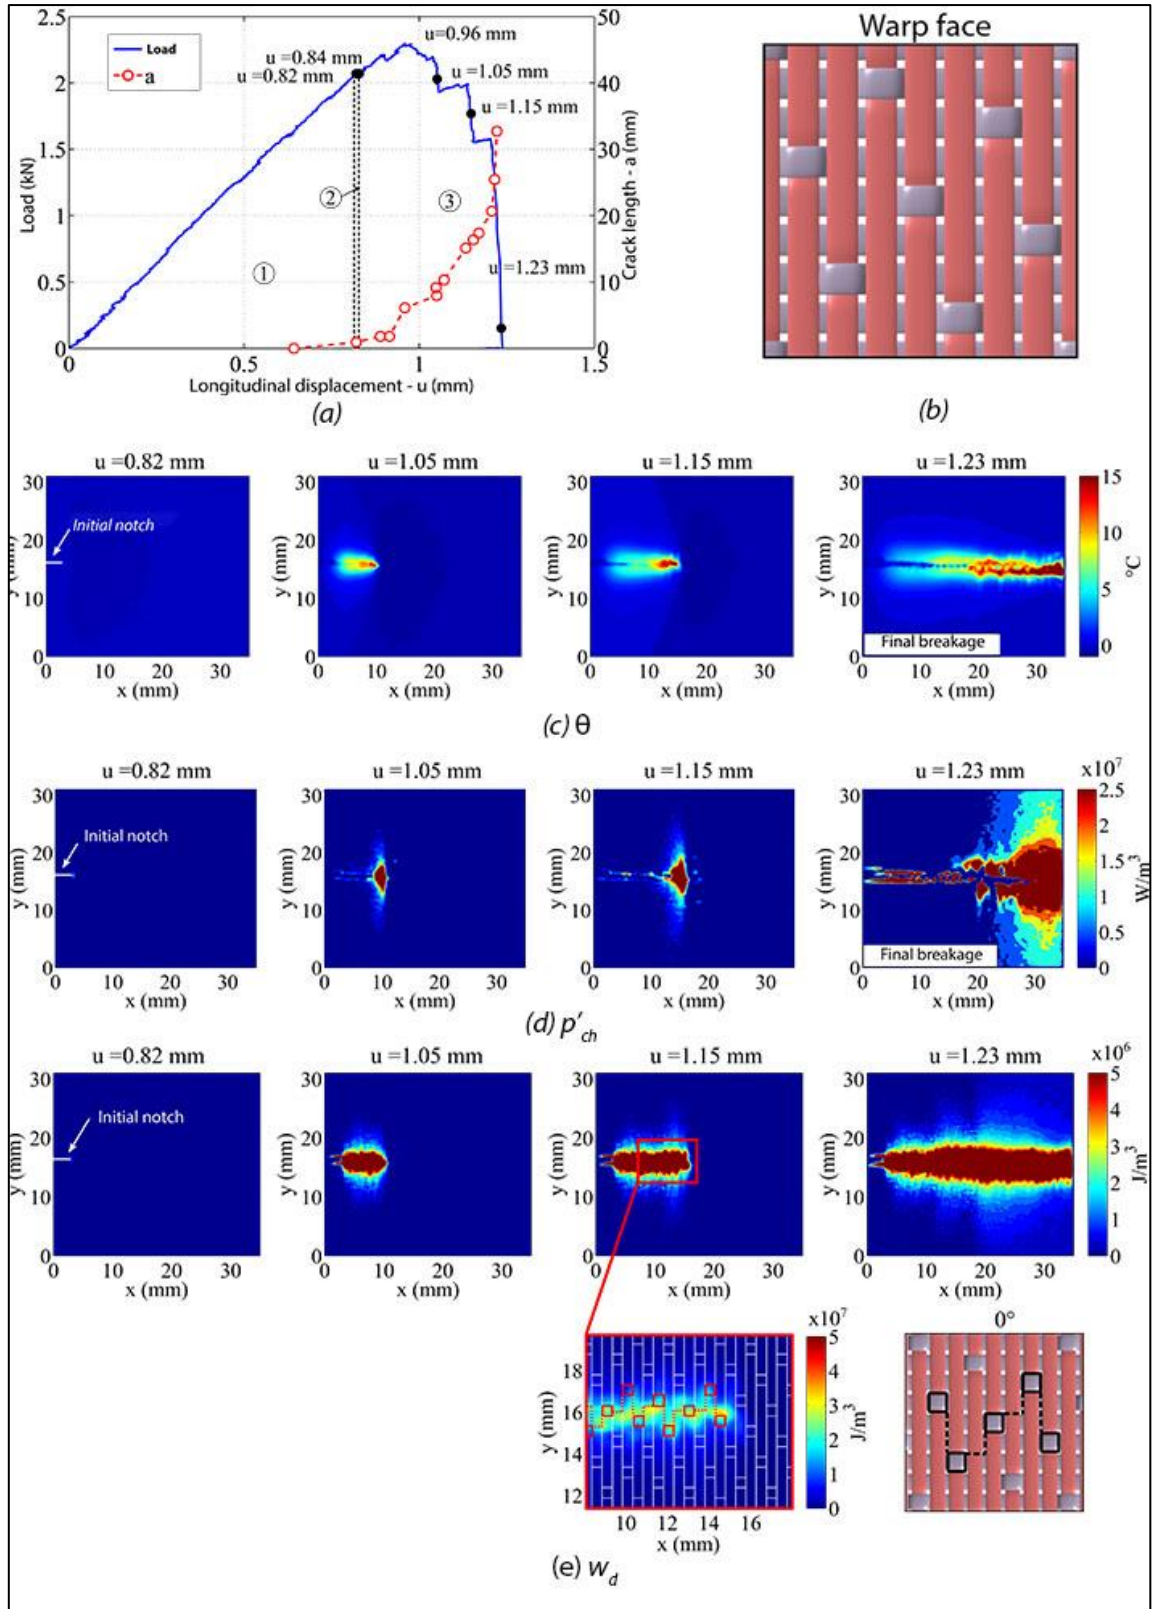
**Figure 6:** (a) strain/displacement curve; (b) warp face pattern; (c) temperature variation field  $\theta$ ; (d) heat source field  $p'_{ch}$  and (e) cumulated heat source field  $w_d$  on warp face

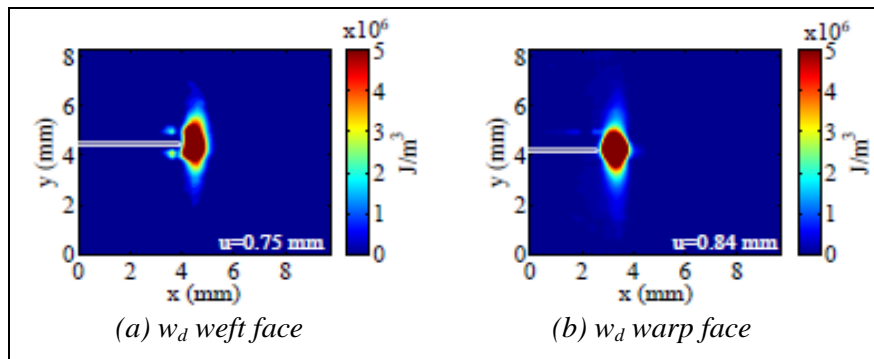
**Figure 7:** Comparison of the damaged zones size (a) weft face and (b) warp face before the crack propagation

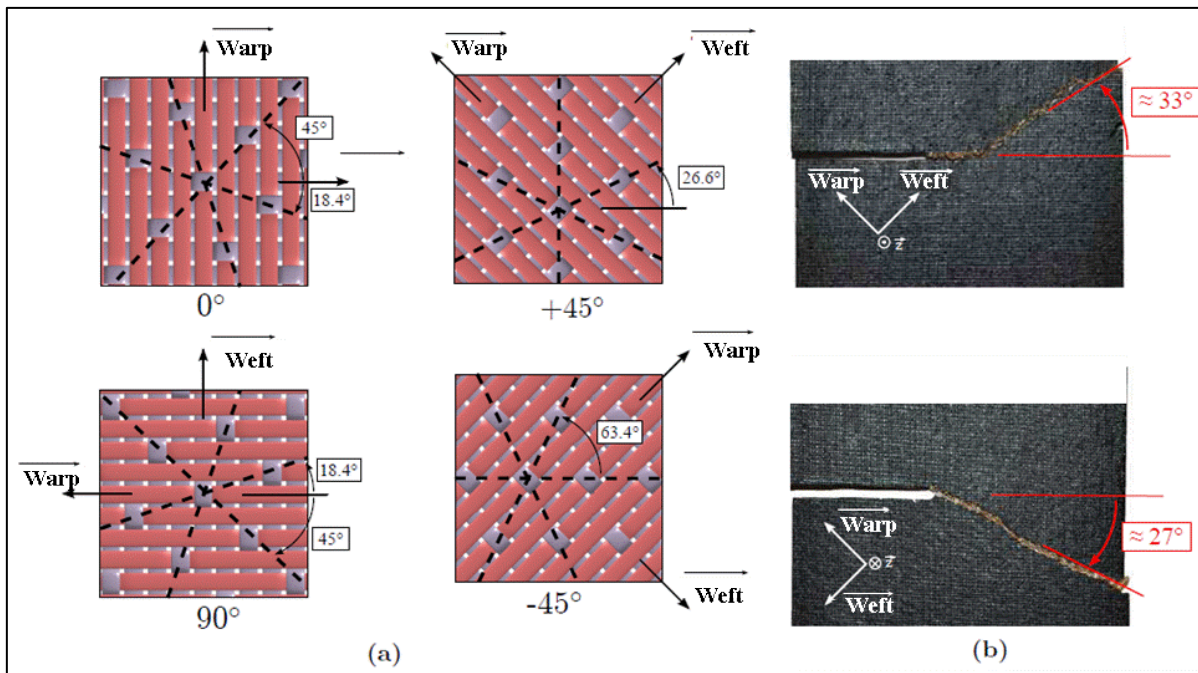
**Figure 8:** (a) Warp face of the weave pattern oriented in the directions  $0^\circ$ ,  $90^\circ$ ,  $+45^\circ$  and  $-45^\circ$ . (b) Photographs of the  $\pm 45^\circ$  specimens after spread of the notch

For propagation tests on  $[\pm 45^\circ]$  composites the direction of the cut is still governed by the position of weaving points (**Figure 8**). However, depending on the ply which controls the propagation ( $+45^\circ$  or  $-45^\circ$  ply), the notch path may be variable. **Figure 8a** shows the preferred alignments of weaving points to several directions of the woven ply. For plies oriented at  $+45^\circ$  the weaving points have preferred orientations:  $\pm 27^\circ$  and  $90^\circ$  relative to the horizontal. For  $-45^\circ$  plies the characteristic angles are  $0^\circ$  and  $\pm 63^\circ$ . **Figure 8b** shows the fracture surfaces obtained for two different tests. The observed disparity reflects the poor reproducibility of the cut paths. Indeed, in the first case the notch is initially propagates horizontally then bifurcates at an angle of about  $33^\circ$  relative to the horizontal, which suggests that the  $-45^\circ$  ply and the  $+45^\circ$  ply control successively the propagation (see warp face, **Figure 8a**). For the second specimen (weft face, **Figure 8b**), the propagation is totally controlled by the  $+45^\circ$  ply since the cut has an orientation at an angle of  $27^\circ$  relative to the horizontal.

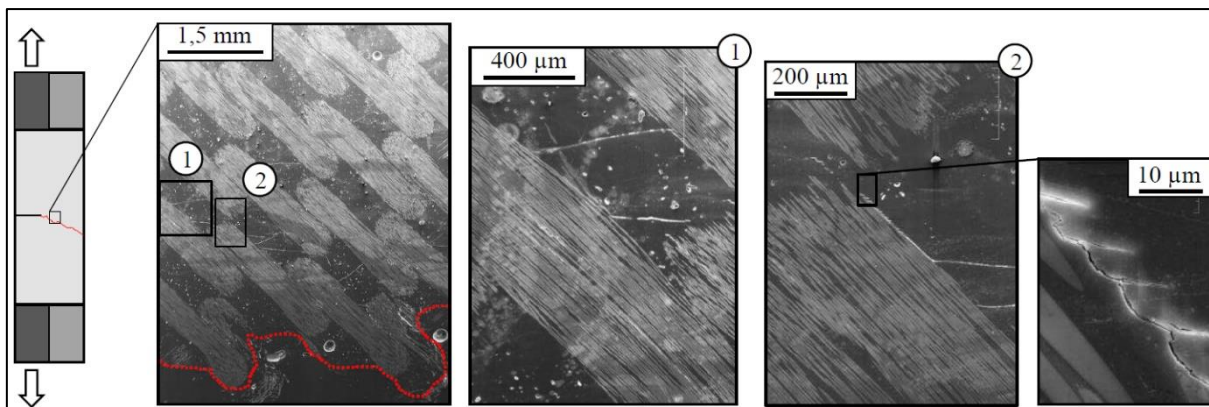
**Figure 9:** Micrographs after breakage of the warp face of a  $\pm 45^\circ$  specimen

The damage observed on a microscopic scale is essentially characterized by shear microcracks in transverse and longitudinal strands (**Figure 9**). These microcracks initially parallel to the fibre direction propagate almost horizontally between two successive strands. The absence of "cups" on these cracks leads us to believe that the spread of intralaminar shear cracks is due to resin breakage.

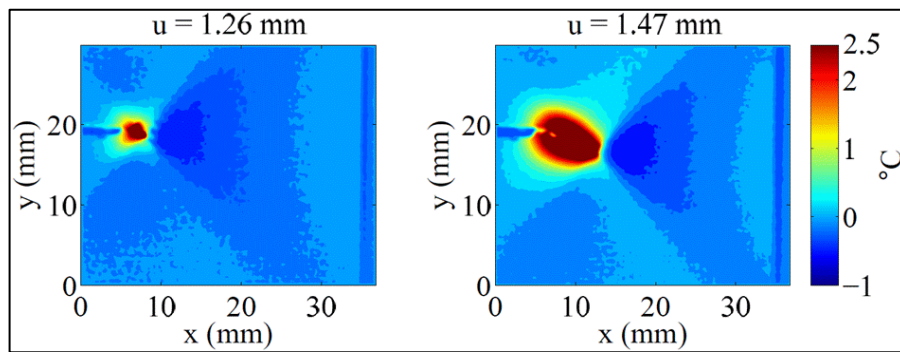
**Figure 10:** Micrographs after breakage of the warp face of a  $\pm 45^\circ$  specimen

cooling is observed in front of the damaged area. The cooling zone is of triangular shape. The sides adjacent to the crack tip are oriented  $\pm 45^\circ$  to the horizontal (**Figure 10**). This indicates that the tension zone at the crack tip is bounded by the first  $+45^\circ$  and  $-45^\circ$  unbroken strands which transmit the load. Furthermore, when the notch approaches the specimen edge, the local field of elastic stresses changes also due to edge effects, affecting the elastic cooling, see **Figure 11c** (weft face,  $u = 1.51$  mm) and **Figure 12c** (warp face,  $u = 1.76$  mm).

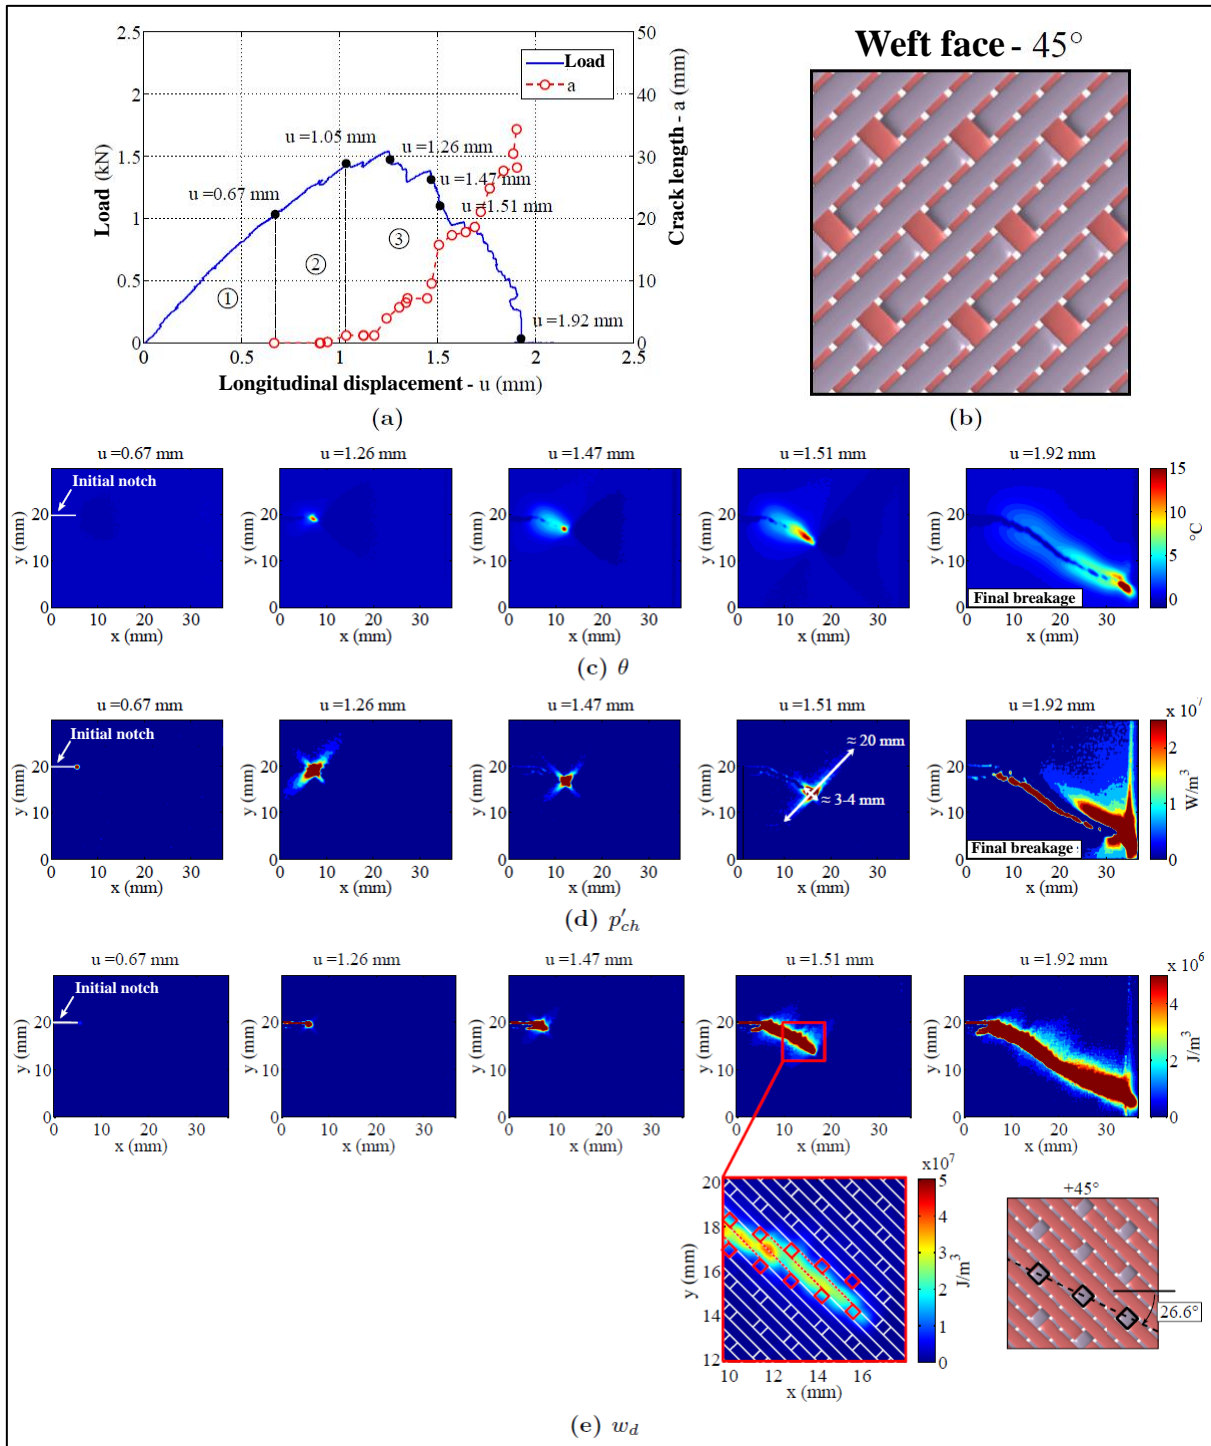
**Figure 11:** Weft face: (a) load vs displacement; (b) weave pattern; (c) changes in temperature fields ( $^\circ\text{C}$ ), (d) heat source fields  $p'_{ch}$  ( $\text{W/m}^3$ ) and (e) cumulative heat source fields  $w_d$  ( $\text{J/m}^3$ )

As for  $[0^\circ]_2$  specimens, changes in temperature of both faces were monitored by IRT (**Figures 11 and 12**). For both cases, a concentrated heating is observed at the crack tip. A maximum rise in temperature of about  $24^\circ\text{C}$  is reached during propagation. A thermos-elastic

As for  $[0^\circ]_2$  specimens, **Figures 11** and **12** allow us to define the notch propagation scenario into three zones: a linear elastic region (1), an area where the damage develops tip of the initial notch (2) and a propagation zone (3). Zone 2 begins nearly at the same displacement for both tests. The cumulative heat source fields (**Figures 11-e** and **12-e**) show that just before the crack propagation extensive damage developed in the direction of the warp and weft strands. The shape of the damaged area is comparable to that of a cross on the weft face (**Figures 10-d**). As for  $[0^\circ]_2$  specimens, the initial notching conditions may explain this disparity. For both cases damaged area is about 1 to 2mm<sup>2</sup> and is smaller than those observed for  $[0^\circ]_2$  specimens. During crack propagation a field of high intensity sources surrounds its path and more diffuse heat sources develop in the directions of the  $+45^\circ$  and  $-45^\circ$  yarns. A “cross” is then observed mainly resulting from the spread of intralaminar shear cracks parallel to the direction of the yarn. Comparing the obtained results with those for  $[0^\circ]_2$  specimens:

- the damaged area observed during the notch propagation is similar;
- positive heat sources are also detected;
- the extent of the damaged area during the propagation and the resulting cumulative heat source fields (**Figures 11-e** and **12-e**) are also similar.

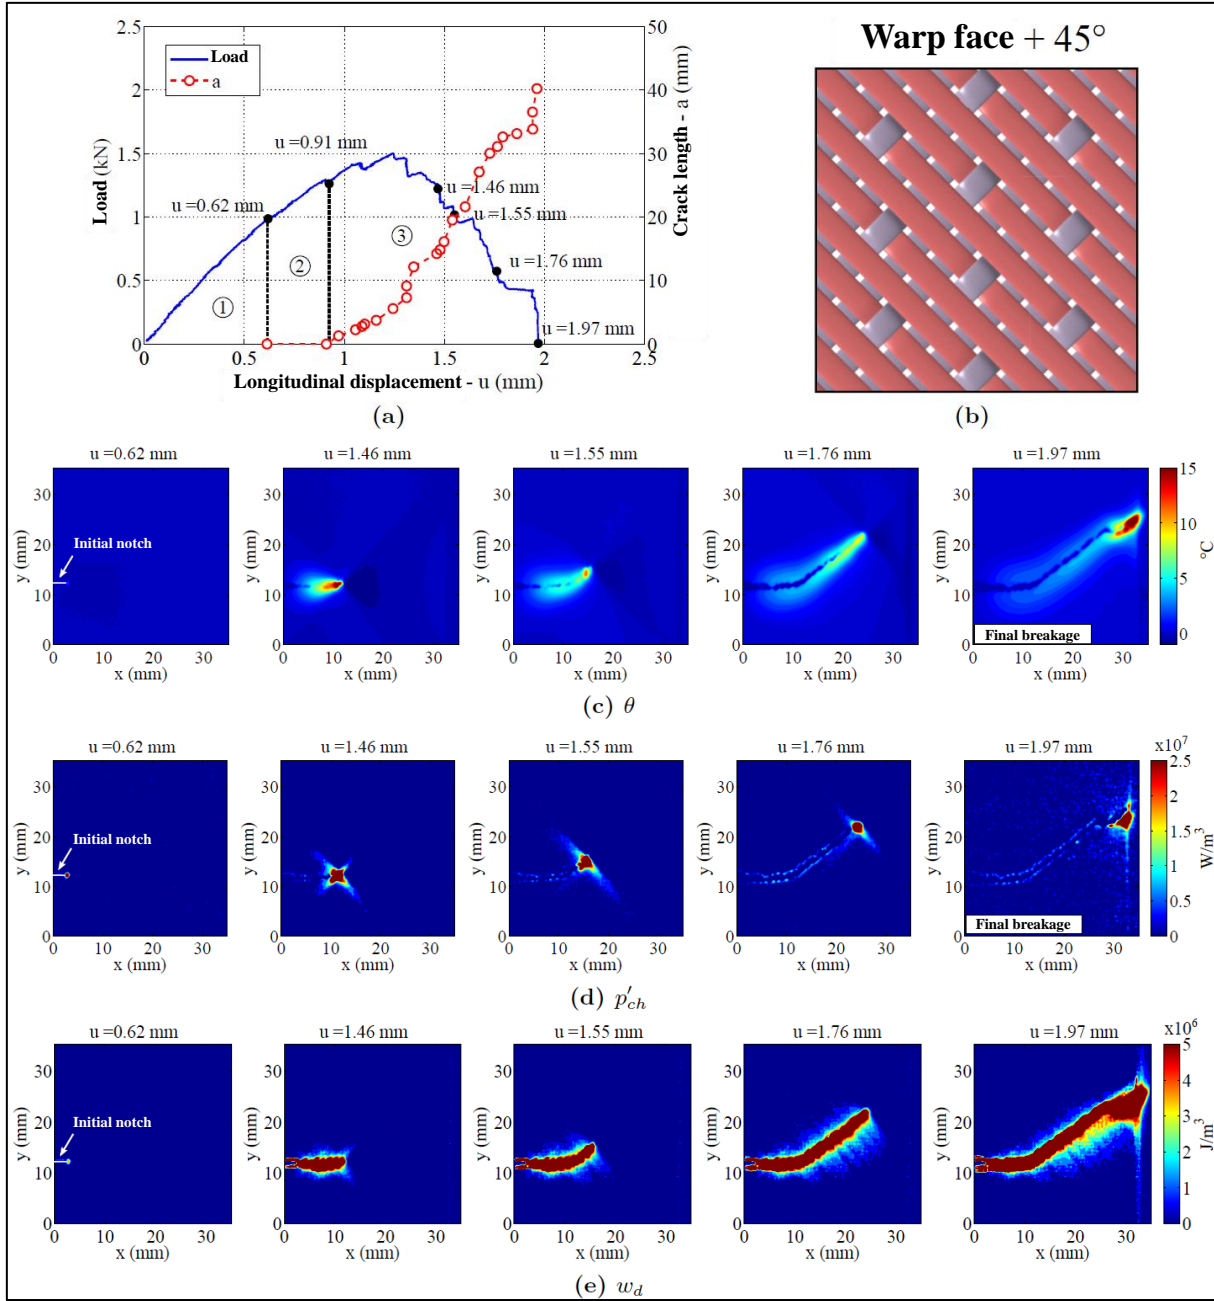
**Figure 12:** Warp face: (a) load vs displacement; (b) weave pattern; (c) changes in temperature fields ( $^{\circ}\text{C}$ ), (d) heat source fields  $p'_{ch}$  ( $\text{W}/\text{m}^3$ ) and (e) cumulative heat source fields  $w_d$  ( $\text{J}/\text{m}^3$ )

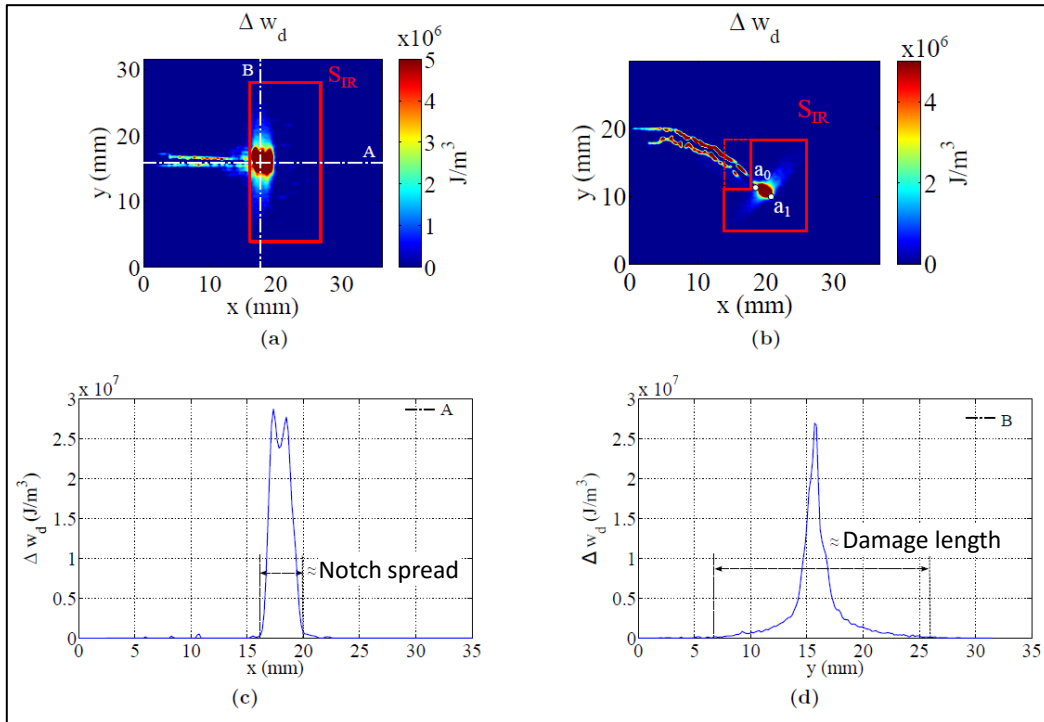
**Figure 13:** Cumulative source fields  $\Delta w_d$  during a notch propagation: (a)  $[0^\circ]_2$  weft side and (b)  $[\pm 45^\circ]_2$  weft side. Changes in  $\Delta w_d$  along profile: (c) A and (d) B defined in (a)

**Figure 13a** shows an example of cumulative heat source fields at crack tip on a  $[0^\circ]_2$  specimen.  $a$  (**Figure 13c**) is measured using profile A defined in **Figure 13a**. The damage length (**Figure 13d**) is measured using profile A defined in **Figure 12a**. Hence the size of the damaged area is known and sets the minimum size of the integration area  $S_{IR}$  (**Figure 13a** and b). For  $[\pm 45^\circ]_2$  specimens the cut path is not horizontal. Crack length is estimated as the norm of the vector defined by  $a_0$  and  $a_1$  (**Figure 13b**).  $G$  is here measured with a modified  $S_{IR}$  in order not to take into account the displacements of the crack edges (**Figure 13b**).  $\beta$  is estimated as the ratio of the rate of heat energy release  $G_{ir}$  and the energy release rate  $G$  (irreversible mechanical energy release rate).

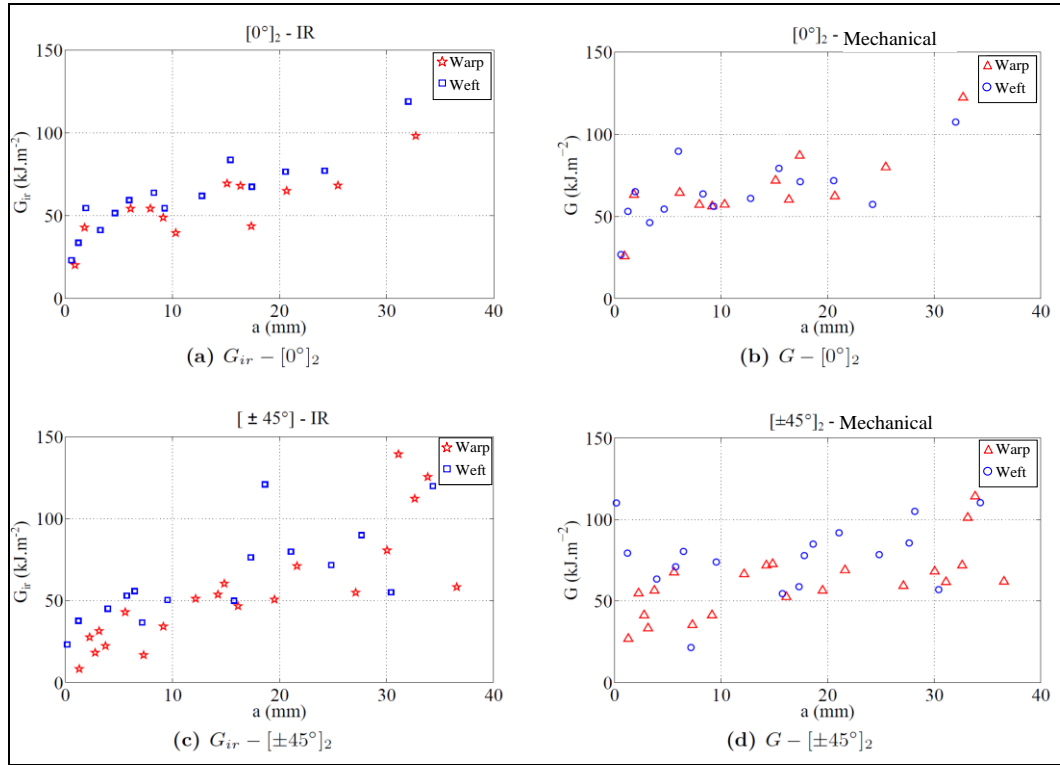
**Figure 14:** Comparison -on weft and warp faces- of the changes in: (a)  $G_{ir}$  and (b)  $G$  for  $[0^\circ]_2$  specimens and (c)  $G_{ir}$  and (d)  $G$  for  $[\pm 45^\circ]_2$  specimens

**Figure 14a** shows the changes in  $G_{ir}$  depending on cut spread for  $[0^\circ]_2$  specimens. Changes in corresponding  $G$  -calculated from the areas method- are given in **Figure 14b**. The evolution of  $G_{ir}$  is comparable for both sides, even if it is found that values obtained on warp face

are slightly lower. The same trends are observed for propagation tests on  $[\pm 45^\circ]_2$  specimens (Figure 14c and d).

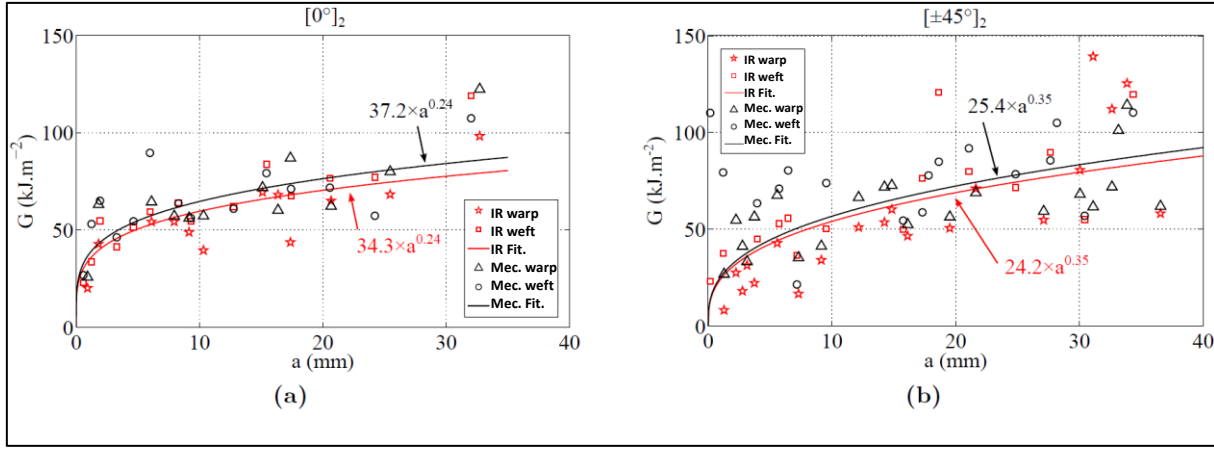
**Figure 15:** Comparison of energy release rates  $G$  and  $G_{ir}$  for configurations (a)  $[0^\circ]_2$  and (b)  $[\pm 45^\circ]_2$

For both configurations, the heat energy release rates *Gir* and mechanical *G*, with associated R-curves (IR fit. and Mec. Fit), are compared in **Figure 15**. R-curves obtained by measuring heat energy remains below those obtained from the estimation of the mechanical energy. For each configuration, an average value of  $\beta$  is then estimated as the ratio between the calorific and the mechanical R-curves. R-curves are approximated using power laws:  $G = m.a^n$ , where  $n$  is respectively set to  $n_0 = 0.24$  and  $n_{45} = 0.35$  for [0°]<sub>2</sub> and [±45°]<sub>2</sub> configurations.  $\beta$  is thus the ratio of  $m$  coefficients. This set value of  $n$  requires that the irreversible mechanical proportion of energy converted to heat remains constant during initiation and propagation of the cut for each configuration. If the spread is stable, notch-tip damages are supposed qualitatively and quantitatively identical and  $\beta$  remains constant. However, define an identical  $\beta$  for propagation and initiation is more debatable. However, areas method is too imprecise to obtain quantitative data when the stiffness variations are small as at the initiation of cracking.  $\beta$  therefore could not be accurately assessed for initiation.

The obtained average values are  $\beta_0 = 0.92$  and  $\beta_{45} = 0.95$ . This indicates that the majority of irreversible mechanical energy is dissipated as heat. As seen previously crack tip damage occurs mainly by multiple microcracks, fibre fractures and interface debonding. With such a high  $\beta$  it can be concluded that the proportion of pseudo-plasticity (shear in the resin) remains low and is mainly localized at the crack tip. It is therefore likely that the damage at the crack tip spreads mainly in the form of longitudinal and transverse microcracks in the yarns, thus relaxing the shear stresses in the resin-rich areas before that they reach their pseudo- hardening threshold.
