Lessons from the autumn 2014 flash floods in the city of Nîmes and its neighborhood (France): behaviour of several mitigation dams and hydrological analysis

C. Fouchier, P. Mériaux, G. Pla, J.L. Nuel, E. Retailleau, P. Royet

Lessons from the autumn 2014 flash floods in the city of Nîmes and its neighborhood (France): behavior of several mitigation dams and hydrological analysis

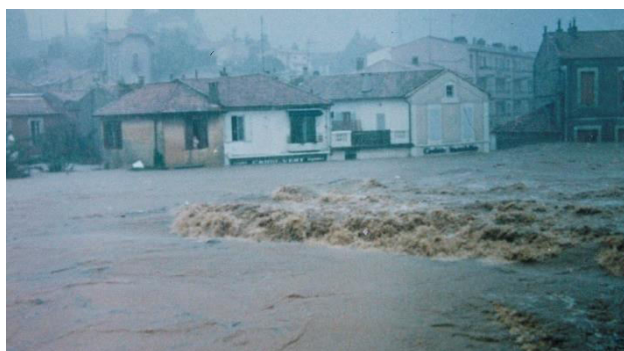
This extremely high vulnerability to torrential runoffs was tragically highlighted by the event of October 3, 1988 (see Fig. 2). At that time, rainfall exceeded 420 mm in 7 to 8 hours, generating specific flow rates that ranged from 20 to 25 m³/s/km². In several places, water levels in the city centre rose above 2 meters. Overflow volumes that transited through the city are estimated at 14 million m³. This event caused the death of 9 people and affected 45,000 other. The total economic cost of the event amounted to €610 million (in 1989 value). The return period of this event was estimated between 2,000 and 10,000 years, depending on the site

Figure 2. Overflowing of the Alès *Cadereau* at the entrance of Nîmes' urban area - October 3, 1988.

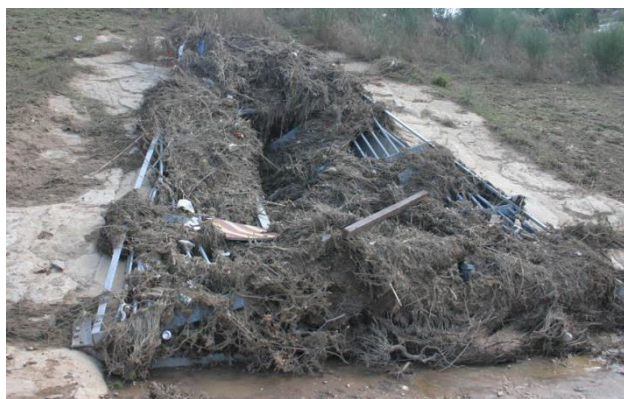
- driving anchoring clay keys deeper depending on the presence of cracked limestone substratum
- specific treatment of crackings in the limestone massif;
- creating a complete internal clay core, when early structures were made with a simple clay anchoring key;
- acceptance of earthworks for the clay anchoring key and a continuous supervision of the implementation of the waterproof clay core layers;
- modifications of the concrete encasement of the bottom outlets, to improve water tightness at the clay-concrete interface;
- modifications to geometries and sizing of the bottom outlet upstream protection screen following the collapse of some fence due to plant debris deposits when water levels fall (see Fig. 3).

Figure 3. Example of bottom outlet fence collapse.

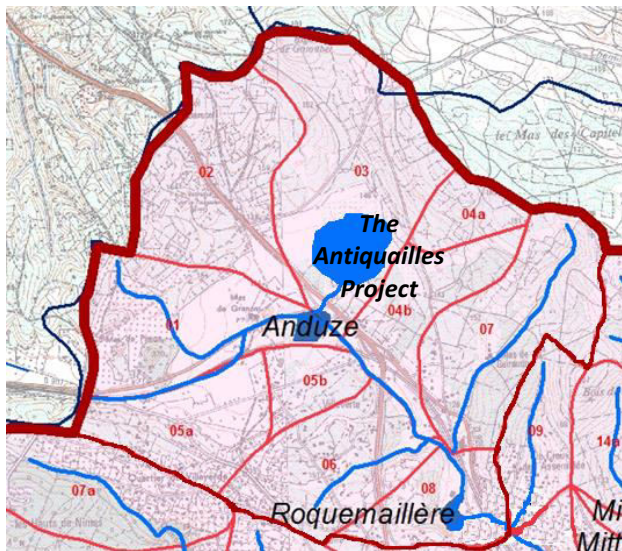
The Roquemaillère dam is located on the upstream part of the Alès *Cadereau* at the outlet of a 7.3 km² catchment area (see Fig. 6).

Figure 6. Catchment area of the Roquemaillère Basin.

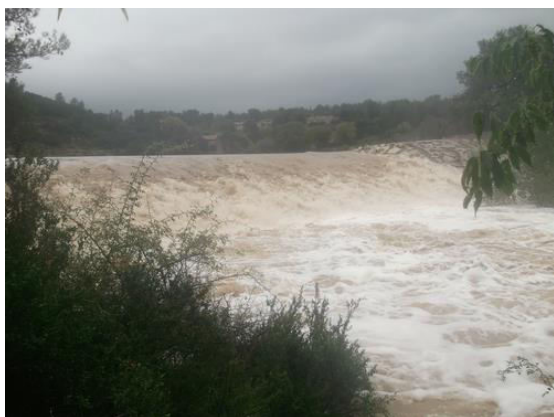
During the event, the safety spillway of Roquemaillère dam was used as can be seen from Figure 7. The water level reached 90 cm above the safety spillway crest, corresponding to a 68 m³/s peak flow.

Figure 7. The Roquemaillère basin safety spillway, October 10, 2014, at 9:30, shortly before the flood peak (estimated Q = 68m³/s).

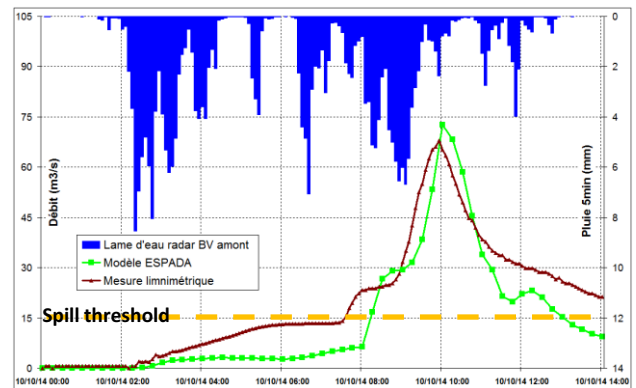
Hydrologic modeling of the ESPADA system gives a satisfactory representation of the flood hydrograph immediately downstream of the basins, notably in terms of peak flow (See Fig. 8).

Figure 8. Calculated and observed output discharges downstream of the Roquemaillère Basin.

The peak flow computed by the ESPADA is 73m³/s, similar to the measured peak discharge of 68 m³/s. What can be noticed is that the hydrologic model does not anticipate the discharge, the calculated discharge is indeed delayed from about 30 minutes. The spillway began to work at 7:40 am. At the 7:00 modeling run, the real-time model forecast that the spillway would start to work at 8:15, and confirmed this forecasting at the 7:30 run. The timing of the flood peak and of the recession curve are better forecast by the model.

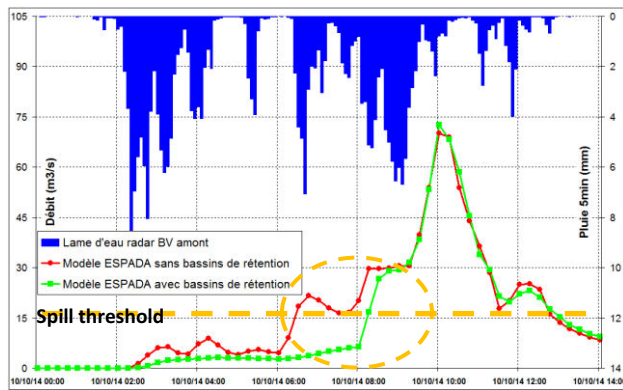
The hydrologic model also makes it possible to compare hydrographs calculated with or without the existing retention basins (see Fig. 9). The comparison of these hydrographs shows that the the Roquemaillère dam was able to play its flood-mitigation role at the beginning of the event. Thanks to its storage capacity, it would have enabled then a 50% reduction of the volume of water drained by the upstream watershed as shown on figure 9 by the dotted circle. It thus limited downstream runoffs in the morning of October, 10th giving additional time to manage the episode. Due to its spillway entering into service at 7:40 am, the dam was however no longer able to play its flood mitigation role at the end of the event, in

Figure 9. Calculated output discharges downstream of the Roquemaillère Basin. The hydrograph in red shows the discharges computed as if no hydraulic works were existing on the catchment, the hydrograph in green show the discharges computed with the current hydraulic retention basins (Roquemaillère and Anduze).

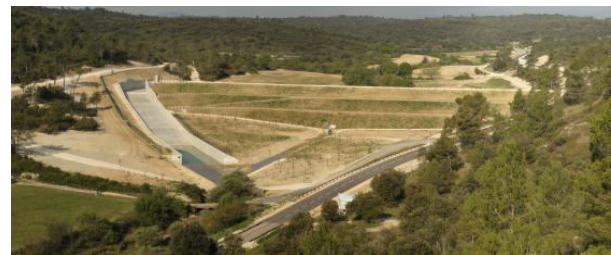
Against this background, the Gardons SMAGE decided to build the Saint Geniès de Malgoirès flood-mitigation dam (see Fig. 10) with fundings from european (20%), national (40%) and local levels (40%). The dam was designed to avoid overflowing in the village for floods with a short return period (20 years), and to divide 100-year flood runoffs by two.

Figure 10. Saint Génies de Malgoirès Dam.

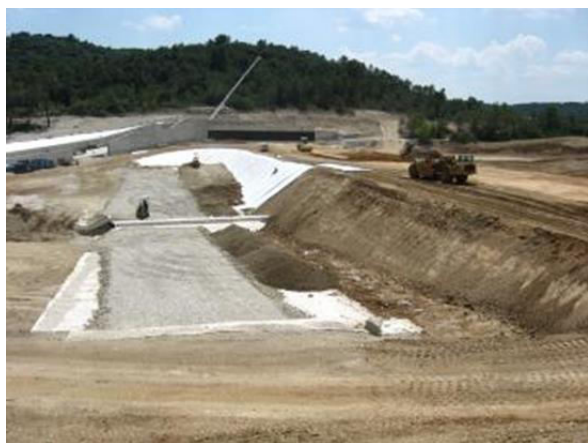
The dam comprises a zoned embankment: a clay core rests on upstream and downstream shoulder. It is 14m high and 205m long, and has a drainage system (see Fig. 11). A bottom outlet enables to evacuate the Esquielle River's usual runoffs. A runoff-reducing plate limits the bottom outlet section to 50 cm by 40 cm, the output discharge is then limited to 1 to 2 m³/s, thus allowing a

Figure 11. Dam construction site: view of the zoned shell, the bottom sluice, the drainage geotextile, the waterproof core, and the flood gate.

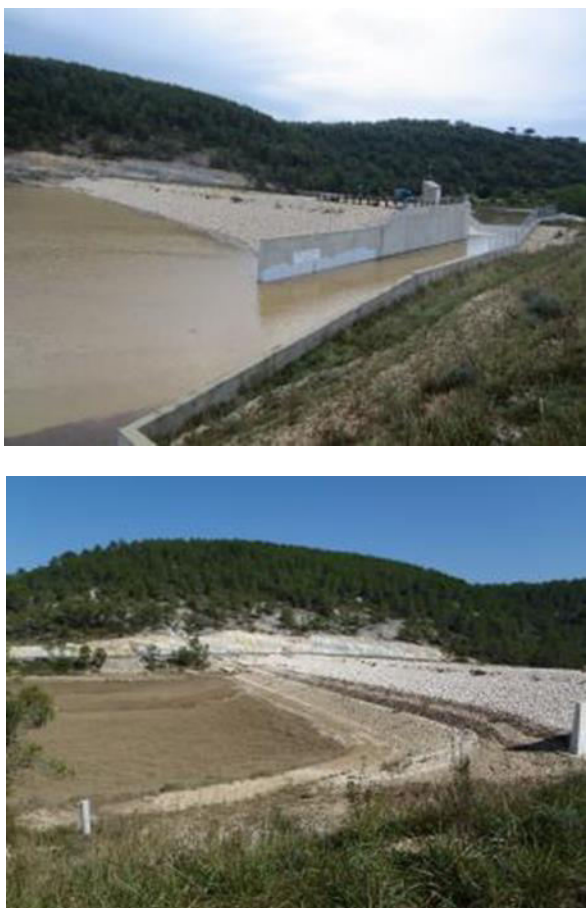
Visits were organized during the event while the structure contained water and during its drainage (See Fig. 12). These guaranteed that the structure was operating properly. A very small amount of debris was found at the dam level. No emergency intervention was required. A clean-up operation was programed for the piezometric sensors and the plant debris on the dam upstream face and at the level of the flood gate. The only significant element was that covering sealants were ripped off the spaces between the concrete blocks of the flood gate. Being too rigid, they cracked and have been damaged prematurely. Sealants were replaced early 2015. As it was the flood gate's first filling, it was decided, during an in-depth technical visit, to empty and clean the energy dissipation hole of the flood gate. This further confirmed that this permanently immersed part of the structure was in a healthy state. Suspended matter was found at the bottom of the pit.

Figure 12. Dam during one of the flood events: during the event (top) / after it has drained (bottom).

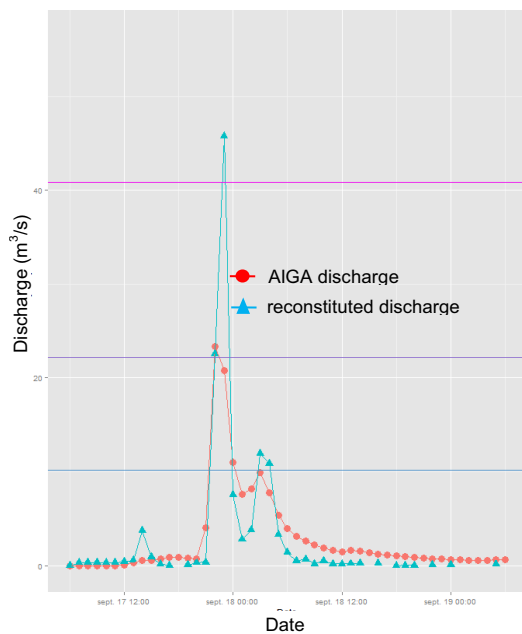
The figure 13 shows the hydrograph modeled using the AIGA method and the hydrograph that has been reconstituted at the reservoir input. It is worth underlying that the AIGA method implemented here is the 1st version of the method which was calibrated on the runoff values of 160 watersheds located in Southeastern France [1]. The method was not locally based on the Esquielle watershed discharge values. Runoff data that can be reconstituted from measurements of water surface levels are an interesting opportunity to test the method performance. This comparison shows that the flood's overall dynamic is adequately reproduced, with a 30-minute anticipation of the flood peak, and a similar anticipation of 2-year and 10-year quantiles, these peak excesses defining the first two levels of alert proposed by the method.

Figure 13. Input and modeled hydrographs on 9/17/2014 at the Esquielle dam.
