Effect of new sealing treatments on corrosion fatigue lifetime of anodized 2024 aluminium alloy

Bertrand Priet, Grégory Odemer, Christine Blanc, Kévin Giffard, Laurent Arurault

Bertrand Priet, Grégory Odemer, Christine Blanc, Kévin Giffard, Laurent Arurault. Effect of new sealing treatments on corrosion fatigue lifetime of anodized 2024 aluminium alloy. *Surface and Coatings Technology*, 2016, 307, Part A, pp.206-219. 10.1016/j.surfcoat.2016.07.083 . hal-01480521

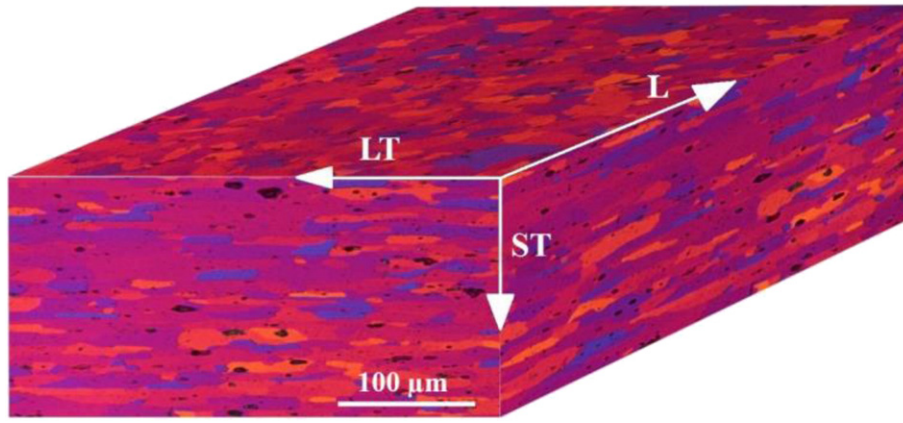
Fig. 1. Optical view of a 2024-T351 rolled plate after electrochemical etching.

Fig. 1 shows an optical microscope (OM, Olympus PMG3) observation of the elongated grain structure of the 2024-T351 rolled plate under polarized light. Before observation, the sample was mechanically abraded with up to 4000 grit SiC papers, polished up to 1 μm with diamond paste on the three characteristic planes and then etched. Electrochemical etching was conducted with HBF_4 (3.5 vol.%) in distilled water for 80s (twice 40s) under 20 V at room temperature. Due to the rolling process, a strong anisotropy of the microstructure was observed. The average grain sizes in L-LT, L-ST and LT-ST planes (L: rolling direction, LT: long transverse direction, ST: short transverse direction) are presented in Table 1.

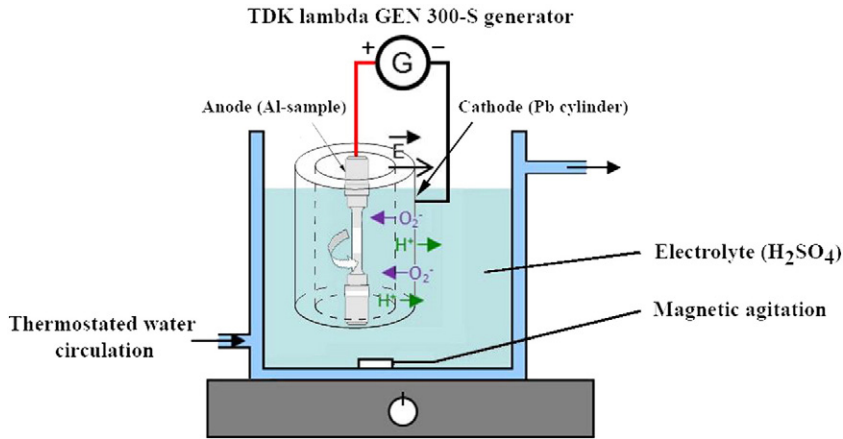
Fig. 2. Schematic illustration of the anodization experimental set-up.

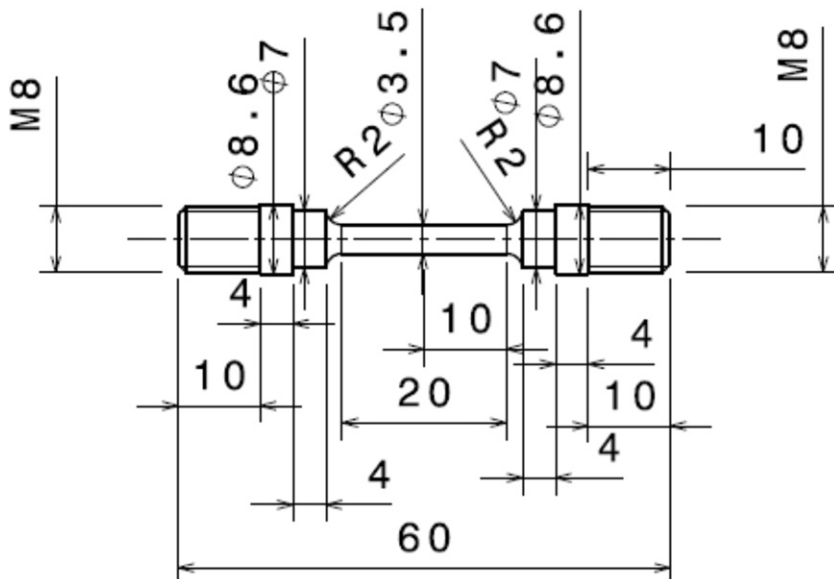
Fig. 3. Geometry of cylindrical fatigue samples.

fatigue tests), on a precision-aligned fatigue machine (BOSE ElectroForce 3330®). The fatigue sample shape is shown in Fig. 3.

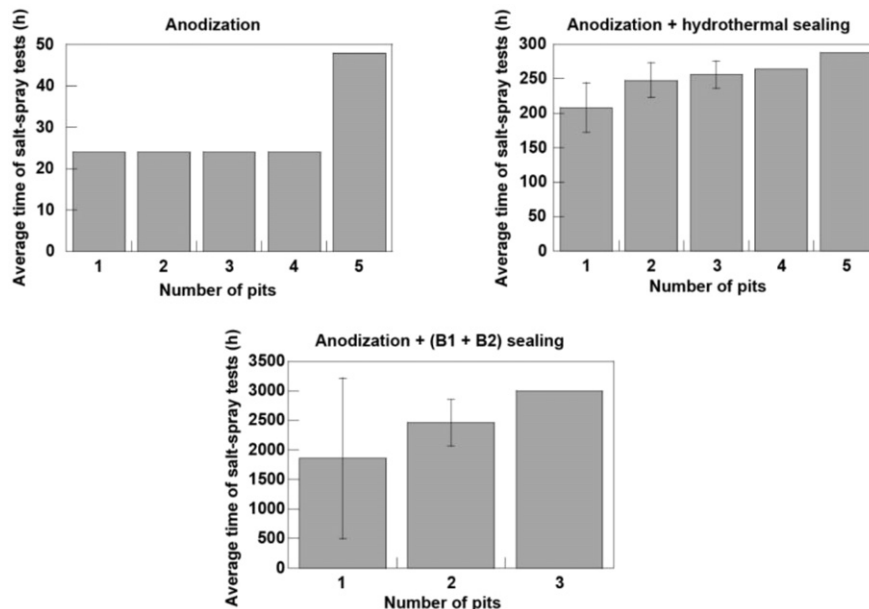
Fig. 4. Salt-spray test results for AA2024 T3 samples with (B1 + B2) sealing and comparison with a classical hydrothermal sealing and the unsealed anodic film.

Fig. 4 shows the results of salt-spray tests for anodized samples and sealed samples. For anodized samples without sealing, pits are observed after only 24 h of salt-spray tests while, for sealed samples, the first pit was observed after about 200 h of exposure for hydrothermal sealing and about 2000 h for (B1 + B2) sealing. Therefore, results highlighted the beneficial effect of sealing process on the corrosion resistance of the AA2024-T3 compared to the only anodized samples. They also showed that (B1 + B2) sealing induced a better corrosion protection than hydrothermal sealing.

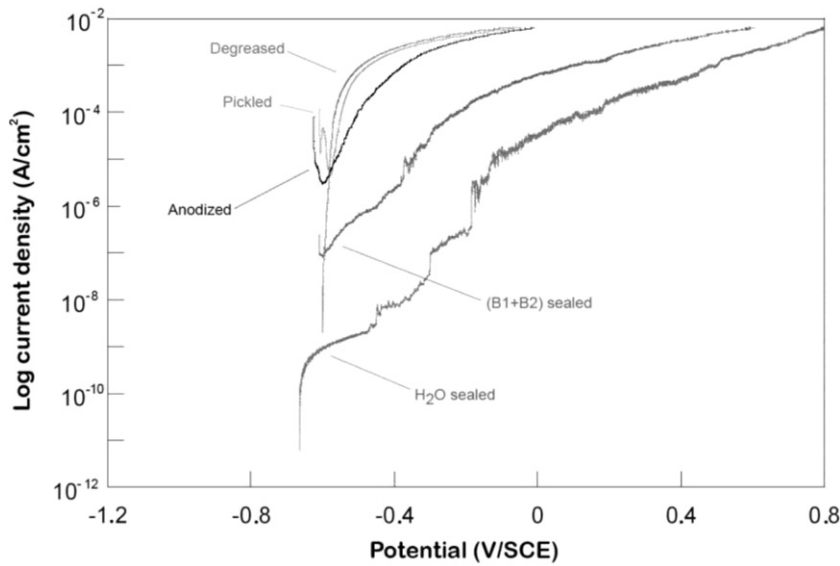
Fig. 5. Polarization curves of AA2024-T3 in 0.85 M NaCl (pH = 6) for each step of surface treatment.

Fig. 5 shows the anodic part of the current-potential curves for AA2024-T3 after each step of the surface treatment, i.e. degreasing, pickling, anodization and hydrothermal or (B1 + B2) sealing. For both the degreased and (degreased + pickled) samples, the strong increase of the current after the corrosion potential showed that the samples were susceptible to corrosion in this electrolyte, and in particular to pitting corrosion as shown by OM observations performed after the

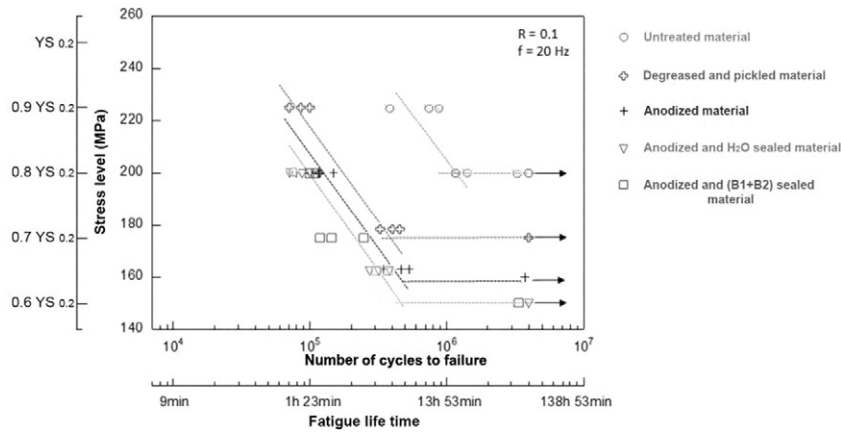
Fig. 6. Effect of surface treatment on fatigue life of AA2024-T351 in air at 25 °C.

Fatigue life curves are presented in Fig. 6 for non-corroded samples after each step of the surface treatment. Results showed a low scattering of fatigue lives on the basis of three fatigue tests performed at a given stress level. The surprising low scattering in fatigue lives for a given stress level will be explained later in this paper.

For the untreated alloy AA2024-T351, fatigue life decreased logically when the applied stress increased. The endurance limit was observed around 200 MPa, i.e. 80% of $YS_{0.2}$. Concerning the degreased and pickled material, a surprising decrease in fatigue life was observed, slightly less than one order of magnitude in comparison with the untreated metal; the result suggested that the pre-treatment, more probably the pickling step, has a strong influence on the material surface. The endurance limit was observed around 175 MPa, i.e. 70% of $YS_{0.2}$.

The anodization process following the pre-treatment (degreasing and pickling) induced a strong fatigue life decrease compared to the untreated material, i.e. one order of magnitude from 60% to 90% of $YS_{0.2}$, and an additional fatigue life decrease of 10% compared to the degreased and pickled material. The decrease in fatigue life for anodized aluminium alloy is consistent with the literature results [3–6] and, as a reminder, is related either to the brittle character of anodic film [11–14] or to tensile residual stresses [15] that finally promote crack initiation. However, these results suggested again that mainly pickling was responsible for the fatigue life decrease.

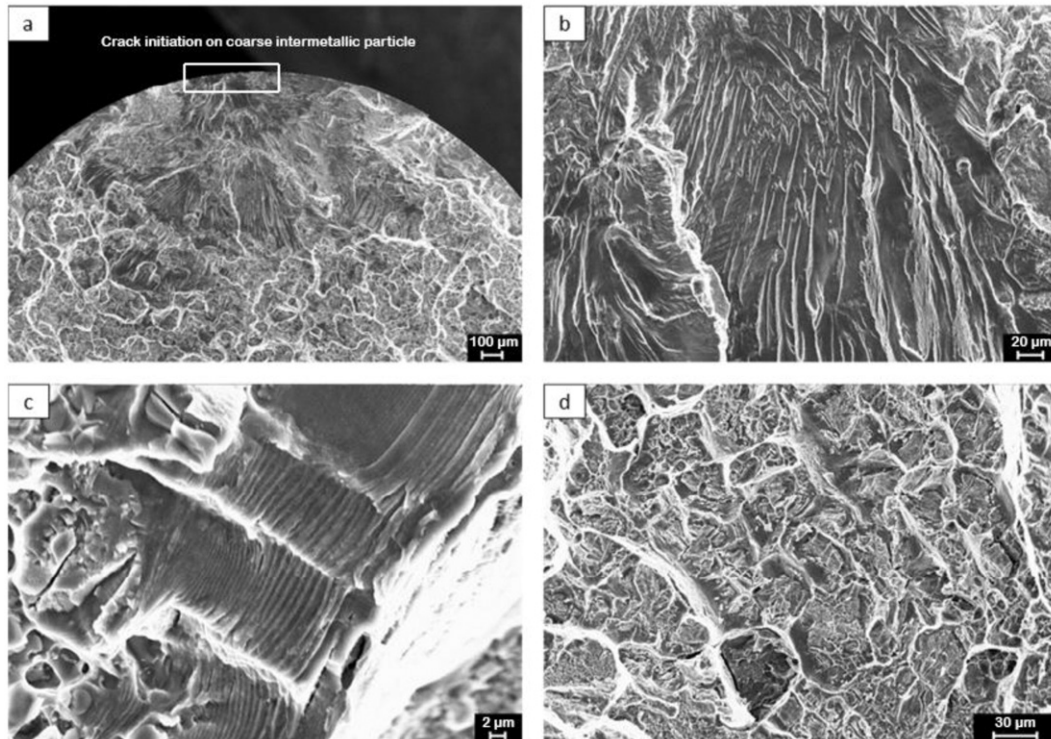
Fig. 7. SEM observations of fatigue fracture surfaces of untreated AA2024-T351 in air at 25 °C and 90% of $YS_{0.2}$. a) Global view b) and (c) zoom on the propagation zone d) final rupture zone.

3.2.2.1. Untreated AA2024-T351. The SEM fracture surfaces of untreated material are presented in Fig. 7. Independently of the stress level, the fracture surfaces presented three distinct zones characterized by different rupture modes: the zone of crack initiation, the zone of crack propagation and the zone corresponding to the final rupture. Crack initiation was always localized on coarse intermetallic particles (Fig. 7a) because it was due to the localisation of plasticity on coarse particles, leading to their shearing. A crystallographic propagation, i.e. cleavage fracture, characterized by river patterns, was observed on the fracture surfaces (Fig. 7b) associated with striations. This type of crystallographic propagation is controlled by environment. Petit and co-workers [24], as well as other authors [25–27] have analysed environmentally-assisted fatigue crack propagation according to two distinct and sequential mechanisms:

Finally, with the increase in the crack propagation rate, crystallographic propagation disappeared in favour of the final ductile rupture zone characterized by dimples (Fig. 7d).

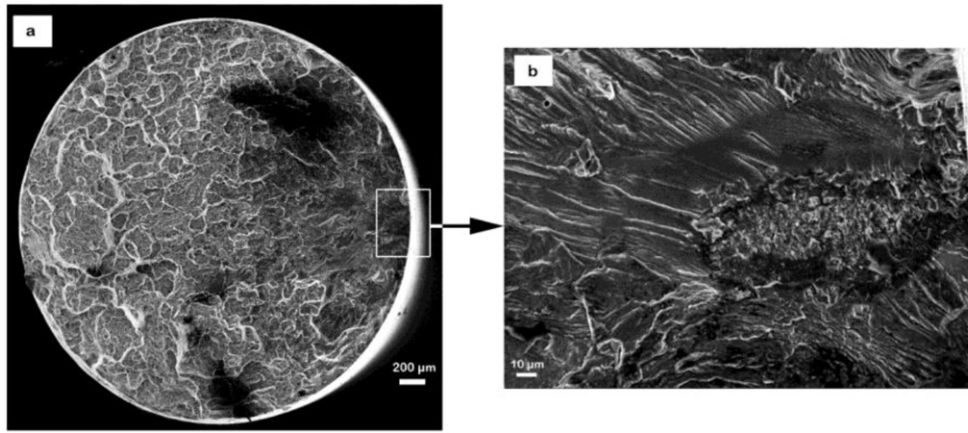
Fig. 8. SEM observations of fracture surface of degreased and pickled material in air at 25 °C and 80% of $YS_{0.2}$ a) Global view b) Zoom on initiation site.

3.2.2.2. Degreased and pickled AA2024-T351. The SEM fracture surfaces of degreased and pickled material are presented in Fig. 8. These observations focused on the initiation zone, given that propagation and final rupture mechanisms were strictly similar to the rupture observed for untreated material.

As suggested by the low R_p values (Table 3) and fatigue endurance curves, localized corrosion, i.e. pitting corrosion, containing some corrosion products (Fig. 8b) was observed on fracture surface. These pits

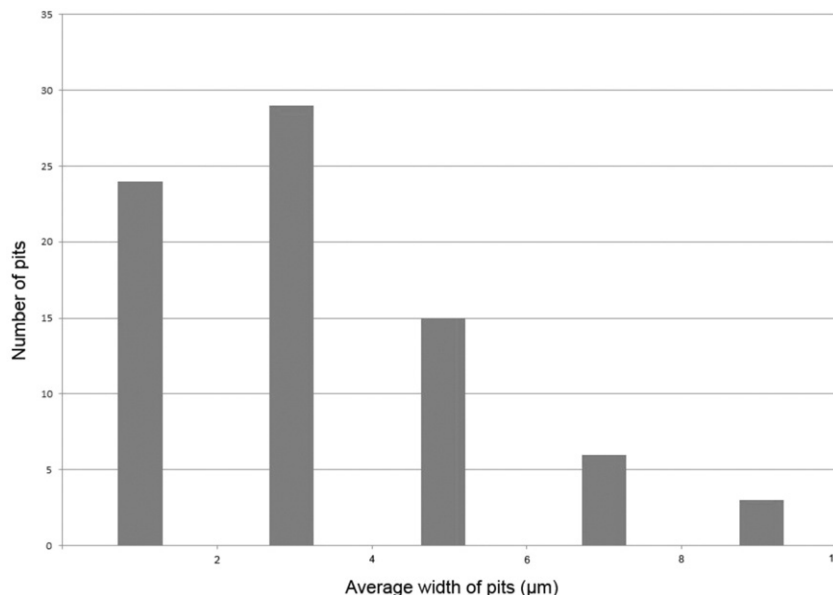
Fig. 9. Distribution of pickling-induced pit width formed after pickling process for a $2 \times 2 \text{ mm}^2$ AA2024-T351 surface.

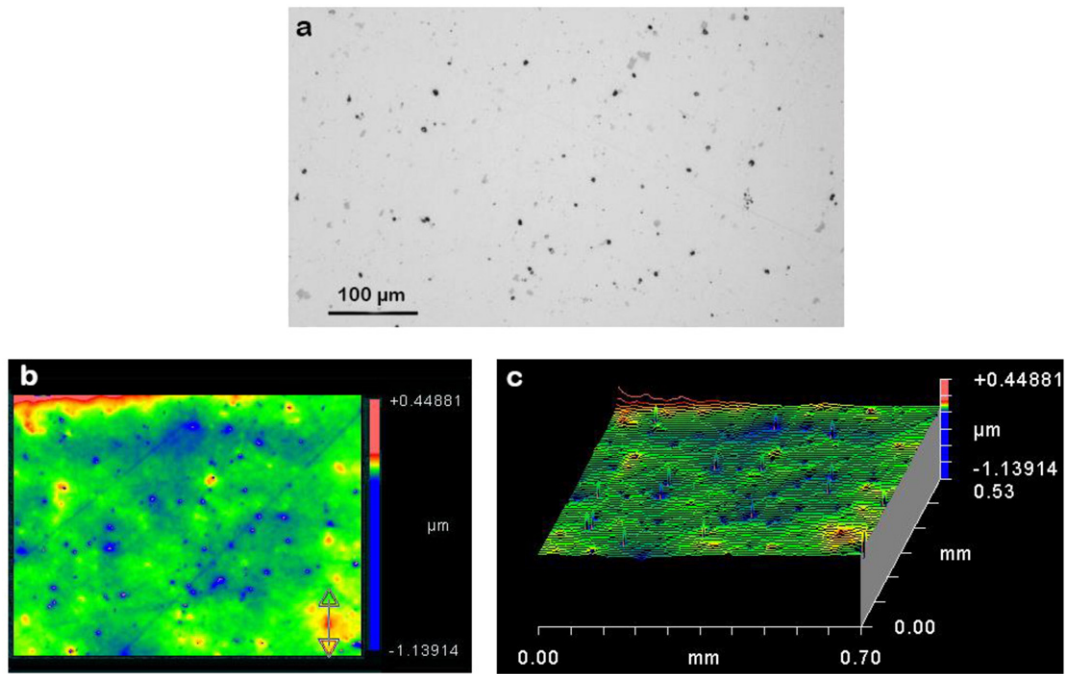
Fig. 10. a) OM observation on AA2024-T351 surface after degreasing and pickling, b) 2D-interferometry map, c) 3D-interferometry map.

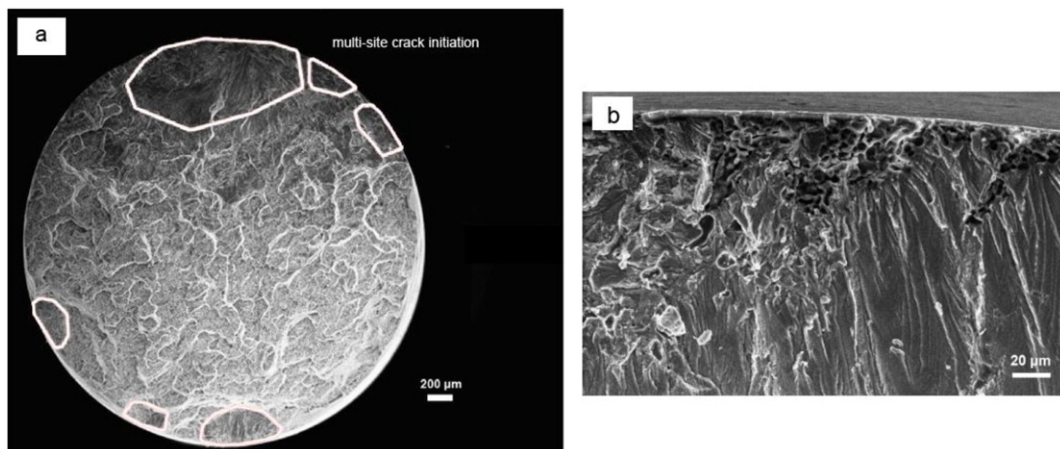
Fig. 11. SEM observations of fracture surface of anodized material in air at 25 °C and 80% of $YS_{0.2}$ a) Global view b) Zoom on initiation site.

3.2.2.3. *Anodized AA2024-T351*. SEM observations of fracture surfaces for anodized material are presented in Fig. 11. Once again, the observations were focused on initiation stage, propagation and final rupture modes remaining unchanged. SEM observations confirmed the presence of pits under the anodic film. However, a multi-site crack initiation was

observed that probably explained the additional decrease in fatigue life of 10% compared to only degreased and pickled material; furthermore, the pit size where crack initiation occurred was abnormally important. The results could be related to the works of Savas and coworkers on AA7075 who studied the effect of different anodization pretreatments on localized corrosion behavior [31]. They suggested that, if the pits initiating during the pretreatment exposures, i.e. pickling in this work, were beyond a threshold size, about 10–20 μm , a higher current density could be measured at these locations during pickling and anodization processes, thus resulting in larger and deeper pit structures. These surface defects enhanced fatigue crack nucleation. For smaller pits, of about 1–5 μm , the anodic process had a smoothing effect and the anodic film growth tended to passivate the pits. These explanations could explain the multi-site crack initiation observed and the pit size.

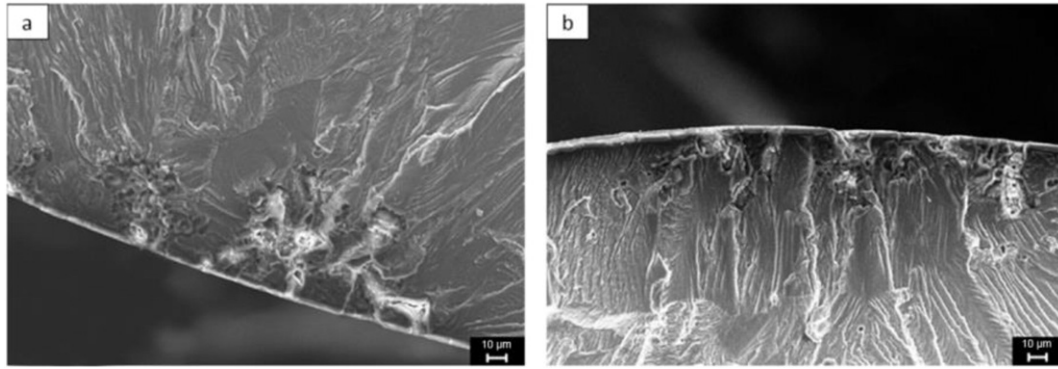
Fig. 12. SEM observations of fracture surface of anodized and sealed material in air at 25 °C and 80% of $YS_{0.2}$ a) Hydrothermal sealing b) (B1 + B2) sealing.

3.2.2.4. *Anodized and sealed AA2024-T351*. SEM observation of fracture surfaces of anodized and sealed material are presented in Fig. 12 for the two sealing processes.

As observed for anodized samples, crack initiation occurred on wide pits under the anodic film and a multi-site crack initiation was observed. As a reminder, the two sealing processes led to the same fatigue life decrease than the anodized material.

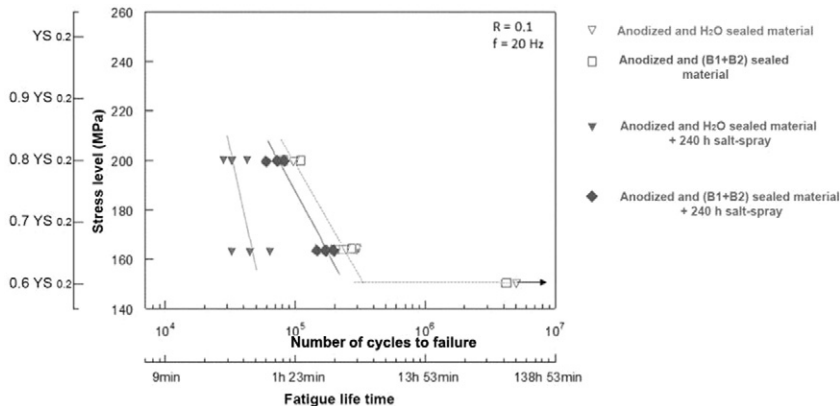
Fig. 13. Effect of surface treatment on fatigue life in air at 25 °C for pre-corroded AA2024-T351 by salt-spray exposure.

The fatigue life curves plotted after a 240 h pre-corrosion treatment by salt-spray exposure for anodized and sealed samples are presented in Fig. 13.

Results of endurance tests showed that hydrothermally sealed samples presented a strong fatigue life decrease after an exposure of 240 h in salt-spray contrary to (B1 + B2) sealed samples which presented a behavior close to the fatigue behavior of non-precorroded anodized and sealed samples. According to salt-spray tests results (Fig. 4), (B1 + B2) sealing led to a better corrosion resistance than hydrothermal sealing for these exposure conditions which suggested that the fatigue behavior of pre-corroded samples could be related to the corrosion protection efficiency of the sealing. The slight fatigue-life decrease observed for the pre-corroded (B1 + B2) sealed samples compared to non-corroded (B1 + B2) sealed samples could also suggest that some pits were present after salt-spray exposure whose size was too small to be visually observed but sufficiently wide to be an initiation site for fatigue crack.

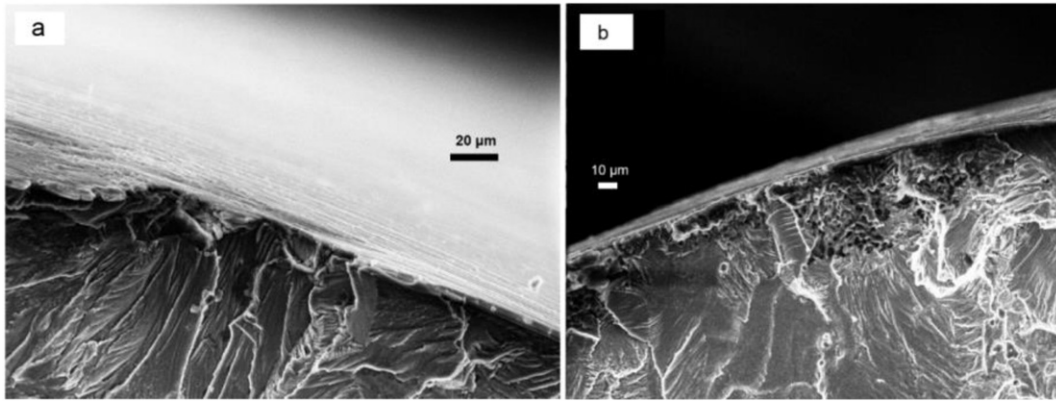
Fig. 14. SEM observations of fracture surface of salt-spray pre-exposed material at 80% of $YS_{0.2}$ a) Hydrothermal sealing b) (B1 + B2) sealing.

SEM observations of fatigue fracture surfaces of salt-spray pre-exposed samples are presented in Fig. 14. They were focused on initiation sites given that propagation and final rupture modes are unchanged compared to fatigue tests without pre-corrosion treatment.

In agreement with the salt-spray and endurance tests which had demonstrated the very good corrosion resistance of (B1 + B2) sealing in these exposure conditions, it was observed that crack initiation occurred on pits localized on sealed anodic film for hydrothermal sealing (Fig. 14a) contrary to crack initiation for (B1 + B2) sealed samples (Fig. 14b) localized preferentially on pits issued from the pickling treatment. The results showed that pits formed during salt-spray exposure enhanced the fatigue life decrease in parallel of pits issued from the pickling process.

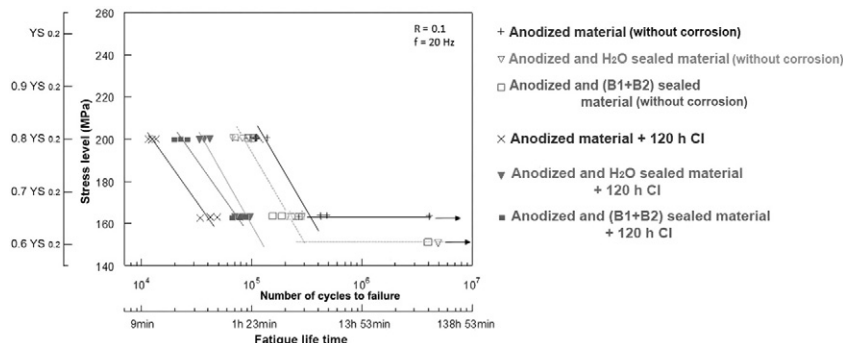
Fig. 15. Effect of surface treatment on fatigue life in air at 25 °C of pre-corroded AA2024-T351 by continuous immersion.

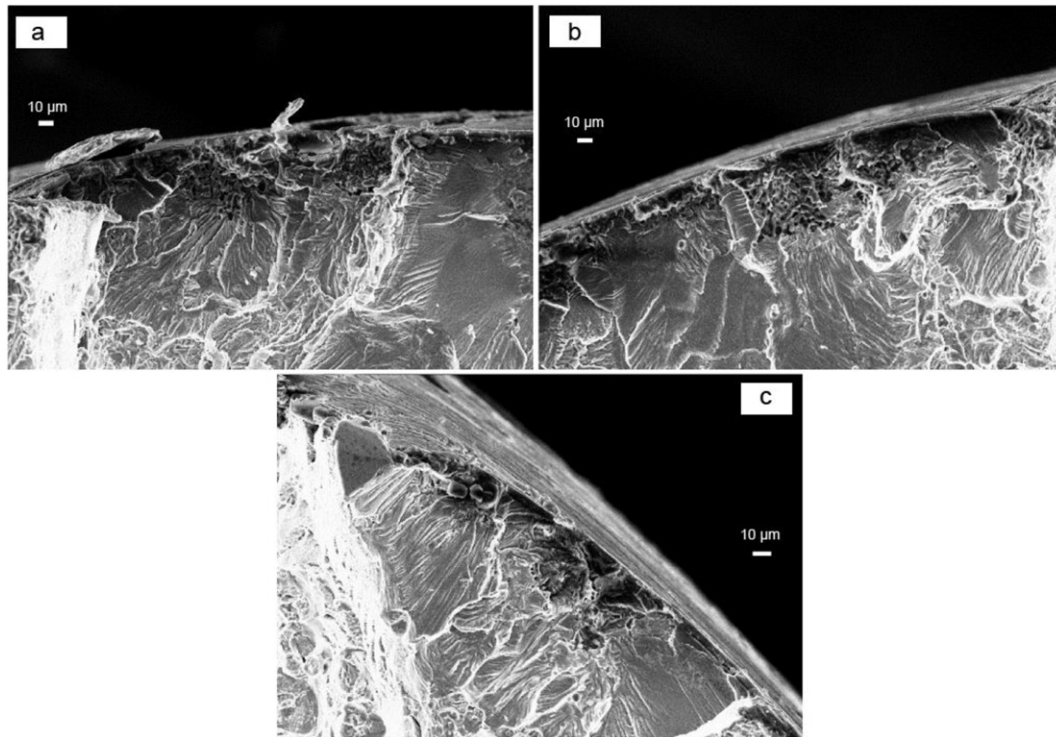
Fig. 16. SEM observations of fatigue crack initiation at 80% of $YS_{0.2}$ of AA2024-T351 pre-corroded by continuous immersion. a) anodized, b) hydrothermally sealed c) (B1 + B2) sealed.

SEM observations of fatigue fracture surfaces of samples pre-corroded by continuous immersion are presented in Fig. 16. They were focused on initiation sites. These micrographs showed that the majority of fatigue crack initiation sites were localized on pits formed during the pickling step. However, previous results showed also that the fatigue life decrease observed on S-N curves after pre-corrosion was due to pits localized on anodic film, including (B1 + B2) sealing (Fig. 16c). This result confirmed that (B1 + B2) sealing was optimized on the basis of salt-spray results and not for continuous immersion exposure.

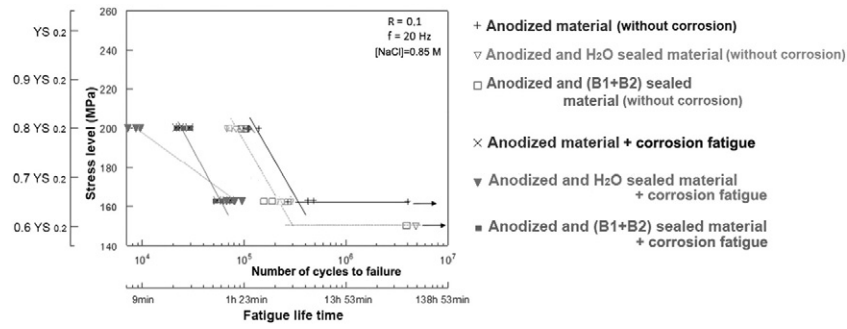
Fig. 17. Effect of surface treatment on corrosion fatigue life of AA2024-T351 in 0.85 M NaCl solution at 35 °C.

Concerning the corrosion fatigue tests, the results indicated that corrosion fatigue induced a decrease in fatigue life for both sealing treatments in comparison with fatigue life in air and, for high stress level, fatigue life after continuous immersion. Crack initiation occurred preferentially on pits formed during the degreasing and pickling steps but also on pits issued from interaction between cyclic loading and

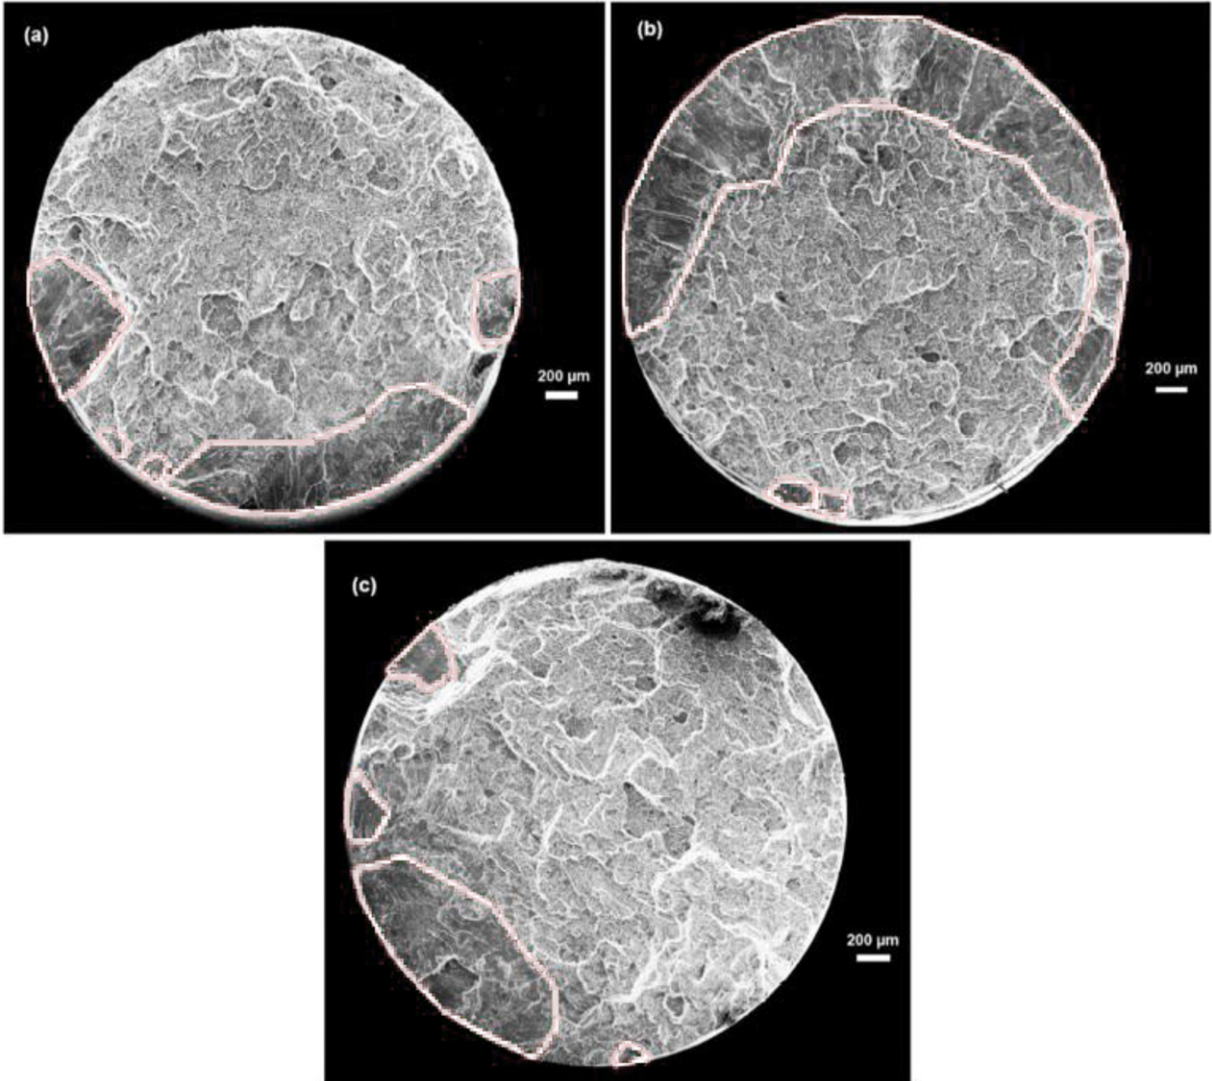
Fig. 18. SEM observations of fracture surfaces after corrosion fatigue tests in 0.85 M NaCl at 80% of $YS_{0.2}$ of a) anodized material, b) hydrothermally sealed material and c) (B1 + B2) sealed material.

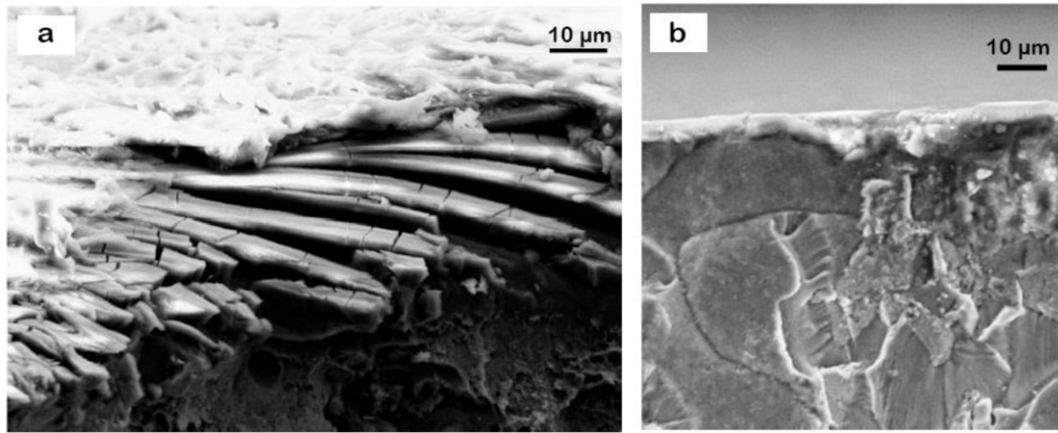
Fig. 19. SEM observations of anodic films after corrosion fatigue tests in 0.85 M NaCl at 80% of YSO_2 of a) hydrothermally sealed material and b) (B1 + B2) sealed material.

confirmed these results with a very strongly damaged anodic film in the case of hydrothermal sealing in comparison with the (B1 + B2) sealing. This strong damage was also observed after fatigue tests in air and fatigue tests after continuous immersion. Finally, this damage of the hydrothermally sealed anodic film enhanced probably the fast apparition of pits, sufficiently wide to induce crack initiation. This fast crack initiation during the first minutes of immersion under corrosion fatigue was already seen in previous works [32,33]. Moreover, Shahzad and

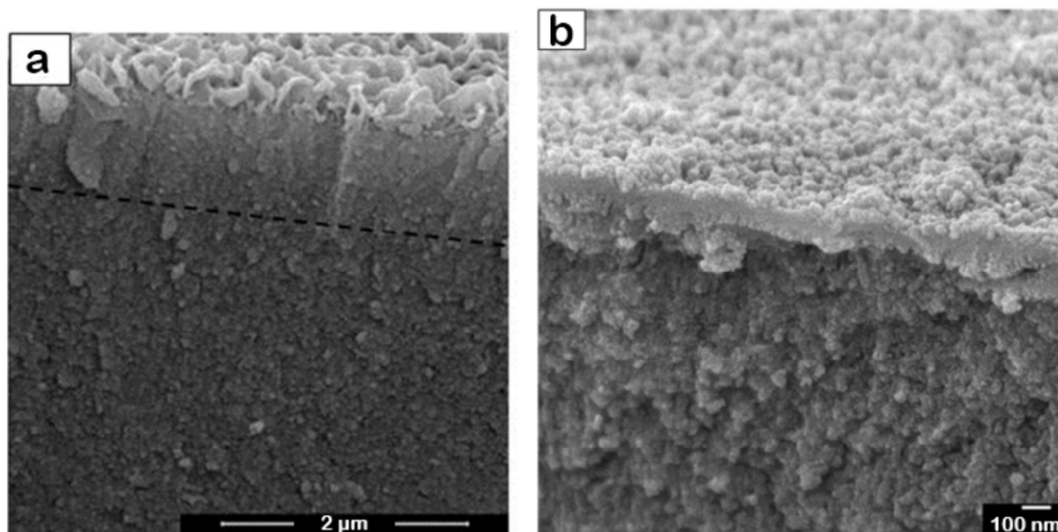
Fig. 20. FEG-SEM observations of transversal cross-section of anodic films of AA2024-T3. (a) after hydrothermal sealing (b) after (B1 + B2) sealing.

To explain the differences in mechanical behavior between hydrothermally sealed and (B1 + B2) sealed anodic films, further SEM-FEG observations were performed (Fig. 20). They showed that hydrothermal process led to a superficial sealing of the anodic film [34]. Sealing concerned only 1 μm compared to the 5 μm global thickness of the anodic

film. Concerning the (B1 + B2) sealing, the sealed layer was particularly thin (100–150 nm) and compact and covered uniformly the anodic film, without creating porosity. These differences in sealed layer morphology could explain the difference in mechanical resistance between the sealed anodic films. Some additional tests need to be conducted to validate or not this hypothesis such as in-situ electrochemical analyses and local observations. This will be done in future works.
