Metallurgical Analysis of Brake Blocks

This study focuses on the characterization of train brake blocks. The brake blocks are an essential organ of train speed control system to ensure comfort and safety to passengers and crew. However, poor quality soles can cause a premature wear of the wheels whose consequences are on the one hand, a damaged brake function, and also high repair costs. Samples were carried out on 3 different batches of brake blocks. Their metallurgical characterization consisted of a study of the hardness and microstructural analysis (microstructures and chemical analyzes) of the different samples. The results show that the hardness of some soles is greater than that of the wheel, mainly associated with a cementite microstructure. This can lead to a premature wear of the wheels at the expense of brake blocks.

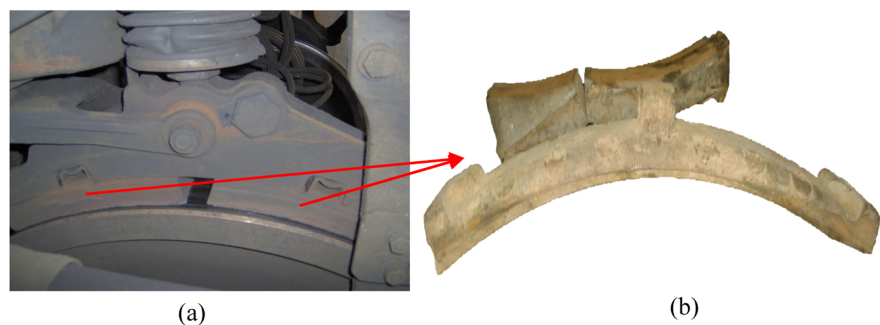
Figure 1. Braking system (a) and brake blocks (b).

They are mounted on the soles-holders which rub against the wheel as shown in **Figure 1**.

The braking sole is a system in which the braking torque is exerted by the friction of brake sole on the wheel tread.

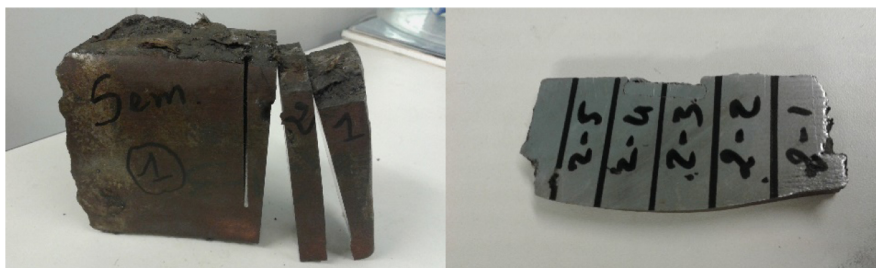
Figure 2. Samples of brake blocks.

Experiments have been carried out on samples of brake blocks (bb), a raw cast iron alloy (rcia) and a train wheel (wh) as shown in **Figure 2**.

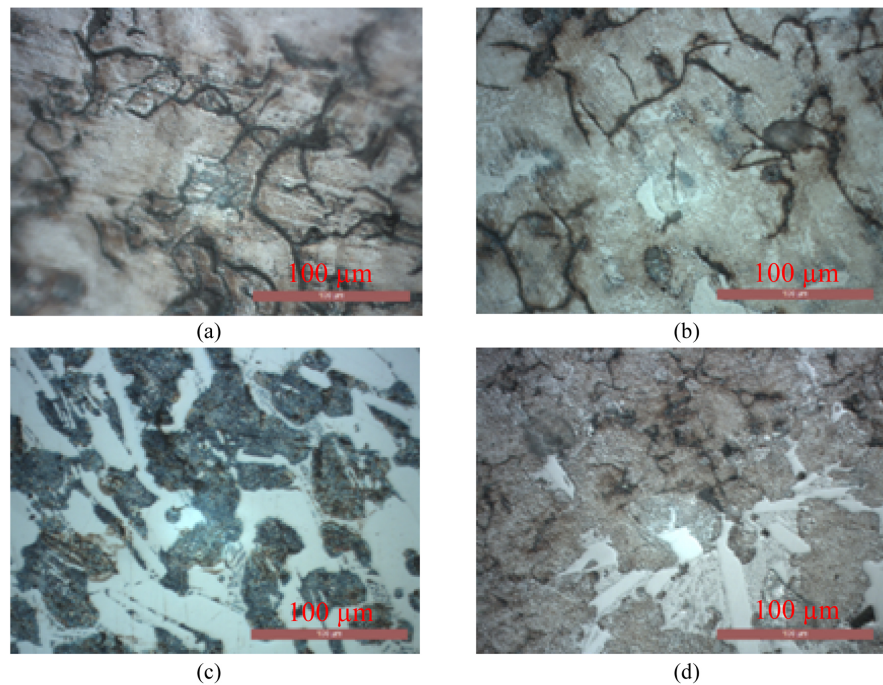
Figure 3. (a), (b), (c) and (d) Microstructural respective brake blocks 1, 2, 3 and the cast iron alloy.

Analysis of the micrographs of **Figure 3** shows that the brake blocks 1, 2 and the casting are made of gray cast iron having a grey appearance to fracture due to the presence of carbon mainly in the form of graphite [6] [9] [10]. As the brake block 3 is formed of a white cast iron have a white appearance to breakage. The carbon they contain is combined with the iron and form the carbide form called cementite.

Examination of **Table 2** and **Figure 4** shows that the hardness varied between 258 and 519 HV1 on all the samples tested. We note a slight difference between the brake block 1, the wheel and casting their respective whose hardness is 293, 295 and 302 HV1. The micrographs of **Figure 3(a)** and **Figure 3(c)** show that these samples belong to the family of gray cast iron. The latter in function of the shape of the graph are divided into several classes and can be characterized by more or less different hardness. [6] [9] [10] [11]. Fine shape and uniform distribution of the graphite in the casting (**Figure 3(c)**) explain the slight increase in hardness with respect to the brake block 1 and the wheel.

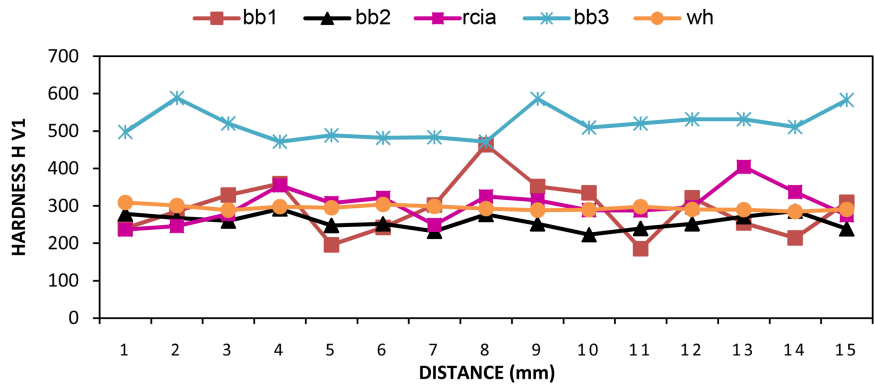
Figure 4. Hardness profile of brake blocks 1, 2, 3 and of the cast iron alloy.

Microhardness profile of brake block 1, 2, 3 and of the cast iron alloy is shown in **Figure 4**.

However, there is a great difference between the hardness of the brake block 3 and the other samples.

This is justified by its microstructure which consists of a white cast iron which is characterized by very low machinability, brittleness and high hardness. For this purpose, studies have shown that the hardness of the white irons varies between 350 to 500 HB while that of the pearlite lamellar graphite cast irons is between 170 to 270 HB, depending on the thickness of the pearlite lamellas, hence this difference observed hardness. [4] [6] [12].

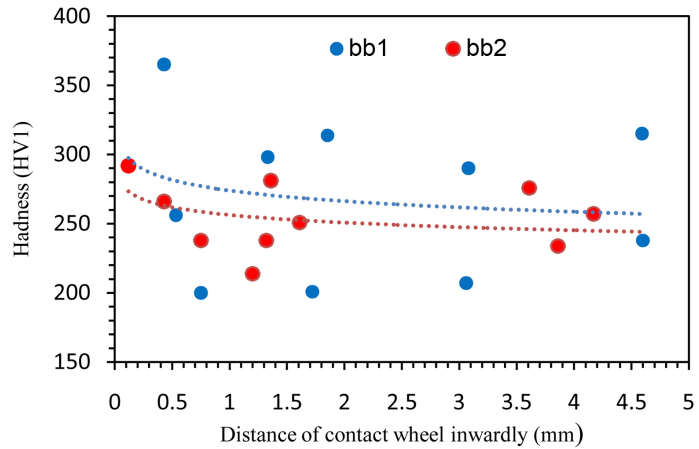
Figure 5. Microhardness profile due to friction with the wheel of brake blocks 1 and 2.

Microhardness profile due to friction with the wheel and brake block 1 and 2 is represented in **Figure 5**.

wheel. **Figure 5** reports the microhardness profile of brake blocks 1 and 2.

The effect of strain hardening of brake block 1 and 2 is highlighted in **Figure 5**. This shows that the hardness is greater at the contact surface wheel/brake block up to about 1 mm inside the brake block and then starts to decrease linearly. This increase in hardness is due to the edge of the friction brake block onto the wheel. This hardening weakens and more cured the brake block which weakens its properties [13].

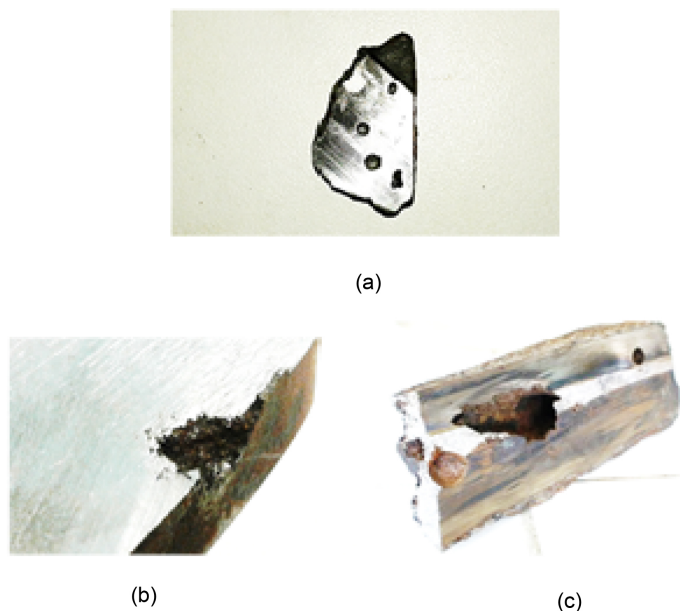
Figure 6. Defaults in the cast iron alloy and respective brake blocks 1 and 3.

Analysis of the samples shows defects that are even visible to the naked eye as shown in **Figure 6** during the sample preparation. These defects called voids are described as closed or open cavities in walls rough dendritic dispersed or aligned with a sliding extension to heart thicknesses. These voids affect the quality of the molded part.

To avoid these voids, external reservoirs are created. They are called feeders and are used to improve the nutrition of parts which solidify last and also allow

directing solidification towards the feeder using coolers [14].
