## Robustness of SiC MOSFET under avalanche conditions

Ilyas Dchar, Marion Zolkos, Cyril Buttay, Hervé Morel

Ilyas Dchar, Marion Zolkos, Cyril Buttay, Hervé Morel. Robustness of SiC MOSFET under avalanche conditions. APEC, Mar 2017, Tampa, FL, United States. pp.2263-2268, 10.1109/APEC.2017.7931015 . hal-01535735

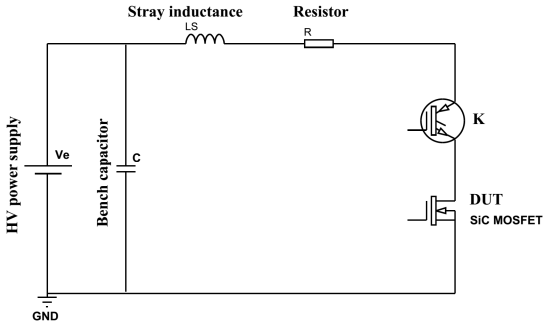
Figure 1 shows the structure of the avalanche test circuit used for the experiment. This circuit is described with more details in [8]. It consists in a high voltage source  $V_E$ , a pulse voltage generator, a current limiting resistor  $R$  (50 Ω), a capacitor bank (1250 μF, 3000 V) and the DUT. An auxiliary high voltage IGBT (3 kV/500 A) is connected in series with the MOSFET to control the avalanche duration of the DUT. The IGBT is driven with an isolated gate signal. Figure 2 shows the picture of the test bench based on the circuit schematic in Fig. 1. For safety reasons, the circuit is placed in a metal enclosure which includes the high voltage power supply, the capacitors, the test zone, and a control panel. An interlocking mechanism, connected to a high voltage contactor, prevents any accidental contact with high voltage. The implementation of these safety systems required a

fairly long cabling between the capacitors and the test zone, resulting in a relatively large total stray inductance (10  $\mu\text{H}$ ).

Fig. 1. Schematic of the avalanche test circuit.

The test circuit in Fig.1 was chosen instead of a more common UIS (Unclamped Inductive Switching) set up [9] because it is more versatile (short-circuit tests, not presented here, can be performed too). With the circuit in Fig. 1, the avalanche energy can be varied without using different inductors: here, the voltage across the capacitor bank and the duration of the pulse are the only parameters to set.

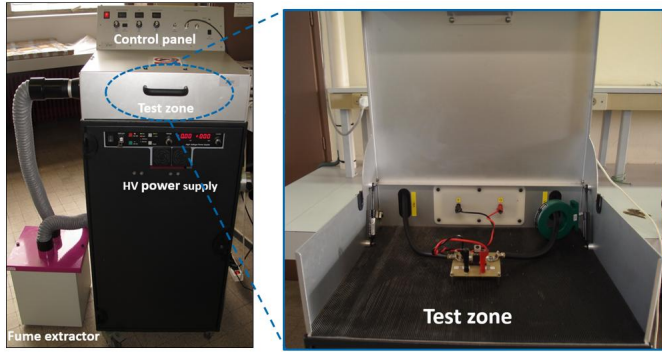
Fig. 2. Experimental setup.

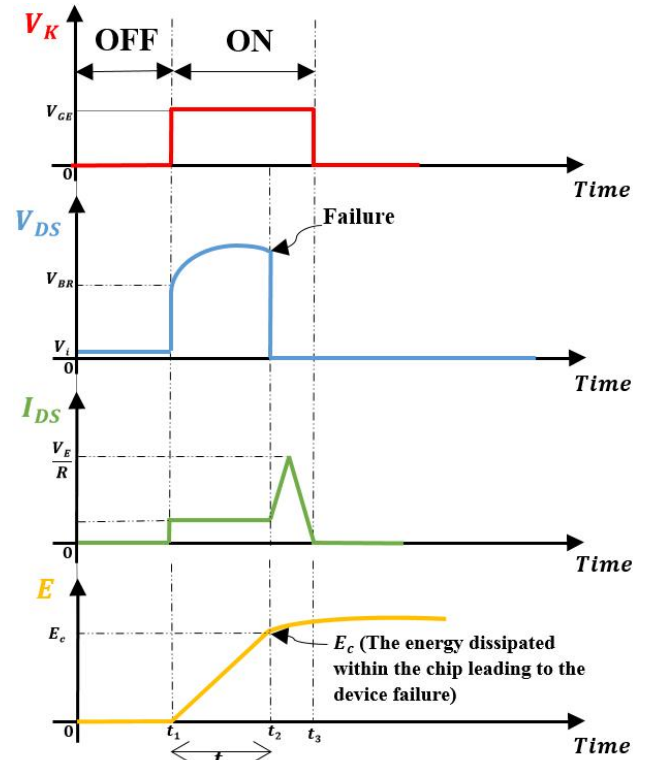
Fig. 3 presents the typical set of waveforms for a destructive single-pulse avalanche test:  $V_K$  is the gate signal applied to the IGBT (red);  $I_{DS}$  is the current in the SiC MOSFET (green) and  $V_{DS}$  is the voltage across the DUT (blue) and  $E$  refers to the amount of energy dissipated by the device during the avalanche time  $t_{av}$  (gold). As can be seen,  $V_{DS}$  is initially equal to ( $V_i \approx 0$ ) when the IGBT is off. Once the pulse is applied through the auxiliary IGBT “K” ( $t_1 \leq t \leq t_3$ ) and the DC voltage exceeds the breakdown voltage ( $V_{BR} < V_E$ ) of the MOSFET, an avalanche current flows. At this stage, the avalanche current is limited by the resistor ( $I = (V_E - V_{BR})/R$ ) to a few amperes. After failure of the device ( $t_2$  in Fig. 3), the voltage across the DUT collapses to almost zero, and the current increases dramatically to  $I = V_E/R$ . Briefly after the failure, the IGBT is turned-off, interrupting the current. During the entire sequence, the DUT is driven with a negative voltage (-8 V) to force it in the off-state.

Fig. 3. Typical avalanche test waveforms.

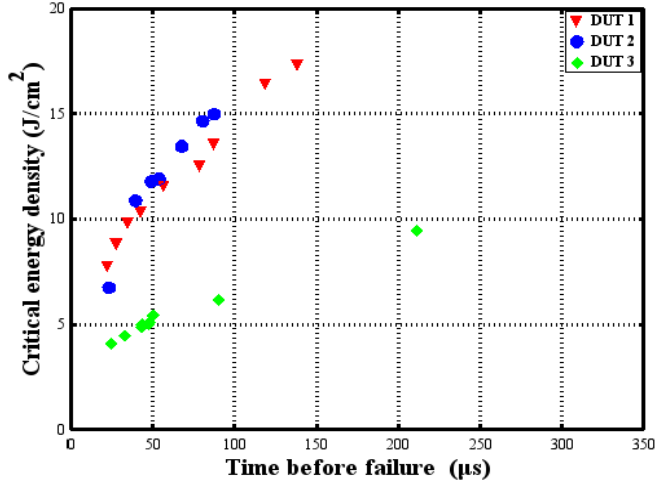
Avalanche experiments were conducted on several samples of each SiC Power MOSFETs listed in table I, at 25 °C. The results are shown in Fig.4, where the energy density threshold to failure (called critical energy density) is plotted as a function of the avalanche duration before failure ( $t_{av}$ ). In this figure, each point is the result of a destructive avalanche test on a given device. In order to compare the robustness of SiC MOSFETs, the critical power density (critical energy divided by the time before failure  $t_{av}$ ) is also given in Fig.5.

Fig. 4. Critical energy density as a function of the avalanche duration. Note that for DUT3, the energy density was calculated using the surface area of the MOSFET die only (for consistency with the other devices). The external diode is not considered in the calculation.

Single pulse avalanche ruggedness was evaluated for commercial SiC MOSFETs from two manufacturers (wolfspeed and RHOM). Each device was tested with increasing magnitude of avalanche energy up to the device's failure point. The results shown in Fig. 4-5 indicate that SiC MOSFETs from Cree (DUT 1 and 2) are relatively more robust to single pulse avalanche compared to MOSFETs from RHOM (DUT 3). The results in Fig. 4 show that the critical energy is not constant for a given device, but increases with the avalanche pulse duration. This seems to indicate that during avalanche, only a small area of the die is involved in the power dissipation. Decapsulation of failed devices are shown in Fig. (9-10-12-14-16) and confirm that the damage is indeed localized in a relatively small area. For Wolfspeed devices, the failures are localized at the source terminal of the SiC die (Fig 9-10-12-14). For RHOM device, shown in Fig. 16, the failure occurs at the edge of an external schottky diode.

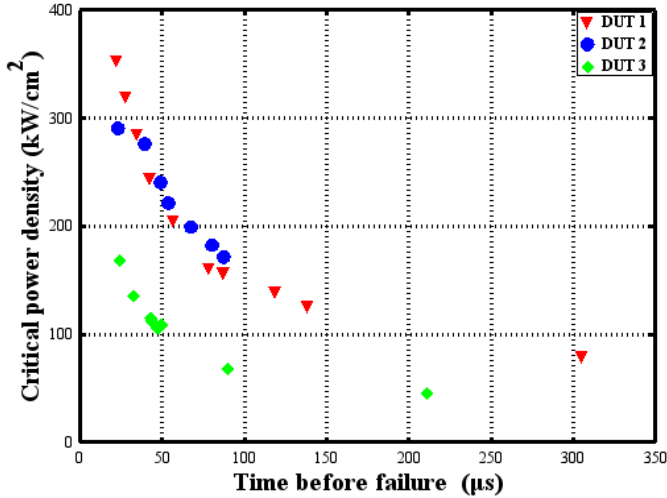
Fig. 5. Critical power density as a function of the avalanche duration.

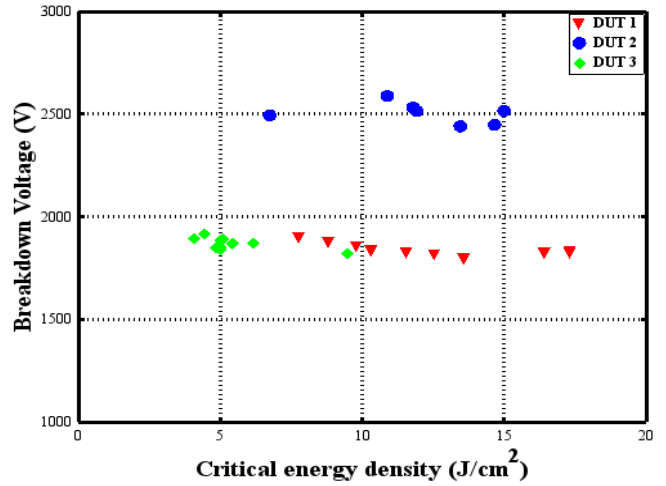
Using the same dataset as in Fig.4, we analyzed the breakdown voltage of the SiC MOSFETs. Fig. 6 presents the distribution of breakdown voltages for DUT 1, 2 and 3 (the breakdown voltage is measured at the beginning of the avalanche pulse). For all tested devices, it appears that the actual breakdown is much higher than the rated voltage of the devices. Moreover, there is a relatively small scattering of the  $V_{BR}$  values between DUT 1 and 3. There is no significant relationship between  $V_{BR}$  and  $E_c$  for a given DUT.

Fig. 6. Breakdown voltage as a function of the avalanche duration.

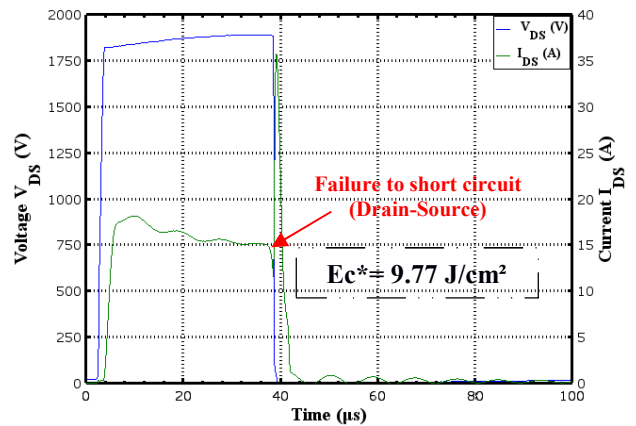
Fig. 7 and 8 show an example of waveforms measured on DUT 1 under destructive avalanche stress for  $T_{CASE} = 25$  °C. The dissipated energy leading to failure is about 1.01 J ( $E_c^* = 9.77$  J/cm<sup>2</sup>). From these figures, failure occurs on both gate and source pads, resulting in a short circuit between all three terminals of the device (Gate-Drain-Source). As shown in Fig.7, a sudden collapse in the voltage across the MOSFET is recorded at 34.4  $\mu$ s. The current increases dramatically to about 35 A after device failure. Fig. 8 shows that the gate oxide fails with a short circuit between gate and source (after avalanche,  $V_{GS}$  reaches 0 V).

Fig. 7. Measured drain-source voltage and current across the DUT 1 under avalanche conditions.  $t_{av} = 34.4$   $\mu$ s;  $E_c = 1.01$  J;  $V_{BR} = 1854$  V.

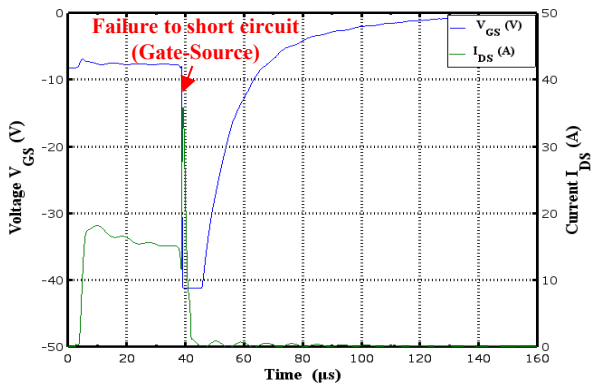
Fig. 8. Measured gate voltage and drain current across the DUT 1 under avalanche conditions.  $t_{av}=34.4 \mu s$ ;  $E_c=1.01 J$ ;  $V_{BR}=1854 V$ .

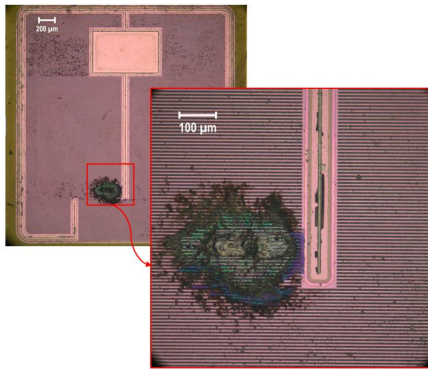
The decapsulation of the device shows that high temperature was reached by the device during avalanche operation, as the source and gate metallization have melted, and the SiC underneath shows a clear change in structure. An example image is shown in Fig. 9. The decapsulated device shows a localized black spot where failure occurred. Other inspected dies for DUT 1 looked similar to that imaged in Fig. 9 (all the failures have led to current crowding in localized area resulting to molten SiC and metallization). The exact location, however, changed from die to die, indicating that there is no clear weak area.

Fig. 9. Damaged SiC die for DUT 1 @  $t_{av}=34.4 \mu s$ ;  $E_c=1.01 J$ ;  $V_{BR}=1854 V$ .

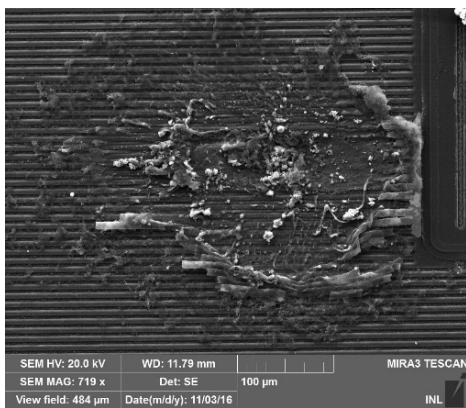
Figure 10 shows the surface analysis of the damaged zone for DUT 1. A surface inspection allows us to see clearly the damage zone at the source metallization. The SEM observation proves that the avalanche is always localized in a small area of the die, resulting in very high temperature sufficient to create a crater in the SiC die. These crater seems to be the origin of the physical short circuit between the drain-source observed during the device failure.

Fig. 10. SEM image of the damaged zone for DUT 1.

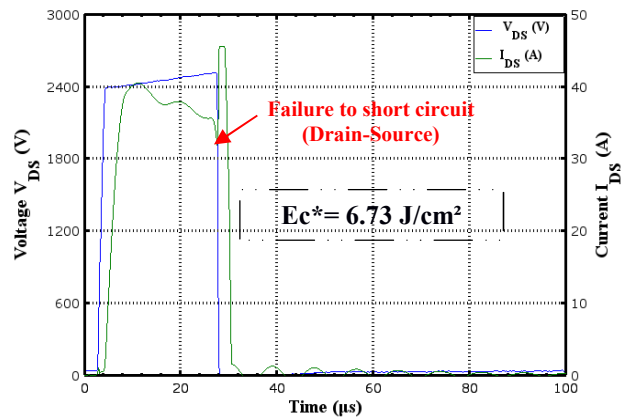
Further avalanche experiments have been conducted on the DUT 2. The first results on DUT 2 are plotted in Fig.11, where drain-source voltage and current are presented. For avalanche duration 23.4  $\mu s$ , failure appears with a short circuit between all three terminals of the device, similarly to failure of DUT 1. Figure 12 shows the microscopic picture of a decapsulated

Fig. 11. Measured reverse voltage and current across the DUT 2 under avalanche conditions.  $t_{av}=23.4 \mu s$ ;  $E_c=2.17 J$ ;  $V_{BR}=2495 V$ .

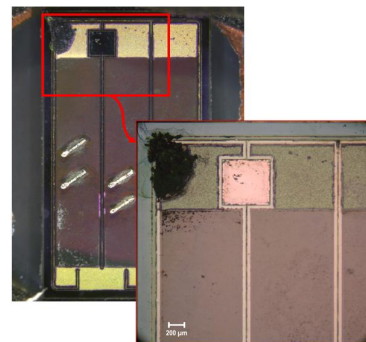
device after avalanche failure at 2.17 J (6.73 J/cm<sup>2</sup>). It can be seen that the damage is located at the left edge of the source metallization.

Fig. 12. Damaged of SiC die for DUT 2 @  $t_{av}=23.4 \mu s$ ;  $E_c=2.17 J$ ;  $V_{BR}=2495 V$ .

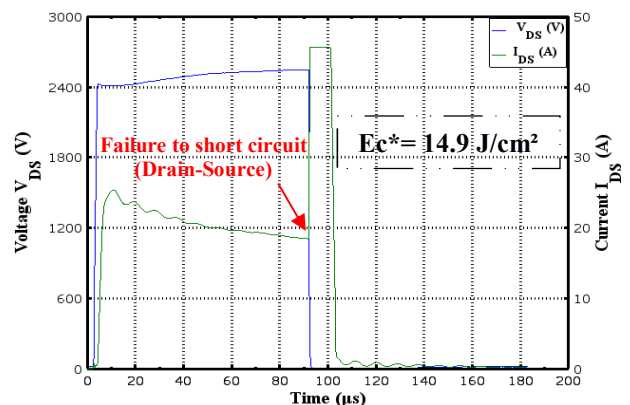
Fig. 13 shows similar results for another sample of DUT 2, measured for a longer avalanche pulse. It can be seen that for higher energy test, the outcome is quite the same: after the voltage collapses across the MOSFET, the current increases dramatically, resulting in a short circuit between all three terminals of the device. Figure 14 shows the location of the damage. Both cases shown in Fig.12 and 14 indicate the same failure mode for DUT 2. The failure sites occur at the source metallization and result in the collapse of the voltage across the DUT 2 (short-circuit failure mode).

Fig. 13. Measured reverse voltage and current across the DUT 2 under avalanche conditions.  $t_{av}=87.4 \mu s$ ;  $E_c=4.492 J$ ;  $V_{BR}=2517 V$ .

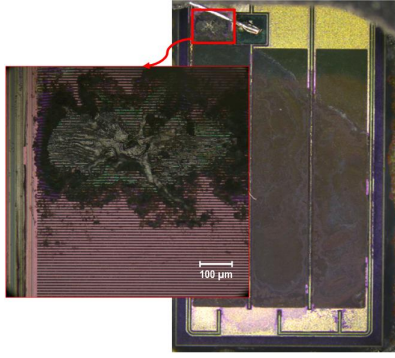
Fig. 14. Damaged SiC die for DUT 2 @  $t_{av}=87.4 \mu s$ ;  $E_c=4.492 J$ ;  $V_{BR}=2517 V$ .

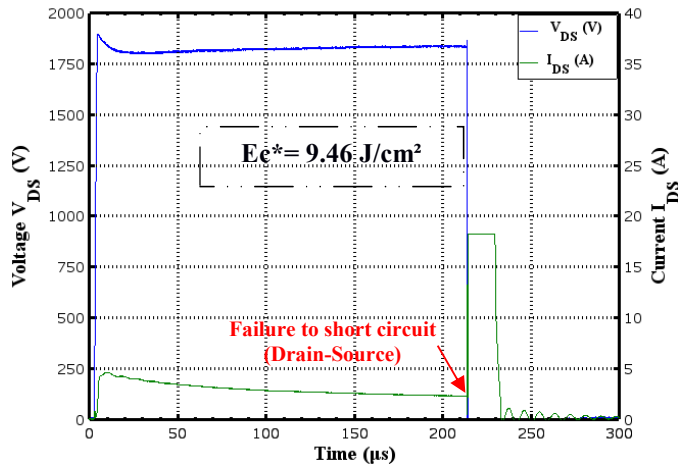
Similar tests have been extended to DUT 3 (For these devices, the manufacturer packaged both a MOSFET and a diode in the same TO-247 case). Figure 15 reports waveforms of DUT 3 measured at ambient temperature (25 °C). The obtained results show that failure appears as a short circuit between the Drain-Source of the DUT 3. Examinations of device that have undergone catastrophic failure during avalanche tests show that failures occur on the edge of the external schottky diode. The failure results in the collapse of the voltage across the diode (short-circuit). Then, to a short circuit between the drain and source terminals of the case. Figure 16 shows such an example of damaged die for DUT 3. As it can be seen, a clear defect is located in the diode's periphery, near the edge of the device. The energy was concentrated in a single spot rather than distributed evenly over the surface of the die. In the other hand, no indication of damage has been observed in the SiC MOSFET die. This means that the failure of MOSFET was caused by the breakdown of the external diode's periphery during avalanche.

Fig. 15. Measured reverse voltage and current across the DUT 3 under avalanche conditions.  $t_{av}=211 \mu s$ ;  $E_c=1.13 J$ ;  $V_{BR}=1821 V$ .

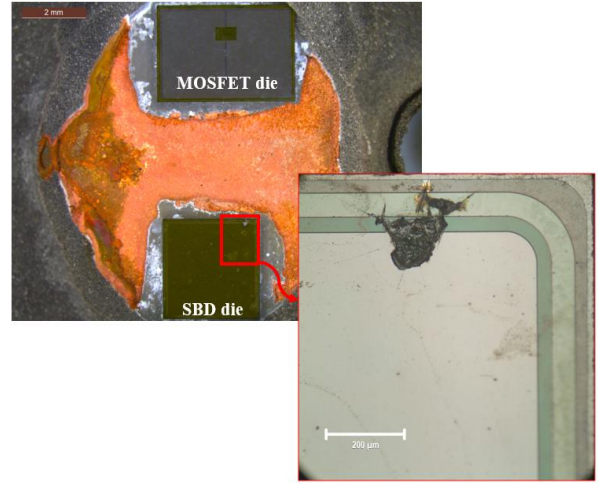
Fig. 16. Damaged SiC die for DUT 3 @  $t_{av}=211 \mu s$ ;  $E_c=1.13 J$ ;  $V_{BR}=1821 V$ .

For DUT 3, it has been noticed that failures appear at lower energy. Examination of failed devices show that all failures occur on the edge of the external schottky diode where the electrical field intensity is greatest. The avalanche is localized at the corner of the external diode resulting to a short circuit between the drain and source terminals of the case. The avalanche test highlighted a weakness in the external diode, not in the MOSFET die itself. This means that for DUT3, our tests are inconclusive regarding the actual robustness of the MOSFET die in avalanche.

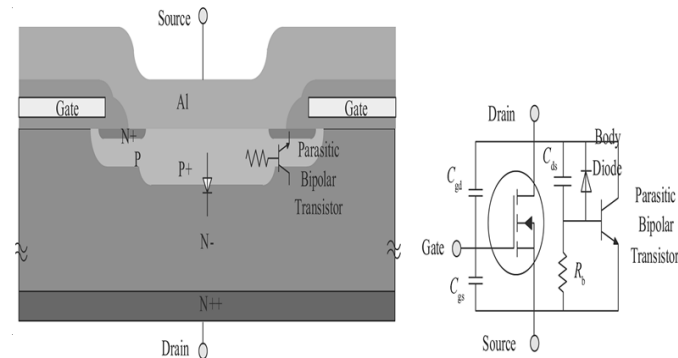
Several internal device failure mechanisms may cause the collapse of the device voltage during avalanche, and eventually the catastrophic failure of these devices. According to the test results, the failures can be classified by failure location on power MOSFETs into two categories. First, for DUT 1 and 2, it has been found that two failure mechanisms may happen. One of the failure mechanisms is the activation of a parasitic BJT which is found in the MOSFET structure. As shown in Fig.17, a NPN parasitic bipolar transistor is formed among the N+ source ("emitter"), the P-body ("base"), and the N-type drain ("collector") [11]. In fact, when the P-N junction is in avalanche mode, a large avalanche current will flow and hole current will turn on the parasitic BJT [12]. Since the BJT will demonstrate a snapback negative resistance characteristic, this will lead to current crowding in localized areas and create a molten spot which lead to a short circuit between the Drain-Source of the MOSFET (short circuit failure mode). This failure mechanism is influenced by the parametric variability between the cells in the power MOSFET which cause non uniform current distribution and temperature surges in the device [13]. A second

Fig. 17. Equivalent circuit of power MOSFET [13].
