# **Lime Treatment: New Perspectives for the use of Silty and Clayey Soils in Earthen Hydraulic Structures**

G. Herrier, D. Puiatti, C. Chevalier, M. Froumentin, Stéphane Bonelli, J.J. Fry

G. Herrier, D. Puiatti, C. Chevalier, M. Froumentin, Stéphane Bonelli, et al.. Lime Treatment: New Perspectives for the use of Silty and Clayey Soils in Earthen Hydraulic Structures. 9th ICOLD European Club Symposium, Apr 2013, Venise, Italy. pp.10. hal-01548437

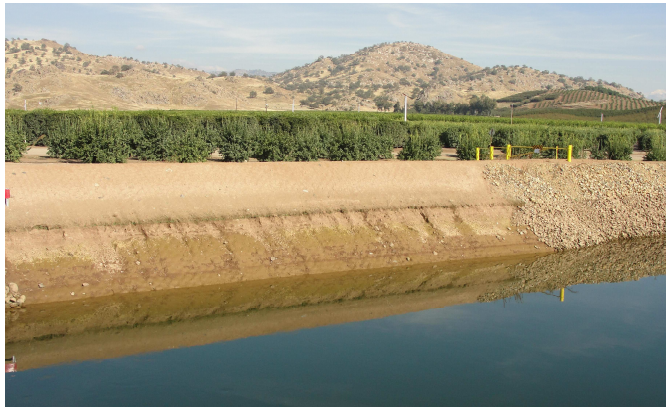
Figure 1: Lime-treated section of the Friant-Kern Canal (taken in November 2010) on the left part; the right part consist of original, untreated slope covered with gravel.

roads and the canal bottom were treated first, using in-place treatment methods. The bank lining material was treated in two sequences, first with a “bench method” on the slope in order to facilitate his moving to the bottom, and second with a dump truck spreading, and mixing with back rippers, angle and U-dozers, and graders. The treated soil was finally placed on the banks in 30-40 cm thickness layers and compacted with a vibrating sheepfoot roller that was winched up and down the slope by a crawler tractor (yo-yo fashion). Typical final thicknesses vary from 0.6 m (service roads and bottom) to approximately 1 to 1.4 m (banks). The final canal banks have 2:1 slopes.

Several evaluations of the results have been performed, no new slips, slides or sloughs have occurred. The viability and economical benefits of the solution were obvious. A recent visit (Figure 1) showed that the sheepfoot roller imprint was still visible both above and below the water surface, 35 years after the job [8]. The picture was taken during a maintenance phase, when the water level was below the normal one, one can see minor erosion along the water level, due to departure of small rocks or “untreated clay balls”, not mixed efficiently with lime due to the poor mixing quality at these ages. The maintenance operations are very limited on this section, considering the lime-treated part is durable and is significantly cost-saving.

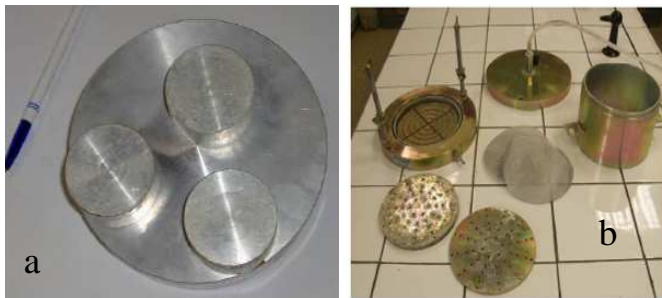
Figure 2: Kneading compaction tool (a) and permeameter (b).

- classical Proctor dynamic compaction, to 95% of the OPN dry density ;
- kneading compaction, performed with a specific tool, simulating the geometry and surface ratios of a sheepfoot roller (Figure 2a) [10]. The specimens were compacted to the same final density as that of the Normal Proctor method. In

The permeability tests were performed at LRPC Angers (France), according to the XP CEN ISO/TS 17892-11 Standard. The samples were directly compacted in the permeameters (Figure 2b). The set-up was similar to CBR moulds except that they were equipped with inox grids and pierced plates for the water entrance and exit. The permeability measurements were performed after 28 days curing at constant water content (after compaction), after 28d curing + 2 months immersion period and 28d curing + 5 months immersion. The following results were highlighted:

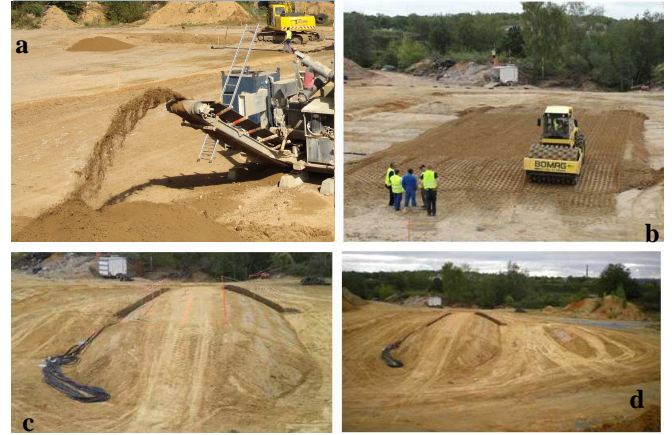
Figure 11: Lime-treated material production (a), application and compaction with a sheepfoot roller (b), global view of the lime-treated dike (c) and of the two dikes (lime-treated and untreated, on the right) (d).

The compaction equipment is a VP5 sheepfoot roller, according the French Standard NF P 98-736 (Figure 11b).

The 2.5% lime treatment with a controlled water addition in the mobile mixing plant, produced a granular, fine material at a humidity level above OMC. This material was transported directly to the jobsite, and then taken by a shovel for the placement of 50 cm thick layers prior to compaction. The compaction step was performed with a kneading compactor in 6 passes at a speed of 3 km/h, producing a final thickness of 30 cm for each layer. Finally, the embankment was constructed in 6 layers, giving a total height of 1.80 m (Figure 10b). Pictures of each step can be viewed in Figure 11.
