# Evaluation of stress corrosion cracking of irradiated 304L stainless steel in PWR environment using heavy ion irradiation

J. Gupta <sup>a, b</sup>, J. Hure <sup>a</sup>, B. Tanguy <sup>a, \*</sup>, L. Laffont <sup>b</sup>, M.-C. Lafont <sup>b</sup>, E. Andrieu <sup>b</sup>

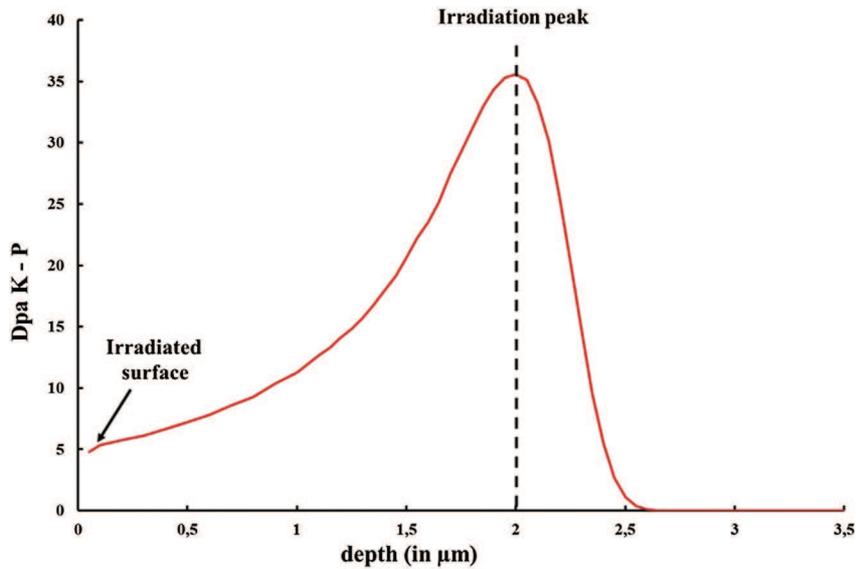
**Fig. 1.** Irradiation damage profile for 304L irradiated with 10 MeV  $\text{Fe}^{5+}$ . Damage was calculated with K–P approximation and plotted as a function of irradiation depth. Damage at the irradiated surface will be used to indicate the damage in the sample.

continuously varying damage ranging from 5 dpa to 35 dpa (see Fig. 1). However, it is known that the irradiation hardening of austenitic steel saturates at about 5–10 dpa, suggesting that the contribution of the damage close to the peak region or the surface region is not expected to be very different. Thus, it can be concluded that Fe irradiation at 450  $^{\circ}\text{C}$  to about 5 dpa leads to an irradiation hardening of ~58%. This hardening is linked to the defects (Frank loops) induced in the microstructure, which act as obstacles to the motion of dislocations.

CERT tests were performed at 340 °C in a PWR environment in order to study the cracking susceptibility after irradiation. Since only a fraction of the gage length was irradiated (i.e. it had both unirradiated and irradiated regions), it gave an opportunity to study the impact of irradiation on cracking susceptibility of the material with the same environment, surface finish, and loading conditions. Inspection of the gauge length in both irradiated and unirradiated areas was performed using SEM. After 4% plastic strain, many cracks were observed on the irradiated area. An example of the surface observed in the irradiated area is shown in Fig. 8a. The intergranular nature of the cracks was clear from surface observations and was verified using transversely cut FIB samples. Fig. 8a illustrates an example of a random crack with a length of 60 μm in the irradiated area. The penetration depth of the crack was measured to be 2.2 μm (Fig. 8b), which seems to indicate that a crack arrest occurs in the vicinity of the boundary between irradiated and unirradiated material (recall that the depth of the irradiated area is ~2.5 μm, as indicated in Fig. 1). The crack initially

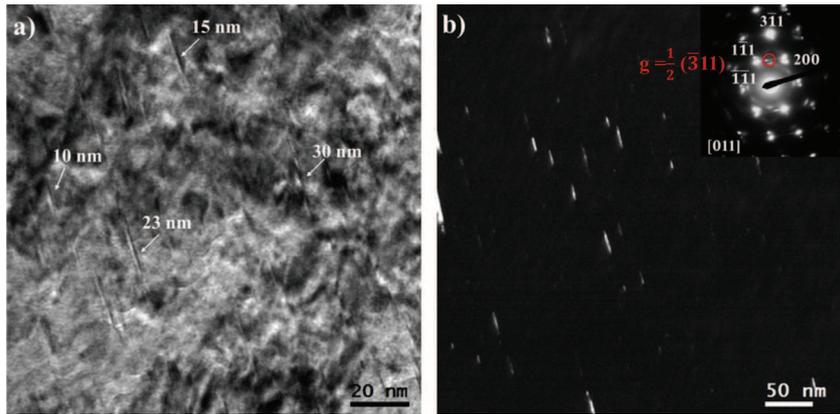
**Fig. 2.** a) Bright Field TEM image indicating the size of few Frank loops observed b) Rel-rod Dark Field TEM image obtained by selecting  $g = \frac{1}{2}(-311)$  streak (encircled in red) in the diffraction pattern (in inset) highlighting the Frank loops present in the microstructure of Fe irradiated 304L. (For interpretation of the references to color in this figure legend, the reader is referred to the web version of this article.)

Heavy ion irradiation performed using 10 MeV Fe at 450 °C induced dislocation loops in the microstructure. Bright Field and Dark Field ( $g = \frac{1}{2} (3-11)$  on zone axis [011]) TEM images of the Frank loops are shown in Fig. 2. As is evident in the images, dislocation loops of different sizes were observed. For the majority of the loops, the diameter ranged between 6 and 14 nm. The largest loop size observed was 30 nm, while no loops smaller than 2 nm were identified. The size distribution of Frank loops is shown in Fig. 3. The size distribution appeared to be an asymmetric distribution that extended up to 30 nm, similar to what has been reported in literature for neutron-irradiated SS 304L [33]. The average number density and mean diameter of dislocation loops observed were  $5 \pm 0.9 \times 10^{21} \text{ m}^{-3}$ <sup>2</sup> and  $13.4 \pm 1.9 \text{ nm}$ , respectively. The mean size of Frank loops obtained was similar to the value (12.5 nm) reported in Ref. [34] on 304 grade stainless steel irradiated with 2.8 MeV Fe at 300 °C at 10 dpa, and the number density was about a factor 10 lower in this study which may be due to the higher irradiation temperature, which tends to decrease the defect density as reported in Ref. [35]. No other irradiation-induced defects (e.g. cavities, radiation induced precipitates) were observed after 5 dpa in the studied material.

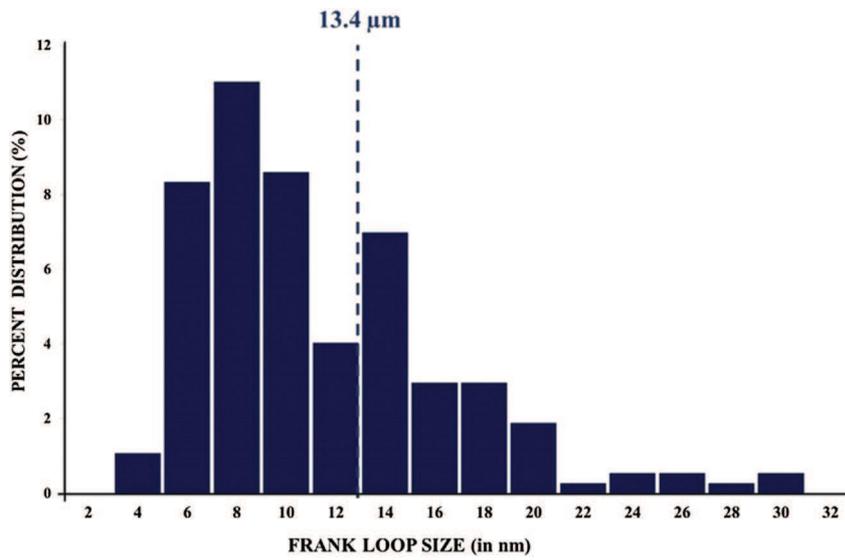
**Fig. 3.** Frank loops size distribution observed in Fe irradiated 304L to a dose of 5 dpa.

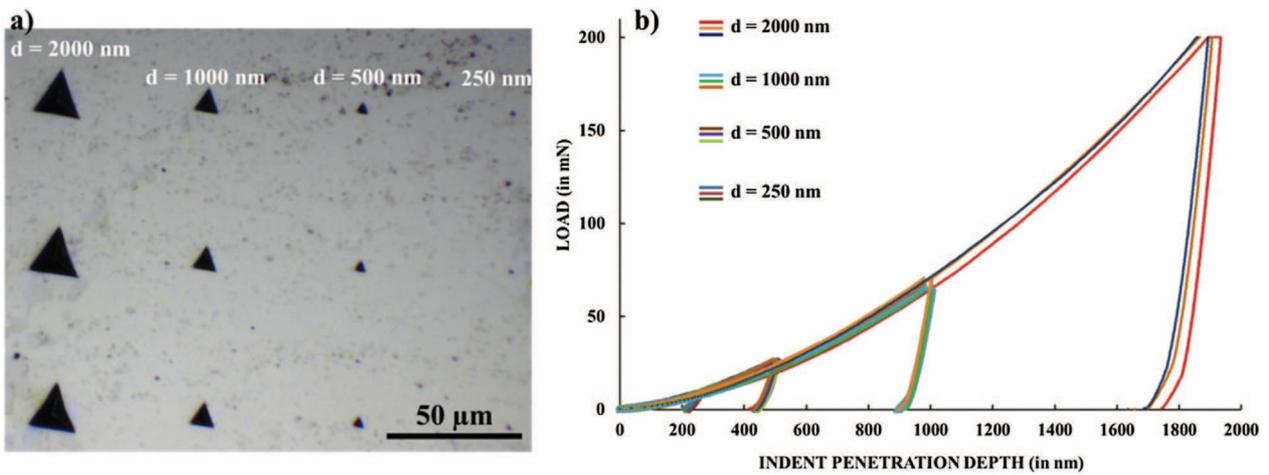
**Fig. 4.** a) Image of the nano indent matrix in the unirradiated region obtained using an optical microscope. b) Evolution of the load as a function of indent penetration depth during nanoindentation tests.

Fig. 4 shows example load – displacement profiles obtained for different indents made at different depths (maximum depth of 2000 nm) in unirradiated samples. It can be seen from Fig. 4b that the reproducibility of the measurements was quite good. The evolution of the hardness as a function of the indentation depth for the unirradiated and irradiated samples is shown in Fig. 5a. The slight decrease in the measured hardness value with increasing indentation depth observed in unirradiated sample was attributed to the indentation size effect. In addition, in the irradiated sample, beyond a certain depth, the zone of plastic deformation originating from the indentation exceeds the boundary between the irradiated and unirradiated regions. As a consequence, a decrease in measured hardness was observed. At a 2  $\mu\text{m}$  indentation depth, the contribution is entirely from the unirradiated region and hence, hardness values at this depth should be the same for the irradiated and unirradiated samples, as shown in Fig. 5a. To get rid of the indentation size effect, Nix and Gao have proposed a relation between the hardness at infinite depth (i.e. macroscopic hardness),  $H_0$ , and the measured hardness,  $H$ , at a given depth,  $D$  [36]. The square of the nanoindentation hardness is plotted against the reciprocal of indentation depth ( $1/D$ ) in Fig. 5b for the unirradiated and irradiated samples. For the unirradiated sample a plot of the square of nanoindentation hardness is proportional versus the reciprocal of the indentation depth reveals excellent linearity. The bulk hardness,  $H_0$  (square root of the intercept value), was estimated to be  $2 \pm 0.7 \text{ GPa}$  for the unirradiated sample. The Vickers hardness value calculated from this bulk hardness value using the relation  $H_v = 0.0945 H_0$  was  $191 \pm 11 \text{ H}_v$  [37,38]. Vickers hardness measurements performed on the unirradiated sample yielded a value of  $200 \pm 30 \text{ H}_v$  which is in good agreement with the value reported above.

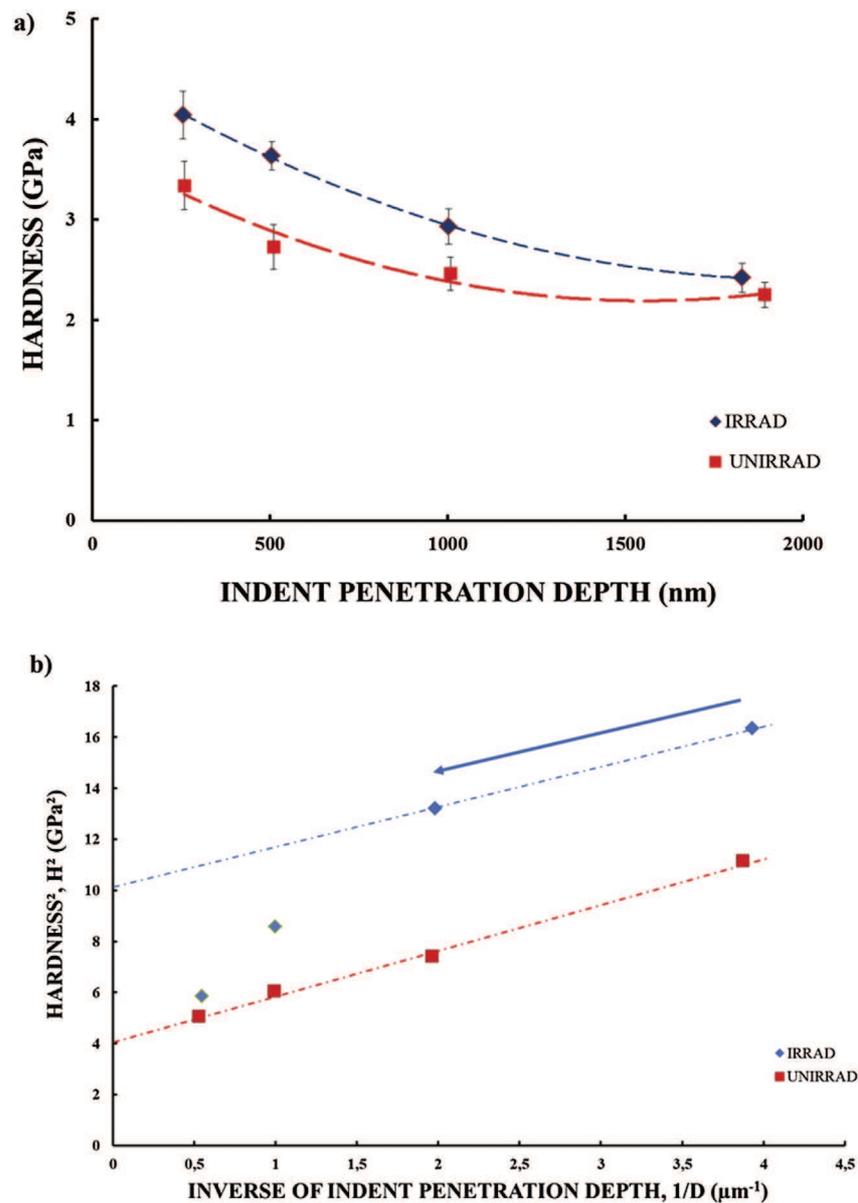
Fig. 5. Comparison of the a) hardness profiles b) Nix - Gao profile ( $H^2$  versus  $1/D$ ) obtained for unirradiated and irradiated samples using nano indentation tests.

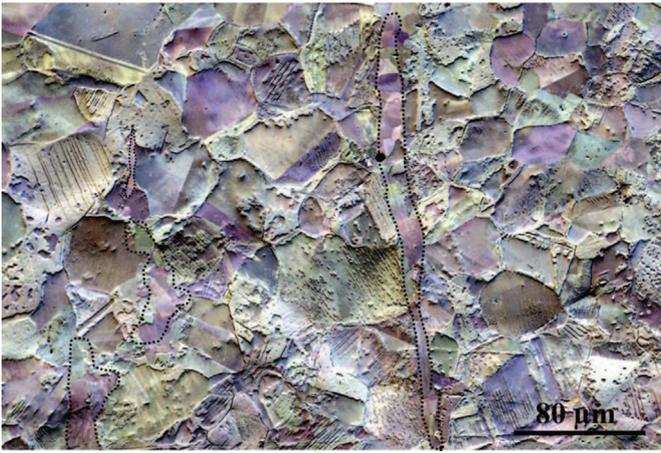
Fig. 6. EBSD cartography obtained using FSE after 4% plastic strain in the irradiated area.

Plastic strain up to 4% at 340  $^{\circ}\text{C}$  produced fine lines representing surface offset in both the unirradiated and irradiated zones of the sample. Fig. 6 shows cartography obtained in the irradiated area using a ForeScattered Electron (FSE) imaging system of the  $e^-$  flash EBSD detectors. Due to its high sensitivity to small orientation

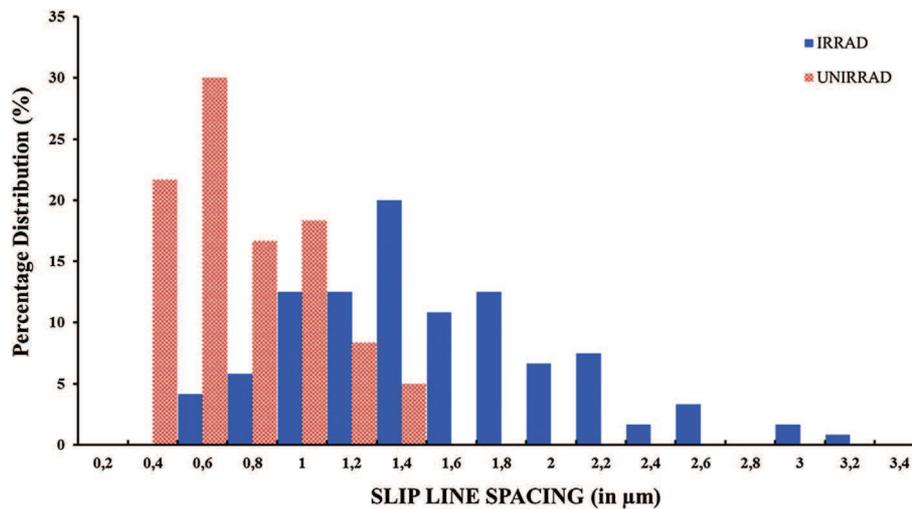
Fig. 7. Probability distribution of slip-line spacing measured in the unirradiated (in red) and Fe irradiated (in blue) region of the same sample after CERT up to 4% plastic deformation. (For interpretation of the references to color in this figure legend, the reader is referred to the web version of this article.)

The average slip-line spacing was computed over 10 SEM images (around 25 grains) for each condition. The value was 0.9 μm for the unirradiated zone<sup>3</sup> and 1.6 μm for the irradiated zone (Fig. 7) of the sample. This implies an increase of 77% in the slip-line spacing with

irradiation. The probability density distribution of slip-line spacing given in Fig. 7 shows that the irradiation broadens the distribution towards larger values. An increase of slip-line spacing after ion irradiation has also been reported in Refs. [22,34] for 1.2 MeV H and 2.8 MeV Fe, respectively. Miura et al. [39] explained that the slip-step spacing widens due to blocking of some of the slips (present in an unirradiated matrix) by damage present in the irradiated region. The author further explained that the increase of step spacing means that the deformation is more localized in each slip. The spacing obtained after Fe irradiation in this study is significantly lower than that reported after proton irradiation (~9–10 μm for 2.5 dpa) of a SUS304 with a 30 μm grain size [22]. This is in accordance to the findings of Jiao and Miura and is attributed to the different penetration depths (or to be precise, the damage depth relative to the grain size) of the two ions in the material [22,39]. As the dislocation channel structure is linked to the localization of plasticity, larger spacing reflects a higher degree of localization [22].

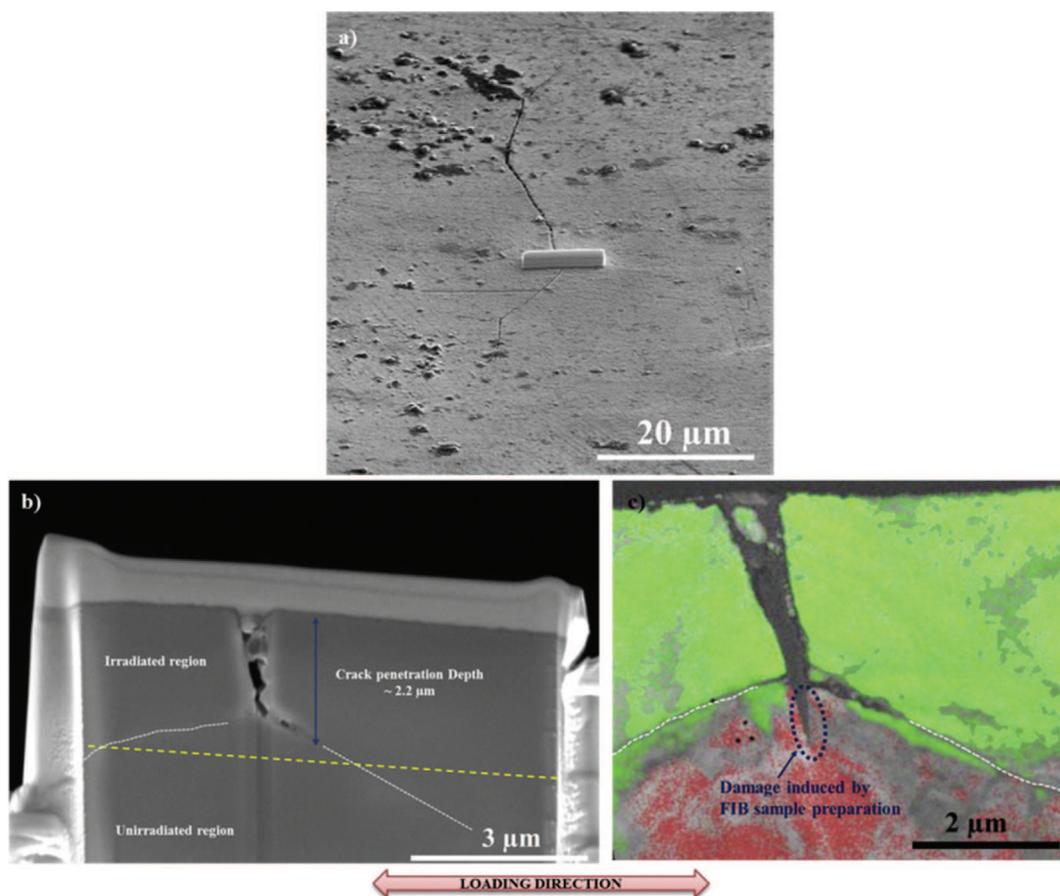
**Fig. 8.** a) SEM image of the crack cut using FIB b) zoomed cross-sectional image of the same crack after FIB cutting (yellow line marks the irradiated – unirradiated transition zone) c) Phase map (obtained using EBSD) of grains around cracks. Green represents austenite phase, while red corresponds to a Body Cubic Centered phase. Grain boundaries are marked in white dashed lines. (For interpretation of the references to color in this figure legend, the reader is referred to the web version of this article.)

propagated along the grain boundaries in a plane perpendicular to the loading direction and then changed direction. The branching of the crack was linked to the presence of a Body Cubic Centered (BCC) phase which was confirmed by EBSD analyses. Based on chemical analysis performed by TEM EDX, which shows that its chemical composition was similar to that of the austenite (different from ferrite), and from the quality patterns from EBSD, this BCC phase was inferred to be martensite. Complementary investigations on the origin of martensite phase are in progress. The grain boundaries cracked were of type RHAB (Randomly High Angle Boundaries) with angles ranging between  $30^\circ$  and  $50^\circ$ . This type of grain boundary has been identified to be strongly correlated with cracking [40].

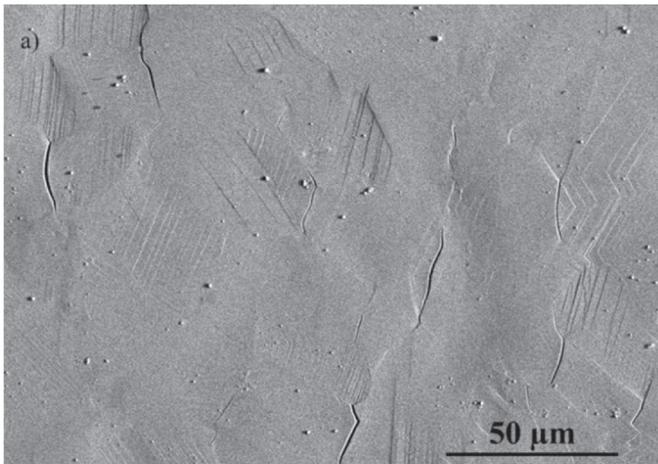
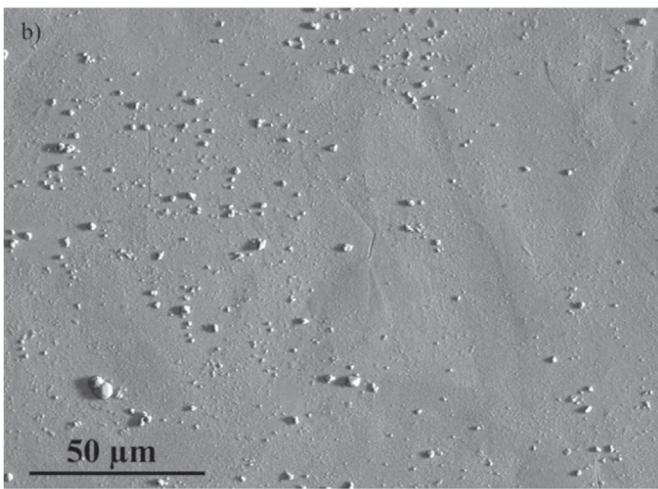
**Fig. 9.** Surface appearance of CERT specimens deformed up to 4% plastic strain in PWR environment as observed by SEM a) 5 dpa Fe b) unirradiated region. Loading direction is indicated below the images.

Most of the cracks in the irradiated region were oriented perpendicular to the loading direction (Fig. 9a). A mean crack density of  $302 \text{ cracks/mm}^2$  and mean crack length of  $17 \mu\text{m}$  were determined. Surface steps are also clearly visible in this image. An identical experiment was conducted in inert Argon. Although slip-line features similar to those described above were observed (see Fig. 11d), no cracks were observed on this sample. The absence of cracks for this test emphasizes that for the irradiation conditions used in this study, a localized strain of 4% is not in itself sufficient for initiating intergranular cracking. In order for cracking to occur, grain boundaries must be embrittled, either by the corrosive environment or by RIS (Radiation Induced Segregation) induced by high irradiation doses or by the combination of two.

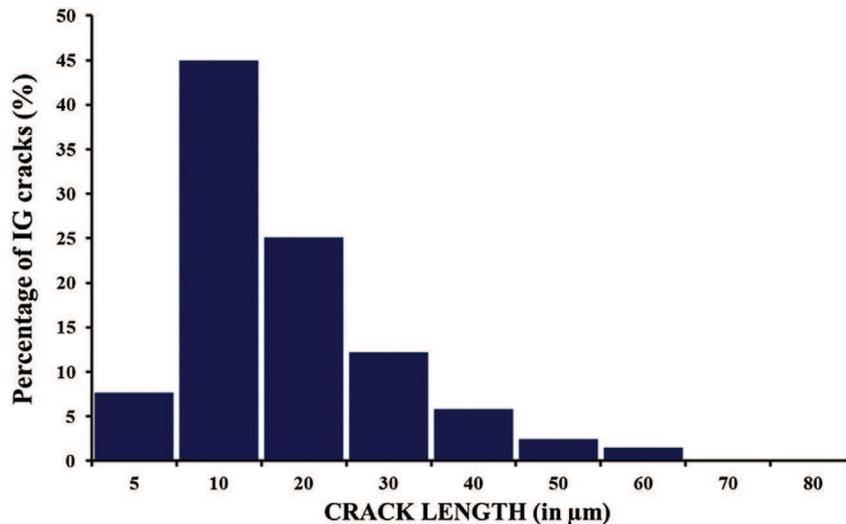
**Fig. 10.** Crack length distribution of 5 dpa Fe irradiated after 4% plastic strain.

The crack length distribution is given in Fig. 10. Most of the cracks have lengths in the range  $5\text{--}30 \mu\text{m}$  with a significant percentage ( $\sim 45\%$ ) around  $10 \mu\text{m}$ . A few cracks have a length up to  $60 \mu\text{m}$ . The majority of the unirradiated area did not present any cracks, as shown in Fig. 9b. However, careful examination revealed the presence of a few small cracks in this region. Fig. 9b shows also that less surface slip-lines are apparently observed in the unirradiated region. This could be explained by the fact that for the same level of plastic strain, localization is less marked for the unirradiated area. Localization is linked to the height of the steps, so with a lower level of localization, less marked steps will be induced in this area.

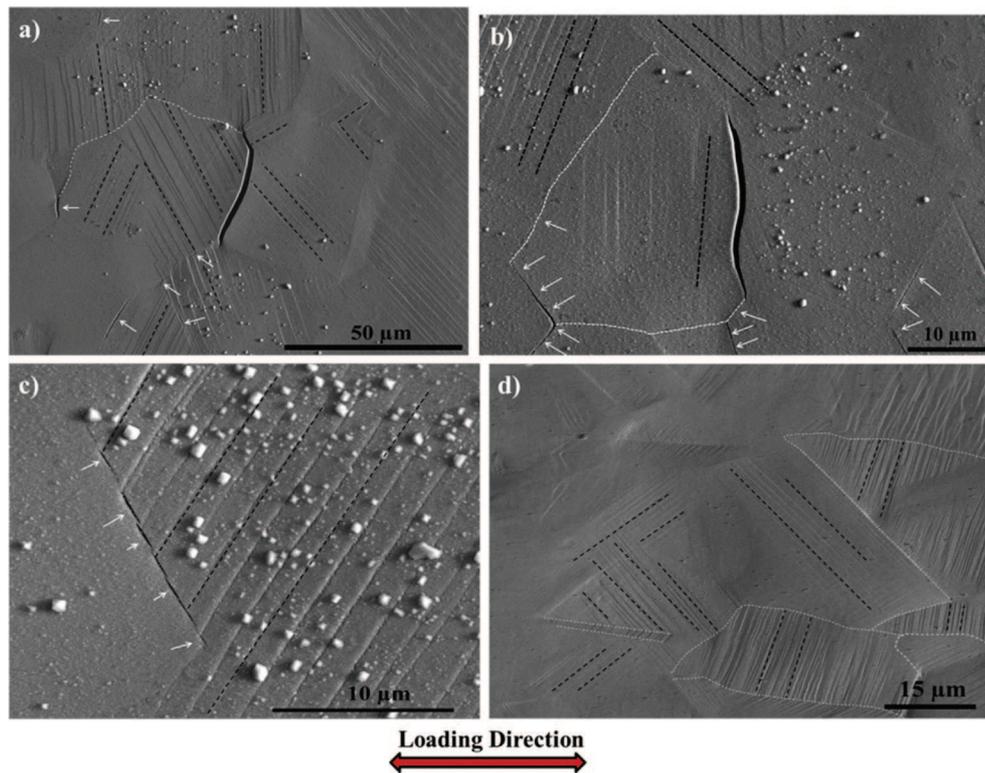
**Fig. 11.** Enlarged SEM images of cracks in Fe-irradiated stainless steel strained up to 4% plastic strain in a PWR environment (a, b, c) and of slip-lines (taken with a sample tilt of 52°) in Argon (d). Slip-lines direction within a grain are indicated by black dashed lines, small cracks are indicated by white arrows, several grain boundaries are indicated by white dotted lines.

Fig. 11 shows enlarged SEM images of different types of crack initiations. For most cases, the slip lines (i.e. surface steps) (represented by black dashed lines in Fig. 11) in a deformed grain were in a single direction, suggesting that one single slip system is dominant for these grains. Moreover, it is evident from the images that these slip-lines were present on either one or both sides of the cracked grain boundaries. Such slip-lines are commonly observed on irradiated stainless steels and have been reported to correspond to planar slip [9,16]. For a few grains, slip-lines were not visible. Open cracks are shown in Fig. 11a and b, where smaller cracks are indicated by white arrows. In Fig. 11a, slip-lines are visible on the two grains adjacent to the open crack. In this case, slip-lines clearly intersect the grain boundary where cracking has occurred. The role of slip-lines in grain boundary cracking is less clear in Fig. 11b,

where slip lines are nearly parallel to the crack on one of the adjacent grains, but no slip-lines can be clearly identified in the second adjacent grain. Crack initiation as a result of the interaction of slip-lines with grain boundaries is clearly shown in Fig. 11c, where discontinuous slip between two adjacent grains is observed.

Quantitative characterization of crack initiation sites, as performed in Ref. [19], was not the aim of this study. However, morphologies of cracking similar to that seen in Fig. 11c have been reported in different studies devoted to IASCC cracking of plastically strained, irradiated stainless steel, either after neutron irradiation [9], or after proton irradiation [17,19,41]. The similarity in the morphologies of the cracks suggests the possibility of using Fe irradiation to study intergranular cracking susceptibility of the material.
