High Temperature Ageing of Microelectronics Assemblies with SAC Solder Joints

Abstract

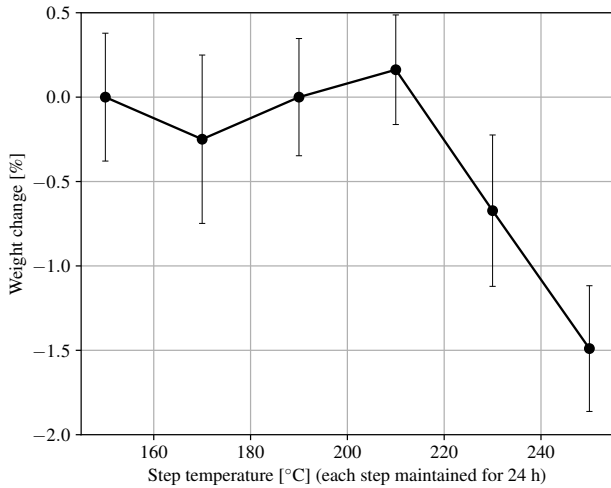
Figure 1: Weight change of unpopulated PCB test coupons during "step stress": each successive temperature step is maintained for 24 h, and one test coupon is removed from the oven at each step, for characterization (including weight measurement).

Fig. 1 shows that no noticeable weight loss was observed at 210 °C and below. A small weight loss (0.7 %) was observed after an additional 24 h step at 230 °C, and a slightly larger weight loss (1.5%) after 24 h at 250 °C. Overall, this weight loss remains very limited compared to that observed on FR4 boards in the same conditions (8% at 230 °C). This is confirmed by a second series of tests (not shown here), where PCBs using the same Arlon 85N material were stored in air for 1000 h at 190 °C without any noticeable weight loss. Such results are consistent with tests performed at higher temperature [11]. Therefore, one can consider that the tests presented hereafter (around 3000 h at 175 °C) should not result in degradation of the PCB material.

None of the the polyimide PCBs was found to be damaged by the long-term exposure to 175 °C. This is consistent with the specifications of the material, and with the preliminary tests presented in Fig. 1 with less than 1% weight loss after 24 h at 230 °C. All damages were found to be in relation with the solder layer: cracks propagated either at the solder interfaces, or in the capacitors, close to the solder joint.

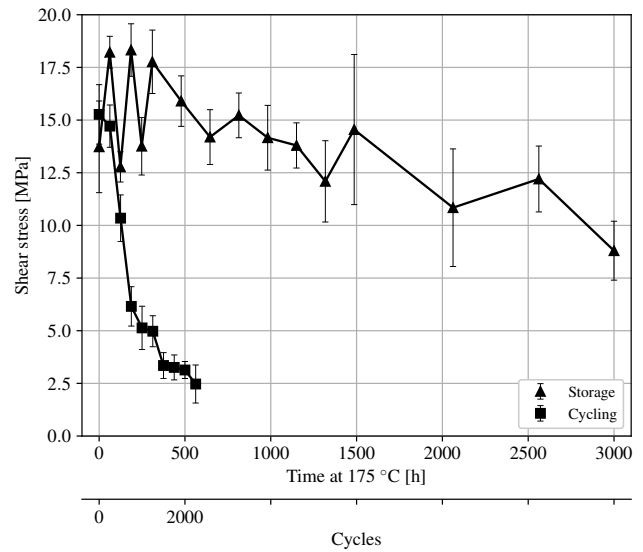
Figure 2: Shear strength of the capacitors as a function of the time spent at 175 °C, for test vehicles submitted to storage or cycling conditions. The error bar corresponds to the standard deviation of the measurements.

The shear-test measurements are presented in Fig 2. Initially, the solder attach has a very good strength, as in most cases the rupture occurs partially in the capacitors. For the storage tests, the mechanical strength slowly decreases from $\approx 15\text{ MPa}$ at $t=0$ down to $\approx 9\text{ MPa}$ at $t=3000\text{ h}$.

For the cycling tests, however, the change is much more dramatic, with a strong reduction (80%) in shear strength after 2250 cycles (equivalent to 562 h at $175\text{ }^{\circ}\text{C}$).

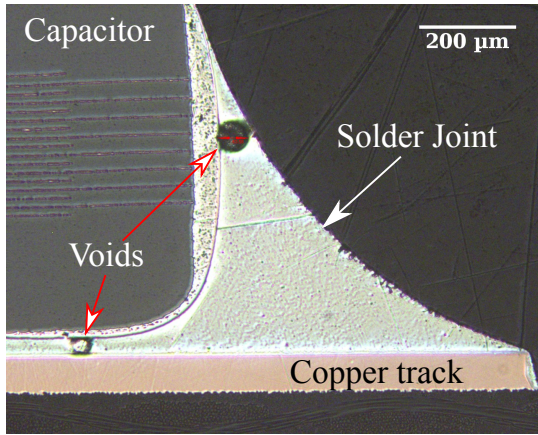
Figure 3: Cross section of solder joints, before testing (a) and after 750 cycles between $-55\text{ }^{\circ}\text{C}$ and $175\text{ }^{\circ}\text{C}$ (b). A few voids are visible initially in Fig. (a). After cycling, a crack develops, first under the capacitor terminals, and eventually across the full solder joint.

Cross-sections of some solder joints are presented in Fig. 3 (optical microscopy). In Fig. 3a, the solder joint was not submitted to any cycling test (initial conditions). This cross section is representative of the solder attaches, with some voiding. Indeed, a noticeable number of voids was found in most solder joints.

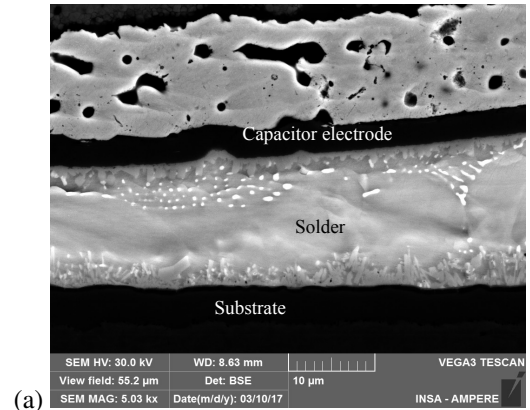
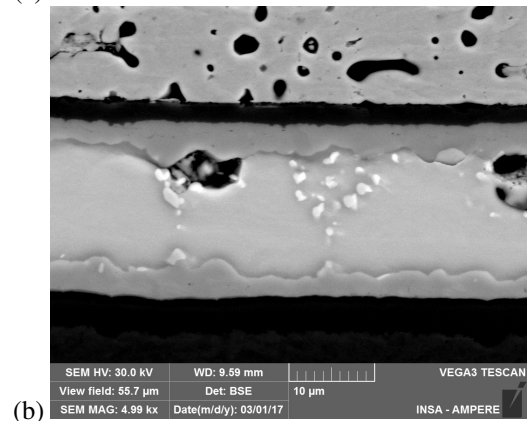
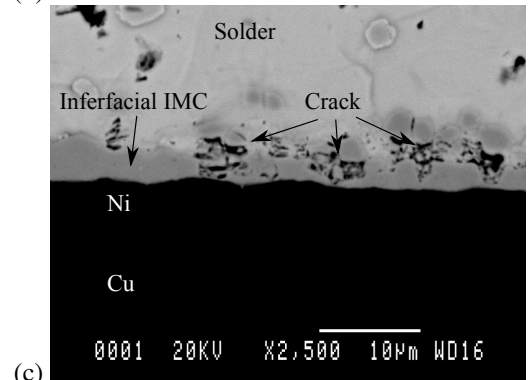
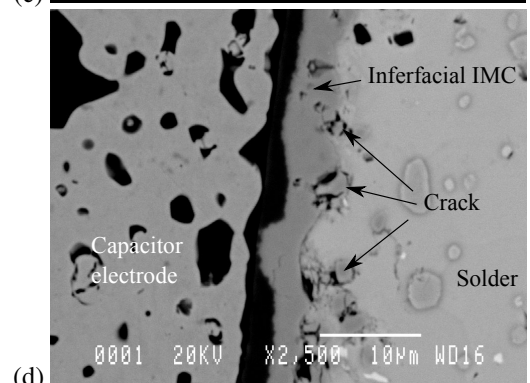
Figure 4: Enlargement of the solder area between the capacitor terminal and the PCB substrate. From top to bottom: cross section before testing (0 h), cross section after 310 h storage at $175\text{ }^{\circ}\text{C}$, substrate/solder interface after 1500 cycles (corresponding to 375 h at $175\text{ }^{\circ}\text{C}$), and capacitor (left)/solder interface, also after 1500 cycles.

SEM observations (Fig. 4) show a change in the interfacial microstructure of the solder joint: in initial conditions (Fig. 4a), the IMCs form a lamellar structure. After 310 h storage (Fig. 4b), the interfacial IMCs become continuous. In cycling tests (Figs. 4c and 4d for substrate and capacitor side, respectively) the interfacial IMCs also become continuous, but some voiding appears at the IMC/bulk solder interface. No such crack is observed in storage (310 h and 1500 cycles are equivalent in terms of time spent at 175 °C). This indicates that the cracks are generated by the thermo-mechanical stresses. This also means that the continuous IMC layers have little influence on the mechanical strength, as presented in Fig. 2.

The cracks occurred both in cycling and storage conditions, but they appeared sooner for cycling, and are related to two different mechanisms. For cycling, the rupture occurred along the brittle IMCs regardless of their position (Figs. 4c and d). In storage, they started under the capacitor electrodes, and were caused by the depletion of the solder joint due to the interfacial IMC growth.

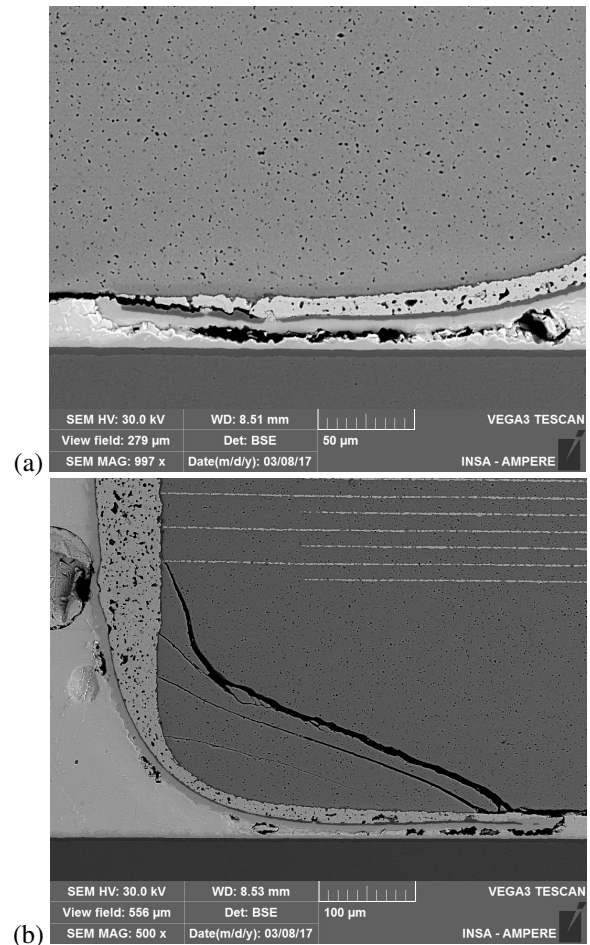
Figure 5: Microsections after 984 h storage at 175 °C. The growth of the IMC generated stresses that resulted in crack, either in the solder joints, in the capacitor metal finish, or in the capacitor body itself.

For longer storage periods, however, cracks start to appear between the capacitor and the substrate (Fig. 5). These cracks develop where the solder is the thinnest, and occur once the IMCs have grown to occupy the entire solder volume. However, this cracking has little influence on the shear strength, as visible in Fig. 2 (no drop in shear strength for samples stored for 984 h). This can be explained because the solder area under the capacitor terminals only represent a small part of the total joint. Another visible effect of storage ageing is the cracks observed on some capacitors (Fig. 5b). However, these are not observed on all capacitors. Only two capacitors were cross-sectioned per time step, so no statistics could be made regarding the effect of storage time on capacitor cracking.

The evolution of the solder interfacial microstructure is as follows: interfacial IMCs grow at different speeds at the capacitor and PCB interfaces; cracks propagate at the solder/IMC interface below the capacitor, where the solder joint is thinner and depletes quicker (Fig. 5); Finally the cracks develop along the complete Sn/IMC interface (Fig. 6). The IMC growth rate is plotted in Fig. 7. Previous tests [6] were performed at lower storage temperatures (80, 125 and 150 °C). After 1000 h, the IMC thicknesses were found to be 2.25, 2.5 and 3.6 µm respectively on a PCB with NiAu finish. This is consistent with the

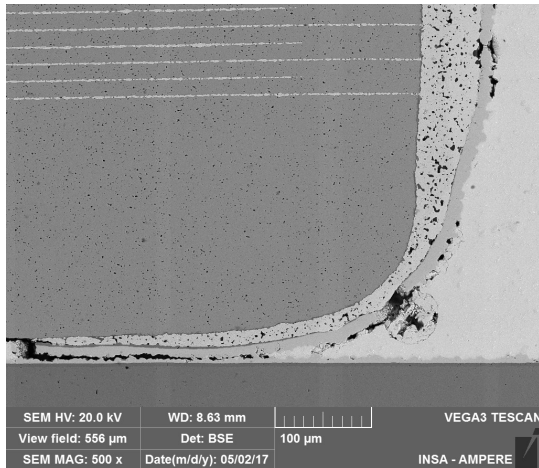
Figure 6: Microsections of the solder joints after 2562 h storage at 175 °C, showing the propagation of the voiding along the IMC/solder interface.

As storage time increases, the IMCs continue to grow, and voids develop all along the IMC/solder interface (Fig. 6), as was observed for the cycled samples in Fig. 4d. This is correlated with the continuous decrease in the shear strength, as plotted in Fig. 2.

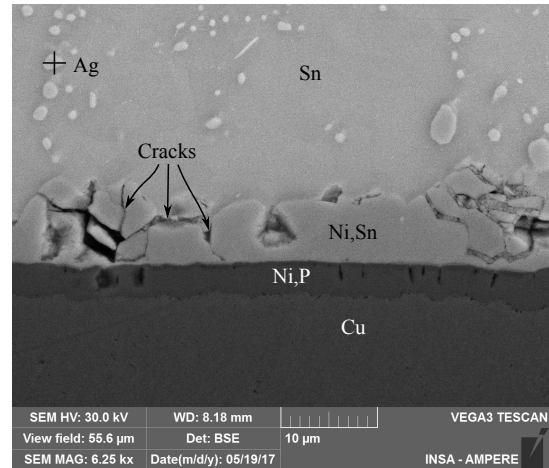
Figure 8: Enlargement of the Substrate/Solder interface after 3000 h storage at 175 °C. Many cracks appear at the interfacial IMC area. Ag forms precipitates (clear areas) in the bulk of the solder joint.

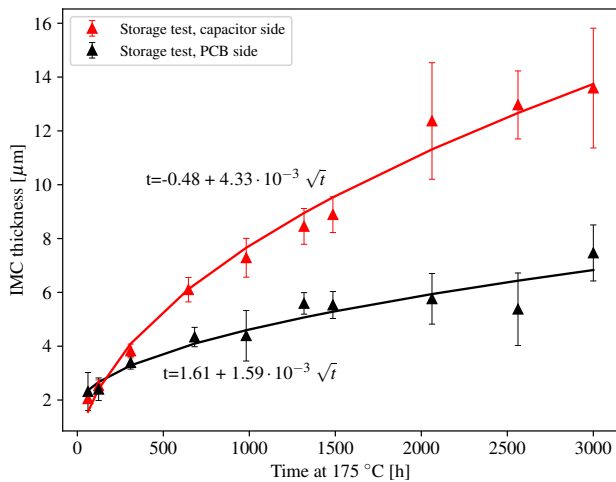
Figure 7: Measured IMC layer thickness as a function of time spent at 175 °C, for different interfaces of the structure (capacitor terminals/solder, PCB/solder).

The thickness of the IMC layers, measured at the solder/substrate interface and at the solder/capacitor interface is shown in Fig. 7, as a function of storage time. The difference in the growth rate is related to the finish of the parts: the capacitors have a Sn finish, while the PCB has a NiAu finish.

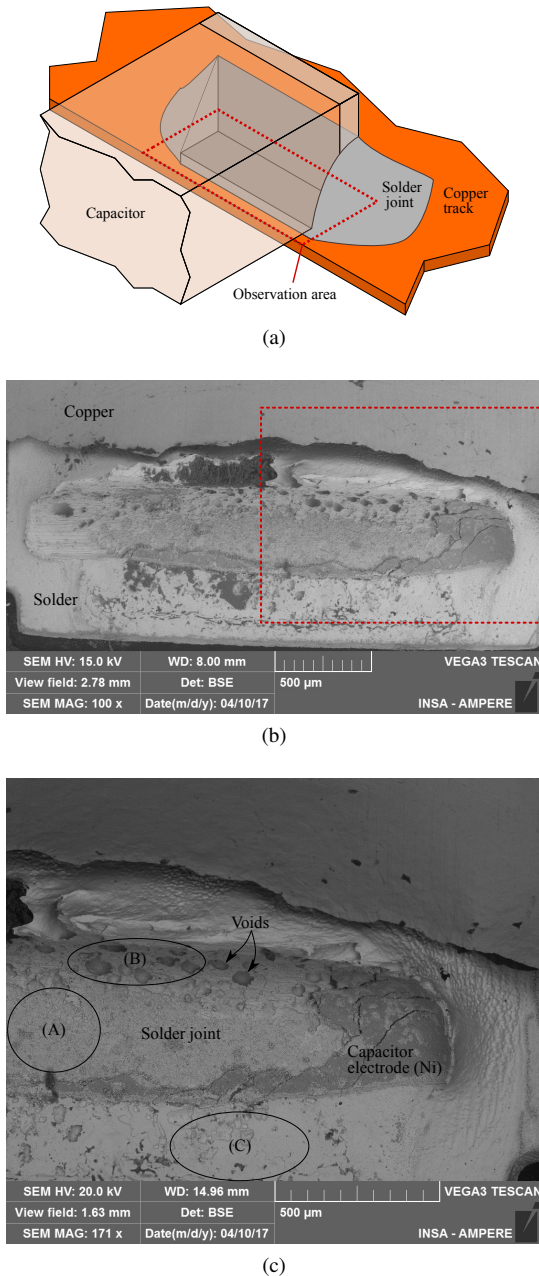
Figure 9: Rupture surface on one side of the capacitor (sample stored for 2062 h at 175 °C): Observation area; overview of the breaking facies after shear test of the capacitor (travel direction of the shear tool was from right to left), zoom on the right area of the rupture surface.

Examples of some rupture surfaces observed for capacitors stored for 2062 h at 175 °C are given in Fig. 9. Several regions can be identified in Fig. 9c: region A corresponds to the solder located below the capacitor electrode. In this area, the shearing of the capacitor caused no smearing, indicating that the solder was completely separated from the capacitor electrode, as can be observed in Figs. 5 and 6. In region B, which corresponds to the “vertical” solder/capacitor interface in Figs. 5 and 6, some smearing can be observed. This indicates that the interface was not completely cracked. Also, many voids can be observed. Region C corresponds to the solder area located below the capacitor ceramic body (where no attach occurred before or after ageing). Finally, in the right side, some leftovers of the capacitor electrode (Ni) can be seen. The solder layer underneath was larger (because the capacitor has rounded edges), and did not crack completely as the IMC grew, resulting in a better solder/metallization interface.
