Evaluation of printed-circuit boards materials for high temperature operation

Oriol AVIÑO-SALVADO, Wissam SABBAH, Cyril BUTTAY,
Hervé MOREL, Pascal BEVILACQUA

Laboratoire Ampère, Lyon, France

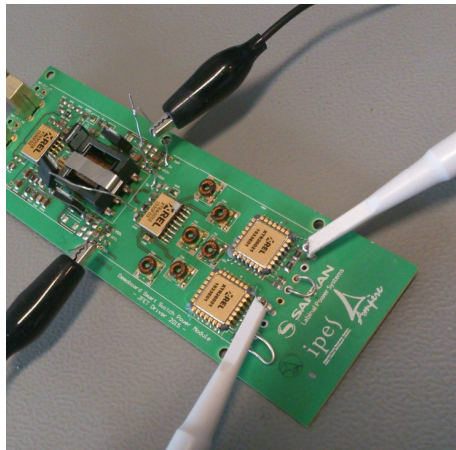
Gate Driver for SiC MOSFET Power Module

- ▶ Relatively complex board
 - ▶ Several ICs
 - ▶ Large magnetic components
 - ▶ Not suited to power substrate (DBC)
- ▶ Need for prototyping solution
 - ▶ Easy procurement
 - ▶ Cheap
- ▶ Objective: eventually 200 °C
 - ▶ Current SiC MOSFETs limited to 175 °C

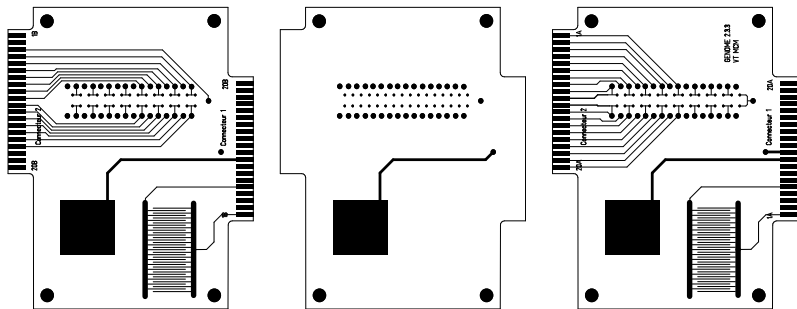
Test Vehicles

- ▶ 6-layer PCBs, 70 μm Cu (2 oz), Ni/Au finish (6 μm /80 nm)
 - ▶ One set on FR-4 (Panasonic R-1755-V, $T_G > 170^\circ\text{C}$)
 - ▶ One set on polyimide (Arlon 85N, $T_G > 250^\circ\text{C}$)
- ▶ 3 test patterns:
 - ▶ Surface isolation resistance (500 μm spacing)
 - ▶ 20x20 mm² capacitance
 - ▶ Daisy-chained vias (450 μm hole diameter)

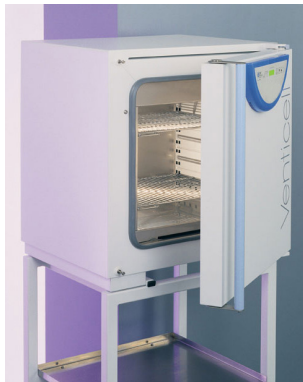
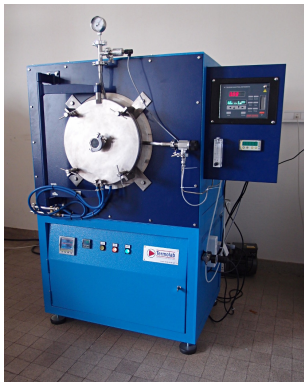
- ▶ Isothermal ageing (“storage conditions”, constant temperature)
- ▶ Two atmosphere compositions:
 - ▶ Air (standard, forced convection oven)
 - ▶ Low-oxygen content (N_2 supply, O_2 content monitored to $<0.1\%$)

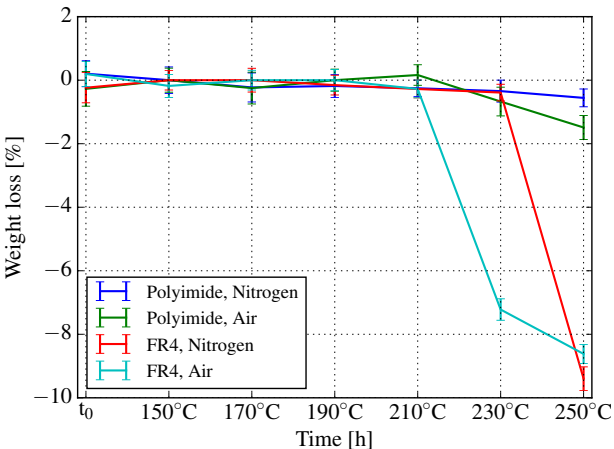
Preliminary tests

Step stress

24 h temperature steps
20 °C increase
From 150 to 250 °C

- ▶ Weight loss measured on small coupons
- ▶ No change observed before 230 °C step
- ➔ 190 °C chosen for 1000 h storage tests

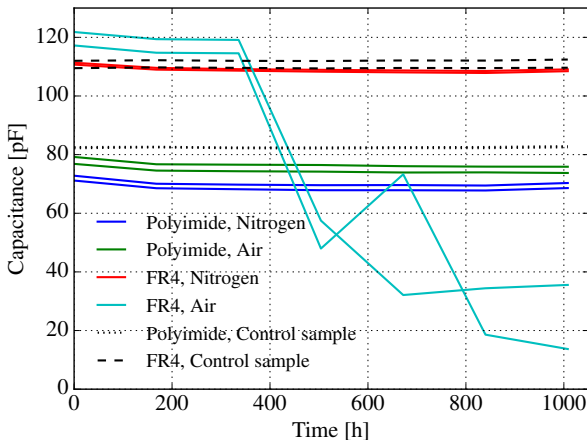
Capacitance variation

- ▶ No change on any board, except FR4, in air
- ▶ For FR4, in air, visible swelling around capacitor pattern (504 h)
- ▶ Blister may be caused by copper electrode, forming gas-tight area

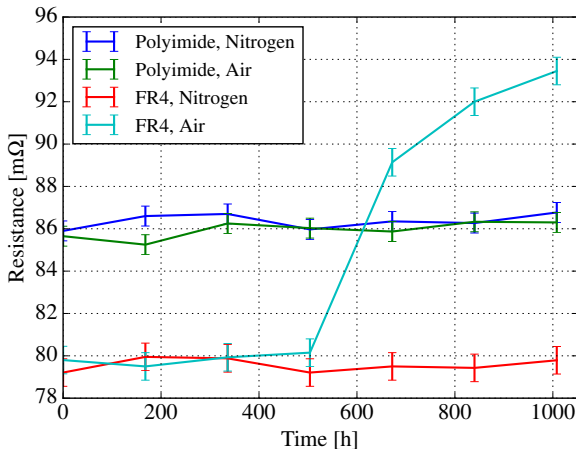
Resistance of Vias

- ▶ As with capacitor patten, change only observed for FR4, in air
- ▶ Swelling of FR4 board causes increase in via resistance
- ▶ Occurs 1 week later than for capacitor (672 h)

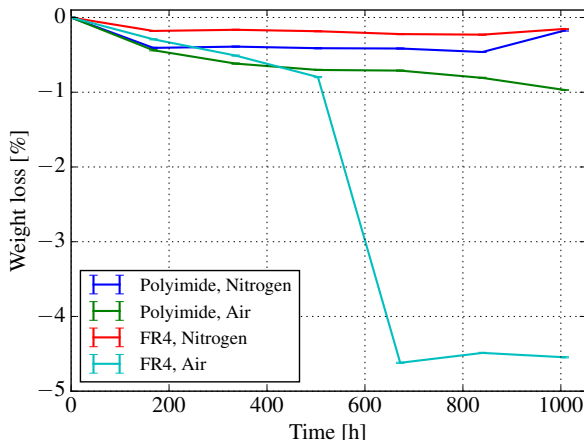
Weight loss

- ▶ Large weight loss for FR4, in air, after 672 h
- ▶ Noticeable weight loss (1 %) for polyimide, in air
- ▶ Negligible weight loss in N_2 , for polyimide and FR4

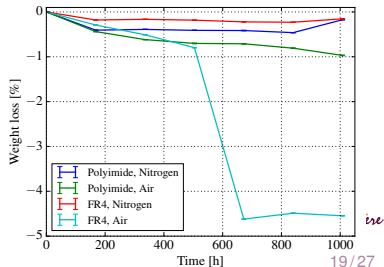
Visual inspection – FR4 board, 190 °C air storage

- 1 week:** darkening of solder resist
- 3 weeks:** lighter hue
- 4 weeks:** inhomogeneous color, strong weight loss

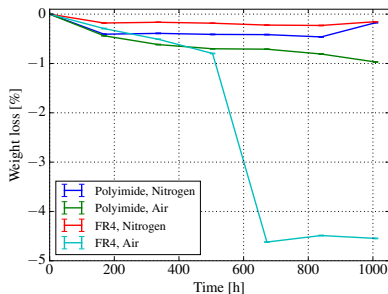
Visual inspection – others

- ▶ For polyimide:
 - ▶ In air, darkening of solder resist
 - ▶ No other noticeable change
 - ▶ In nitrogen, no visual change
- ▶ for FR4:
 - ▶ No visual change
 - ▶ No corrosion of Au finish
