# Hydromorphological Monitoring of a Sediment Replenishment Operation: The Case of the Saint-Sauveur dam in the Buëch River (Southern Alps. France)

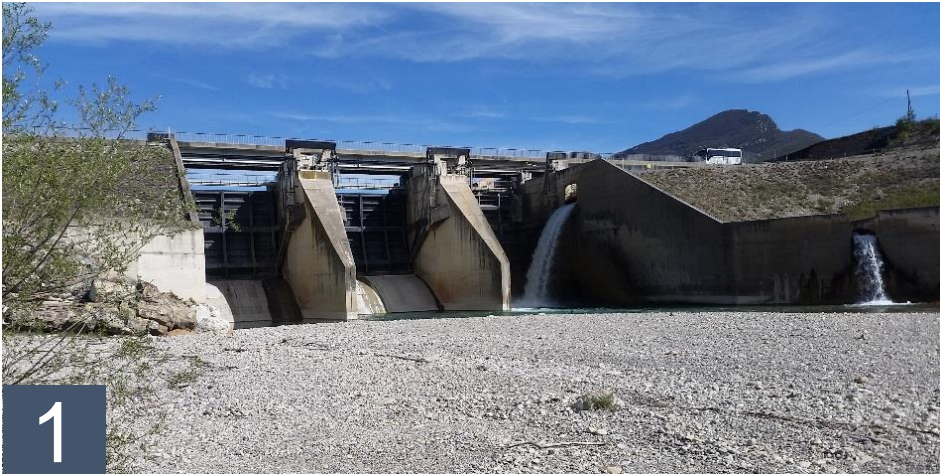
1

Drainage area (km <sup>2</sup> )	836
Length of the study reach (km)	2.2
Active channel width (m)	180
Channel slope (m/m)	0.009
Planform morphology	Braided/wandering patterns

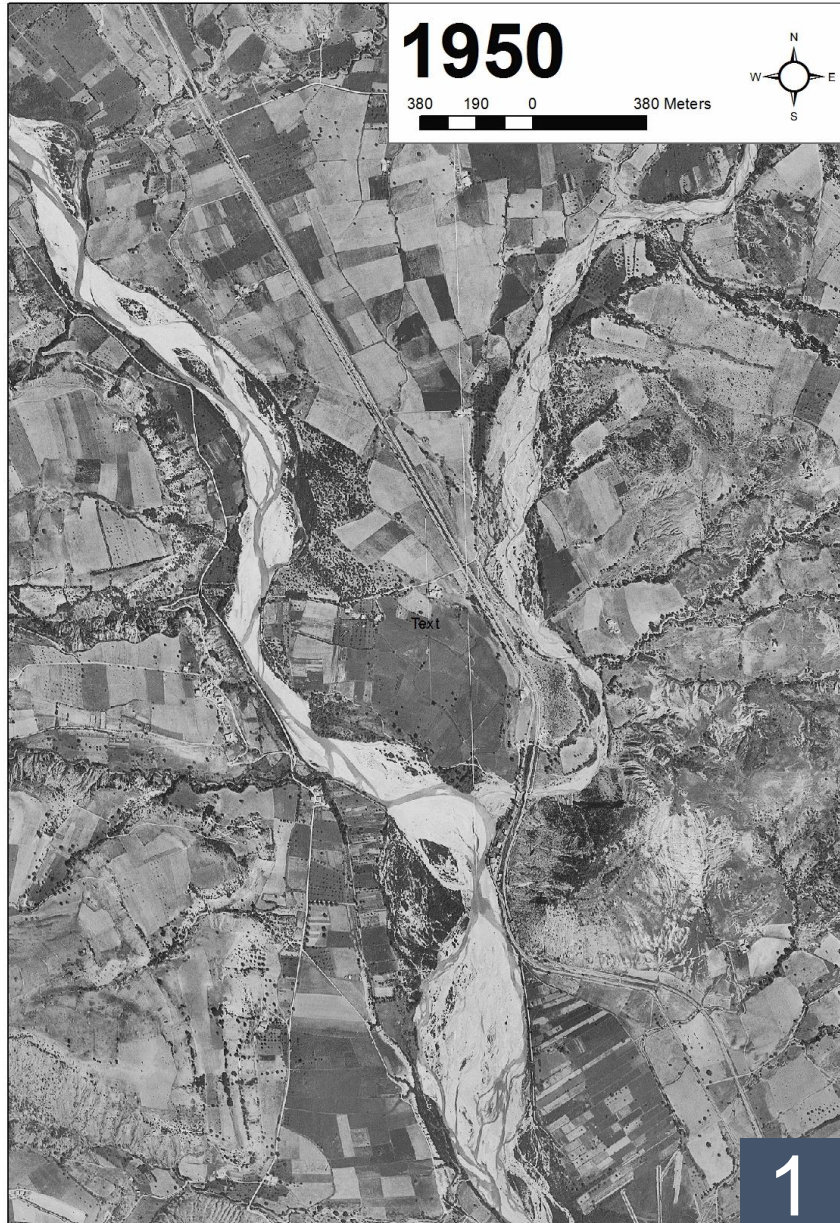
Human alterations of the physical fluvial corridor :

Gravel mining

> 3 million m<sup>3</sup> in the upper catchment

> 6 million m<sup>3</sup> in the lower catchment

Dam was built between 1991 and 1992 => dredging of 600,000 m<sup>3</sup> of sediment

Sedimentary transport continuity has been strongly impacted

Rapid channel responses :

- Alluvial fan is aggrading upstream the reservoir
- Contraction and degradation of the active channel with downstream propagation
  - Marly bedrock outcrops are observed along the degraded reach
  - A shift from a braided to a wandering pattern

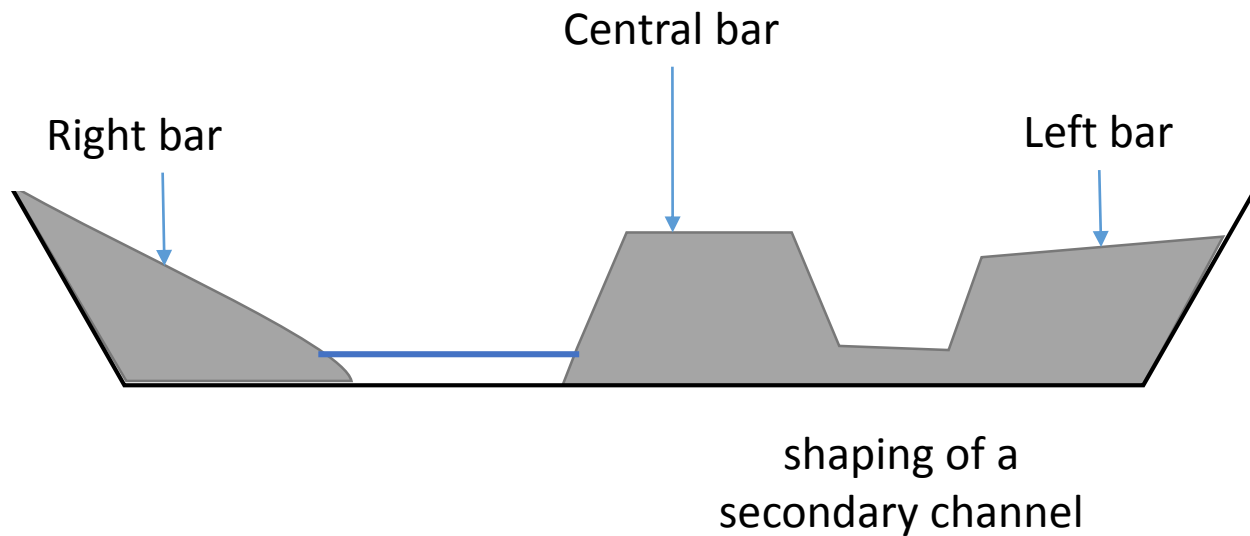
#### Schematic cross section of the replenishment operation

- Dredging the alluvial fan of the Saint Sauveur reservoir (50,000 m<sup>3</sup>)
- Sediment replenishment downstream of the dam (44,000 m<sup>3</sup>)

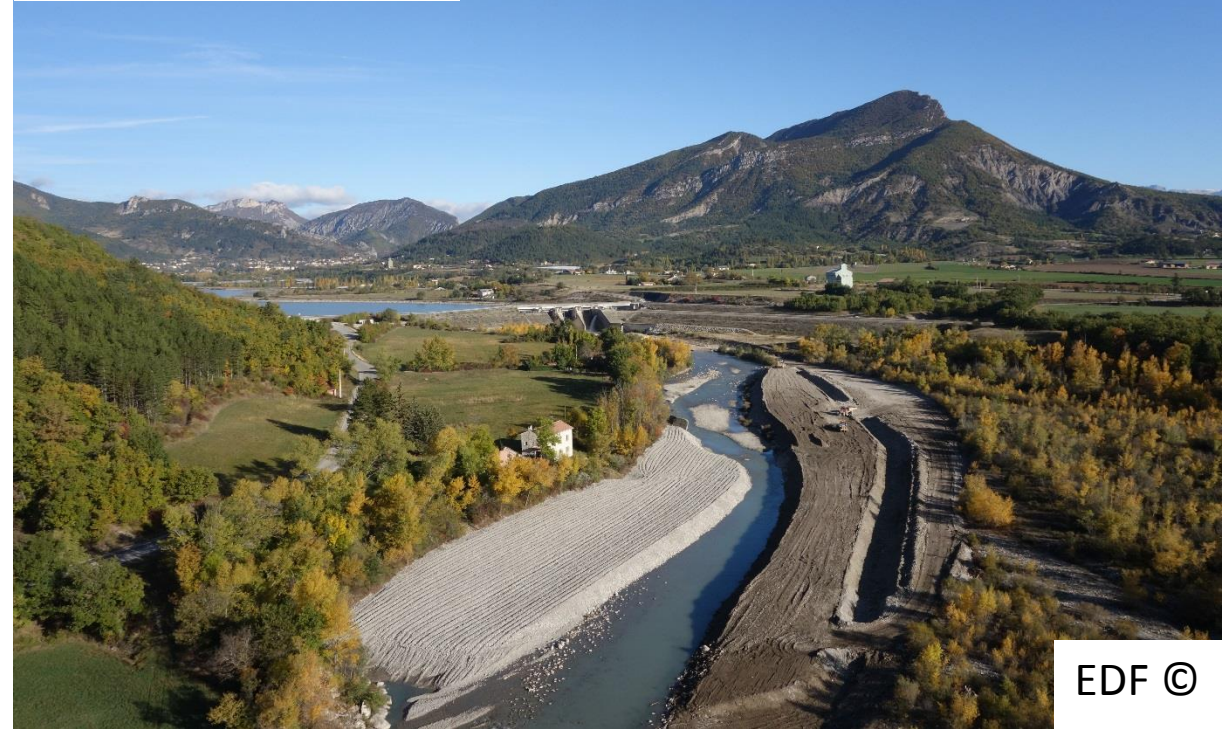
End of the operation

EDF	Right bank	Left bank
Volume (m <sup>3</sup> )	12,256	31,189
Total (m <sup>3</sup> )	43,445

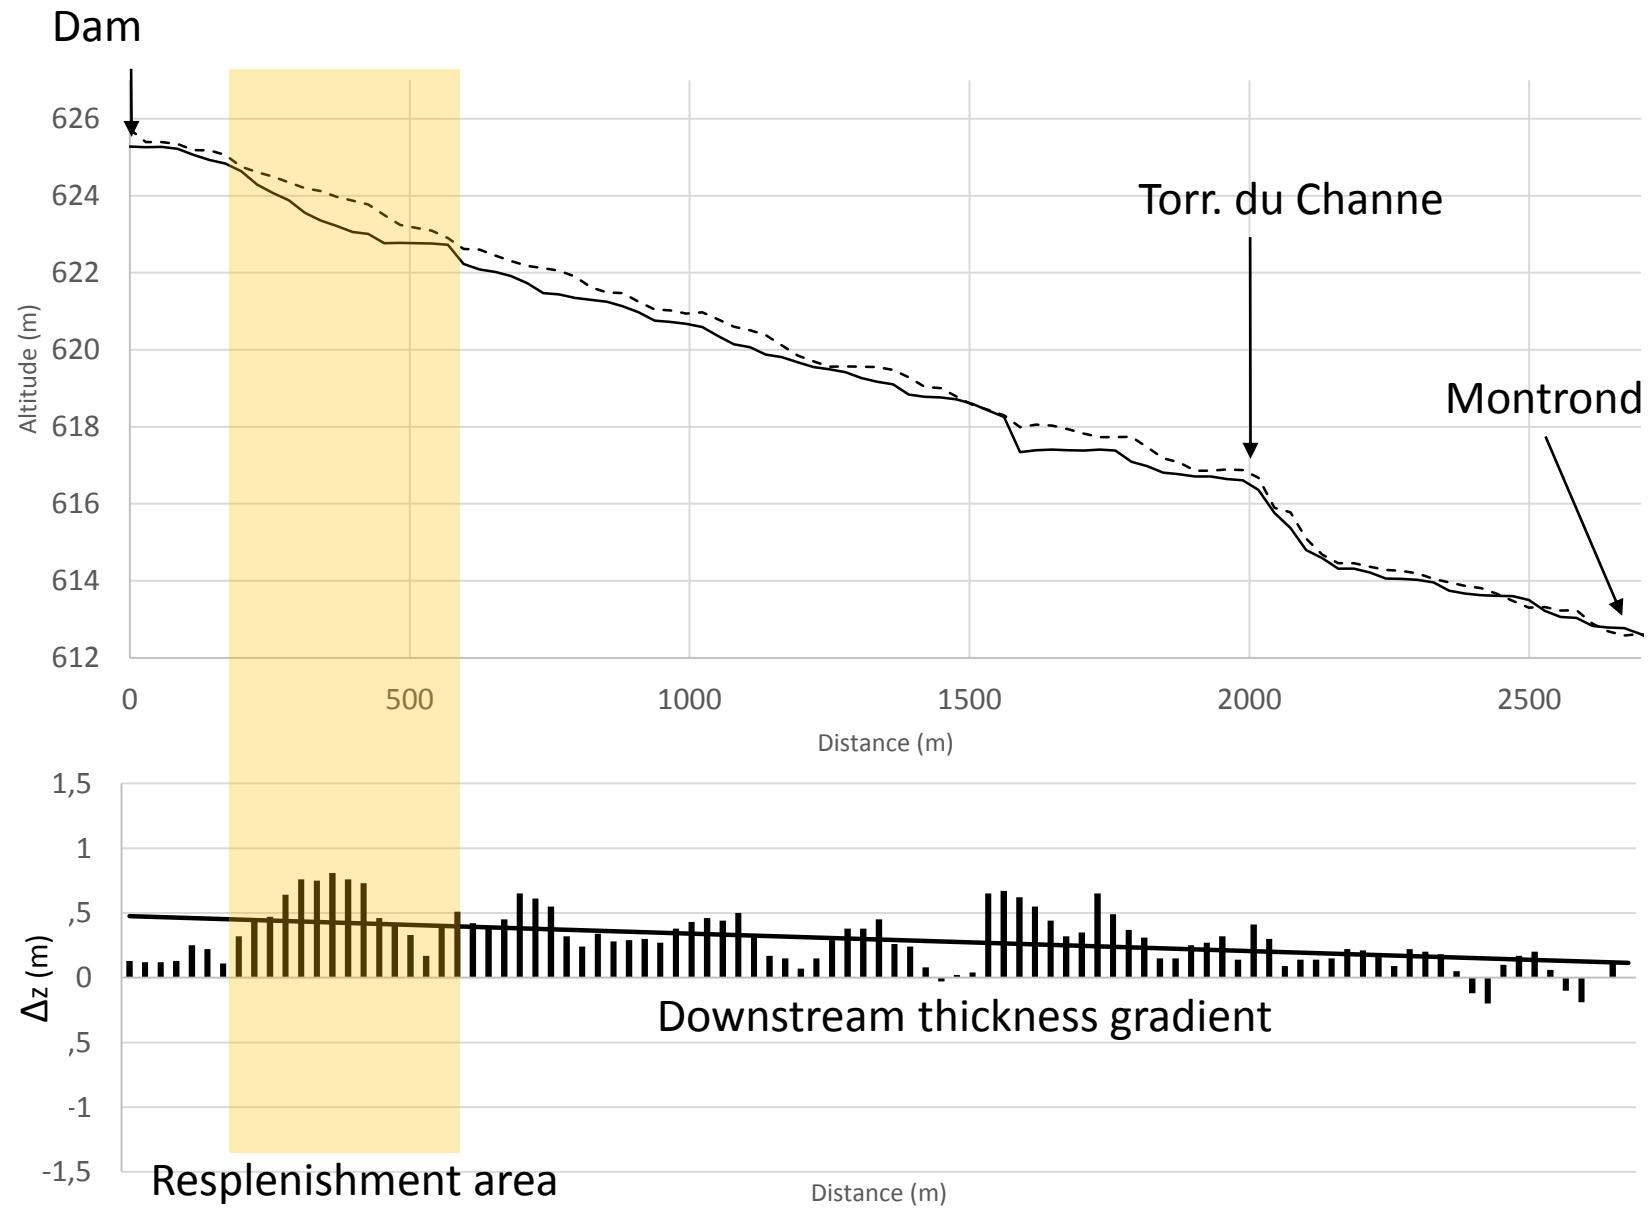
### The main channel

Vertical adjustments

Cross section spacing = 25 m

Difference between the min value of each cross section

$\Delta z$ (m)
Min	-0.20
Max	0.81
Average	0.30
SD	0.22

An important aggradation of the main channel

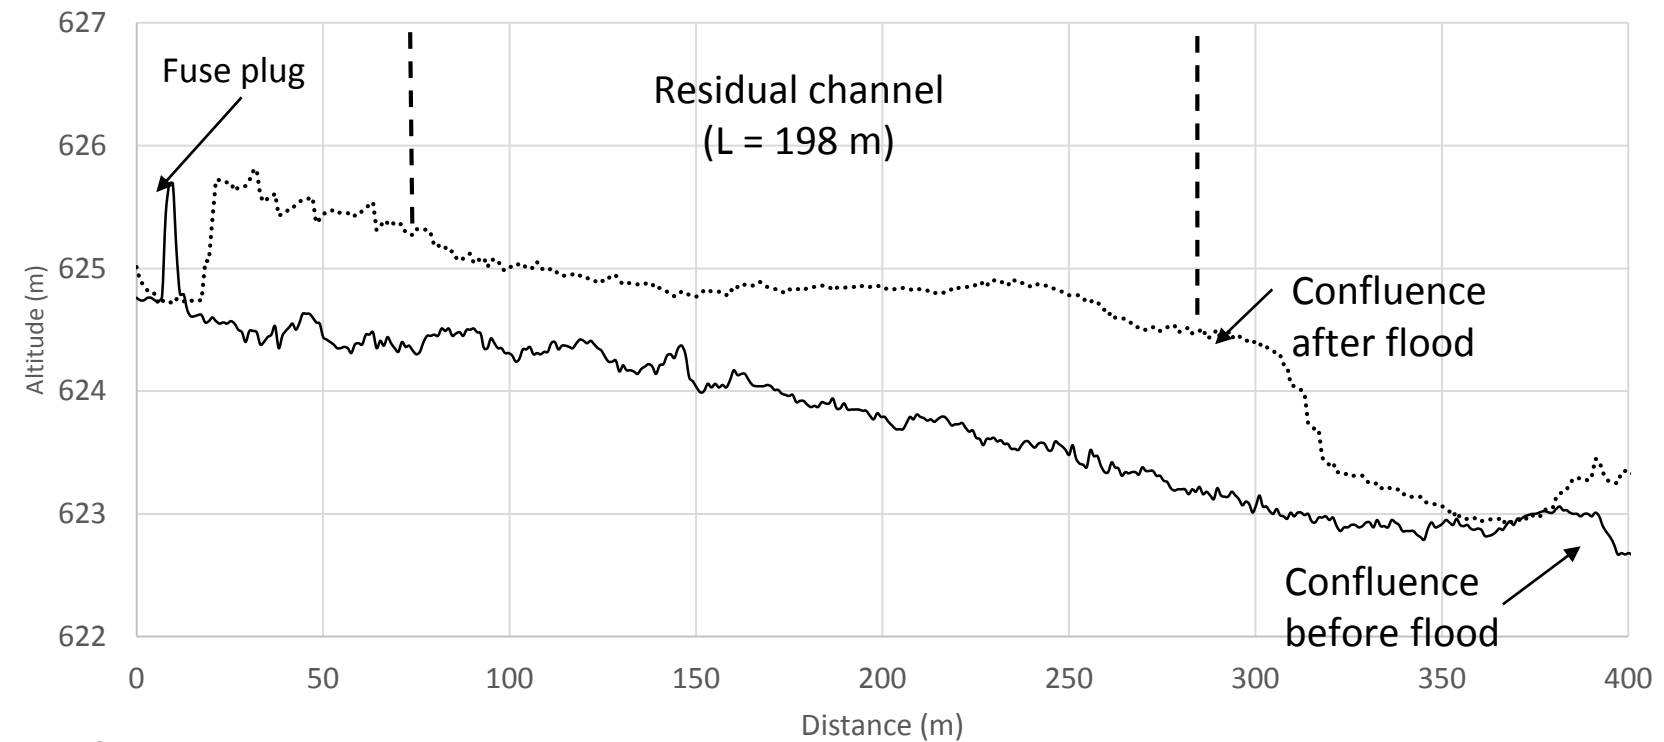
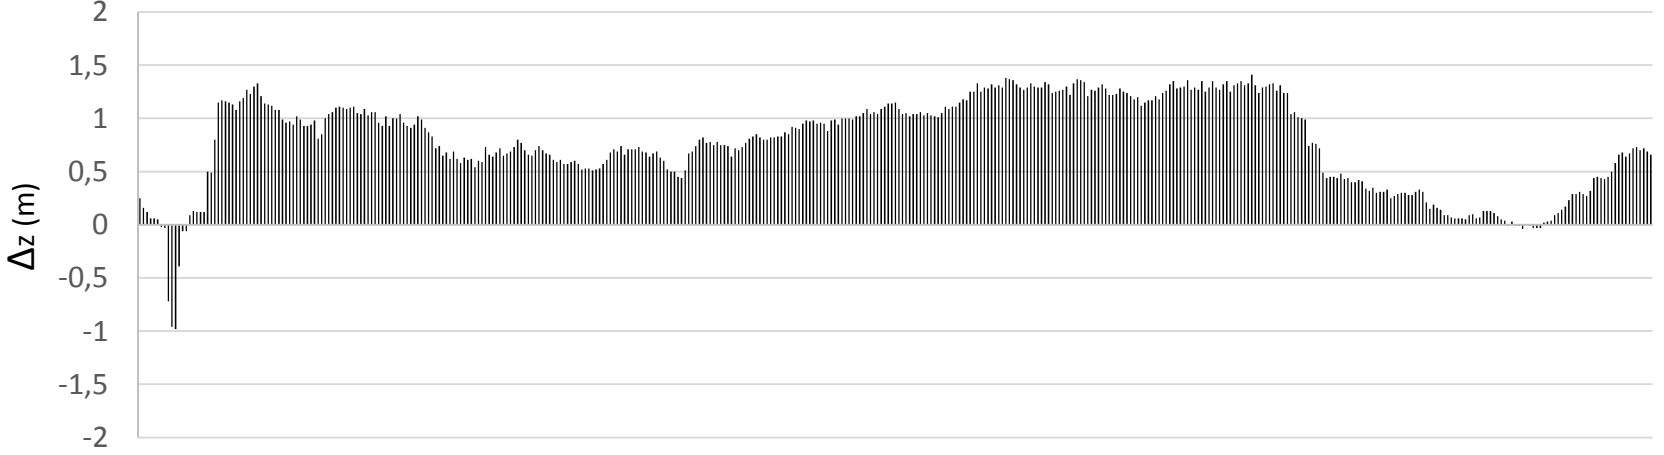
### The secondary channel

Vertical adjustments  
 1 point/m  
 Difference between before and after flood values

Before flood	After flood	Evolution (%)
length (m)	380	198	-48
Slope (%)	0.54	0.20	-63

Δz (m)
Min	-0.98
Max	1.41
Average	0.78
SD	0.43

The contribution of the secondary channel is a little disappointing

- Now it is perched by the main channel
- No development of aquatic habitat
- The decrease in energy due to this channel has probably limited the erosion
- Especially for the left bar

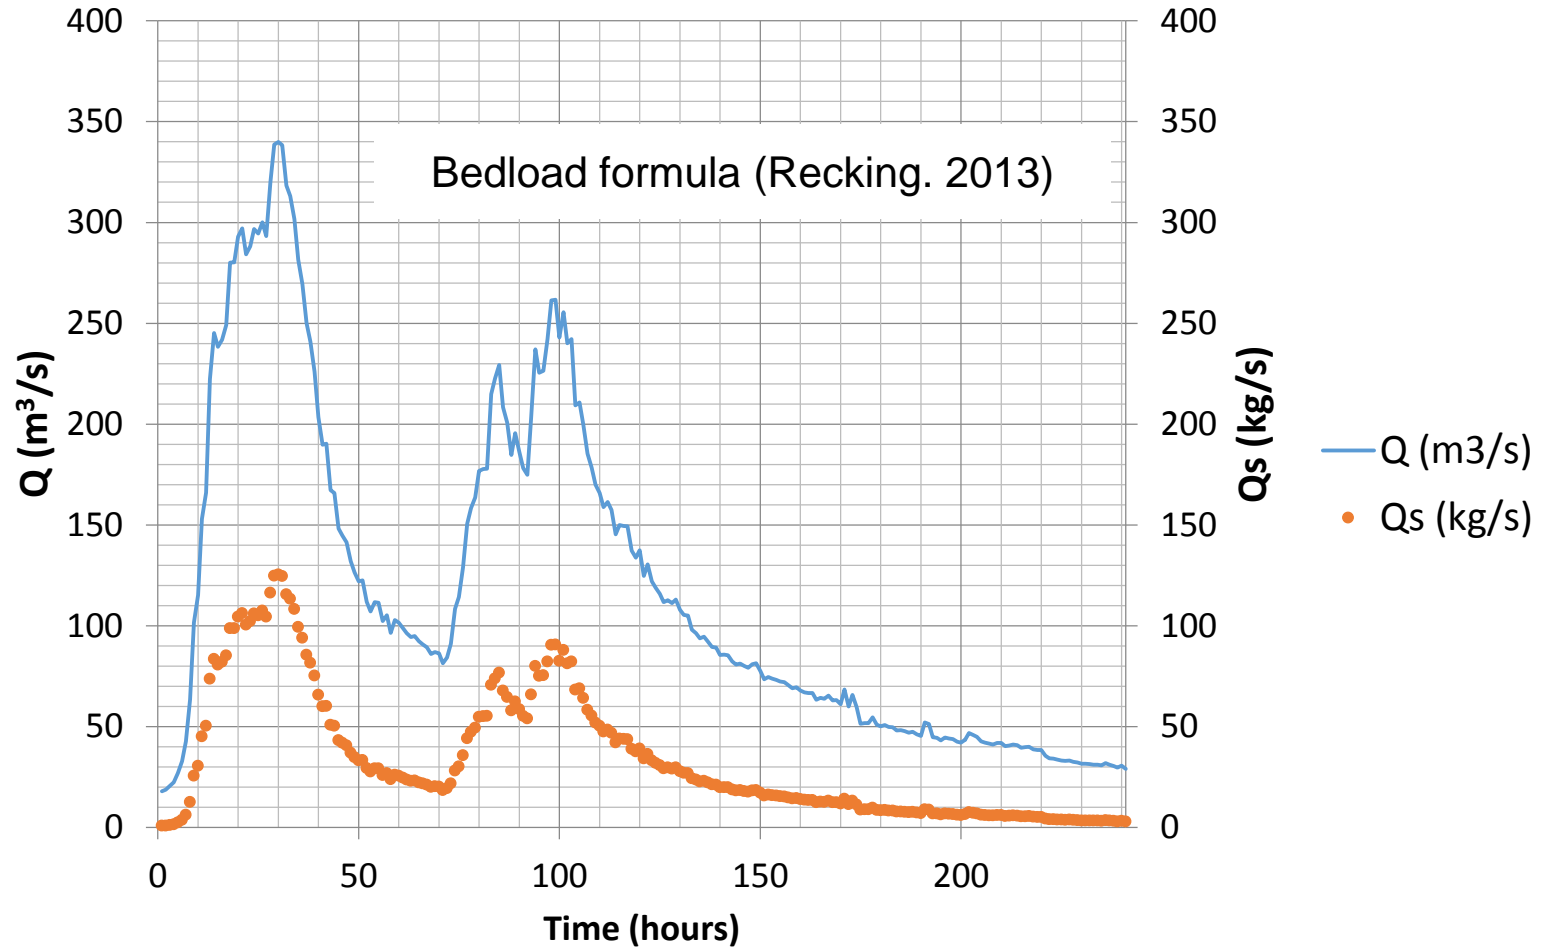
- Wolman granulometry after flood
- 1 cross section
- 1 longitudinal profile
- Flood marks
- Bedload formula integration in the hydrogram

Parameter: Q <sub>max</sub>		
d	1.23	m
S	0.00319	m/m
W	70.00	m
R	1.19	m
U	2.19	m/s
τ	37.15	N/m <sup>2</sup>
τ*	0.055	d84
τ <sub>c</sub> *	0.023	d84
τ* / τ <sub>c</sub> *	2.43	d84

$D_{50} = 20.8 \text{ mm}$

$D_{84} = 40.9 \text{ mm}$

$O \text{ (bedload)} = 12,000 \text{ m}^3$

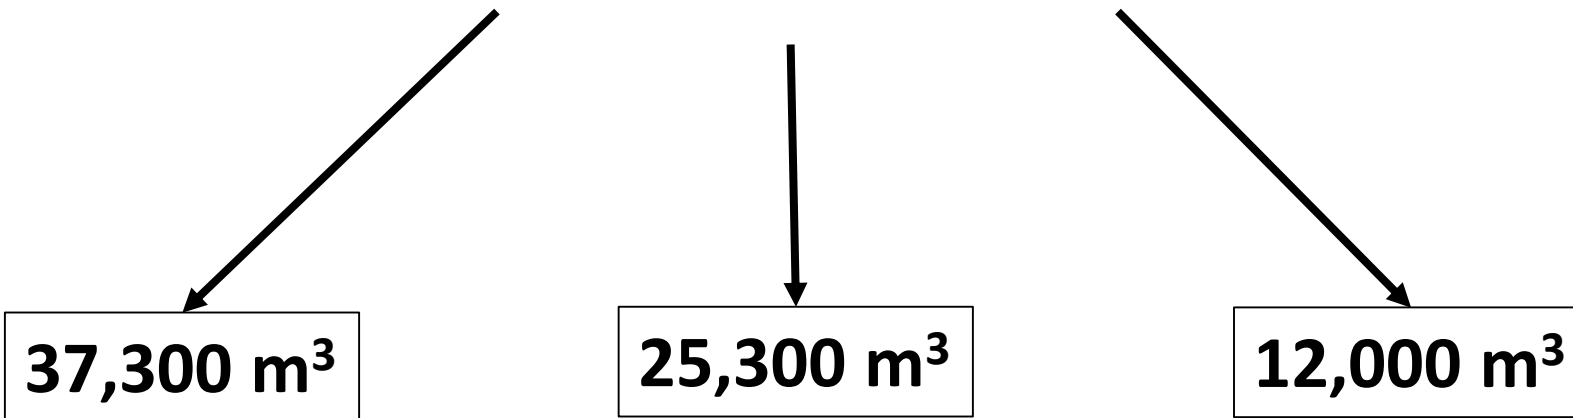
Sedimentary budget

90% of the mean annual sediment supply upstream the dam

190% of the mean annual bedload downstream the dam
