Ageing, Shocks and Wear Mechanisms in ZTA and the Long-Term Performance of Hip Joint Materials

Abstract: The surface morphologies and microstructures of Zirconia Toughened Alumina (ZTA) femoral heads were analyzed following in vitro tests aiming to simulate in vivo degradation. Three phenomena potentially leading to degradation were investigated: shocks, friction and hydrothermal ageing. Shocks due to micro-separation created the main damage with the formation of wear stripes on the femoral head surfaces. Atomic Force Microscopy (AFM) images suggested the release of wear debris of various shapes and sizes through inter- and intra-granular cracks; some debris may have a size lower than 100 nm. A decrease in hardness and Young's modulus was measured within the wear stripes by nanoindentation technique and was attributed to the presence of surface and sub-surface micro-cracks. Such micro-cracks mechanically triggered the zirconia phase transformation in those worn areas, which in return presumably reduced further crack propagation. In comparison with shocks, friction caused little wear degradation as observed from AFM images by scarce pullout of grains. The long-term resistance of th

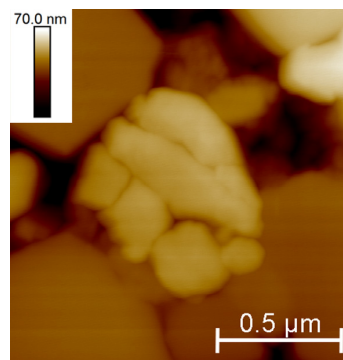
Figure 4. Atomic Force Microscope (AFM) height image of the sample #SH9 illustrating a cracked grain within the wear stripe area.

A closer inspection of the surfaces revealed the presence of cracked grains (Figure 4) within the wear stripes of the samples submitted to shocks (#SH6 and #SH9). Intra-granular cracks were observed and suggest the formation of wear debris whose size is smaller than the grain size and whose shape is irregular; some debris may have a size lower than 100 nm. Such debris was identified on the worn surface into the remaining pits caused by grains pullout as well as at the grain boundaries (Figure 5). An EDX analysis showed that the chemical composition on the worn areas was not different to the debris-free areas (such as on #AUT or #SIM), which ruled out the possibility of a contamination and confirmed the presence of ceramic debris.

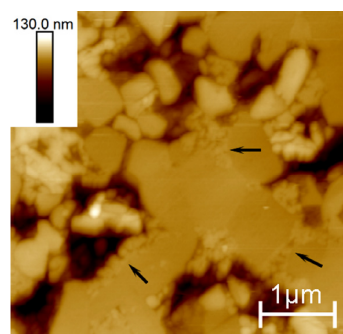
Figure 5. AFM height image of the wear stripe area of the sample #SH9 illustrating debris piled into pits and at the grain boundaries.

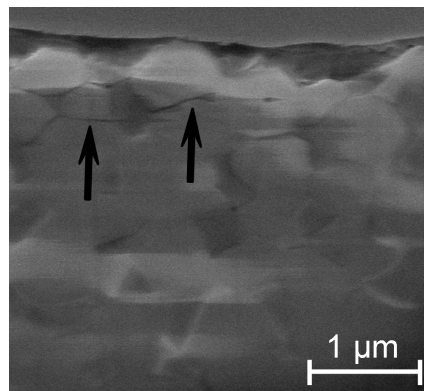
Figure 6. Image from a cross-section obtained by DB-FIB below the worn surface of the sample #SH9; a few micro-cracks were identified (black arrows).

A few micro-cracks were observed by Dual Beam-Focused Ion Beam (DB-FIB) at the subsurface of the sample #SH9, i.e., below the area of wear stripe (Figure 6). The micro-cracks were mainly horizontal and limited to the very first μm in depth. The subsurface microstructure of the control-sample was also imaged for the comparison: no micro-cracks could have been observed in the studied area. The DB-FIB analysis will be more detailed in a next paper.
