# Ageing, Shocks and Wear Mechanisms in ZTA and the Long-Term Performance of Hip Joint Materials

**Abstract:** The surface morphologies and microstructures of Zirconia Toughened Alumina (ZTA) femoral heads were analyzed following in vitro tests aiming to simulate in vivo degradation. Three phenomena potentially leading to degradation were investigated: shocks, friction and hydrothermal ageing. Shocks due to micro-separation created the main damage with the formation of wear stripes on the femoral head surfaces. Atomic Force Microscopy (AFM) images suggested the release of wear debris of various shapes and sizes through inter- and intra-granular cracks; some debris may have a size lower than 100 nm. A decrease in hardness and Young's modulus was measured within the wear stripes by nanoindentation technique and was attributed to the presence of surface and sub-surface micro-cracks. Such micro-cracks mechanically triggered the zirconia phase transformation in those worn areas, which in return presumably reduced further crack propagation. In comparison with shocks, friction caused little wear degradation as observed from AFM images by scarce pullout of grains. The long-term resistance

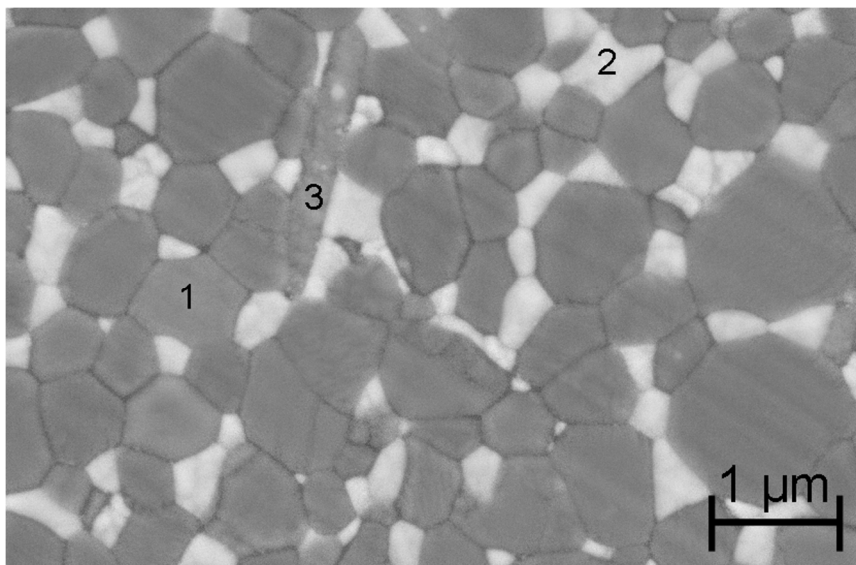
**Figure 1.** Scanning Electron Microscopy (SEM) image of a thermally etched as-received BioloX<sup>®</sup> delta implant: (1) alumina grain; (2) yttria-stabilized zirconia grain; and (3) platelet-shaped crystal of strontium aluminate.

The studied hip joints (36 mm femoral heads and acetabular cups) are made of ZTA composite belonging to the latest generation of commercialized BioloX<sup>®</sup> delta implants, CeramTec AG (Plochingen, Germany). SEM imaging (MEB FEG ZEISS SUPRA 55 VP) of a thermally etched (1300 °C in air for 12 min) as-received BioloX<sup>®</sup> delta implant shows yttria-stabilized zirconia grains homogeneously dispersed in a continuous alumina matrix (Figure 1). These zirconia grains can transform under stress at the vicinity of an advancing crack and are the main source of toughening. Addition of strontium oxide created platelet-shaped crystals of strontium aluminate composite that may induce an additional toughening by deflecting crack growth. The manufacturing process yields a fine microstructure (alumina, roughly 1 µm, and zirconia lower than 0.5 µm of grain size).

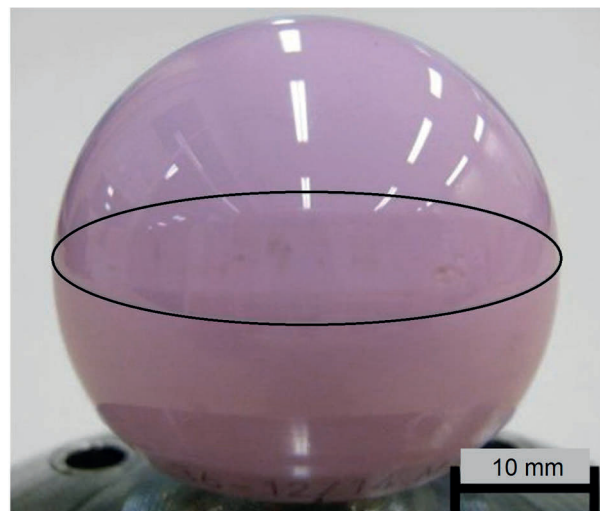
**Figure 2.** Image of a femoral head with a visible wear stripe (surrounded by an oval shape).

At the end of the in vitro tests, a section of interest was extracted from each head using a linear precision saw (ISOMET 4000, Buehler) to allow further characterization. The sectioning was done well away from the area of interest in order to avoid sawing-induced damage near the cuttings. It is worth noting that the sections of interest in the samples #SH6 and #SH9 (shock tests) exclusively held areas of visible wear stripes, typical of micro-separation (Figure 2).

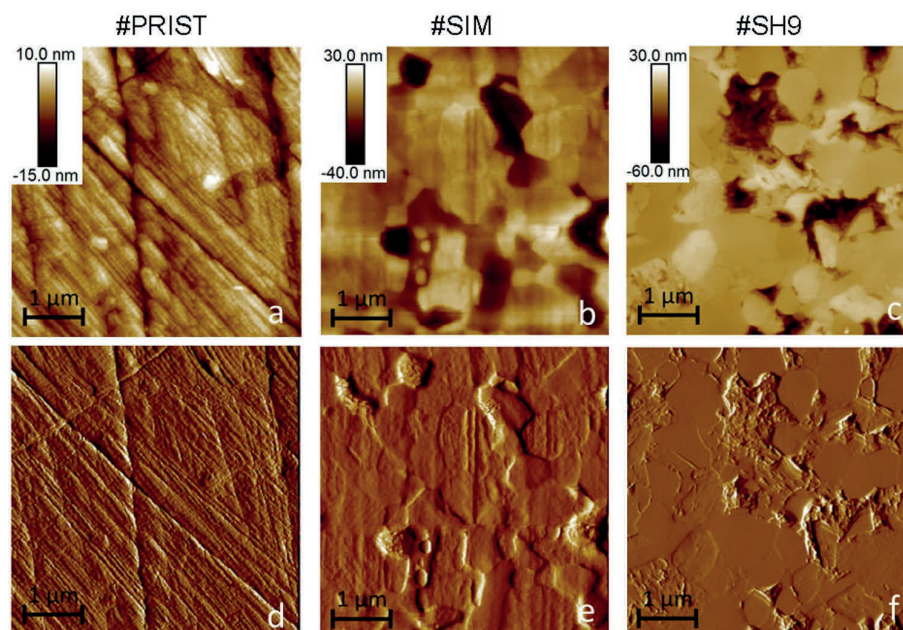
**Figure 3.** AFM height (top) and derivative (bottom) images of the control-sample #PRIST ((a) and (d)), the sample #SIM ((b) and (e)) and the sample #SH9 (wear stripe area, (c) and (f)).

Polishing scratches dominated the surface of the control-sample (#PRIST, Figure 3a,d) and prevented the detection of its microstructure. The surface of the sample #AUT also revealed polishing marks and only differed from the one of the pristine sample because of a few pullout of grains. The area of pitting reached less than 1.5% of the total imaged areas and  $R_{\text{max}}$ , which represents the maximum vertical distance between the highest and lowest data point in an image, averaged about 170 nm (#AUT) compared to 40 nm for #PRIST.

The surface sample of #SIM was non-homogeneous and the severity of the degradation varied depending on the zones analyzed on the head surface; however we did not find any correlation between the type of damage and the location of the zones on the head. The wear features exhibited on the most damaged zones are shown in Figure 3b,e. The area of pitting reached up to 12% within those zones and  $R_{\text{max}}$  averaged about 170 nm. The polishing features were partly erased on the surface sample depending on the areas of analysis; some areas were similar to the surface of the control-sample.

The surfaces imaged on the sample #SH9 revealed other wear features (Figure 3c,f). They did not contain any initial polishing scratches as the ones observed on the surface of the pristine sample since the areas of interest (areas of wear stripes) have been created through the continuous release of materials (from surface to bulk) during in vitro shock tests [15]. The area of pitting averaged here 12% of the total imaged areas and  $R_{max}$  was about 300 nm. Micro-cracks were observed at the grain boundaries. The worn surface exhibited smooth and spread grains compared to that observed on the surface sample of #SIM. The surfaces imaged on the sample #SH6 (areas of wear stripes) showed similar wear features as the sample #SH9;  $R_{max}$  averaged about 300 nm.

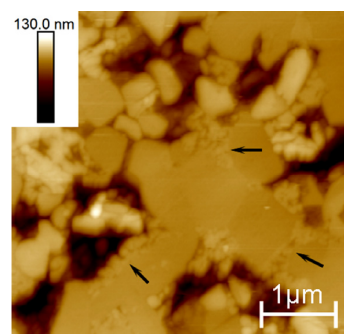
**Figure 5.** AFM height image of the wear stripe area of the sample #SH9 illustrating debris piled into pits and at the grain boundaries.

A closer inspection of the surfaces revealed the presence of cracked grains (Figure 4) within the wear stripes of the samples submitted to shocks (#SH6 and #SH9). Intra-granular cracks were observed and suggest the formation of wear debris whose size is smaller than the grain size and whose shape is irregular; some debris may have a size lower than 100 nm. Such debris was identified on the worn surface into the remaining pits caused by grains pullout as well as at the grain boundaries (Figure 5). An EDX analysis showed that the chemical composition on the worn areas was not different to the debris-free areas (such as on #AUT or #SIM), which ruled out the possibility of a contamination and confirmed the presence of ceramic debris.

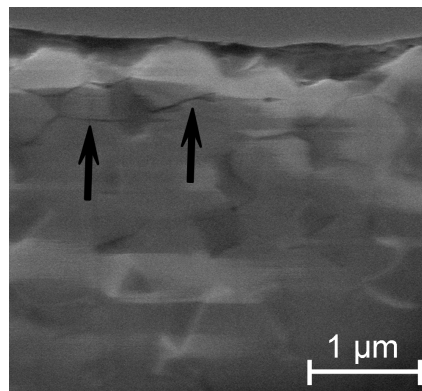
**Figure 6.** Image from a cross-section obtained by DB-FIB below the worn surface of the sample #SH9; a few micro-cracks were identified (black arrows).

A few micro-cracks were observed by Dual Beam-Focused Ion Beam (DB-FIB) at the subsurface of the sample #SH9, i.e., below the area of wear stripe (Figure 6). The micro-cracks were mainly horizontal and limited to the very first  $\mu\text{m}$  in depth. The subsurface microstructure of the control-sample was also imaged for the comparison: no micro-cracks could have been observed in the studied area. The DB-FIB analysis will be more detailed in a next paper.

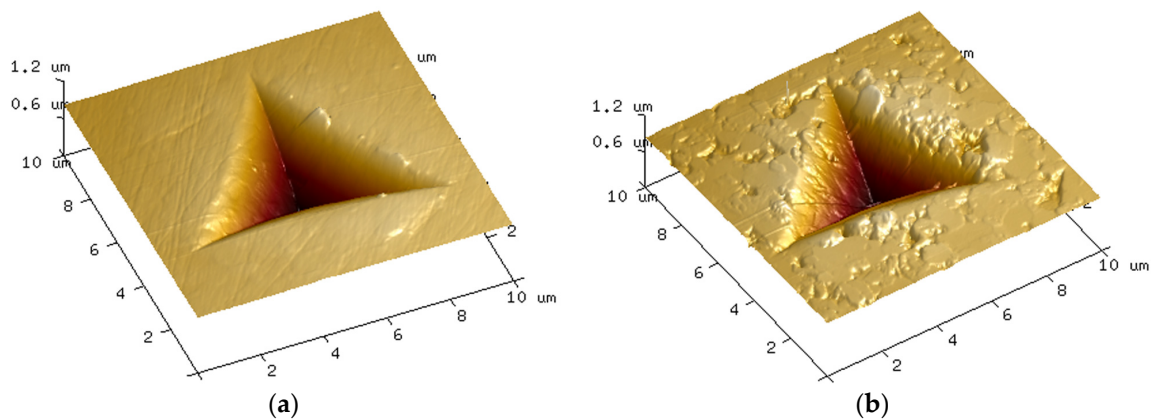
**Figure 7.** 3D AFM images of residual indents on: (a) undamaged surface (#PRIST); and (b) area of wear stripe (#SH9).

Nanoindentation tests revealed loading-unloading curves without discontinuities such as pop-in or pop-out effects [24] independently of the sample condition. 3D AFM images on undamaged (#PRIST) and damaged, i.e., wear stripe areas, (#SH9) surfaces show the residual triangular indent from the Berkovich indenter (Figure 7). On all the tested samples, the AFM images confirmed that the applied load did not induce the formation of radial cracks around or at the edge of the indent. The size of the indents was determined from these images: the triangle sides averaged  $8\ \mu\text{m}$ , i.e., a total area of about  $28\ \mu\text{m}^2$ . The indent size was much higher than the mean grain size, showing that the mechanical measurements were not affected by the grain size distribution in the composite.

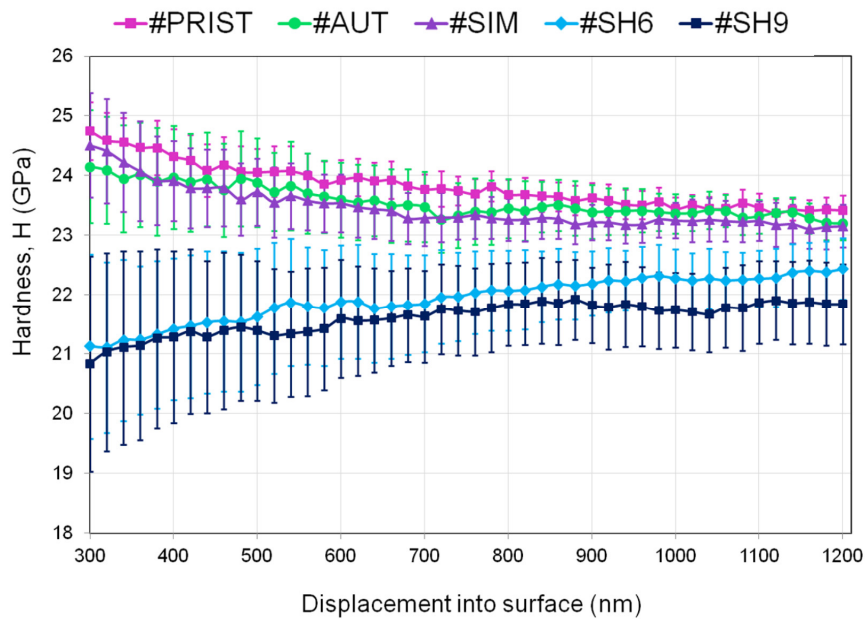
**Figure 8.** Hardness evolution as a function of penetration depth: averaged curves over the fifteen independent measurements performed on every sample.

Figures 8 and 9 illustrate the averaged data points calculated every 20 nm for hardness ( $H$ ) and Young's modulus ( $E$ ), respectively. Every point represents the average of the fifteen indents and is accompanied by a 95% confidence interval. The values of hardness of the samples #SH6 and #SH9 were significantly lower than the ones of the samples #PRIST ( $p < 0.001$  for #SH9 and  $p = 0.001$  for #SH6), #AUT ( $p = 0.002$  for #SH9 and  $p = 0.005$  for #SH6) and #SIM ( $p = 0.003$  for #SH9 and  $p = 0.007$  for #SH6). The decrease in hardness (with respect to the control-sample) was higher for #SH9 than for #SH6 and was reduced with the penetration depth (Table 2). The two samples #SH6 and #SH9 exhibited a singular behavior compared with the samples #PRIST, #AUT and #SIM: the former experienced an increase in  $H$  with increasing depth (Figure 8). During indentation tests, ceramics have a tendency to show a decrease in the mechanical properties ( $H$  or  $E$ ) as a function of depth due to the indentation

size effect (ISE) that may be attributed to several phenomena (elastic recovery, dislocations, work hardening, etc. [25]). The increasing trend observed on the samples #SH6 and #SH9 may be associated with the degree of degradation within the wear stripes (increasing roughness, grains pullout, cracks at grain boundaries, etc.) that must be reduced in the bulk. In terms of Young's modulus, the sample #SH9 showed lower values compared with the other samples (Figure 9). Its values tended towards those of the control-sample after the first  $\mu\text{m}$  in depth (Table 2). For every sample, the curve of  $E$  was less smooth than the one of  $H$ .

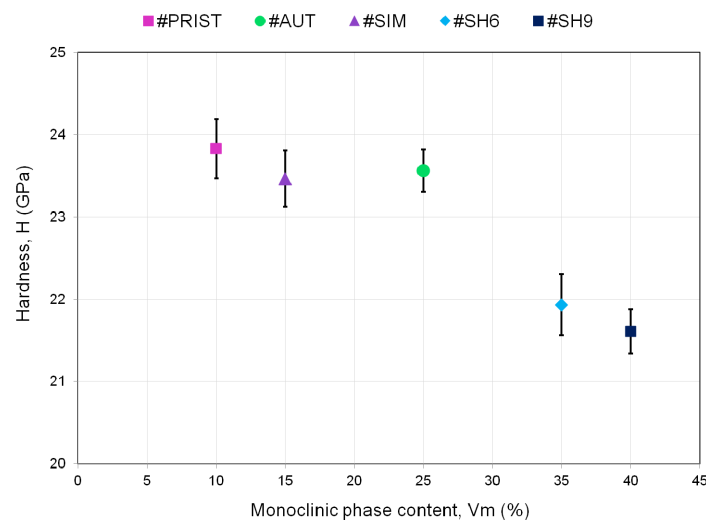
**Figure 10.** Relation between the occurrence of the phase transformation and the hardness value (averaged over the range of the analyzed penetration depth 300–1200 nm).

There is a lack of available data concerning a decline in the mechanical properties of recent alumina–zirconia composites as a response to hydrothermal alteration. The sample #AUT went here through a heavy and tough treatment in an autoclave that simulates hundreds of years of in vivo time, i.e., that is representative of the material long-term performance. Alteration on the implant surface is characterized by a few grains pullout that represent a small area of pitting (less than 1.5%) compared to that observed on the samples mechanically damaged (#SIM, #SH6 and #SH9). Both  $H$  and  $E$  are comparable to non-altered control on the sample #AUT whose monoclinic phase content rose from 10% to 25% on the surface (Figure 10). This confirms the long-term resistance of tailored ZTA composite against hydrothermal ageing and the fact that (moderate) increase of monoclinic fraction does not necessarily means decrease in mechanical properties for this specific type of composite.

The two samples #SH9 and #SH6 exhibited the highest monoclinic phase content (35% and 40%, respectively, Figure 10). The phase transformation may however not be the direct cause of the decrease in  $H$  and  $E$ . This is supported by the fact that the mechanical properties of the sample #AUT remained unchanged while its monoclinic phase content increased (Figure 10); this sample showed a negligible surface degradation and no micro-cracks. Several authors [24,28,38,39] have already attributed such a decrease in  $H$  and  $E$  to micro-cracking on hydrothermally aged zirconia based ceramics. The AFM and DB-FIB analyses of the sample #SH9 also revealed here the presence of micro-cracks on the worn surface and in the first  $\mu\text{m}$  in depth. They may play a role about the mechanical properties deterioration and explain the dissemblance observed between the evolutions of  $H$  and  $E$ . The assessment of  $E$  is sensitive to the elastic field below the analyzed depth and the presence of micro-cracks on and near the surface has a low contribution in the whole field. The decrease in  $E$  is therefore lower than the one in  $H$  whose assessment is exclusively affected by the deterioration around the indenter. This observation may indicate that the damage is more extended in depth for the sample #SH9 compared with the sample #SH6 (Figure 9); this may explain the lower wear volume release for the latter [15]. A threshold in the intensity of shocks might exist between 6 and 9 kN and affect the material mechanical response and therefore the long-term structural integrity of the implant. Further investigations have to be carried out at other shock intensities in order to confirm the presence of this potential threshold.
