Influence of surface treatments on fatigue life of Al 7010 alloy

Majid Shahzad*, Michel Chaussumier, Rémy Chieragatti, Catherine Mabru, Farhad Rezai Aria

Université de Toulouse, Institut Clément Ader, ISAE DMSM, 10 Av. Edouard Belin, 31055 Toulouse Cedex 4, France

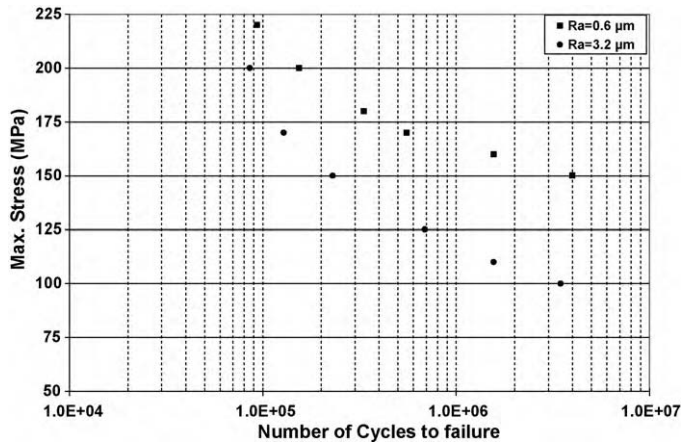
Fig. 3. Fatigue test results for two different surface roughnesses.

The result of rotating bending fatigue tests for first group is shown in Fig. 3. Surface roughness is clearly effective in reducing fatigue life for this material. In low cycle regime there is about 10% decrease in fatigue strength while in high cycle regime there is 32% decrease. This confirms that surface roughness plays a vital role especially in high cycle fatigue in which major part of fatigue life is consumed in nucleating the cracks.
