## **4D imaging and quantification of pore structure modifications inside natural building stones by means of high resolution X-ray CT**

J. Dewanckele, T. de Kock, M. A. Boone, V. Cnudde, L. Brabant, M. N. Boone, Gilles Fronteau, L. van Hoorebeke, P. Jacobs

### Abstract

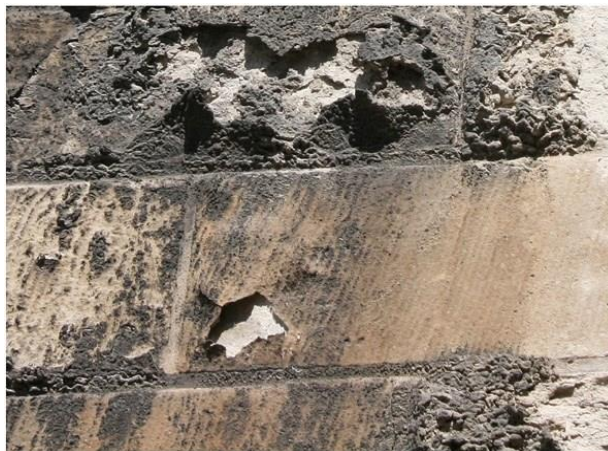
Fig. 2. Formation and eruptions of blisters on the Lede stone surface (Saint Bavo's Cathedral, Ghent, Belgium).

The slightly soluble gypsum can be removed from the external part of the stone by rain. In this case, the stone remains in a clean state and erodes slowly. In the case of a sheltered part of a façade, the acid in the polluted air will continually condense on the wet surface. As a result, those areas can see the growth of a thick gypsum crust that becomes less and less permeable. In other words, the first formed gypsum crystals will prevent the structure below from continuing erosion. Those surfaces often become black because of the incorporation of pollution particles. Over time, those thick crusts can gradually peel off or form blisters. These phenomena are frequently found on less resistant limestones and calcareous sandstone, such as the Lede stone, as can be seen in Fig. 2. The stone surface immediately behind the blister is fragile and will therefore be preferentially vulnerable for further acid attack (Fig. 3).

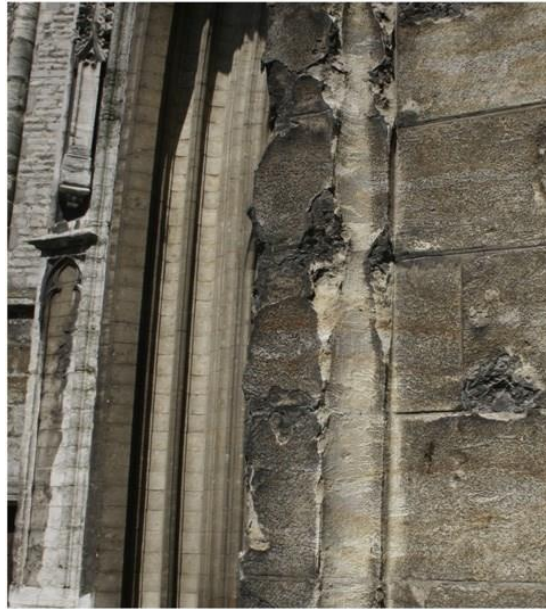
Fig. 3. Weathering pattern of the Lede stone at the Saint Bavo's Cathedral (Ghent, Belgium), where the black gypsum crust is visible and is peeling-off.
