Corrosion behaviour of an assembly between an AA1370 cable and a pure copper connector for car manufacturing applications

Rosanne Gravina^{a,b}, Nadine Pébère^a, Adrien Laurino^b, Christine Blanc^{a,*}

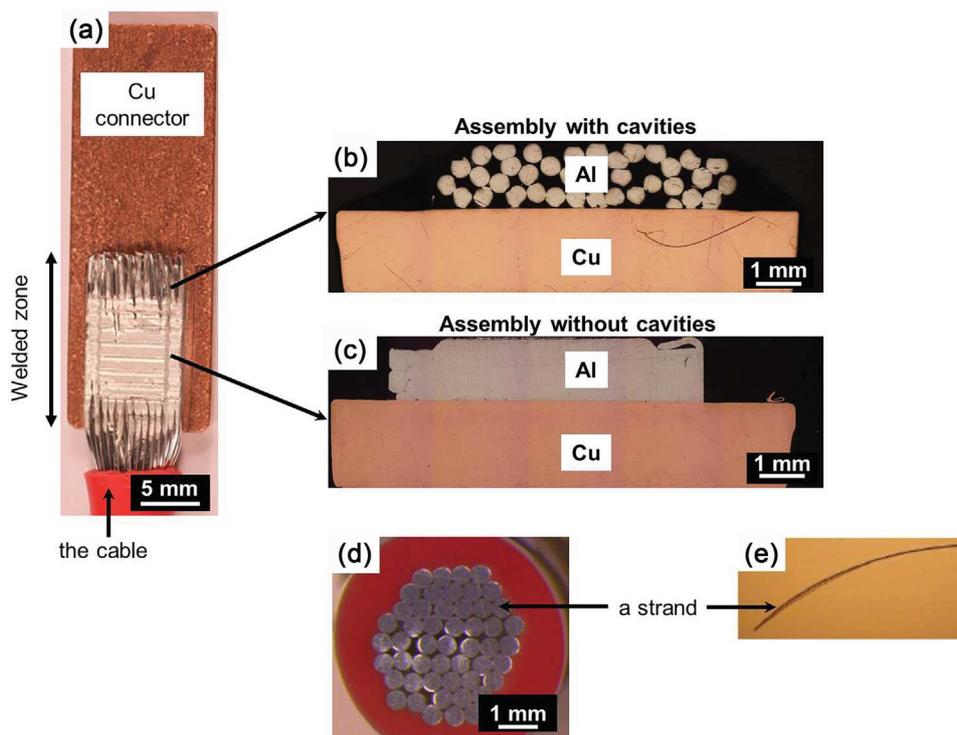
Fig. 1. (a) Global view of the assembly between AA1370 cable and pure Cu connector; cross-sections of the assemblies (b) with and (c) without cavities; (d) the AA1370 cable and (e) a strand.

The galvanic coupling at the Al/Cu interface was studied by electrochemical measurements performed on two cross-sections of the assembly. Fig. 1a shows a global picture of the assembly. The two selected cross-sections are shown in Fig. 1b and c. One of the cross-sections was removed from a porous zone of the cable due to the fact that the strands constitutive of the cable were not entirely welded together (henceforth called 'assembly with cavities') (Fig. 1b). Another cross-section was removed from the effective welded zone where no cavities were observed between the welded strands (henceforth called 'assembly without cavities')

(Fig. 1c). Before corrosion tests, the cross-sections were embedded in an epoxy-resin without filling the cavities. This was achieved by embedding the cross-sections in a parafilm shell.

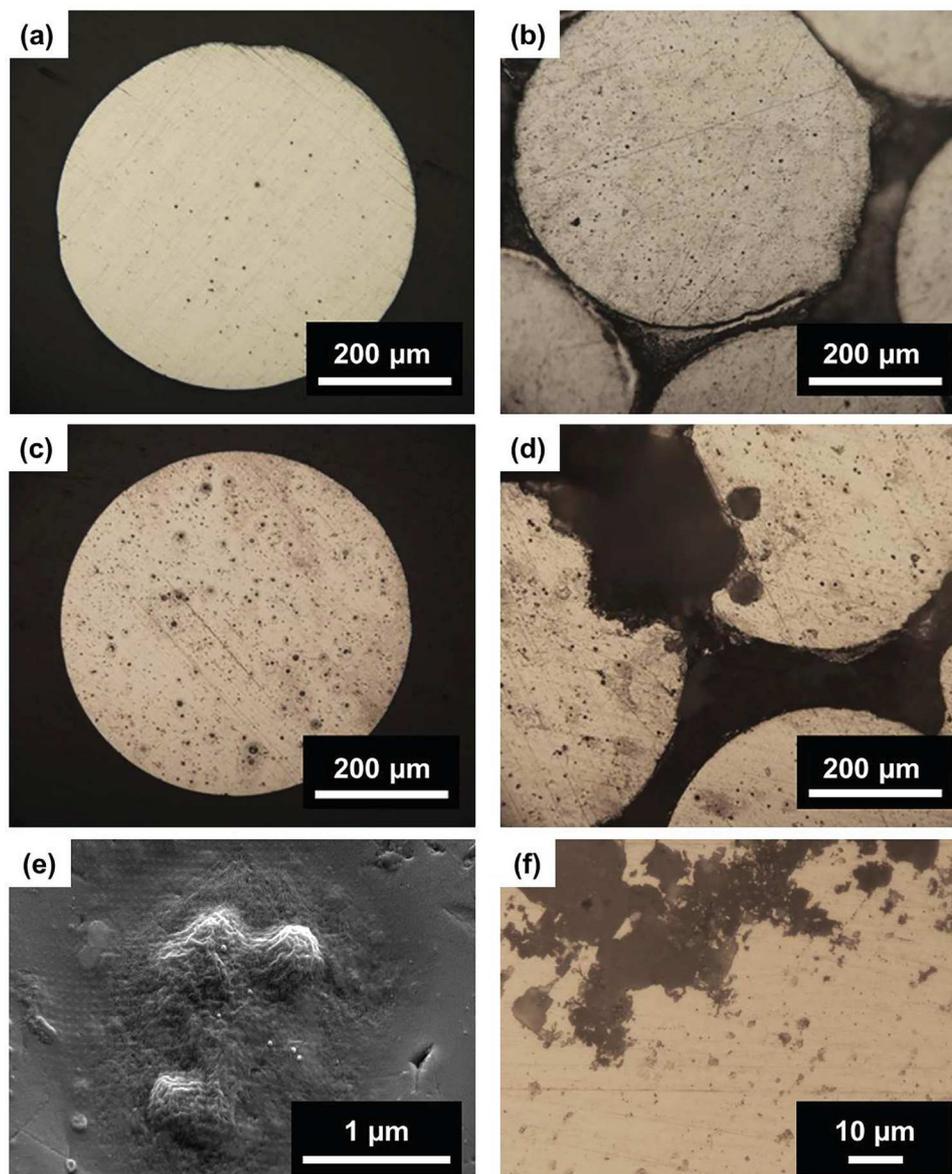
Fig. 2. Optical microscope (OM) observations of the strand and of the cable after: (a, b) 3 h of immersion and (c, d) 168 h of immersion at E_{corr} in 0.1 M Na_2SO_4 + 0.001 M NaCl. (a) and (c) correspond to the strand, (b) and (d) to the cable. (e) SEM observation of corrosion phenomena occurring at the Al_3Fe intermetallic particles. (f) close-up on the corrosion filaments observed.

Fig. 2 shows OM observations of a strand and of the cable after two exposure times (3 h and 168 h) to the aggressive solution at their corrosion potential. For both samples, a weak dissolution of the matrix around the Fe-rich particles, identified as Al_3Fe particles [29], was observed [7–9]. However, comparison of Fig. 2a and

b showed that after 3 h the matrix dissolution around the intermetallic particles was more extended for the cable than for the strand. After 168 h of immersion (Fig. 2c and d), a significant dissolution of the matrix around the Fe-rich particles (Fig. 2e) can be seen on the whole surface for both samples, and in addition, for the cable, large pits surrounded by fine filaments (Fig. 2f) were also observed at the periphery of the strands. These corrosion features, in agreement with literature data, accounted for the penetration of the electrolyte inside the cable leading to a confined medium and crevice corrosion phenomenon [10,11]. OM observations of cross-sections parallel to the cable axis after various exposure times to the chloride-containing sulphate solution corroborated this assumption and allowed the depth of the corroded zone to be measured (Fig. 3a). It was assumed to be a good indication of the electrolyte penetration depth. In order to measure the depth of the corroded zone, the corrosion damage was enhanced by polarizing at -700 mV/SCE for 5 min the samples after the exposure at E_{corr} (Fig. 3a and b). The electrolyte penetration depth was found to

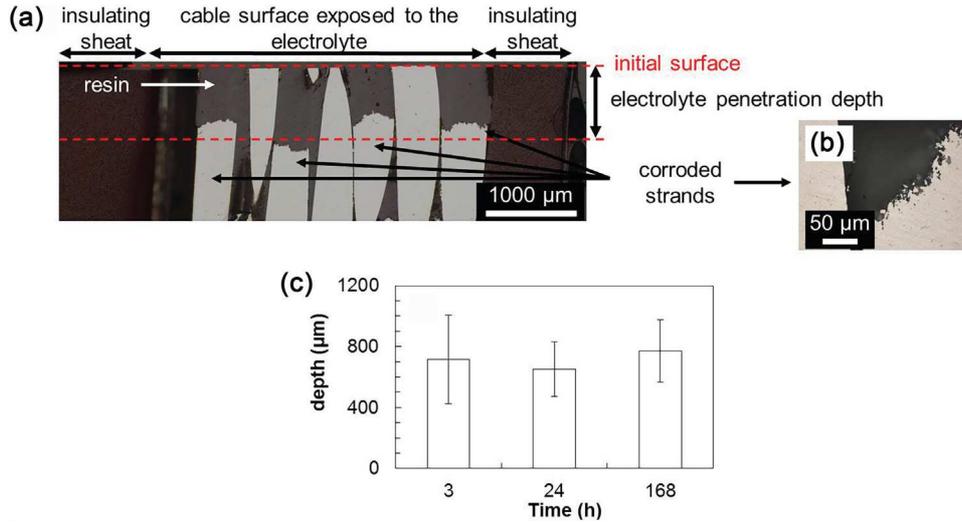
Fig. 3. (a) OM observation of a cable cross-section (parallel to the cable axis) after 3 h of exposure to the 0.1 M Na₂SO₄ + 0.001 M NaCl solution followed by polarization for 5 min at -700 mV/SCE; (b) close-up on a corroded strand inside the cable; (c) electrolyte penetration depth versus the exposure time.

become rapidly independent of the exposure time, reaching about $800 \mu\text{m}$ after 3 h of exposure (Fig. 3c).

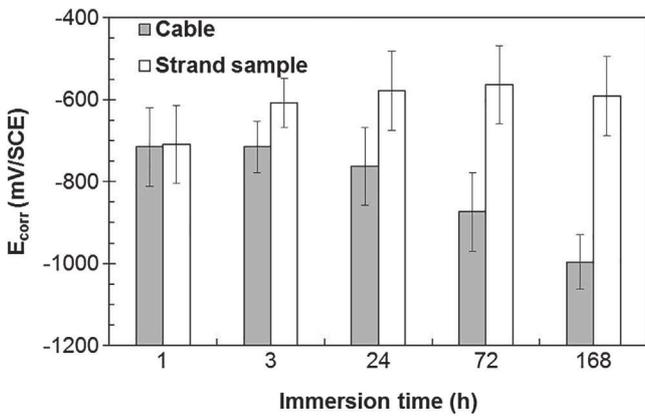
Fig. 4. Variation of E_{corr} during immersion in 0.1 M Na₂SO₄ + 0.001 M NaCl for the strand sample and the cable.

Fig. 4 reports E_{corr} values versus exposure time to the electrolyte for the strand sample and the cable. For the strand sample, E_{corr} stabilized rapidly and an almost stationary value (around -600 mV/SCE) was obtained after 3 h of immersion. On the contrary, for the cable, E_{corr} decreased significantly towards more negative values during immersion which was in agreement with the differences in corrosion morphology observed between the two samples (Fig. 2). Fig. 5 shows the polarization curves for the strand sample and the cable obtained after 3 h of exposure to the chloride-containing sulphate solution. For the cable, the current densities were calculated by taking into account (i) only the cross-sections of the 50 strands constitutive of the cable, i.e. only the surface exposed to the bulk solution ($S=0.11 \text{ cm}^2$, no corrected surface in Fig. 5) and (ii) both the cross-sections and the lateral surface of the 50 strands on a $800 \mu\text{m}$ depth, i.e. both the surfaces exposed to the bulk and to a confined electrolyte ($S=0.76 \text{ cm}^2$, corrected

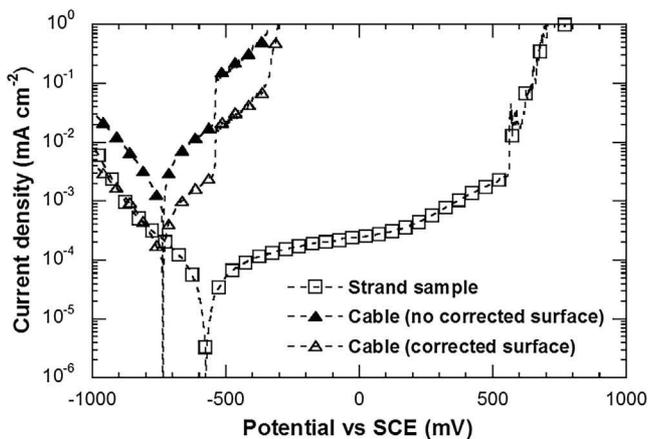
Fig. 5. Polarization curves of the strand sample and the cable obtained after 3 h of immersion at E_{corr} in 0.1 M Na₂SO₄ + 0.001 M NaCl. Scan rate = 0.07 mV s⁻¹. For the cable, the curve 'no corrected surface' only takes into account the cable surface exposed to the bulk ($S = 0.11 \text{ cm}^2$); the 'corrected surface' curve takes into account both the surface exposed to the bulk and that exposed to the confined medium inside the cavities ($S = 0.76 \text{ cm}^2$).

surface in Fig. 5). For both the strand sample and the cable, the cathodic branch, corresponding mainly to the oxygen reduction, was similar. For the strand sample and the cable, E_{corr} values were -580 mV/SCE and -730 mV/SCE respectively. The anodic domain was characterized for the strand sample by a passivity plateau, with passive current densities of about $4.10^{-4} \text{ mA cm}^{-2}$, followed by a breakdown potential at 500 mV/SCE associated with, first, a slow increase of the anodic current densities and then a sharper one. This could be associated to, first, an increase of the dissolution rate of the matrix surrounding the Fe-rich particles and then to pitting corrosion. Besides, the significant current fluctuations observed after the sharp increase of the current densities constitutes a characteristic feature of the pitting corrosion. For the cable, a short pseudo-plateau was observed and the anodic current densities were about $2.10^{-3} \text{ mA cm}^{-2}$ (corrected surface). Whatever the surface taken into account, the current densities were higher for the cable, as compared to the strand sample; this could be assigned to a dissolution process rather than a passivity process. A breakdown potential was then observed at -550 mV/SCE followed by a sharp increase of the anodic current densities. All the results showed a lower corrosion resistance for the cable as compared to the strand sample. The differences in corrosion behaviour between the two samples were related to the penetration of the electrolyte inside the cable cavities leading to the formation of a confined and then more aggressive electrolyte. This confirmed, for the cable, the occurrence of both pitting corrosion on the surface exposed to the bulk solution and crevice corrosion on the surface exposed to the confined medium inside the cavities. The higher anodic current densities observed for the cable were related to the progressive modification of the electrolyte trapped inside the cavities and subsequent dissolution phenomenon.

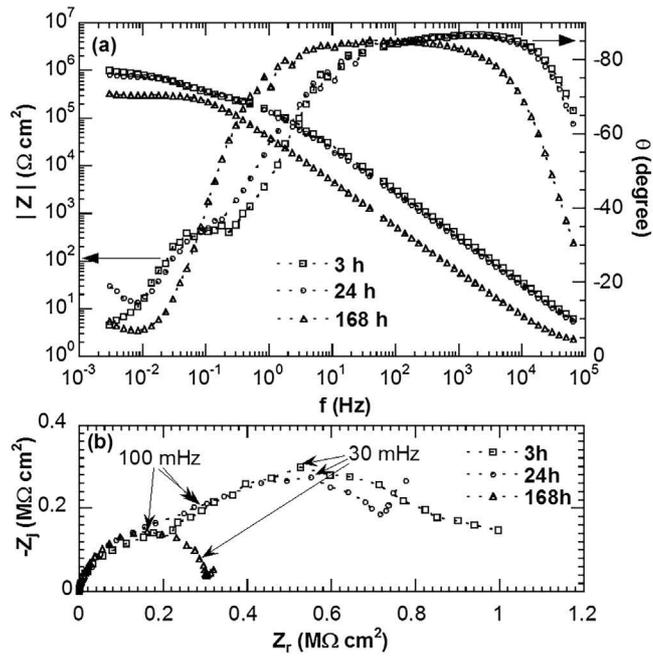
Fig. 6. Electrochemical impedance diagrams obtained for the strand sample – (a) Bode and (b) Nyquist coordinates – after different exposure times at E_{corr} to 0.1 M $\text{Na}_2\text{SO}_4 + 0.001$ M NaCl.

Impedance measurements were performed for the strand sample and the cable after different exposure times to the chloride-containing sulphate solution. Fig. 6 shows the diagrams in Bode (Fig. 6a) and Nyquist (Fig. 6b) coordinates for the strand sample. After 3 h and 24 h of immersion, the impedance diagrams are characterized by two time constants. The first time constant (60 kHz–1 Hz) was associated to the response of the passive film, while the second time constant (1 Hz–100 mHz) was attributed to the charge transfer process and to the oxygen reduction on the passive film in agreement with literature [27]. Impedance measurements performed at E_{corr} in a deaerated electrolyte (results not shown) revealed the disappearance of the time constant observed

at low frequencies and no modification in the high frequency domain. This confirmed the attribution of the low frequency time constant to the oxygen reduction. After 168 h of immersion, the impedance diagram showed only one time constant with a lower resistance which could be associated to the corrosion of the alloy, i.e. to the charge transfer process. Such an evolution of the diagrams was in agreement with the OM observations (Fig. 2c), i.e. the dissolution of the matrix surrounding the Fe-rich particles due to oxygen reduction on the intermetallics and subsequent alcalinization of the electrolyte for increasing immersion times. The impedance diagrams obtained for the cable (Fig. 7) were clearly modified as compared to those obtained for the strand sample. The results are presented by taking into account the total surface exposed to the electrolyte (the surface exposed to the bulk solution and that exposed to the confined medium trapped inside the cavities). The Nyquist diagram (Fig. 7b) was constituted by a straight line in the high-frequency domain followed by a semicircle. This typical shape can be associated to the oxygen diffusion in a porous system [30–33] in agreement with the penetration of the electrolyte inside the cable cavities. The flattened semicircle may originate from the cavity shape [34]. The impedance values for the cable were ten times smaller than those obtained for the strand sample in agreement with the differences in corrosion damage between the two samples which highlighted the influence of the electrolyte penetration through the cavities of the cable. For 168 h of immersion, a decrease of the impedance was observed and, in the high-frequency domain, a time constant appeared which could be associated to the corrosion of the alloy in the confined medium [35,36]. Additional experiments (results not shown) were performed with a cross-section of the cable for which the cavities had been sealed with a resin by forcing the resin to penetrate into the cavities with a vacuum system. The impedance diagram obtained for the cable with sealed cavities after immersion in the aggressive solution and that of the strand sample were superimposed. This was in agreement with comments in the experimental part and confirmed that the corrosion behaviour of the cable was controlled by the penetration of the electrolyte inside the cable.

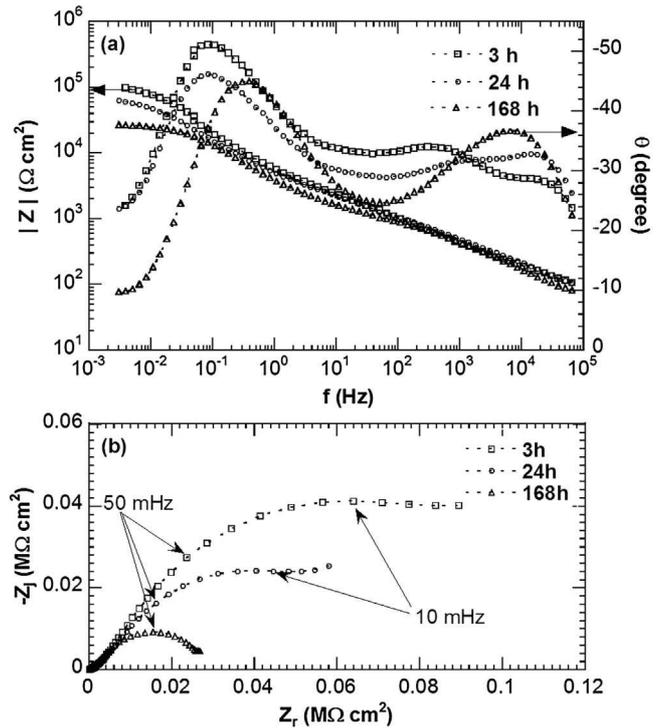
Fig. 7. Electrochemical impedance diagrams obtained for the cable – (a) Bode and (b) Nyquist coordinates – after different exposure times at E_{corr} to 0.1 M $\text{Na}_2\text{SO}_4 + 0.001$ M NaCl. The impedance values take into account both the surface exposed to the bulk and that exposed to the confined medium inside the cavities ($S = 0.76$ cm²).

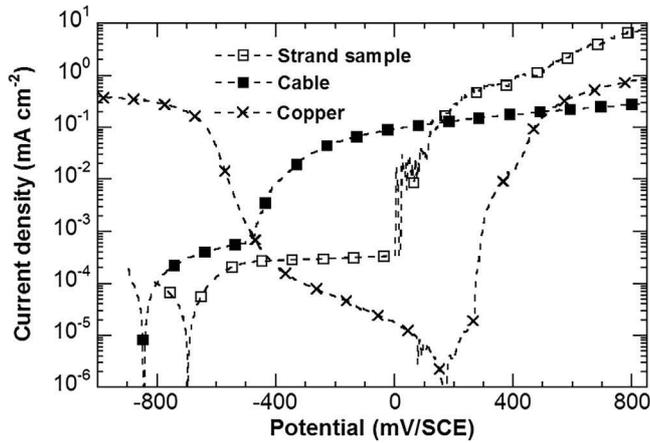
Fig. 8. Polarization curves of the AA1370 strand sample, the AA1370 cable and the pure Cu connector after 3 h of immersion at E_{corr} in 0.001 M NaCl solution.

A preliminary study was performed in 0.001 M NaCl to characterize separately the corrosion behaviour of Al (i.e. AA1370) and Cu in the same solution as that used for the LEIS measurements. First, the anodic branch of the polarization curves for the Al samples (strand sample and cable) and the cathodic and anodic branches for pure Cu were obtained (Fig. 8). Comparison of Figs. 5 and 8 showed that the global shape of the curves for the Al samples was the same independently of the electrolyte. For the strand sample, a 600 mV-long plateau corresponding to a passivity plateau with low anodic current densities ($3 \cdot 10^{-4} \text{ mA cm}^{-2}$) was observed and followed by an abrupt increase of the current associated to pitting corrosion. For the cable, a plateau was also observed; it was better defined than in sulphate and chloride-containing solutions but, again, corresponded to higher anodic current densities than for the strand sample and was considered as a pseudo-passivity plateau. It was rapidly followed by a sharp increase of the anodic current densities associated to both pitting and crevice corrosion as previ-

Therefore, in the crevice formed at the Al/Cu interface, the pH got more acidic which should promote a crevice corrosion phenomenon for Cu. On the opposite, far from the Al/Cu interface, Cu was in contact with the bulk solution where oxygen is present [21] leading to a non-corroded surface. For the Al part, for the assembly without cavities, pitting corrosion was observed. Concerning the assembly with cavities, pitting corrosion was observed on the Al surface exposed to the bulk solution and crevice corrosion occurred in the cavities existing between the strands due to the penetration of the electrolyte inside the cavities. Therefore, the corrosion products observed should include both copper oxides, aluminium oxides and hydroxides [20,38,40,42]. Håkansson et al. showed that the main corrosion products formed during galvanic corrosion of aluminium/carbon systems in 0.6 M NaCl was $\text{Al}(\text{OH})_3$, presented as a gelatinous substance in the crevices between the Al wires [43]. These authors also showed that $\text{Al}(\text{OH})_3$ should control the rate of the corrosion processes which should explain the plateau observed on the polarization curves for the cable after the breakdown potential (Fig. 8).

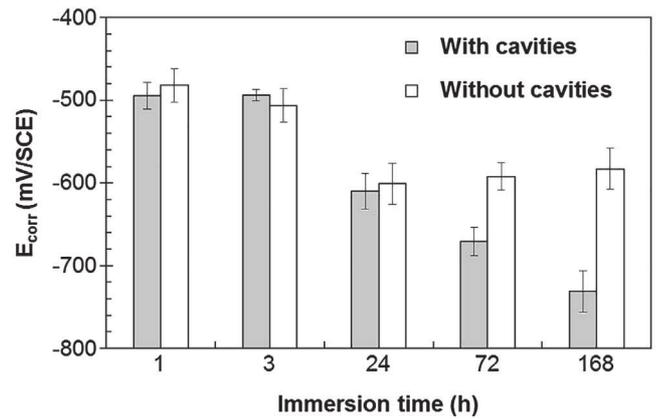
Fig. 9. Variation of E_{corr} during immersion in 0.001 M NaCl solution for the Al/Cu assemblies with and without cavities.

Fig. 9 showed E_{corr} values versus immersion time in 0.001 M NaCl for the two types of assembly. As expected, E_{corr} values were between those of the Al cable and Cu. For both assemblies, E_{corr} values decreased with increasing immersion time which could be related to corrosion damage. During the first 24 h, E_{corr} values were the same for the two types of assembly; they decreased slowly from -500 mV/SCE to -600 mV/SCE. After 24 h of immersion, E_{corr} of the assembly without cavities stabilized around -600 mV/SCE, whereas, for the assembly with cavities, E_{corr} moved towards more negative values and reached -770 mV/SCE after 168 h of immersion. This variation of E_{corr} suggested that, for an immersion time longer than 24 h, the corrosion damage was more extended for the assembly with cavities and underlined, as already discussed, that the presence of cavities in the cable modified the corrosion processes.

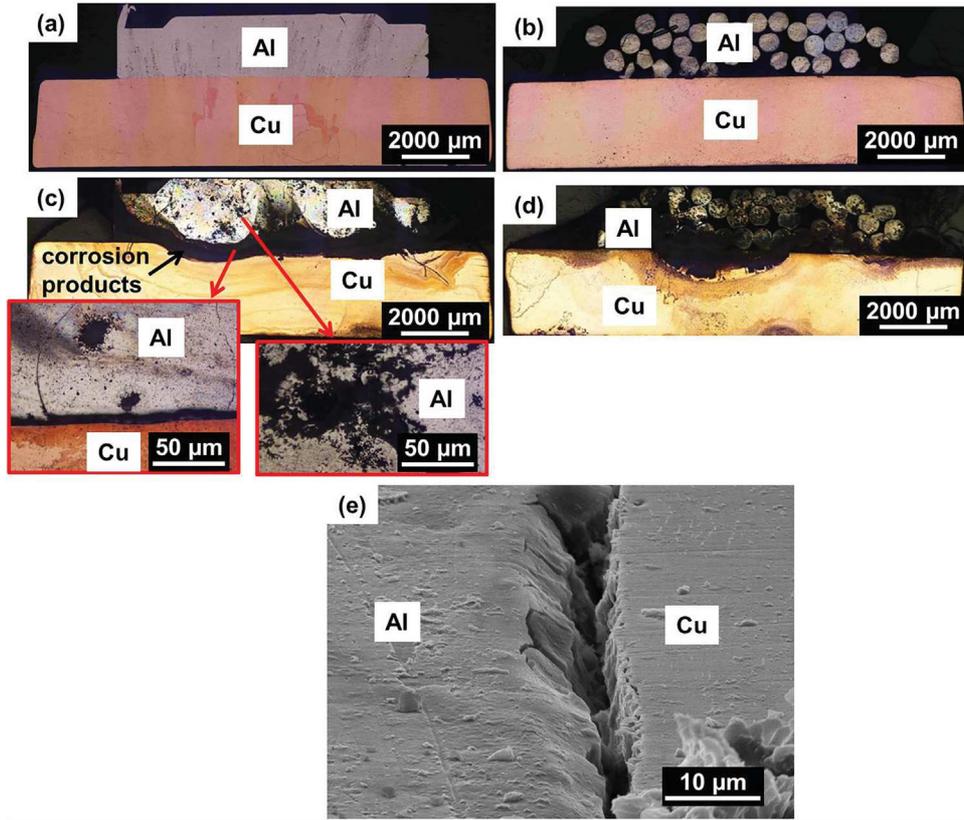
Fig. 10. Optical microscope observations of the corrosion damage for the Al/Cu assemblies after (a, b) 3 h and (c, d) 168 h of immersion at E_{corr} in a 0.001 M NaCl solution: assembly (a, c) without and (b, d) with cavities. (e) SEM micrograph of the Al/Cu interface of the assembly without cavities after 24 h of immersion in 0.001 M NaCl solution (tilt of 70°).

The corrosion damages for the two types of assembly were observed by OM and SEM after short immersion times (3 h and 24 h) and long immersion time (168 h) in 0.001 M NaCl (Fig. 10; results are only given for 3 h and 168 h). Independently of the immersion time, Al part was corroded while the Cu surface exposed to the bulk solution remained safe. For a short immersion time, no significant difference was observed between the two types of assembly (Fig. 10a and b). After 168 h of immersion, significant differences were observed for the Al part depending on the presence or not of cavities (Fig. 10c and d). For the assembly without cavities, OM observations showed the presence of pits and numerous fine filaments around the pits for the Al part (Fig. 10c). For the assembly with cavities, a severe corrosion damage of the Al part was observed with not only pits observed on the surface exposed to the bulk solution but also some strands constitutive of the cable completely dissolved over several hundreds of micrometers in depth. These

corrosion features were in agreement with pitting corrosion phenomena occurring on the surface exposed to the bulk solution while crevice corrosion occurred in the cavities [38]. More detailed attention was paid to the Al-Cu interface. For both assemblies, corrosion products (black areas in Fig. 10c and d) were clearly observed at the Al/Cu interface and spread all over the Al part for the assembly with cavities (Fig. 10d). Fig. 10e shows a SEM micrograph of the Al/Cu interface after 24 h of immersion for the assembly without cavities. At the Al/Cu interface, a crevice was clearly visible and also the Al dissolution. Such a crevice was also observed for the assembly with cavities: it was even more visible. Similar feature was already observed for a Al/Cu model couple [19]. This showed that for Cu, even though no corrosion damage was observed on the surface exposed to the bulk solution, corrosion phenomena occurred on the vertical wall inside the crevice, referring to crevice corrosion processes [20,21]. Thus, for both assemblies, the initial step of the corrosion process was the dissolution of the Al part at the Al/Cu interface due to the alkalisation linked to the oxygen reduction reaction on the Cu part [19]. The electrochemical reactions that justify the aluminium corrosion were as follows [38,40–42]:

showed with both the decrease of α and the increase of Q in the zone where SEM micrographies (Fig. 10e) showed a crevice on the Al part. This evolution was more marked for an assembly with cavities in relation with a lower corrosion resistance of the Al part due to the penetration of the electrolyte inside the cavities of the cable. After 168 h of immersion, α and Q values confirmed the increase of the

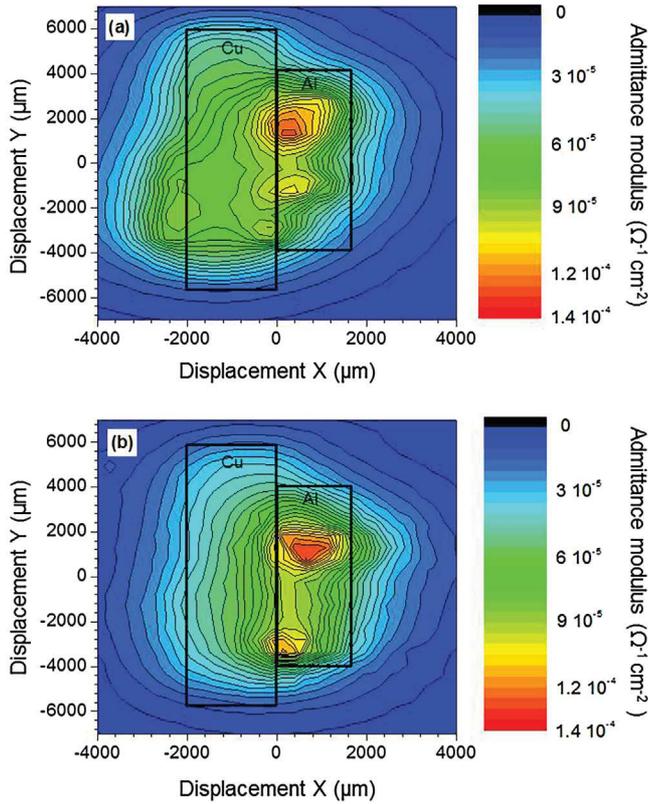
Fig. 11. Admittance maps obtained after 24 h of immersion at E_{corr} in 0.001 M NaCl solution at 10 Hz above the Al/Cu assemblies: (a) without cavities and (b) with cavities. Admittance values are calculated taking into account an analyzed surface of 1 mm^2 .

were observed on the Al part in accordance with pitting corrosion processes, as previously shown. Comparison of Fig. 11a and b did not show significant differences between the two types of assembly in agreement with E_{corr} measurements (Fig. 9).

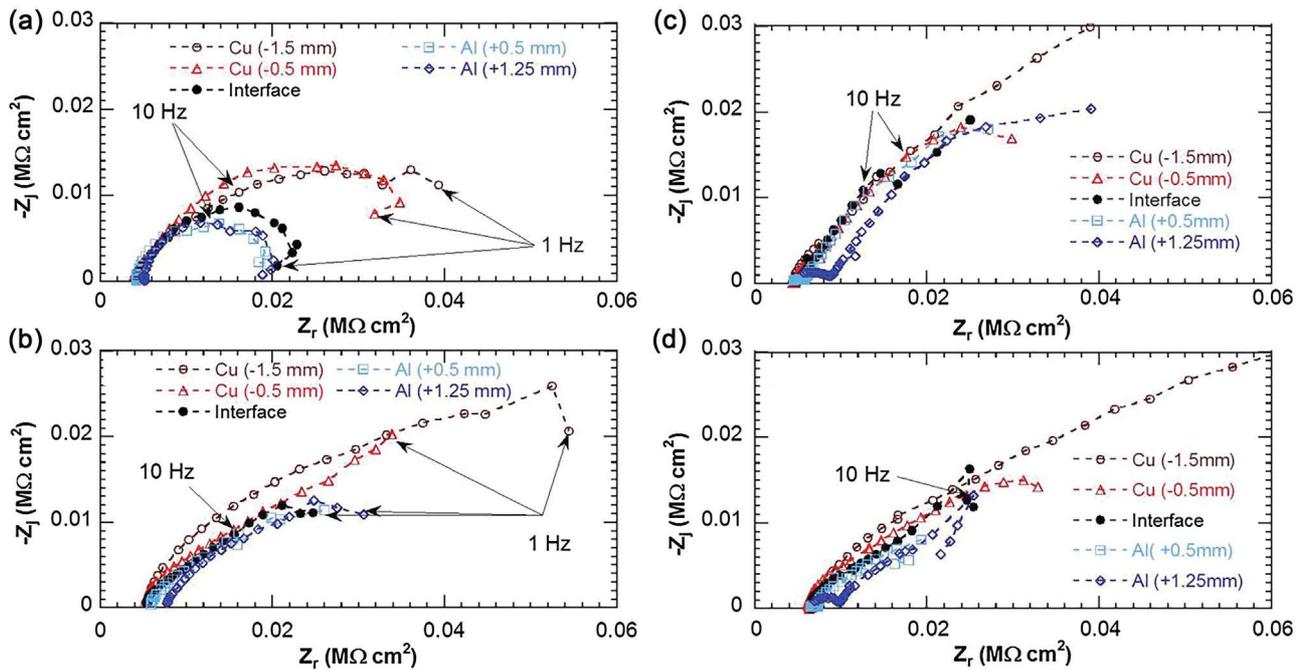
Fig. 12. Local impedance spectra obtained after (a, b) 24 h and (c, d) 168 h of immersion at E_{corr} in 0.001 M NaCl solution for different positions of the bi-electrode above the Al/Cu assemblies: (a, c) without cavities and (b, d) with cavities. Impedance values are calculated taking into account an analyzed surface of 1 mm^2 .

Then, for both assemblies, the impedance values after 24 h of immersion (Fig. 12a and b) were higher on the Cu part, then decreased when the probe moved towards the Al/Cu interface, and decreased again when the probe was over the Al part. Such an evolution of the impedance as a function of the position of the probe was in agreement with the galvanic coupling between Al and Cu. After 24 h of immersion, pitting corrosion occurred on the Al part (Fig. 10). For the assembly with cavities, the diagrams plotted for the Cu part (red curves in Fig. 12) are significantly modified in the low frequency range as compared to those obtained for the assembly without cavities. Their global shape suggested a diffusion-controlled electrochemical process in relation with the cathodic reaction of oxygen reduction on the Cu part. After 168 h of immersion, the diffusion-controlled process was even more marked on the diagrams for the assembly with cavities (Fig. 12d) and could be also noted for the assembly without cavities (Fig. 12c). This conclusion could be related to those of Håkansson et al. who showed that, for a Al/carbon couple, the rate controlling mechanism was solely the mass transport of oxygen through the gelatinous $\text{Al}(\text{OH})_3$ inside the crevice [43].

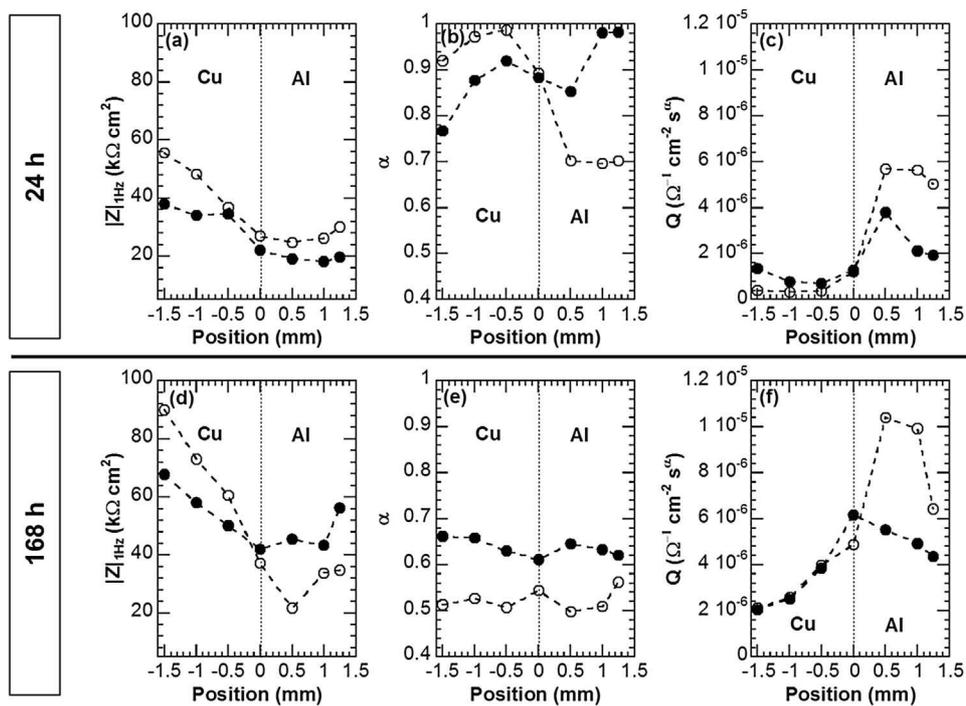
Fig. 13. Variation of the parameters ((a) and (d) $|Z|_{1\text{Hz}}$, (b) and (e) α and (c) and (f) Q) obtained from the local impedance spectra after different exposure times in 0.001 M NaCl and for different positions of the bi-electrode over the Al/Cu assemblies: (●) without cavities and (○) with cavities. Impedance values are calculated taking into account an analyzed surface of 1 mm^2 .

In order to quantitatively analyse the LEIS diagrams, three parameters were graphically extracted: the CPE values (α and Q) and the values of the impedance modulus at 1 Hz ($|Z|_{1\text{Hz}}$). Fig. 13 shows the variation of these parameters for each diagram obtained over the Al and Cu parts. Independently of the assembly and of the immersion time, $|Z|_{1\text{Hz}}$ values for the Cu part were higher than those for the Al part, which confirmed the differences in reactivity between the two metals when they were coupled (Fig. 13a, d). On the Cu part, the low frequency range was related to the diffusion process linked to the oxygen reduction (Fig. 12). Whatever the assembly, the increase of $|Z|_{1\text{Hz}}$ between 24 h and 168 h of immersion was in good agreement with the shift of the corrosion potentials measured for the assemblies towards more and more negative values from 24 h to 168 h of immersion (Fig. 9): this was linked to a more and more significant cathodic polarization for the Cu part. When the immersion time increased, in agreement with the corrosion potential values measured for the two assemblies, the differences in $|Z|_{1\text{Hz}}$ values between the Al and Cu parts were even more marked for the assembly with cavities. After 168 h of immersion, $|Z|_{1\text{Hz}}$ values measured on the Al part for the assembly with cavities were lower than those of the Al part for the assembly without cavities. This was explained by taking into account the increase of the electrochemical processes in a confined medium previously showed for the cable: the effect of the galvanic coupling

galvanic coupling effect. Between 24 h and 168 h of immersion, α values significantly decreased in agreement with an increase of the diffusion processes on the Cu part and a stronger corrosion for the Al part. Moreover, it can be seen that after 168 h of immersion, α values are lower for both the Cu and Al parts for the assembly with cavities as compared to the assembly without cavities. The result could be linked to a stronger increase of Q values at the Al/Cu interface observed for the assembly with cavities as compared to the assembly without cavities. The results were in good agreement with the presence of the confined electrolyte which amplified the effect of the galvanic coupling when the immersion time increased.
