## **Wear pattern on a retrieved Total Knee Replacement: The “fourth body abrasion”**

Charles Garabédian, Maxence Bigerelle, Denis Najjar, Henri Migaud. Wear pattern on a retrieved Total Knee Replacement: The “fourth body abrasion”. *Biotribology*, 2017, 11, pp.29 - 43. 10.1016/j.biotri.2017.05.003 . hal-01714618

# Wear Pattern on a Retrieved Total Knee Replacement: The “Fourth Body Abrasion”

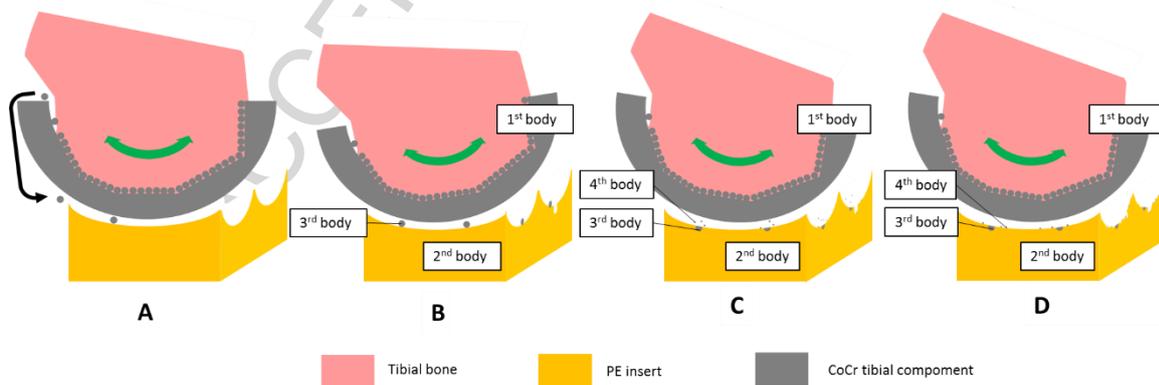
Fourth body abrasion of the PE insert in a knee implant: Coating bead loosening and entrapment in the articulating interface (A), Third body abrasion of the PE insert: large scratches (B), Fourth body generation by abrasion of the coating beads embedded in the PE insert (C), Fourth body abrasion of the PE insert: smaller scratches (D)

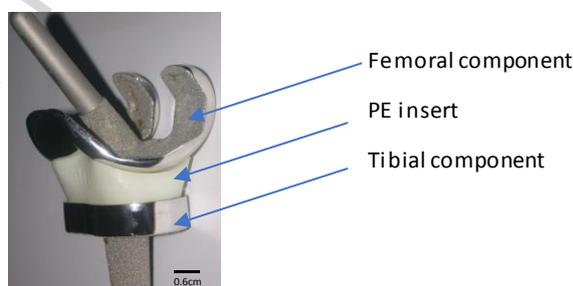
Figure 1. Side view of a three-component TKR implant.

A PE mobile-bearing knee implant was retrieved (LCS®-Rotating Platform, DePuy, Warsaw, USA) after 3.5 years of implantation. The patient was 58 years old. The surfaces of the Cobalt-Chromium (CoCr) alloy femoral and tibial components in contact with bone are coated with three porous layers of CoCr sintered beads. The tibial and the femoral components feature two partially-coated pegs to secure implant anchorage in the bones (Fig. 1).

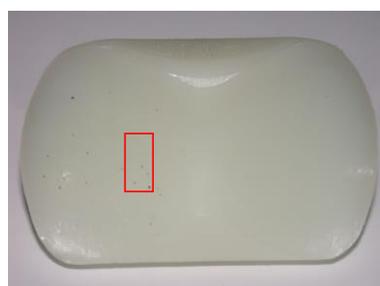
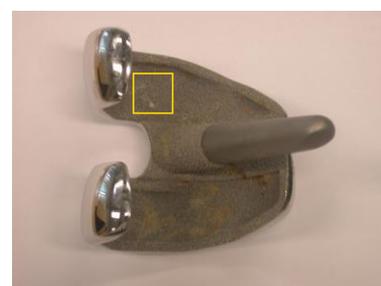
Table 1. Settings of the two optical topographical instruments.

A sample from the porous metallic coating of the femoral component was measured by Focus variation microscope (Infinite Focus™, Alicona Imaging GmbH, Grambach, Austria) in order to capture statistical distribution of some bead geometrical characteristics. The measurement details are in the Table 1.

The further investigations are focused on the upper surface of the PE insert because this articulating surface mirrors the knee flexion, which is the primary motion of the joint. As a highly accurate measurement is not able to capture the wholly PE surface, the Interferometer layout (NewView™ 7300, Zygo, Middlefield, USA) was monitored to randomly acquire 700 measurements over a 19x9mm area. The surface curvature of the area was taken account in the algorithm as a fifth-degree polynomial shifted to match the measured focal points. The complete settings of the Interferometer are in the Table 1 and in the Appendix A.

The areas of interest of the Table 1 were imaged by Scanning Electron Microscope (SEM). An Energy Dispersive X-ray (EDX) analyses were performed on these surface samples (Philips XL30 ESEM-FEG, Eindhoven, The Netherlands).

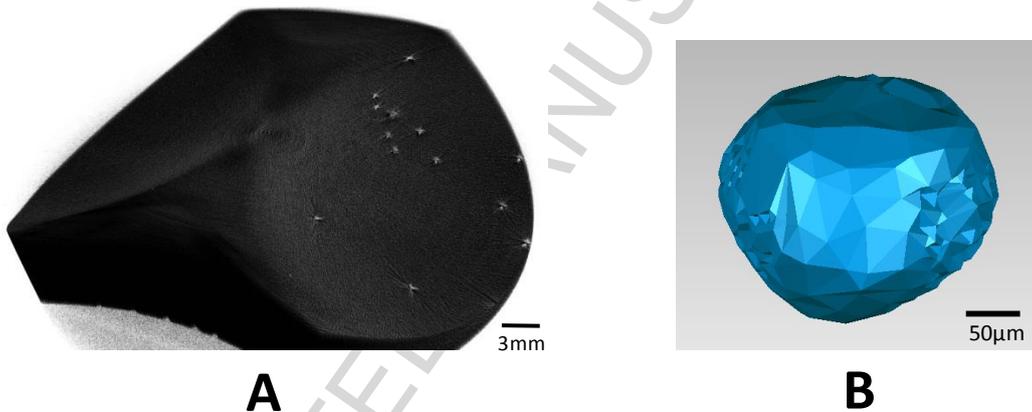
The scans of the mobile bearing measured by X-ray micro-tomography were firstly reconstructed. The PE insert exhibits some highly X-ray absorbing spherical particles embedded beneath the implant surface (Fig. 2.A). Twelve beads and a stack of six beads were captured by micro-tomographic measurements. They are mostly gathered on the medial side of the implant. The mean embedded bead radius is approximately  $146 \pm 10\mu\text{m}$ . The beads were worn in the upper half bead size (Fig. 2.B).

Figure 2. Top view of the upper PE insert surface after micro-tomographic scan reconstruction. The dark area corresponds to the PE component and the brighter elements to the embedded beads (A). Side view of a worn bead exhibiting a flat apex (Geomagic Wrap, 3D System, Rock Hill, USA) (B).

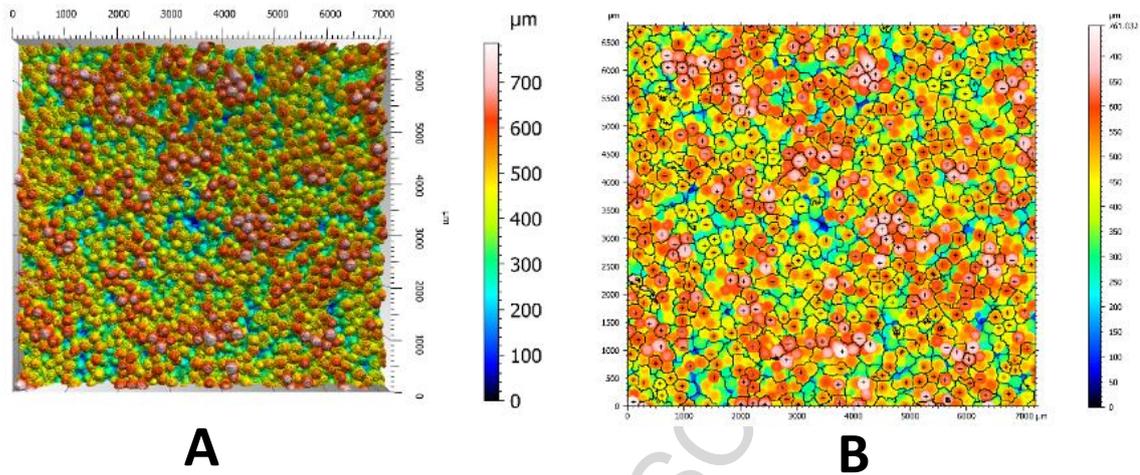
The porous metallic coating was measured by the Focus variation microscope. Then the beads were isolated by a method based on the “wolf-pruning” algorithm (Mountains Digital Surf™, Besançon, France). The method is detailed in the Appendix B. The mean diameter of the coating beads is  $241 \pm 13 \mu\text{m}$  (Fig. 3.A), relatively similar to the mean embedded diameter ( $292\mu\text{m}$ ) (Fig. 2.B). Therefore, the embedded particles are beads dislodged from the sintered CoCr implant coating. Some noise occurring around the beads after micro-tomography reconstruction (Fig. 2.A) is responsible for a bead size overestimation. Bead loosening in a TKR implant was reported by Rosenqvist *et al.* [13]: over 34 porous coated knee arthroplasties, 19 showed radiographic evidence of displacement of some beads. Moreover, a preferential failure site between beads and substrate was supported by the fatigue tests performed by Manley *et al.* [14].

Figure 3. Focus variation measurement of the yellow area (Table 1) on the femoral component coating (A). Bead diameter statistics were computed from the “wolf-pruning” method (B).

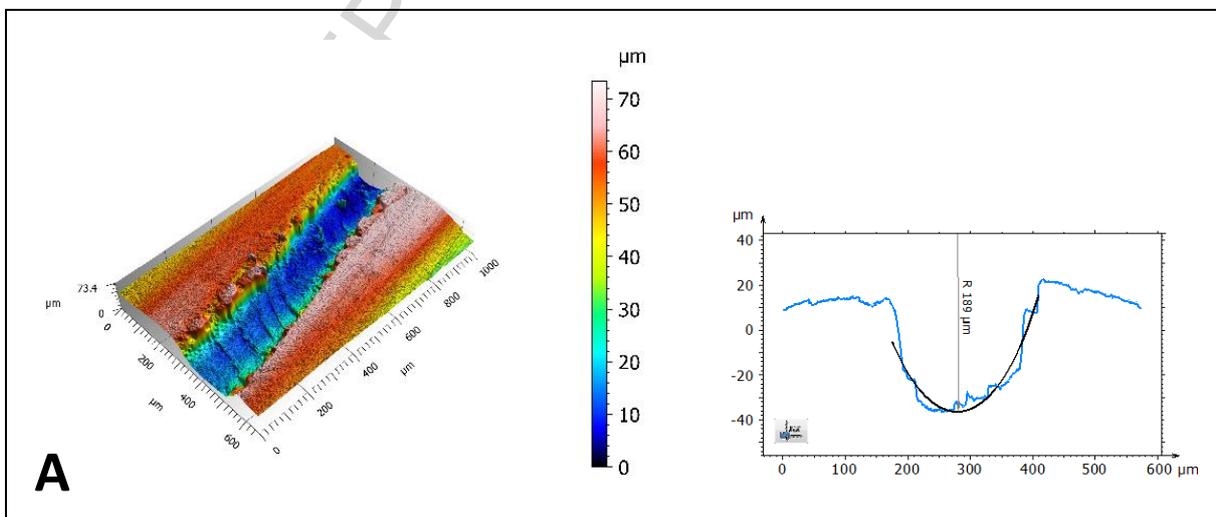
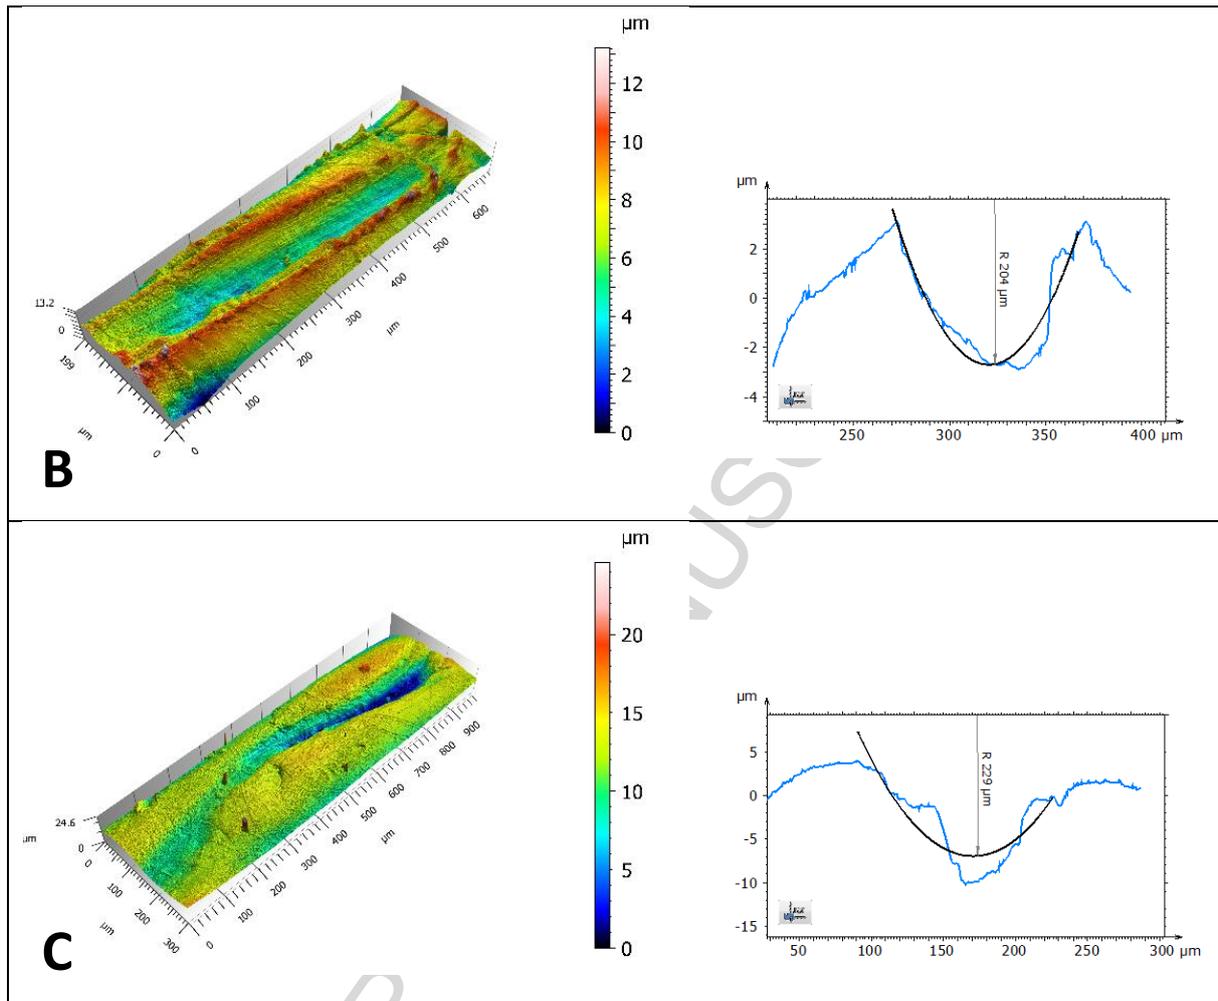
The area exhibited in the Table 1 was topographically investigated by Interferometer in order to discriminate features of interest. Thus, large scratches were captured on the PE insert surface (Fig. 4). A profile normal to the scratch direction was retained as characteristic of the scratch curvature. An arc segment representative to the scratch was defined on the profile. The arc is approximated by a circle by the method of least squares. The scratch curvature radius corresponds therefore to the radius of the approximating circle. Scratching is one of the most reported wear patterns on retrieved PE components [15]. Similar scratches on the PE surface were measured on SEM images [12] and exhibiting a width range between 200 and 100 μm [16].

Figure 4. Interferometric measurements and curvature radius computations of an antero-posteriorly oriented scratch (A), of a medially-laterally oriented scratch (B) and of a curved scratch (C).

The scratch curvature radii are approximately twice as large as the coating bead radii. However, it was shown that the curvature radii increase with the time due to the elastic and creep recoveries of a scratch, which tend to flatten the groove after passage of the tip [17]. The scratch radius is therefore expected to be initially close to the bead radius. These scratches are generated by the PE abrasion of CoCr beads dislodged from the porous coating. Basically, this wear pattern is caused by a third body abrasion between the CoCr femoral component, the CoCr bead and the PE insert. Third-body abrasion by dislodged coating beads was also reported by Goodman *et al.* [18]. When the bead motion is easily driven by the knee biomechanics, the resulting scratches exhibit a characteristic U shape, as shown for the Antero-posterior scratch (Fig. 4.A). Some skipping marks – characteristic of a scratch on a polymer surface [19] - are observed along the scratch track (Fig. 4.A). They were also captured on pin tests and retrieval bearings [12]. Atwood *et al.* [12] reported their “*plastic gouging appearance*”. They result from a ratchetinglike mechanism, in which the bead tends to partially embed in the PE matrix as long as a force drives it to roll in order to further scratch the polymer surface [12].

Interestingly, a couple of scratch paths is uncorrelated with the biomechanical motion of the articulating surface (Fig. 4.B.C). However, these scratches exhibit remarkable features: curved scratches (Fig. 4.C) and for the most inert beads, the resulting scratch pattern consists of holes separated by necks (Fig. 5).

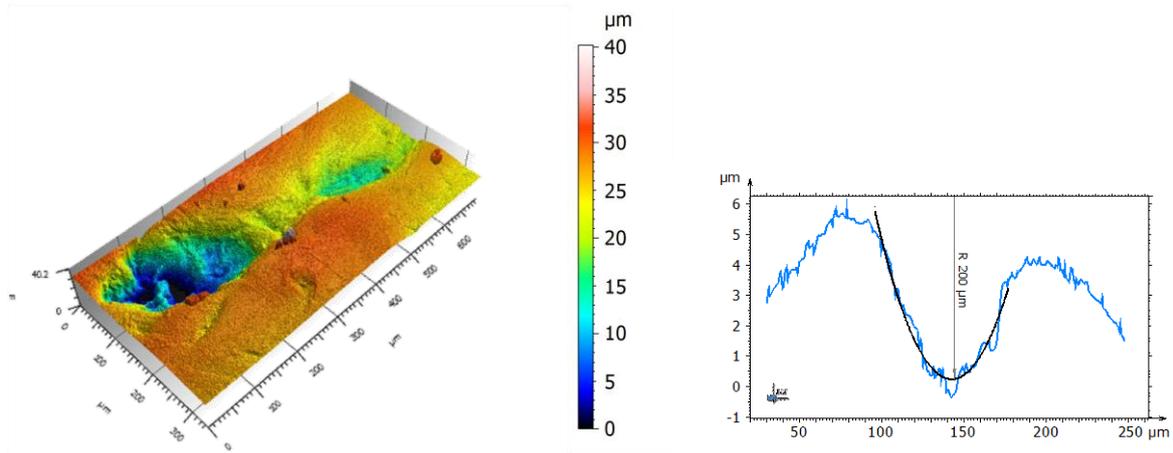
Figure 5. Topography of two holes in the PE surface captured by Interferometer (left). Curvature radius determination on the neck between the two holes (right).

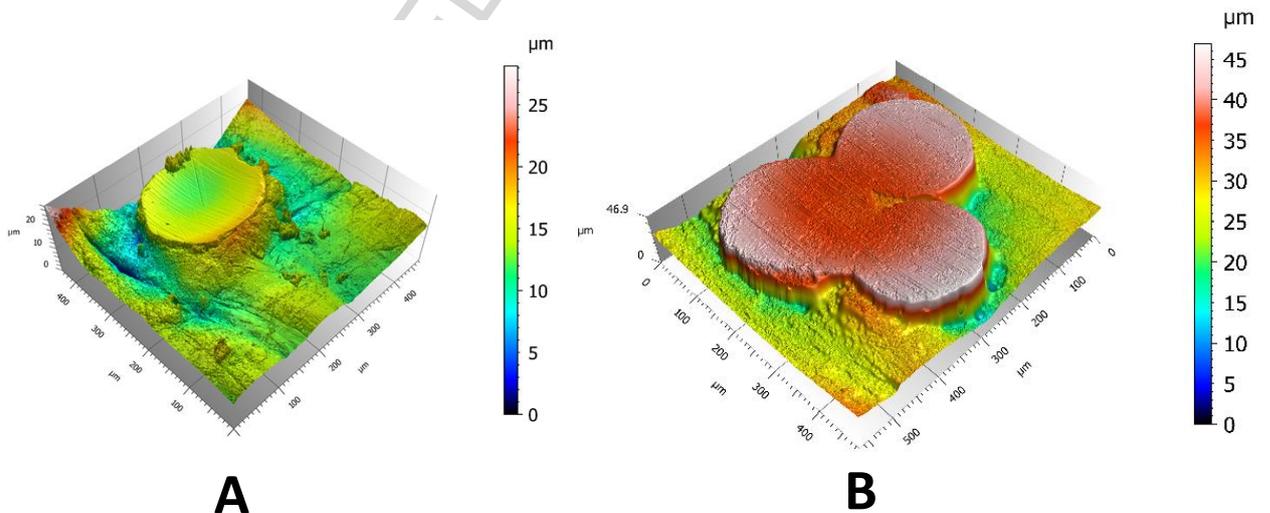
After scratching the mobile bearing, beads or agglomerates of beads bound by sintering embed in the PE matrix (Fig. 6), as demonstrated by Atwood *et al.* [12] performing a pin-on-flat test with a 100 $\mu\text{m}$ -sized CoCr bead and reported in numerous retrieval studies [15]. While bead pushing into the PE bulk, the polymer creeps to fill the depression caused by the bead resulting in an intimate embedding of the bead in the PE matrix (Fig. 6).

Figure 6. Topographies of one sintering bead (A) or a sintering bead agglomerate (B) embedded in the PE surface.

According to the Figure 6, the worn beads feature two different wear patterns: the bead apex wears either into a curved form (Fig. 6.A) or into a tilted plane (Fig. 6.B). The mentioned apex curvature of some worn beads (Fig. 6.A) mirrors the form of the upper femoral component. Basically, after bead embedding, an abrasion occurs between the CoCr bead and the CoCr femoral component. In the same way, the embedded CoCr beads on the inferior surface of PE insert retrievals measured by Atwood *et al.* [12] are worn almost down to the PE level.

Moreover, the topographies of the worn bead surfaces exhibit a fine scratching pattern characteristic of a small-scale abrasion process (Fig. 6). The abraded bead surfaces highlight 0.1 $\mu\text{m}$ -high anisotropic ridges (Fig. 9.A). They are mostly directed along the Antero-posterior axis, as highlighted by a major groove orientation of 94.8° (Fig. 9.B), consistently with the observations of Atwood *et al.* [12]. Two significant orientation deviations are observed at + 31° and at - 41° in the spectrum (Fig. 9.B). Zarins *et al.* [20] reported that between 30° and 90° of flexion, knee rotation angles range from + 25° to - 45°, including then the two measured angular deviations. Therefore, these transverse scratches might result from another abrasion mechanism occurring at maximally-rotated knee configurations, which are potentially highly-constraining.

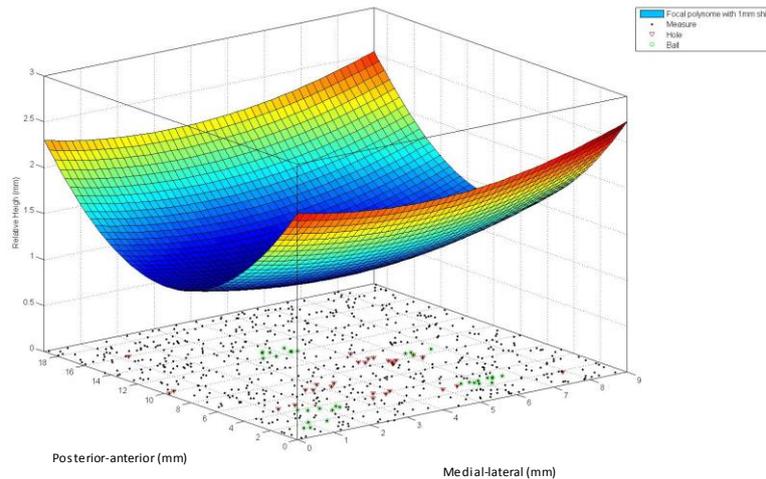
The detected embedded beads or holes are represented in a measurement matrix (Fig. 7). 27 holes and 32 beads were captured on the sample surface described in the Table 1. This approximate equal number of holes and beads may be explained by a wear-release bead mechanism: as highlighted by the micro-tomographic measurements, the beads are worn in the upper pole. Consequently, when the wear, assumed to be continuous and constant with the time, occurs below the medium plane of the bead, the bead would be released from the PE matrix, generating a hole.

Interestingly, beads are mostly embedded on the posterior side of the area of interest.

Figure 7. Schematic representation of the feature positions measured by Interferometer on the red area (Table 1). The focal polynome is expected to match the curvature of the area of interest.

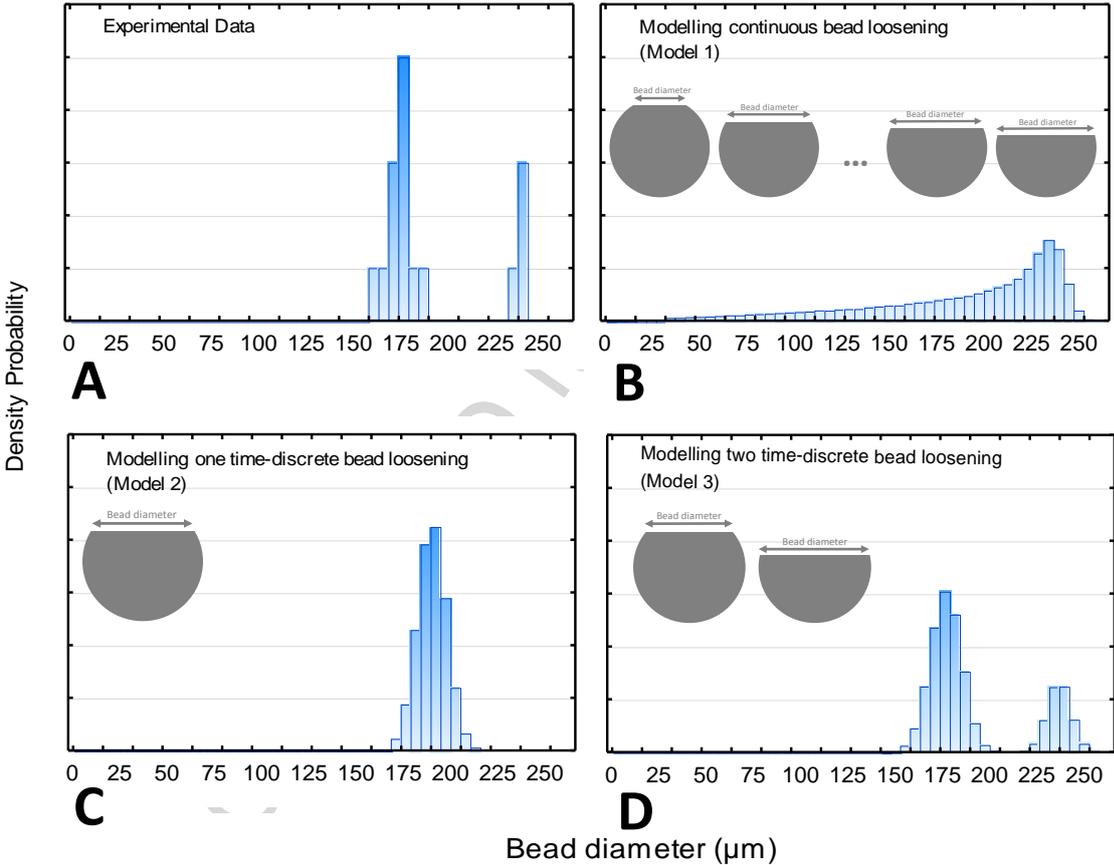
In order to quantify bead wear, the apparent embedded bead diameters were measured on the topographies by interferometry. The mean embedded bead diameter ( $190 \pm 30\mu\text{m}$ ) is lower than the coating bead diameter ( $241\mu\text{m}$ , Fig. 3) because, as mentioned previously, the bead embedding occurs in more than the half of the mean bead height. Moreover, the worn apparent bead diameter distribution features two distinct populations centered around  $175\mu\text{m}$  and  $230\mu\text{m}$  (Fig. 8.A).

The Model 1 (Fig. 8.B) resulting in a uniform distribution of mean bead wear depths (Table 2) is discrepant with the measured diameter distribution (Fig. 8.A). As a result, the bead loosening is not

continuous with the time. The Model 2 outcomes present a unimodal distribution with a mean diameter of 190 $\mu\text{m}$  (Fig. 8.C), corresponding to a mean wear depth of 47 $\mu\text{m}$  (Table 2). The Model 3 exhibits two modes centered around 175 $\mu\text{m}$  and 230 $\mu\text{m}$  (Fig. 8.D) and two mean bead wear depths (39 $\mu\text{m}$  and 101 $\mu\text{m}$ ) (Table 2). As the generated distribution from the Model 3 is consistent with the experimental distribution (Fig. 8.A), the assumptions of the Model 3 seem to be more trustworthy than the ones of the Model 2. Consequently, the bead loosening might therefore occur at two different periods. Consistently, Atwood *et al.* [16] suggested that a second different particle population might be released at a later time.

Figure 8. Measured and simulated worn bead diameter distributions using SAS software (SAS Institute, Cary, USA). Schematic representations of the mean wear depths of the beads.

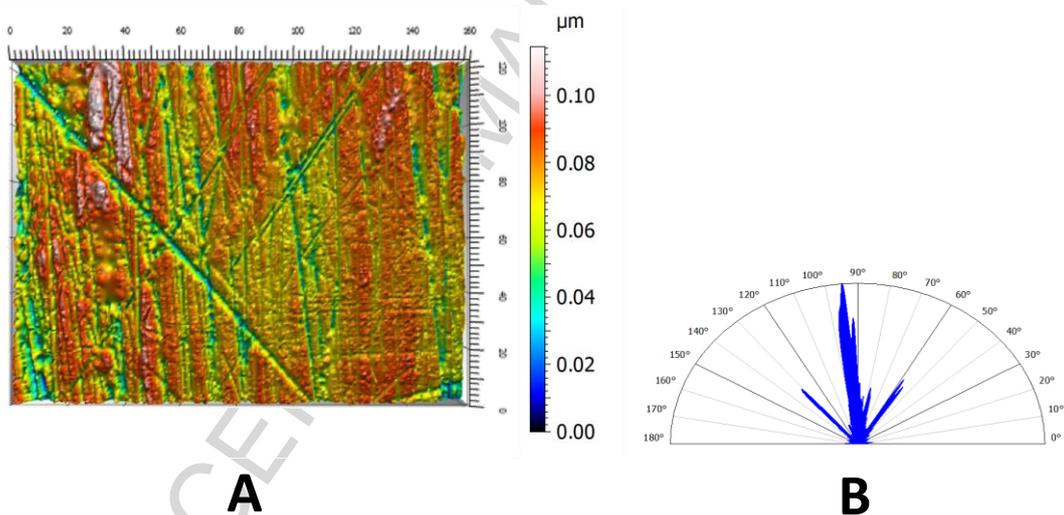
Figure 9. Anisotropically-abraded bead surface roughness (A). Isotropic rose quantifying the groove orientations (B).

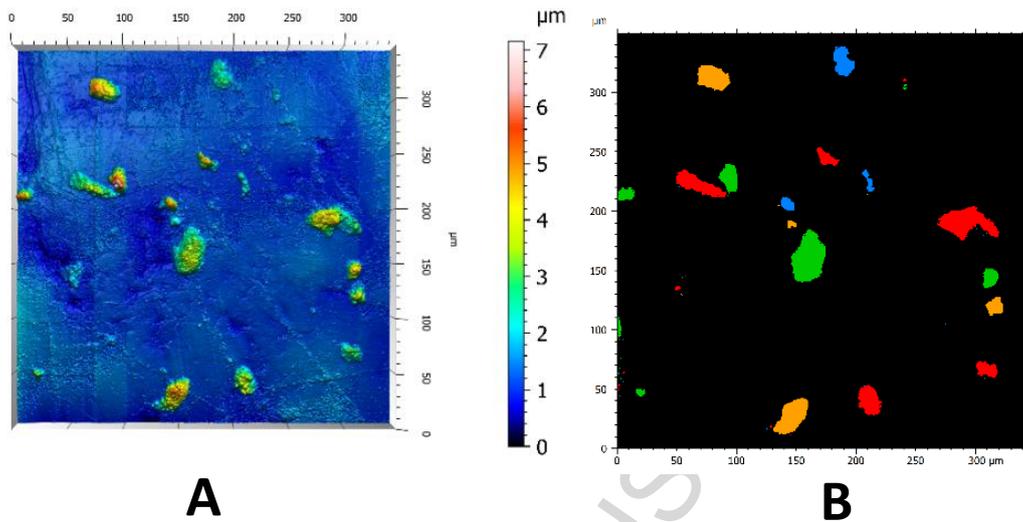
The retrieved PE surface was further investigated at smaller scales. Some debris are observed on the polymer (Fig. 10.A). A segmentation procedure (Mountains Digital Surf™, Besançon, France) is performed to compute a mean debris equivalent diameter of 18 $\mu\text{m}$  (Fig. 10.B). The segmentation procedure consists in thresholding the surface with a material ratio of 1.5%.

Figure 10. Interferometric measurement of a debris population on the PE surface (A). Debris diameter determination by surface segmentation (B).

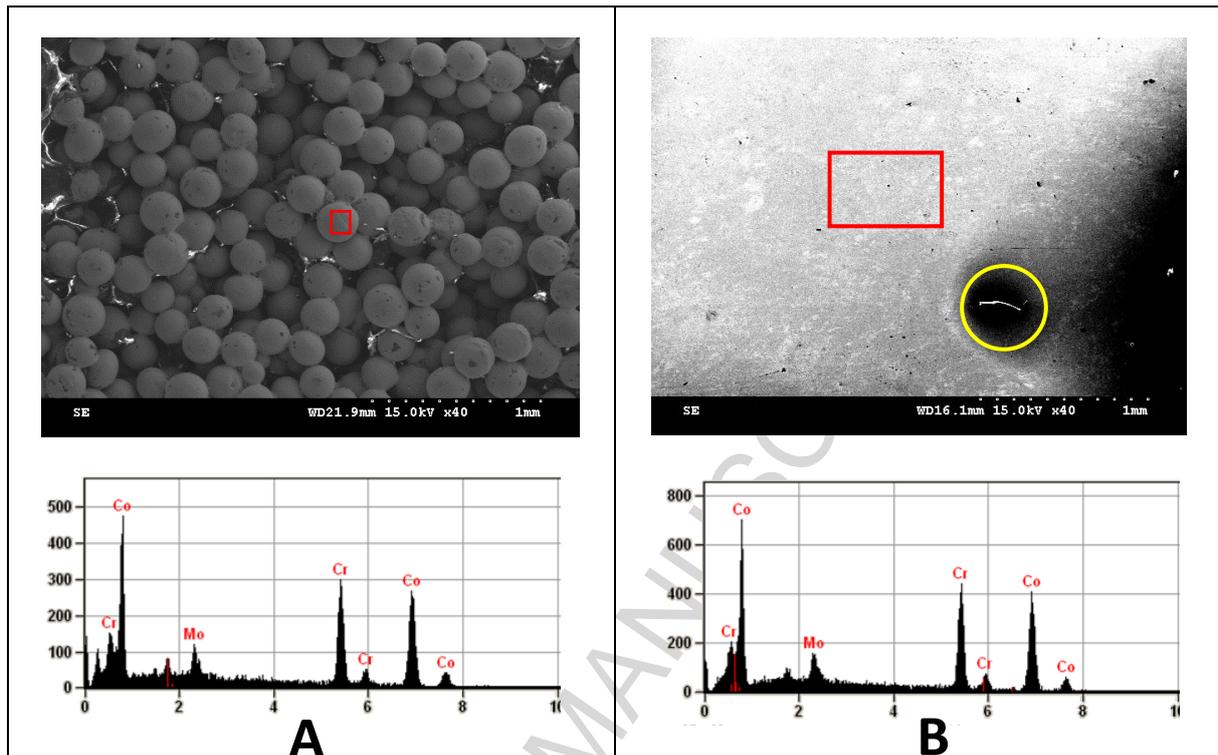
A EDX analysis was performed on an area exhibiting similar fine particles on the PE surface to quantify their chemical composition (Fig. 11.B). The area was chosen on purpose without bead. Comparatively, a same analysis was performed on a bead of the femoral component coating (Fig. 11.A). As a result, the particles have the same chemical ratios as the coating bead (63% Cobalt, 31% Chromium, 5% Molybdenum). Therefore, the measured particles on the PE surface were generated by the abrasion between the bead embedded in the PE liner – expected to be in the hole (Fig. 11.B) – and the metallic femoral component.

Figure 11. Comparison of the chemical element weight ratios measured on a coating bead (A) and on an area exhibiting fine particles on the PE surface (B). The red squares represent the field, on which the EDX analyses were performed. The yellow circle delimits the hole of a bead.

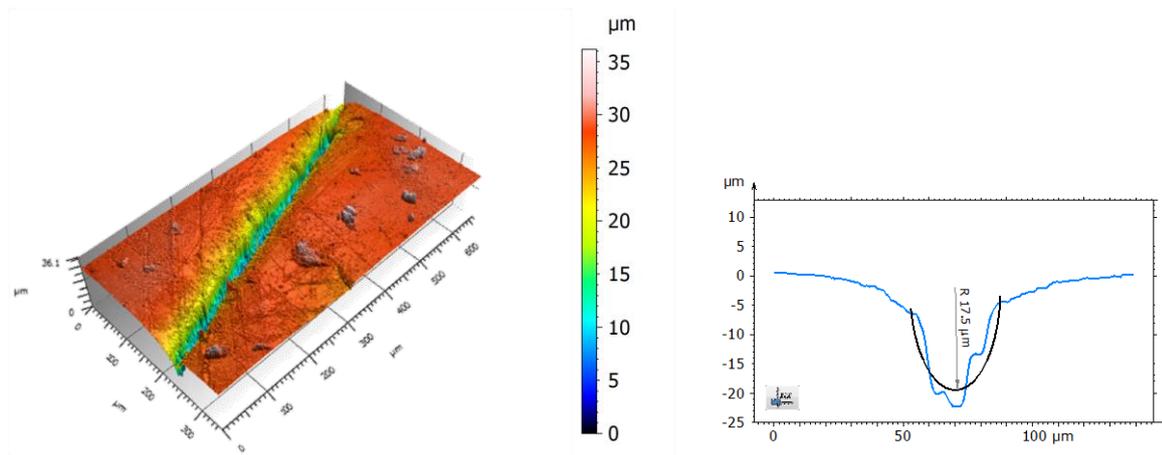
A further topographical investigation characterized the wear pattern of the "fourth body abrasion". Firstly, the metallic particles abrade the PE liner into some sharp-edged scratches (Fig. 12). Consistently, similar fine scratches 1 $\mu$ m to 10 $\mu$ m in depth and width, probably caused by fine and hard particles released from the metal component, were observed by Jasty *et al.* [10].

Figure 12. The first hallmark of the “fourth body abrasion”: fine scratches of the PE surface measured by Interferometer. The curvature radius of the scratch is computed.

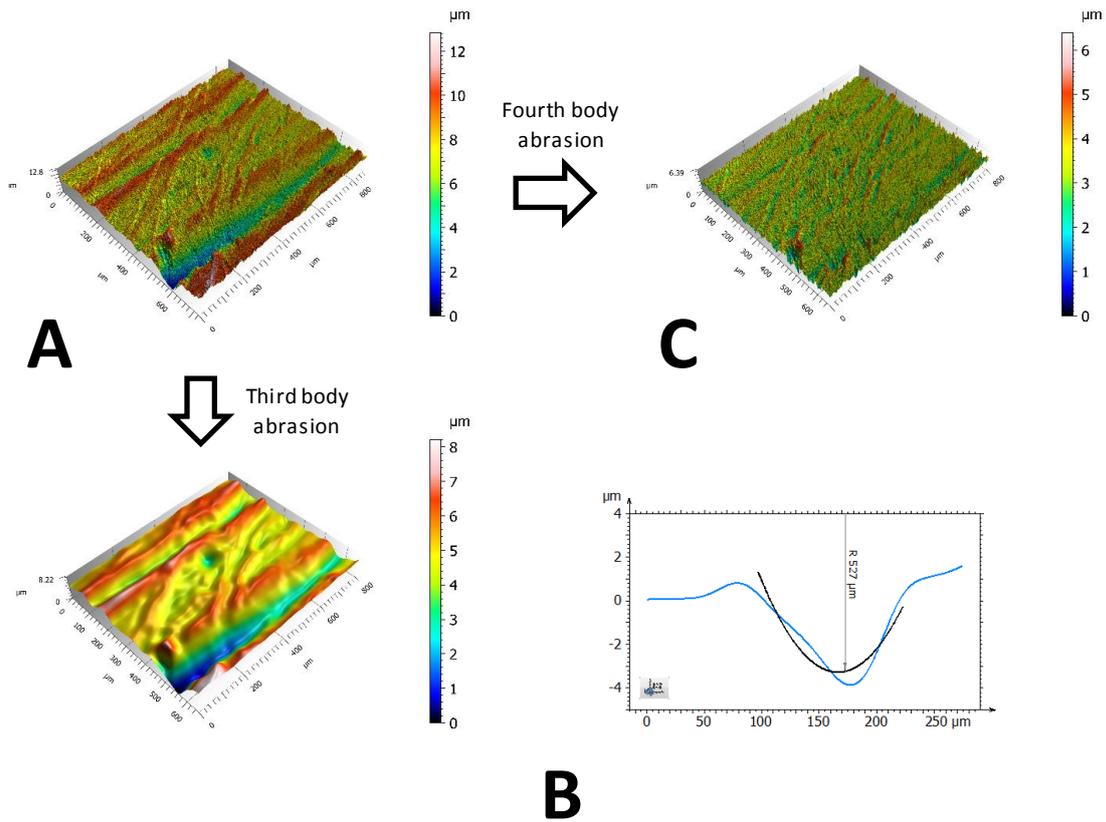
Sequentially, the “fourth body abrasion” is a second wear mechanism, occurring after bead scratching. On a surface exhibiting a complex wear pattern (Fig. 13.A), the two wear processes were decomposed by a topographical filter. A Gaussian filter (according to the ISO 16610-61 standard) with a cut-off wavelength of  $70\mu\text{m}$  was used. When the high frequencies of the surface are filtered, the large scratch and therefore the third body abrasion are highlighted (Fig. 13.B). Conversely, when the low frequential content of the surface is filtered, the small-scale roughness and therefore the “fourth body abrasion” are retained: shorter close scratches parallel to the large scratch direction (Fig. 13.C). These scratches result therefore from the abrasion of the PE by the metallic wear debris. Some curved scratches highlight a complex motion pattern of metallic debris. Furthermore, these two wear mechanisms may be interlocked, resulting in a significant wear of the large scratch, as suggested by a higher curvature radius of the large scratch (Fig. 13.B) than the ones previously reported (Fig. 4). Consistently, 69% (20/29) of the scratches was noted “*demonstrated a complex profile of peaks and valleys within the scratch cross section*” [16].

Figure 13. The second hallmark of the “fourth body abrasion”: wear of large scratch shapes. The third body abrasion (B) and the “fourth body abrasion” (C) were split by a filtering method on the original surface (A). The filter cut-off is  $70\mu\text{m}$ .

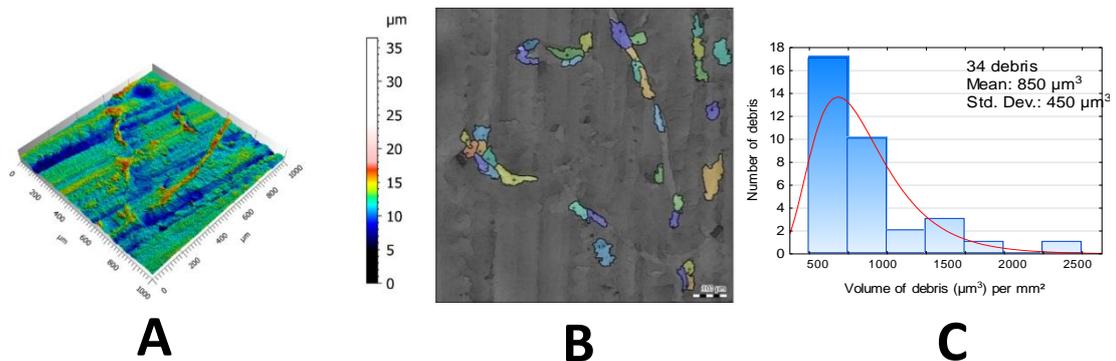
Finally, the metallic particle-induced abrasion generates PE debris agglomerates, shaped in large stripes (Fig. 14.A). A population of PE debris was isolated by the “wolf-pruning” method (Mountains Digital Surf<sup>TM</sup>, Besançon, France) (Fig. 14.B) in order to plot the mean debris volume distribution (Fig. 14.C). The method is detailed in the Appendix B. The mean debris volume was computed ( $850\mu\text{m}^3$ ). Consequently, by peeling the PE surface and by releasing such large PE debris, the “fourth body abrasion” is expected to be deleterious. An extensive scratching on the PE surface was also observed by Atwood *et al.* [12] on the retrievals. However, the worn pins did not support this hallmark because of the limited duration of the tribotest [12].

Figure 14. The third hallmark of the “fourth body abrasion”: PE debris agglomerate generation. Topography of a PE debris population (A). The “wolf-pruning” method (B) performed to compute statistical laws (C).

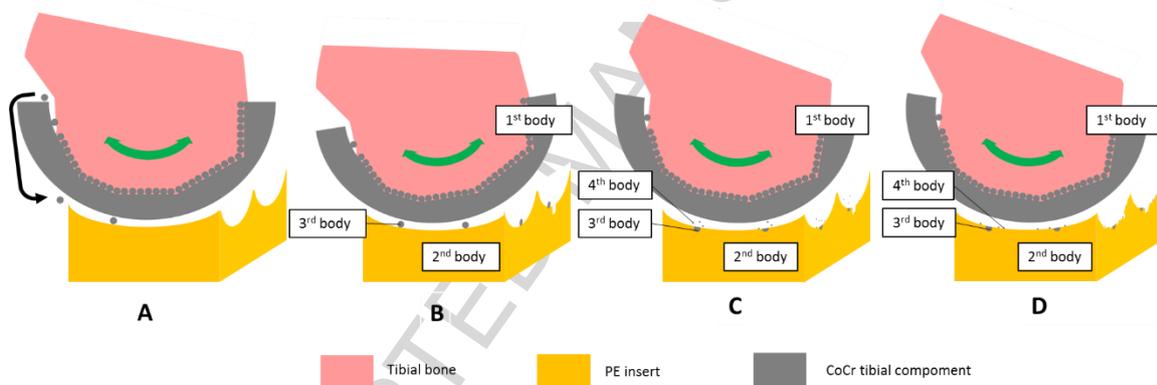
A wear mechanism of the PE insert superior surface, namely the «fourth body abrasion», was modelled from the topographical measurements of a TKR retrieval. The metallic bone ingrowth-promoting beads are liable to be released from the coating according to a discrete time frame and to be entrapped in the articulating interface (Fig. 15.A). Before being embedded in the PE component, the released beads generate large scratches on the PE surface (Fig. 15.B). Subsequently, the abrasion between the metallic surface of the femoral component and the embedded beads releases a population of metallic debris on the PE surface (Fig. 15.C). With the relative motion between the PE mobile bearing surface and the CoCr femoral component surface, these metallic debris are responsible for a “fourth body abrasion” of the PE surface: fine scratching pattern and PE debris agglomerates are then generated (Fig. 15.D)

Figure 15. Fourth body abrasion of the PE insert in a knee implant: Coating bead loosening and entrapment in the articulating interface (A), Third body abrasion of the PE insert: large scratches (B), Fourth body generation by abrasion of the coating beads embedded in the PE insert (C), Fourth body abrasion of the PE insert: smaller scratches (D)

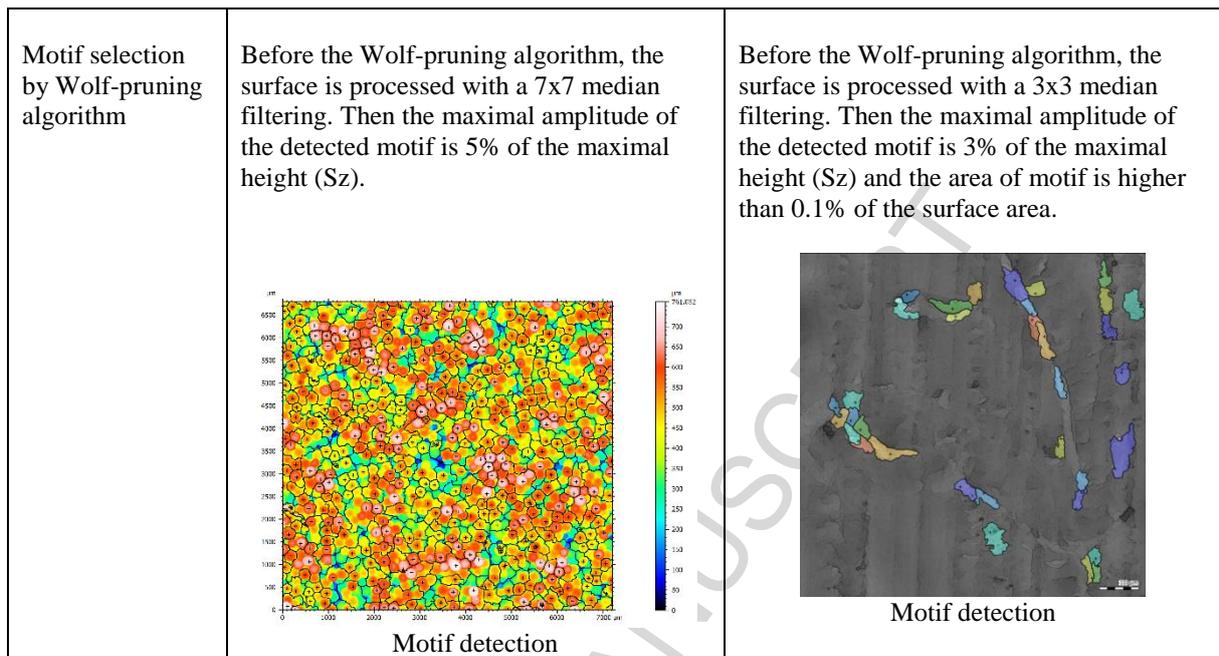
Fig. B.1 Two topographical procedures of the Wolf-pruning algorithm

| | Bead diameter | Wear debris volume |
|---|--|---|
| <p>Surface of interest</p> | <p style="text-align: center;">Coating beads of the femoral component</p> | <p style="text-align: center;">PE particles on the PE surface after "fourth body abrasion"</p> |
| <p>Orientating the surface, such as the first texture direction is vertically orientated</p> | <p style="text-align: center;">3D Auto-correlation function of the surface</p> <p style="text-align: center;">Associated anisotropic rose</p> <p>The surface is isotropic. No rotation is required.</p> | <p style="text-align: center;">3D Auto-correlation function of the surface</p> <p style="text-align: center;">Associated anisotropic rose</p> <p>The surface exhibits a major groove orientation at 11.9°. An anticlockwise rotation of 11.9° is needed.</p> |
| <p>Filtering the low frequency content (&lt;10% of the power spectrum via Fast Fourier Transform)</p> | <p style="text-align: center;">Filtered surface</p> | <p style="text-align: center;">Filtered surface</p> |

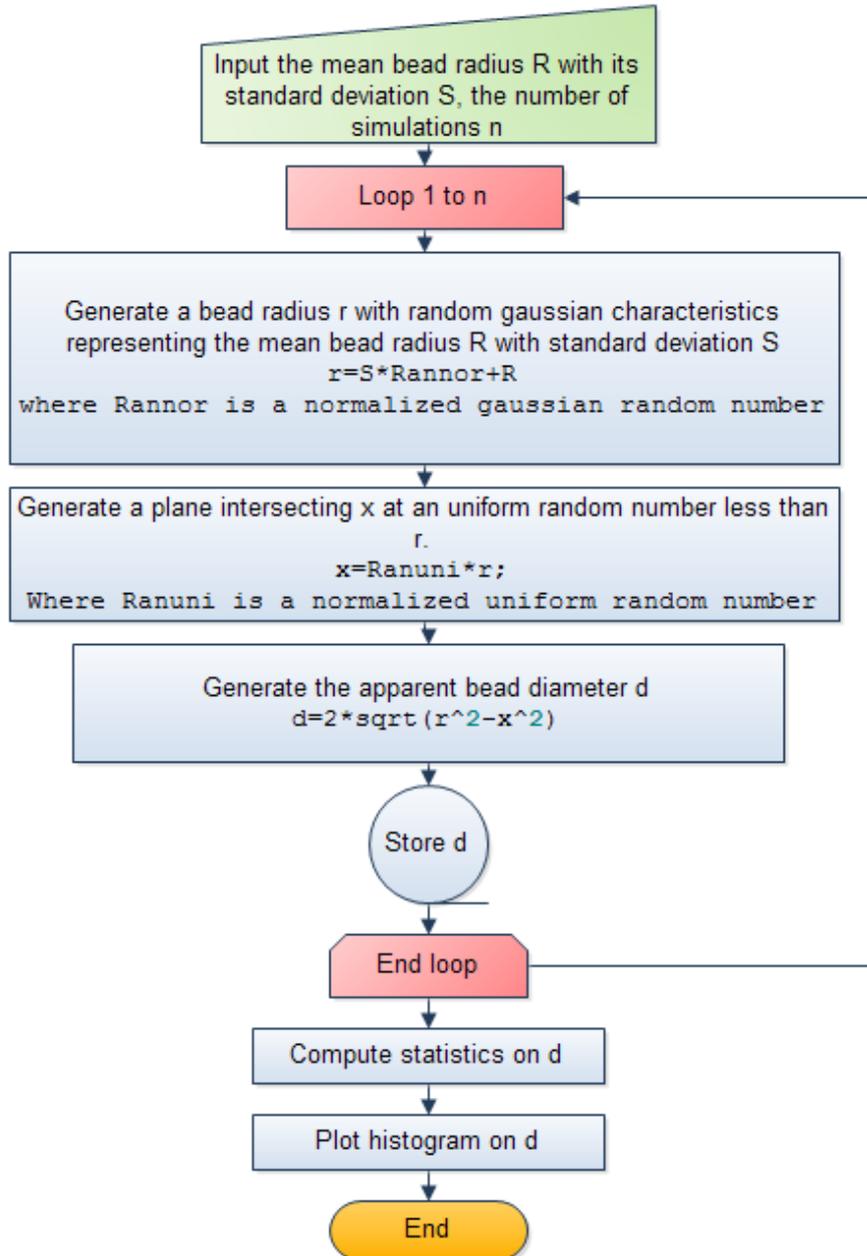
Fig. C.1 Algorithm of the Model 1

By simulating a random intersecting plane of the beads, the Model 1 simulates a continuous bead loosening with the time. The loop will generate a population of beads ( $n = 160\,000$ ).

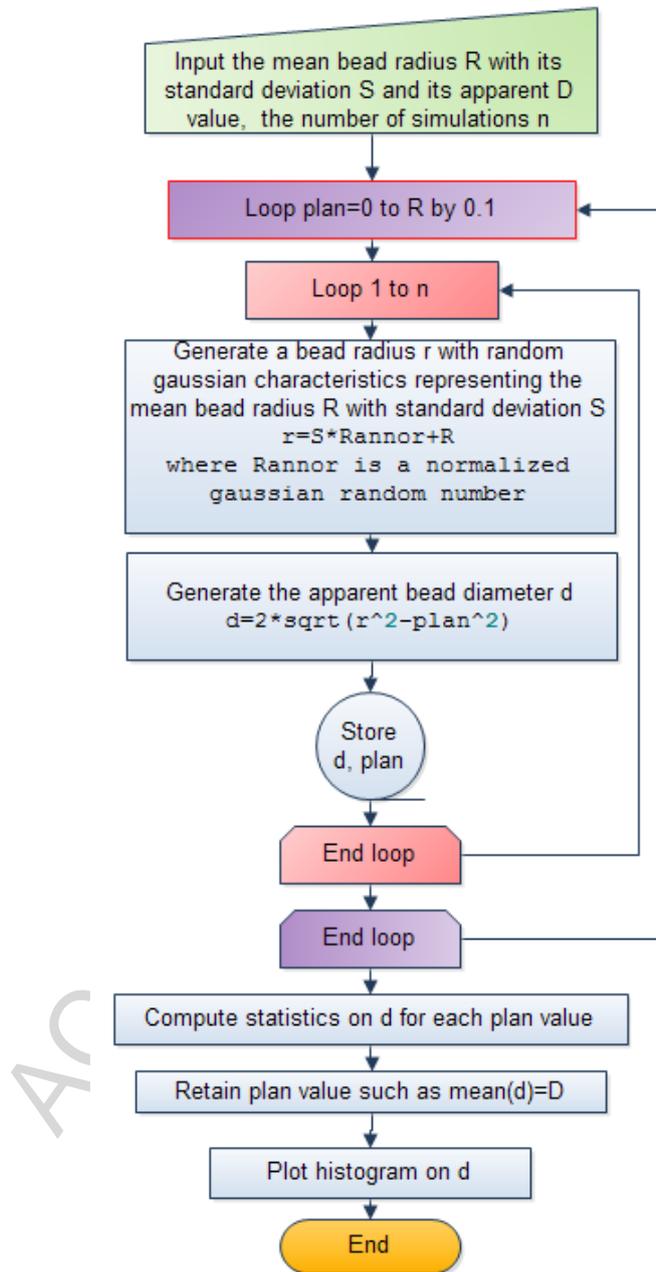
Fig. C.2 Algorithm of the Model 2

The Model 2 is based on a screening of the intersecting plane before generating the bead population ( $n = 160\,000$ ). By retaining only one plane, the Model 2 simulates a one time-discrete bead loosening.

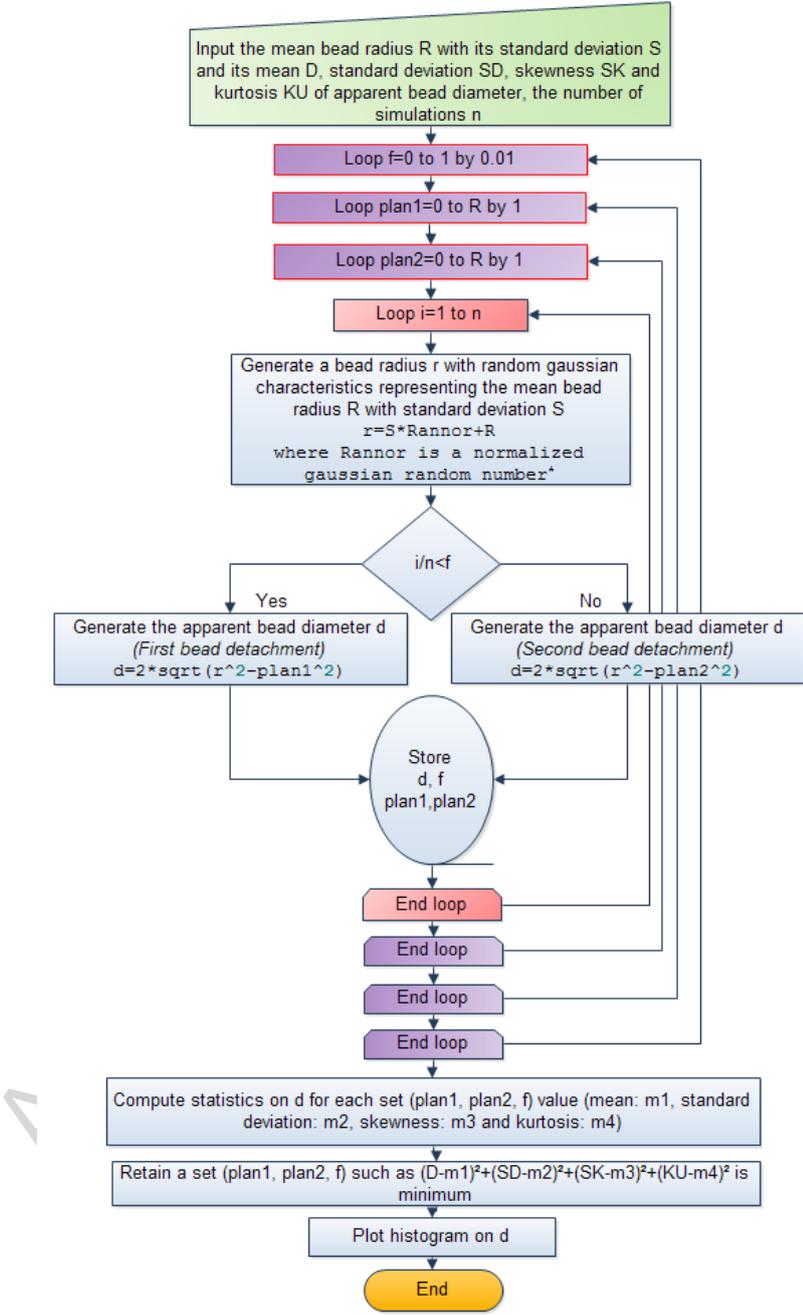
Fig. C.3 Algorithm of the Model 3

The Model 3 is based on a screening of two intersecting planes before generating the bead population ( $n = 160\,000$ ). By retaining only two planes, the Model 3 simulates a two time-discrete bead loosening.
